Hampshire Country Club Planned Residential Development
Village of Mamaroneck,
Westchester County, New York
Final Environmental Impact Statement

J Flood Gate Assessment

MEMORANDUM

To: Mr. Dan Pfeffer
From: Michael Junghans, PE
Kimley-Horn and Associates, Inc.
Date: 2018-09-07
Subject: Hampshire Country Club – Flood Gate Assessment

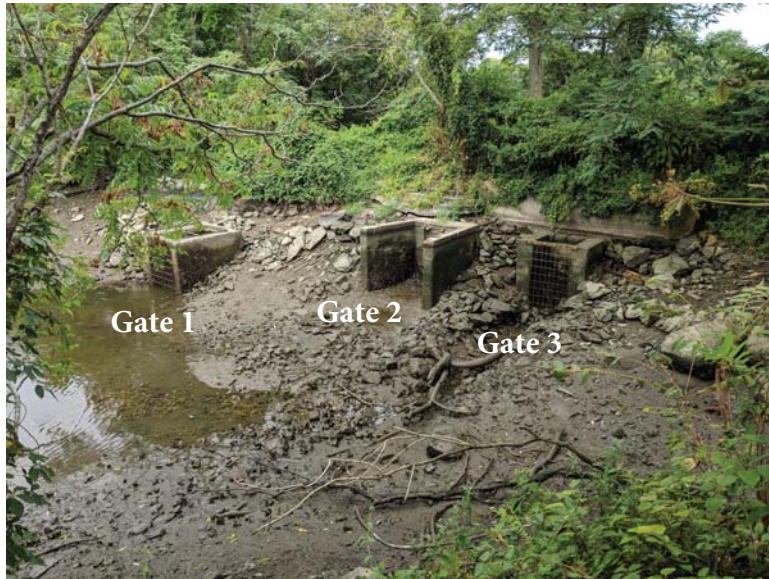
1. Delancey Cove Flood Gates

At Delancey Cove there are three flood gates, number 1, 2 and 3. All flood gates are hinged flap style gates. These flap gates are mounted on concrete headwalls at the end of three pipes that drain the southern portion of the site. The inspection showed that the three gates were in good working order. As presented in the pictures, all three gates were in the closed position during low tide. There were no obstructions or evidence of water being detained on site due to flood gate malfunction. I noticed the accumulation of minor debris in the vicinity of the gates due to tidal wash in and out of the cove. The minor debris was not impacting the gate operation.

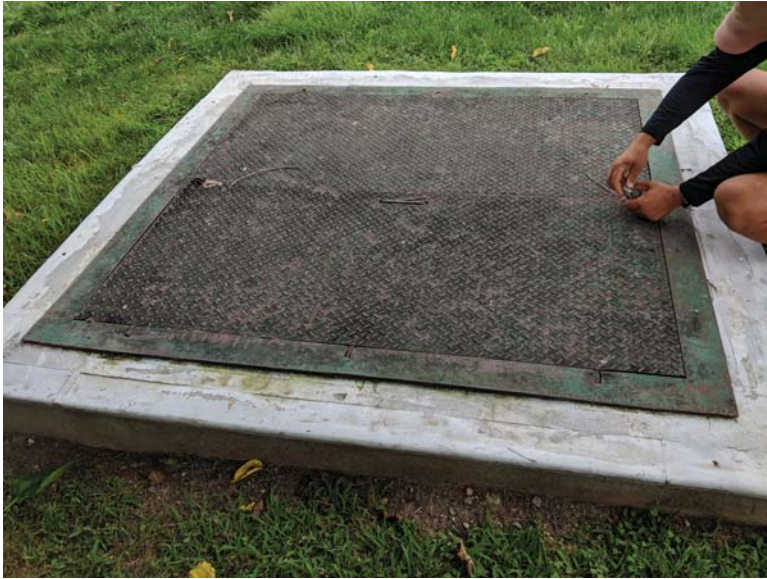
5. Flood Gate 4 Cover - Hommocks Field

At Hommocks Road there are two gates within subgrade concrete structures at the edge of the sports fields at Hommocks School. The gates are the same flap type as the gates at Delancey Cove. The structures are connected to pipes that discharge to the wetland area west of Hommocks School. The flood gates are mounted to the interior of the structure on the tide side of the discharge pipe from the site. The gates appear to be in excellent condition and do not appear to have any significant accumulation of debris. There were no obstructions or evidence of water being detained on site due to flood gate malfunction.
