# SECTION V HARBOR ISLAND - COAST GUARD BUILDING

## VILLAGE OF MAMARONECK MUNICIPAL FACILITIES SPACE NEEDS ASSESSMENT

# **COAST GUARD BUILDING PLAN**

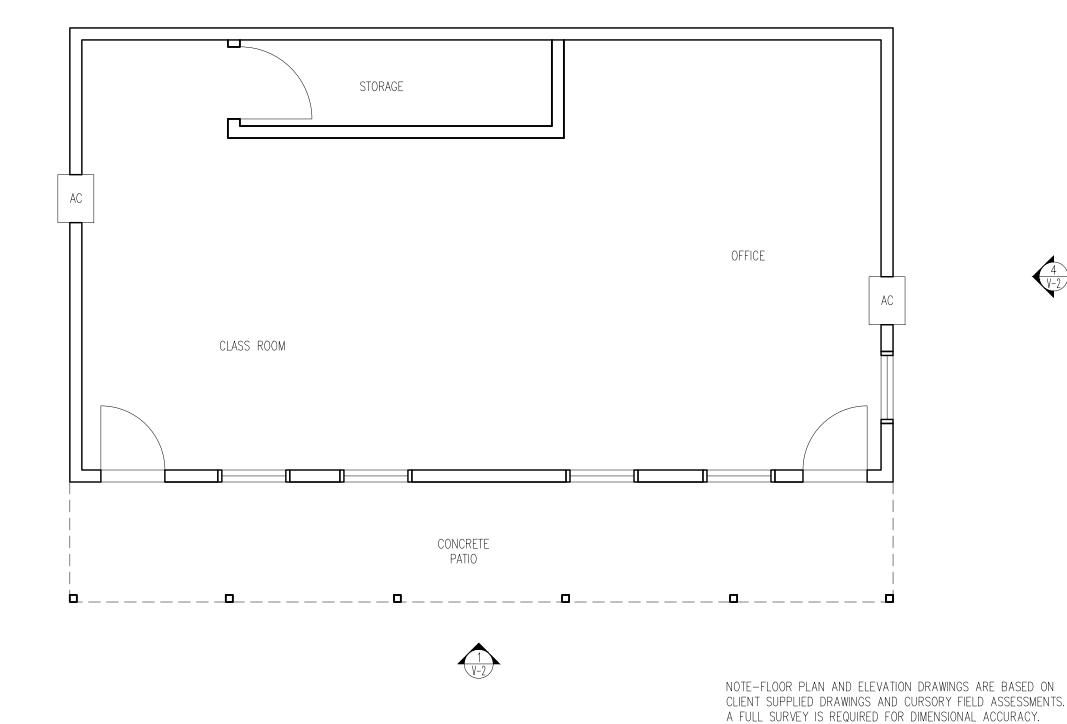
COAST GUARD BUILDING PLAN

The building does not comply with ADA since both of the doors have a step. Also there is a small step in the floor near the storage area.

- At minimum replace roof and provide accessible entrances to the building and storage area.
- Lack of toilet facilities also needs to be addressed. This can be handled by constructing a toilet building with men's and women's ADA compliant toilet rooms sized to serve the load of this building, the police building and the senior building. This could be a free standing structure or could be added to the senior building.
- A third option would be to completely remove all 3 buildings and provide a single structure that could provide for the functions of all three existing buildings and toilet facilities as well as be more appropriate to the park setting.

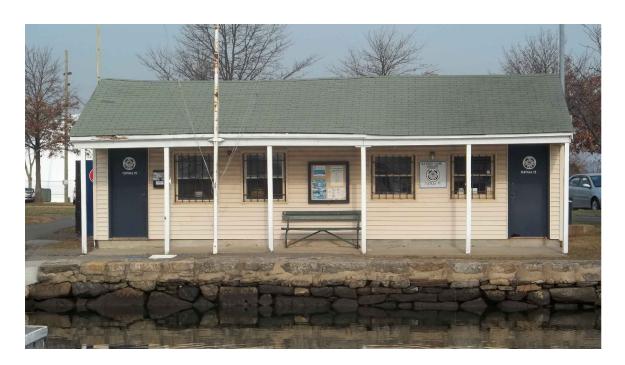
SOUTH ELEVATION NOT TO SCALE

The roof is in poor condition there is evidence of leaks and sections of the rake trim are damaged or missing. There is a noticeable sag in the ridge indicating that there may also be concealed structural problems.
