SECTION X
DPW GARAGE/OFFICES & TRANSFER STATION

BUILDING DESCRIPTION NARRATIVE

VILLAGE OF MAMARONECK
MUNICIPAL FACILITIES
SPACE NEEDS ASSESSMENT

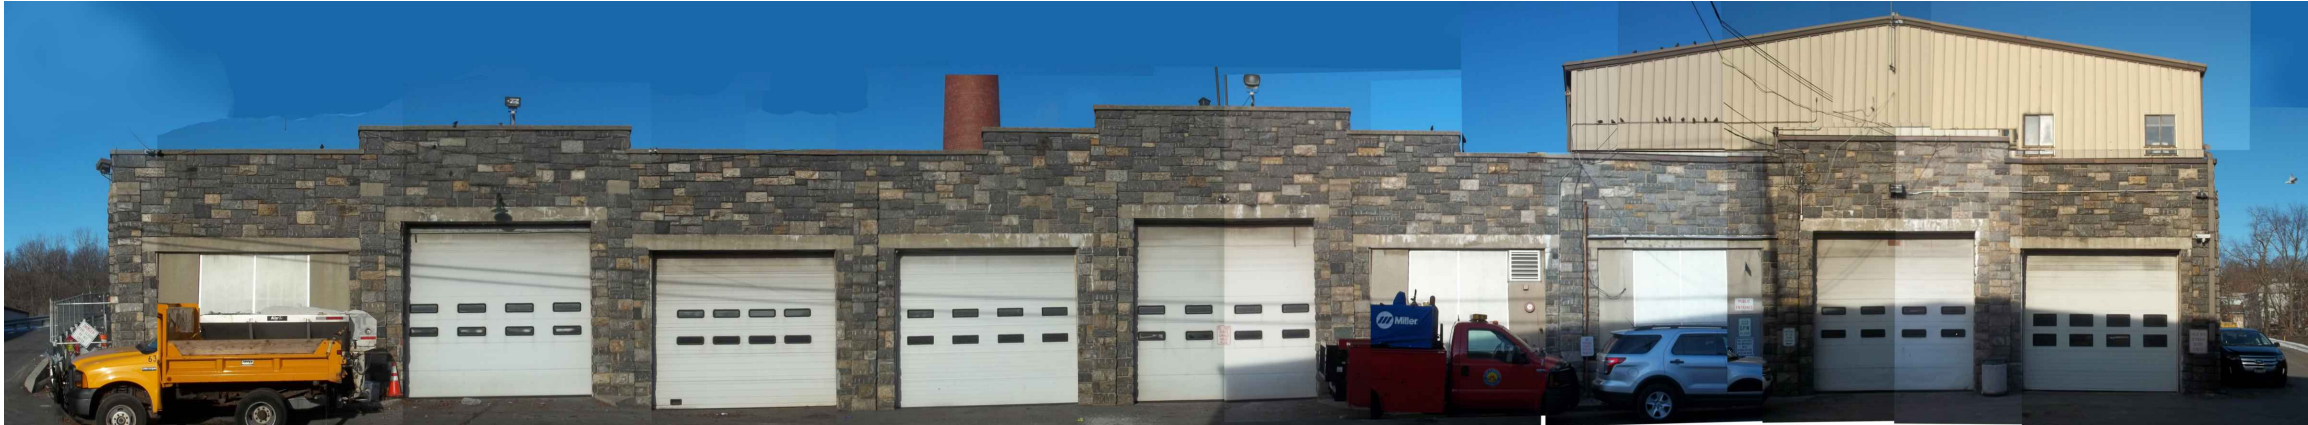
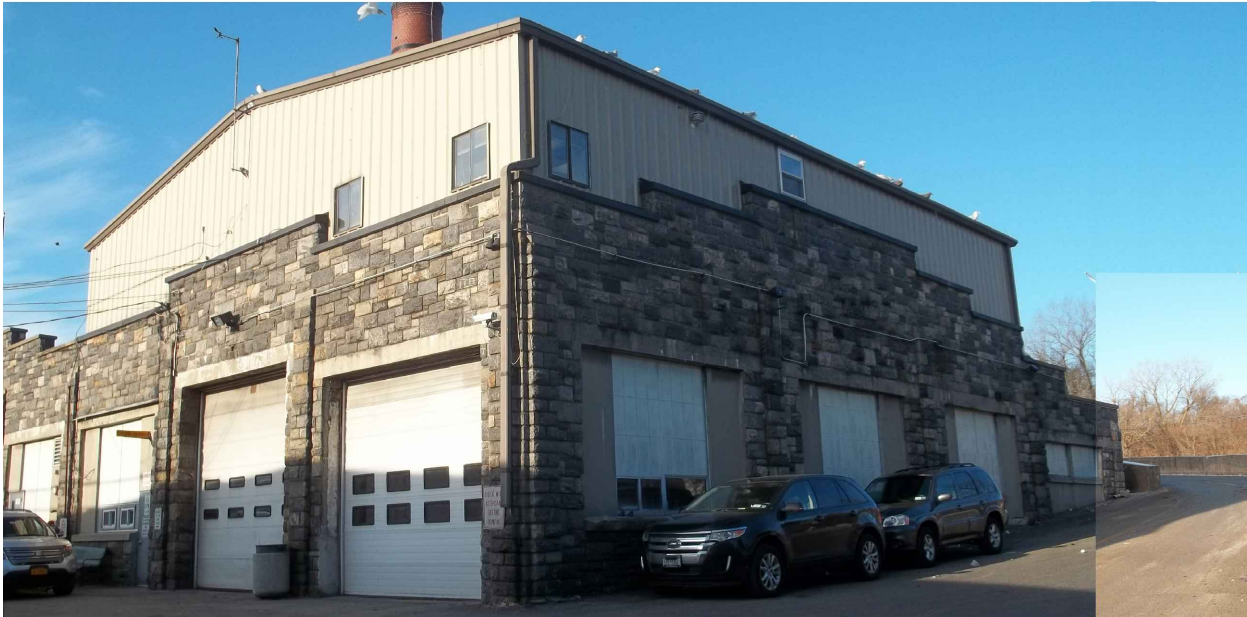
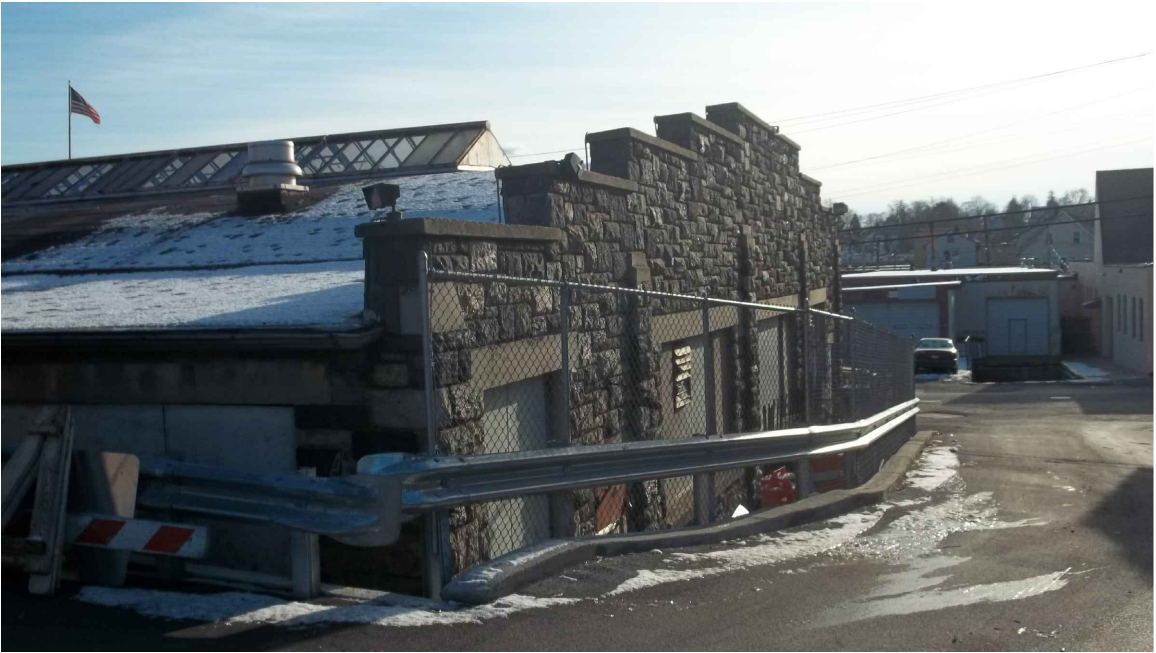
GARAGE / OFFICES
BUILDING ELEVATIONS

The exterior masonry and metal panels are in good condition.

The windows have been reconfigured and the opens have generally been made smaller and glass has been replaced with a translucent panel system. The parged masonry infill is in good condition as are the translucent panels and windows. There is a damaged louver on the west wall it should be replaced.

The exterior doors are in fair condition.

There were no visible leaks and none were reported so the roof is probable in fair to good condition as is the skylight.

The exterior catwalk and stair appear to be in fair to good condition.

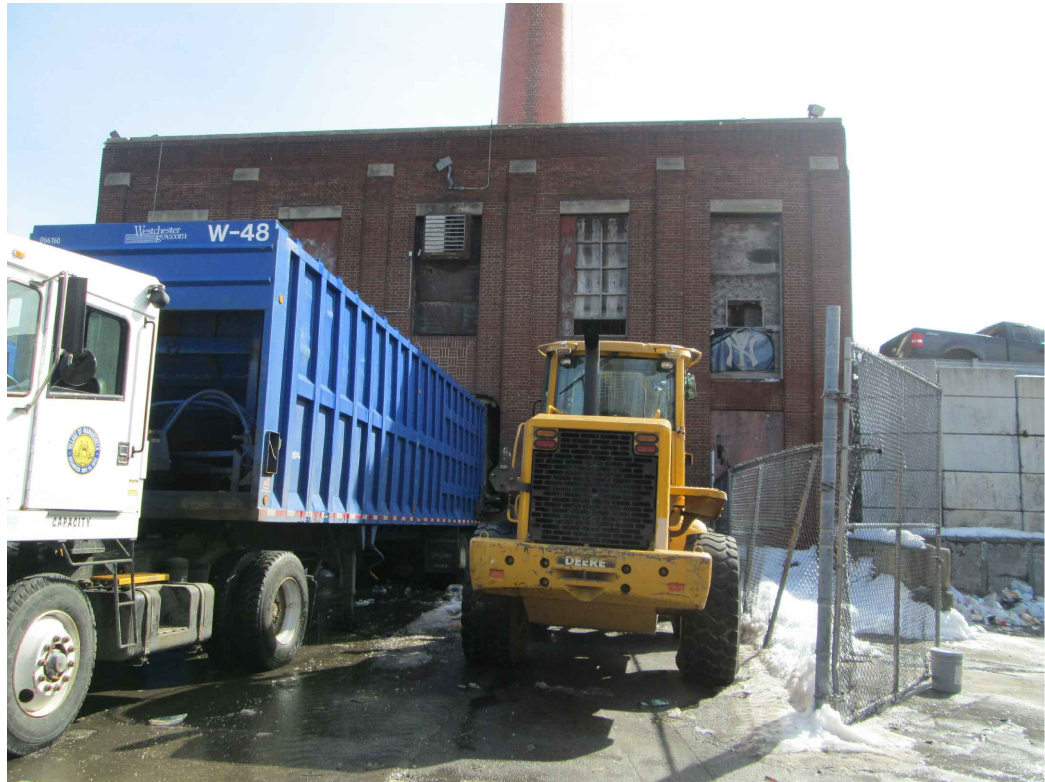
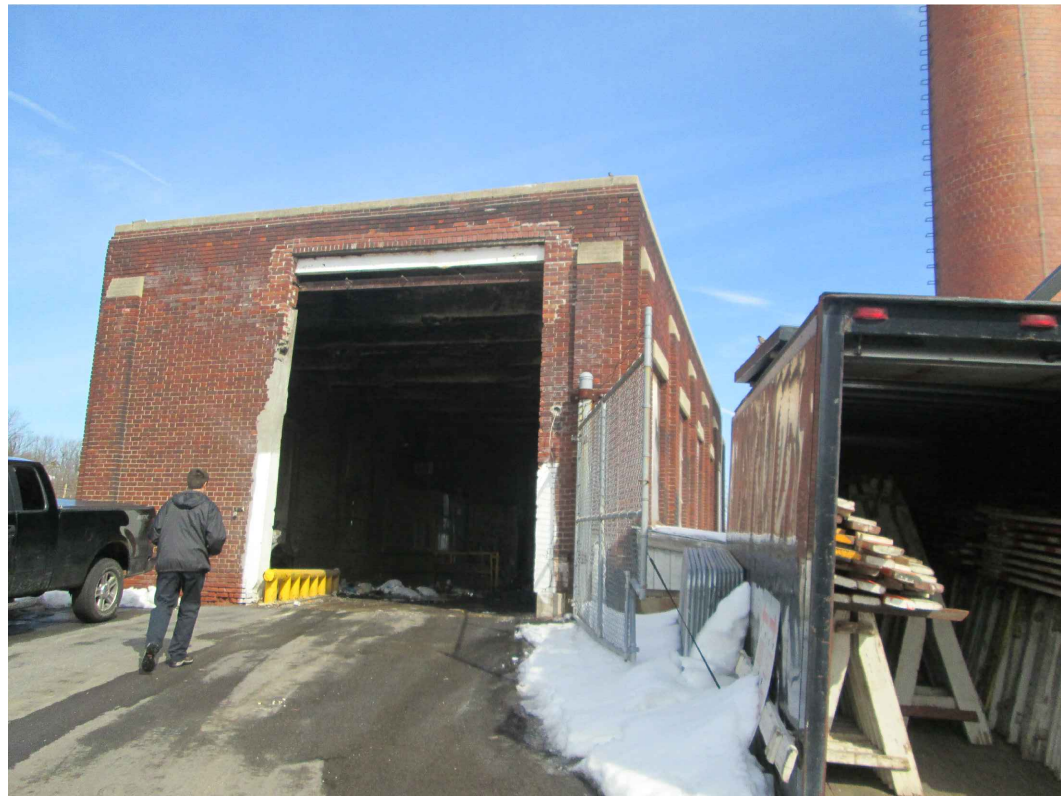
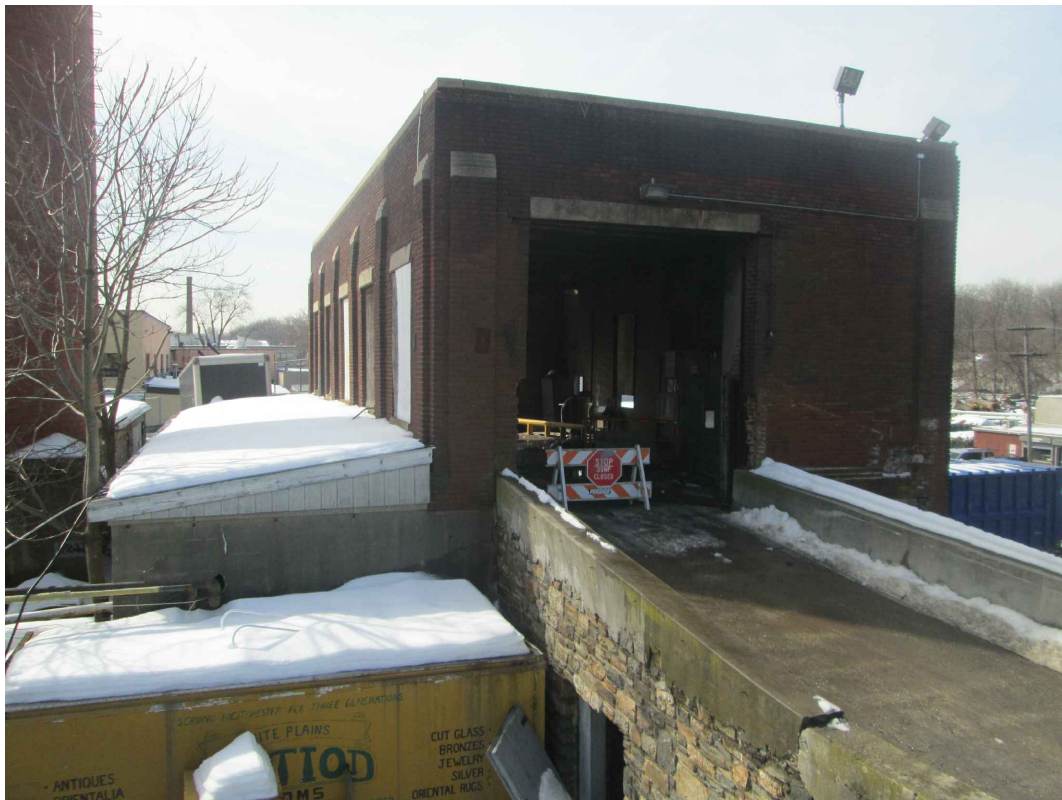
TRANSFER STATION
ELEVATIONS

The exterior masonry appears to be in fair condition.

The windows are almost all broken and have been covered with plywood.

The roof structure has been severely compromised most of the reinforcement in the bottom of the beams is exposed and one of the beams has had a section removed almost to the slab above. The steel core of this beam has also been removed. There is significant deflection in the roof slab at this area. A structural engineer should evaluate this situation to determine if the structural integrity of the building has been compromised to the point that it could be in danger of collapse.

There is a door to the space under the ramp that broken and needs to be replaced.

- Provide a new roof and make upgrades to ADA. Roof shall be set high enough to mitigate damage from compactor truck when they unload. Use of translucent roof panels could aid in reducing electrical consumption.

- Demolish existing structure and upper portions of ramps.
- Widen ramps and provide upper level ramps that are supported on columns so that space under them can be used for employee parking that is relocated from other side of street.
- Construct new 2 lane transfer station with staggered dump locations on upper level and staggered compactors below. Area below transfer station not used for compactors can be used for additional parking or recycling storage.
