**Draft VILLAGE OF MAMARONECK COMMITTEE FOR THE ENVIRONMENT
MINUTES OF November 15, 2022 MEETING**

PAUL SALCHERT, P.E.

VILLAGE OF MAMARONECK

1.1 Structure Location and Age

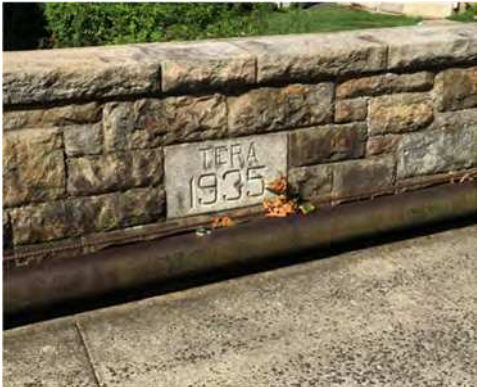
Figure 1-2: Presumed structure age based on etching on Southwest parapet.

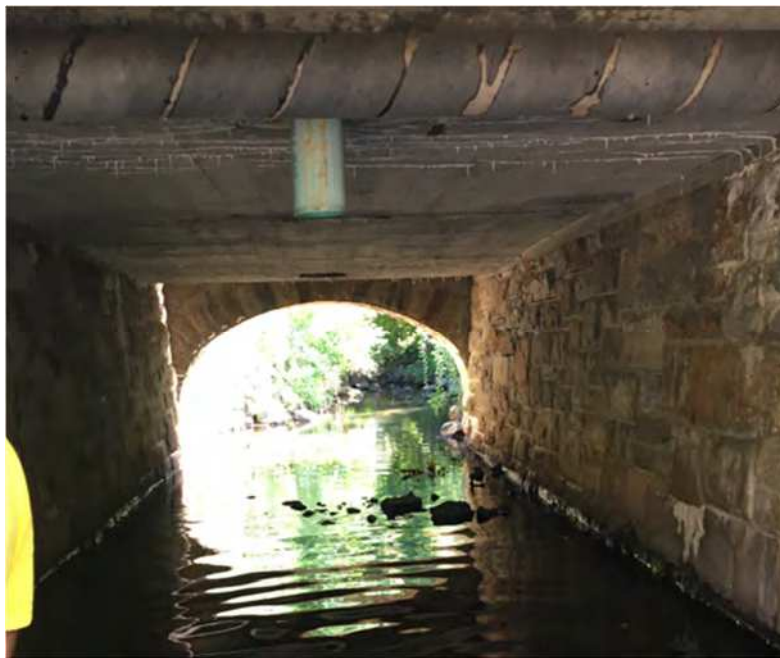
Figure 1-3: View of the inside of the culvert. Walls are stone masonry blocks and the top slab is reinforced concrete.

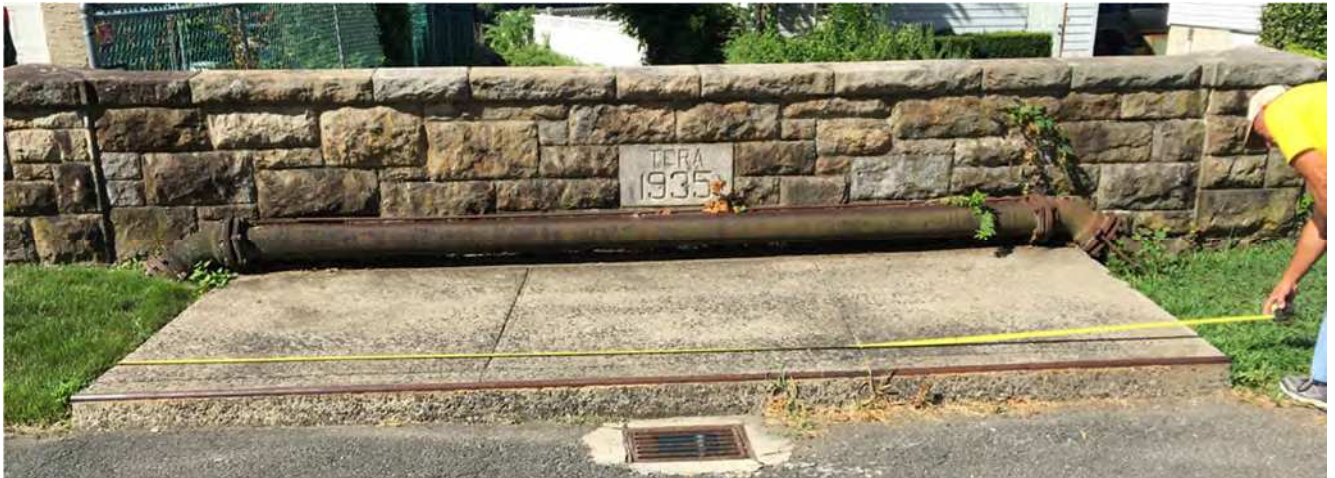
Figure 1-7: Sidewalk and stone masonry block parapet over the culvert. Note utilities and drainage over the culvert.

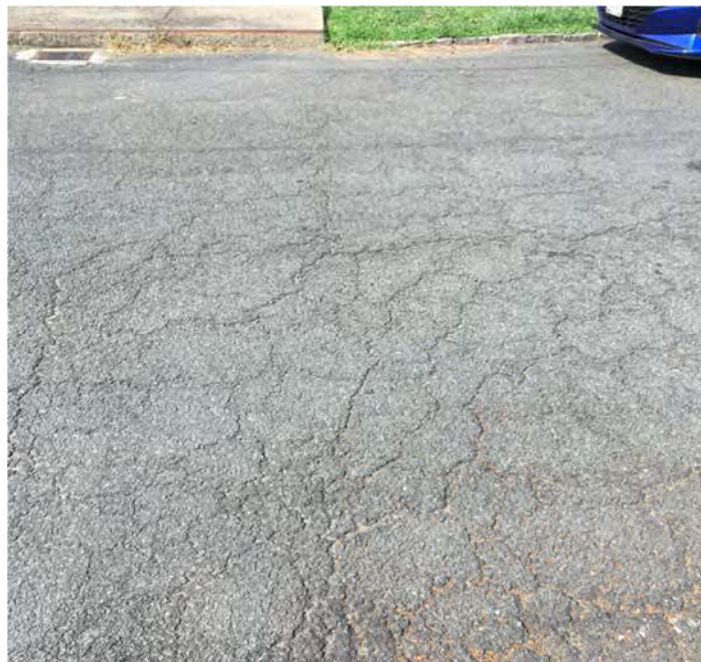
There are transverse cracks where the approach roadway meets the existing structure with an existent but negligible height difference between the approach and structure pavement (Figure 2-1). The cracks may be caused by natural settlement of the soil behind the culvert walls or from water mobilizing fill behind the culvert's masonry block walls. Rating: FAIR.

Figure 2-1: Transverse cracks forming at the structure and approach roadway intersection.

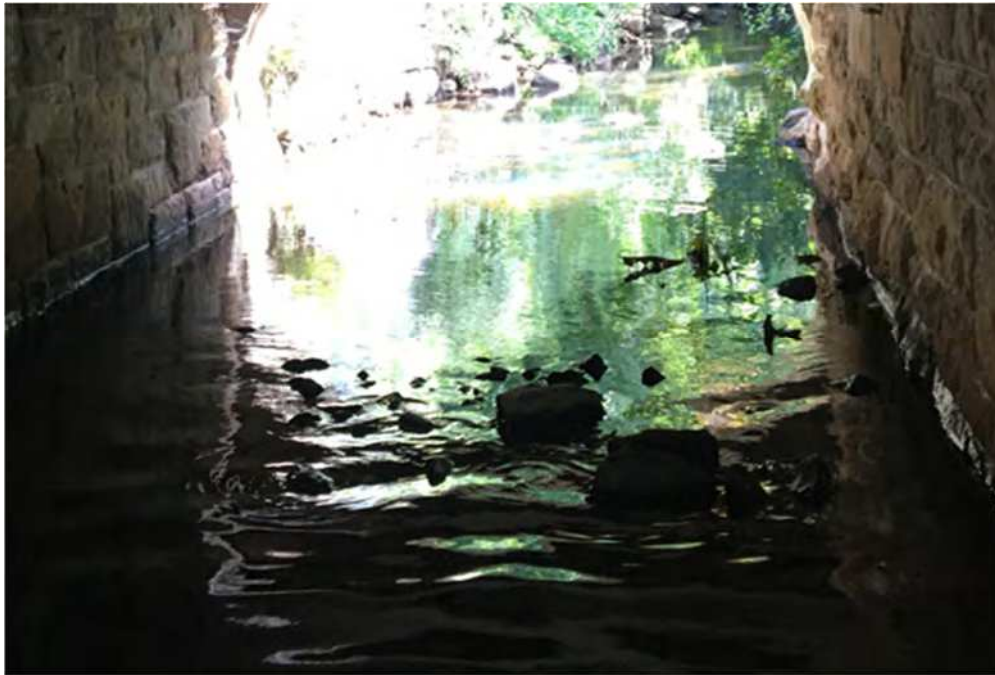
There are currently no signs of bank erosion within the brook. Scour holes were found primarily at the inlet of the culvert with the deposition from the holes being noticed shortly downstream, approximately midlength of the culvert (Figure 2-3). Rating: FAIR.

Figure 2-3: Displacement from scour holes causing a hump midlength of the culvert.

The streambed of the culvert will need to be replaced with a form of scour protection such as stone fill. The stone fill should start at the inlet of the structure and extend to the midpoint of the structure which is where the scour was observed.

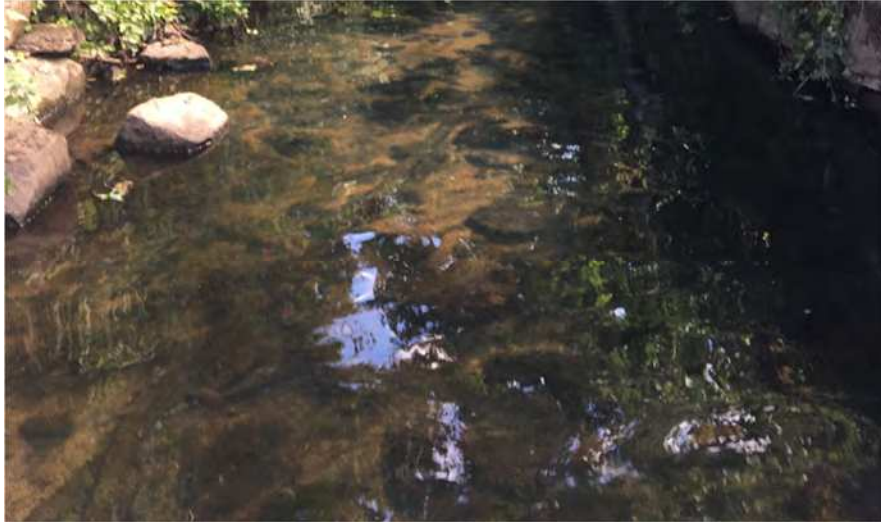
There are stones of various size throughout the channel, but they are limited in quantity and not enough to provide protection for the culvert (Figure 2-4). Rating: POOR.

Figure 2-4: Stones present immediately upstream of the culvert.

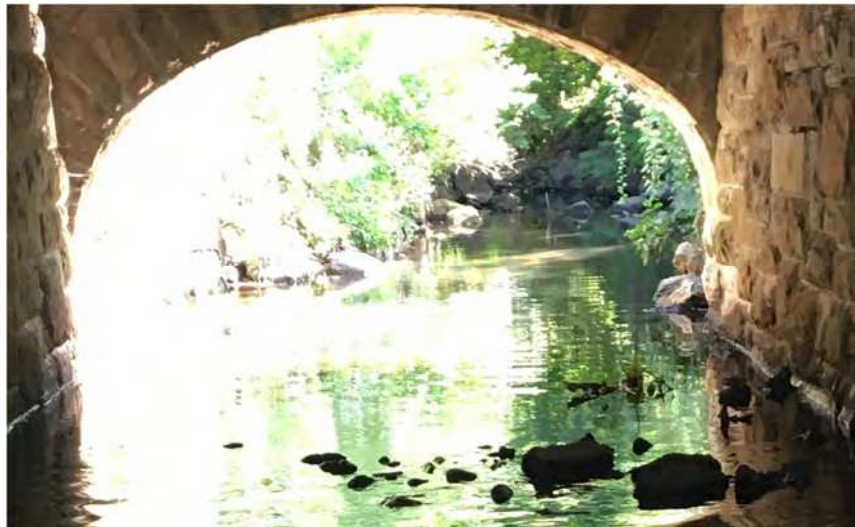
As previously mentioned, the deposition from the scour holes have caused crests and ridges near the inlet of the channel. This has caused sediment and debris accumulation, namely a large branch has been caught at the inlet (Figure 2-5). Other debris such as large portions of garbage were found within the brook. Although not causing significant issues now, there is potential for more debris to accumulate and clog the waterway if left unattended. Rating: FAIR.

Figure 2-5: View of sediment accumulation and portion of branch caught at inlet.

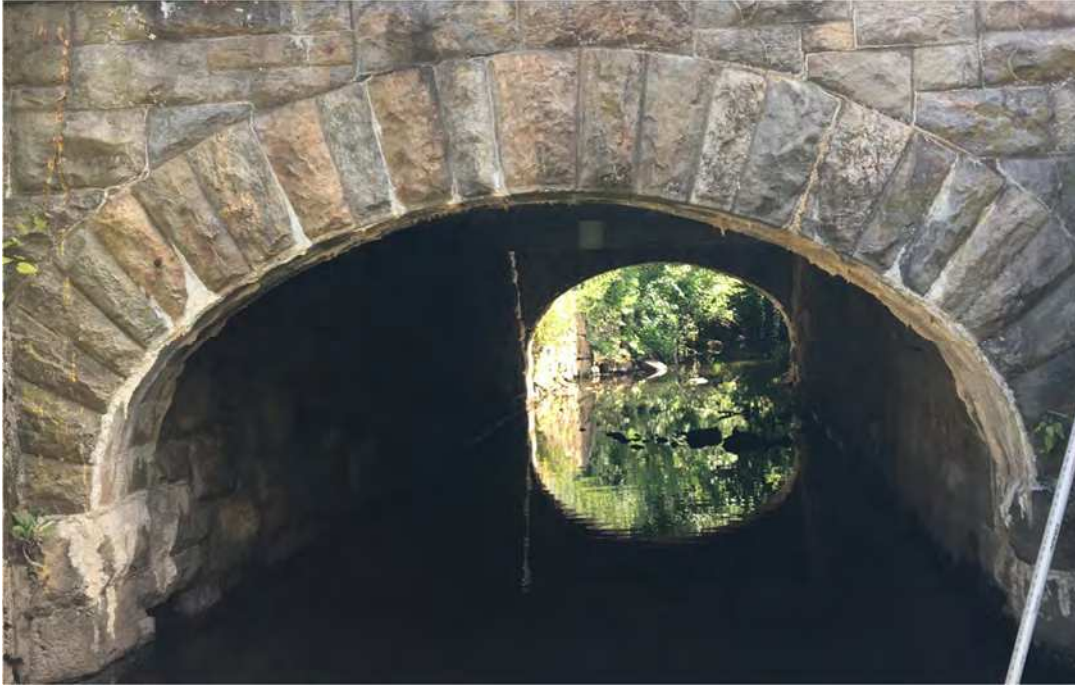
The stone masonry block arch end sections at the inlet and outlet do not have any visible cracks on the stone or joints (Figure 2-6). Rating: GOOD.

Figure 2-6: Close up of culvert end section (outlet).

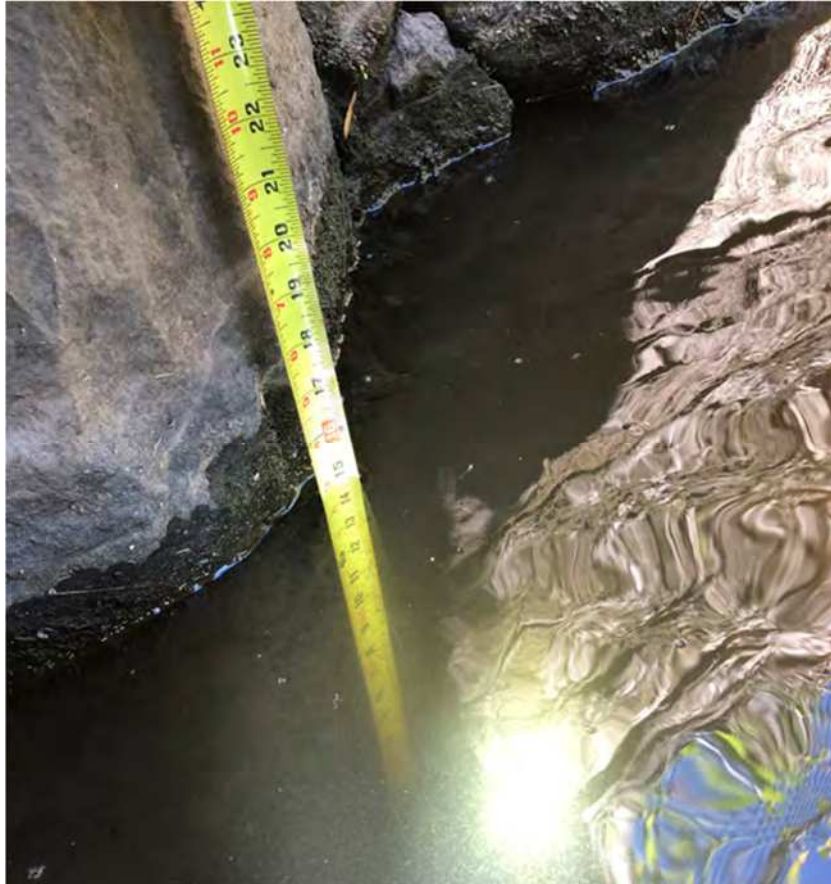
A scour hole is forming in the Northwest corner of the structure and the top of the footing is visible. No vertical faces of the footing are visible. The scour hole is approximately 1 foot deep (Figure 2-7). Rating: FAIR.

Figure 2-7: Depth to top of footing at end section's scour hole.

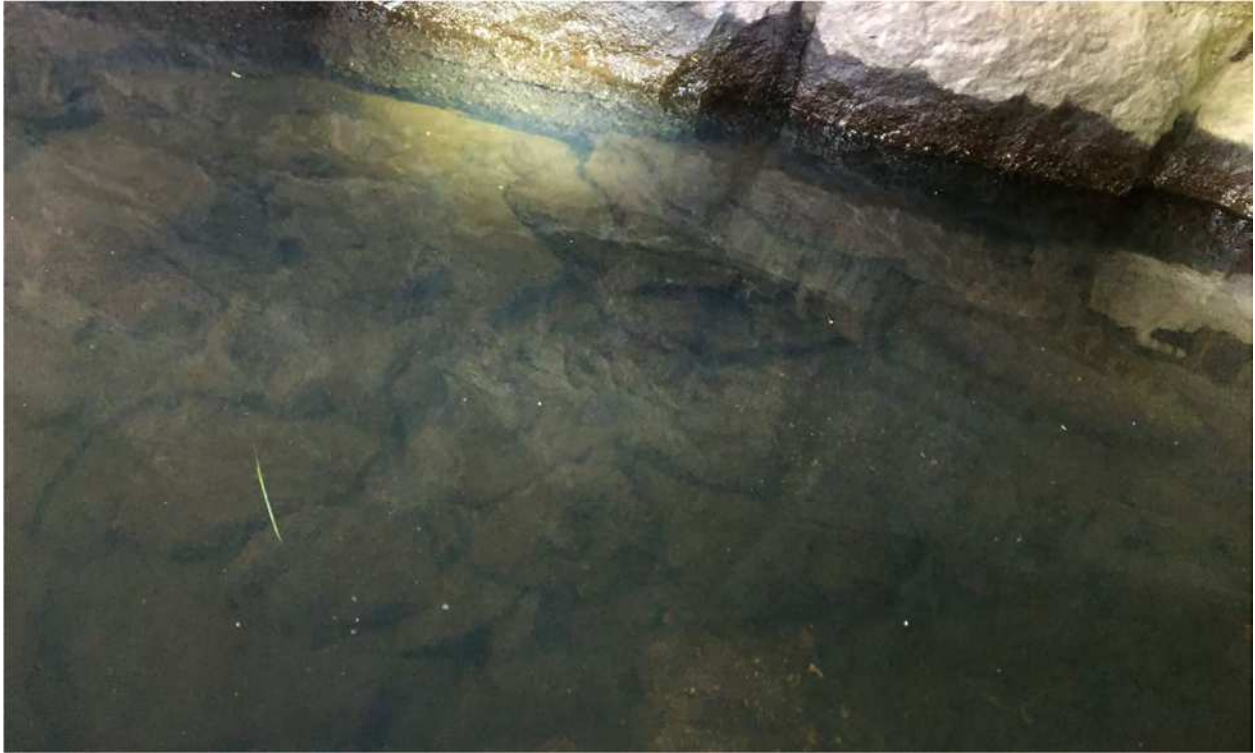
As mentioned in section 2.4.2, there are scour holes in the culvert whose deposited material is causing crests and ridges within the culvert. The scour holes caused by these displaced materials are uncovering previously buried structures (Figure 2-8). There is no undermining of the footing. Rating: FAIR.

Figure 2-8: Previously buried section of culvert unearthed by scour.

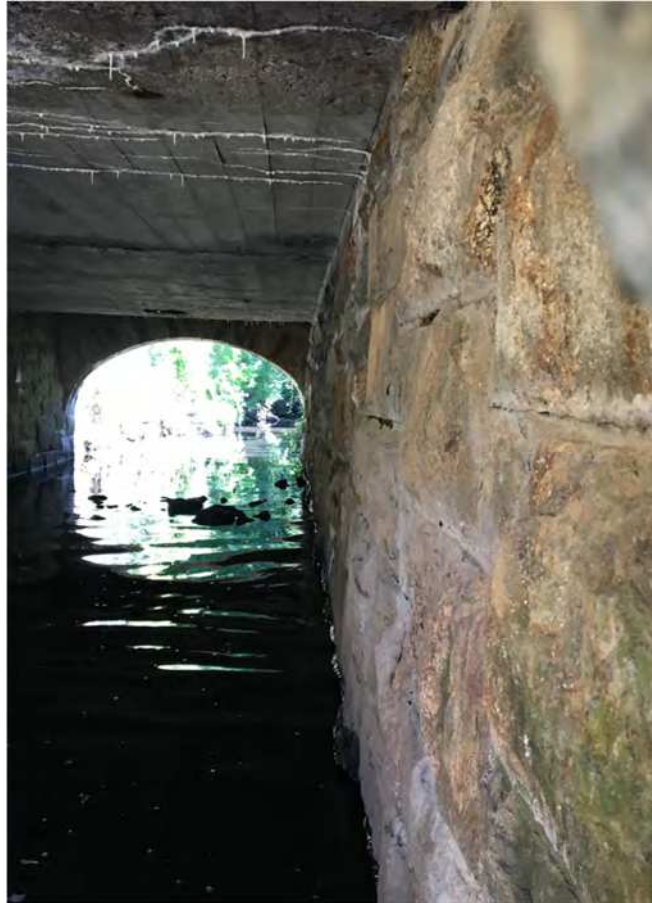
The barrel appears to be aligned with the channel with no noticeable heaving or bulging in the walls (Figure 2-9). Rating: GOOD.

Figure 2-9: Horizontal and vertical alignment of the barrel (south wall shown, north wall similar).

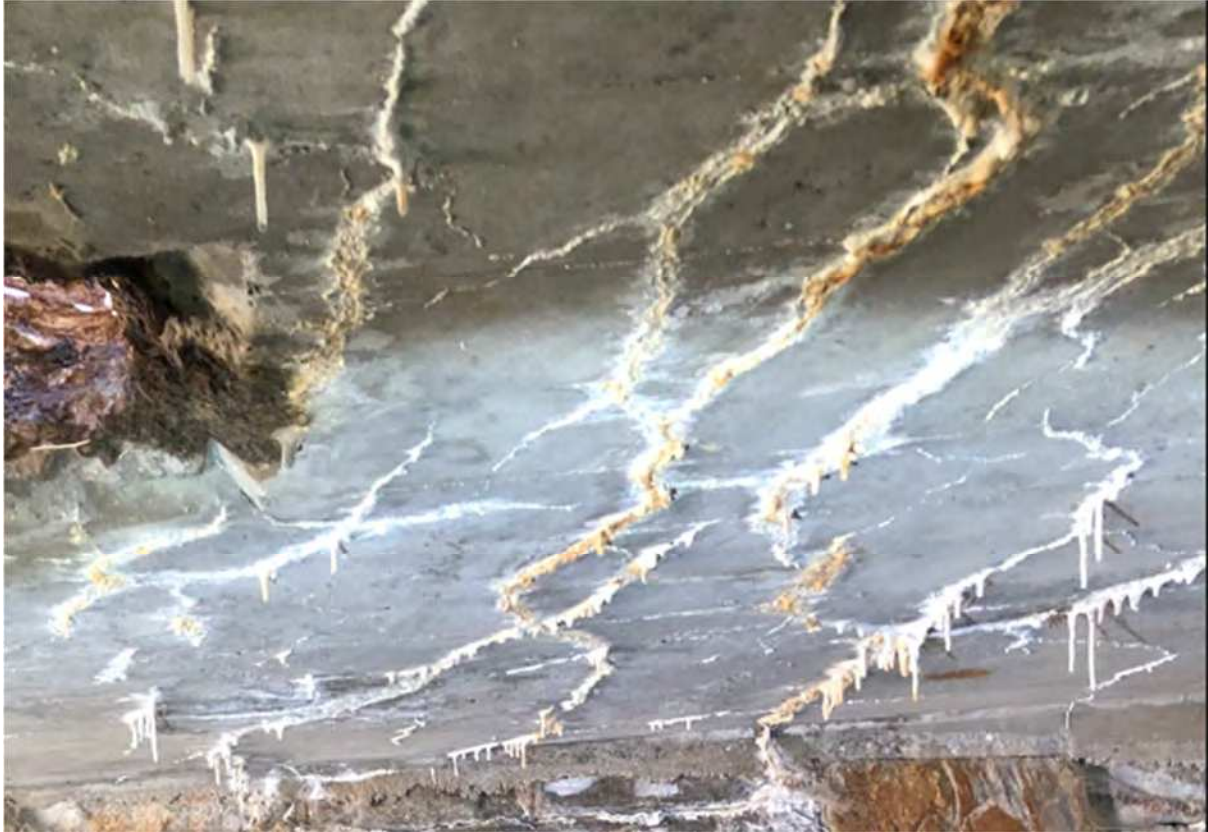
The top slab of the culvert is the only section of the culvert that is concrete. The top slab is plagued with an abundance of efflorescence which is likely exacerbated by the absence of a waterproofing membrane (Figure 2-10). Underneath the efflorescence, shallow cracks are visible. Rating: POOR.

Figure 2-10: Efflorescence on the top slab of the culvert.

The cracking was the controlling factor in the rating. Rating: POOR.

The top slab should be cleaned of all efflorescence and the cracks revealed should be fixed. Based on HVEA's inspection, the cracks appear surface level but widespread. Parging of the affected areas is expected to be appropriate for the majority of the slab however if the removal of the efflorescence reveals poor quality or damaged concrete, it should be removed and patched as necessary. For the areas

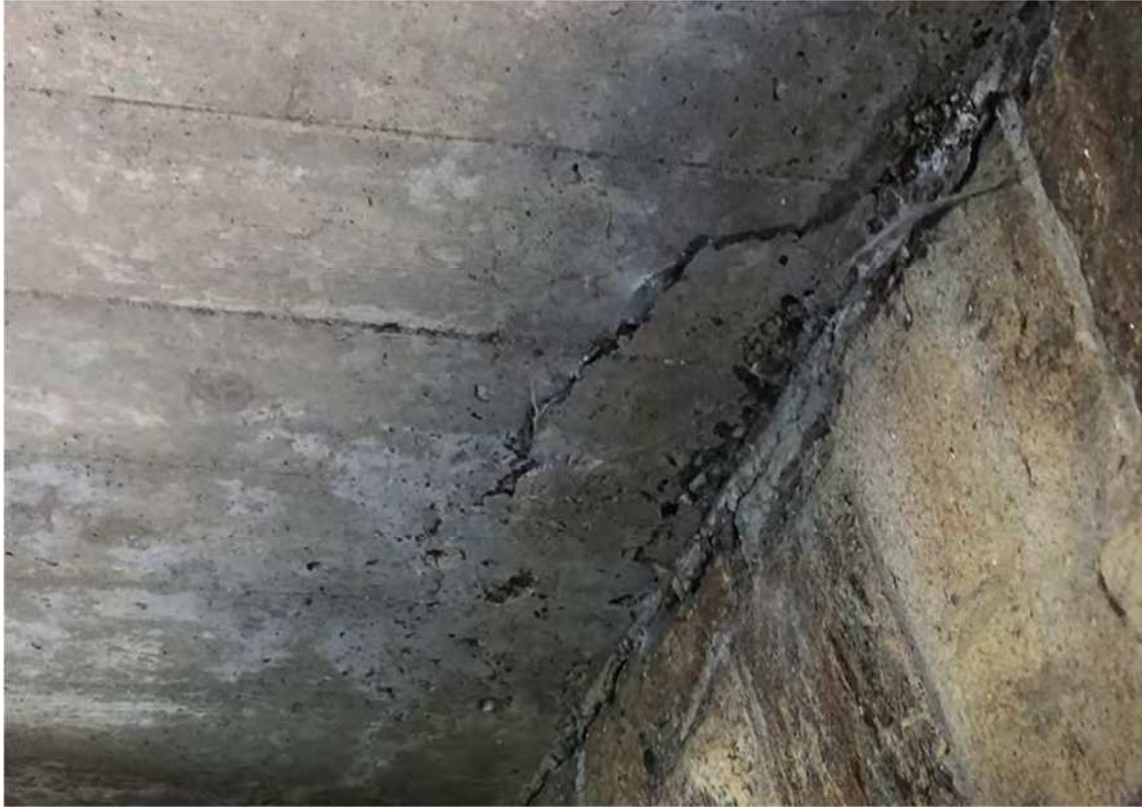
One small, shallow area of delamination was noticed at the inlet of the structure (Figure 2-11). There are a few areas of rusting and spalling. In these spalled areas, rebar is visible (Figure 2-12). However, the depth of the spalls are only fractions of an inch and yet the rebar is still visible. This indicates that the top slab was improperly constructed and cover requirements were not met. The poor construction is further indicated by segregation being noticeable which is most likely a byproduct of poor forming or consolidation when pouring the concrete. Rating: FAIR.

Figure 2-11: Delamination at the inlet of the culvert on the top slab.

where the concrete has spalled or delaminated, the unsound concrete around the damage should be removed and the concrete should be replaced. The spalled and delaminated areas are shallow and the visible rebar has not corroded so no supplemental reinforcement in these damaged areas are necessary. At the openings in the slab for the roadway drainage, it is recommended that a pipe or similar device be installed to keep the water and debris away from the concrete as this will prevent any further abrasion of the concrete. The surrounding concrete will need to be removed and replaced. Appendix B provides the locations of the damage on the concrete slab.

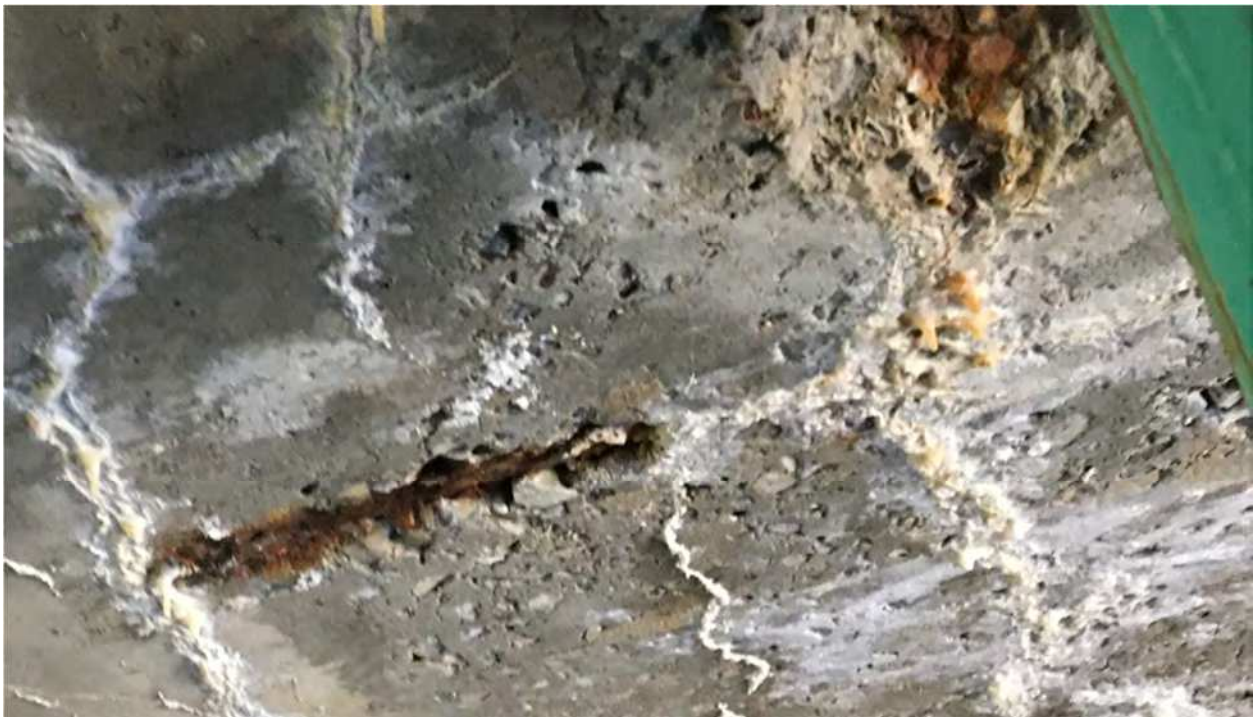
Figure 2-12: Visible rebar and segregation on the top slab.

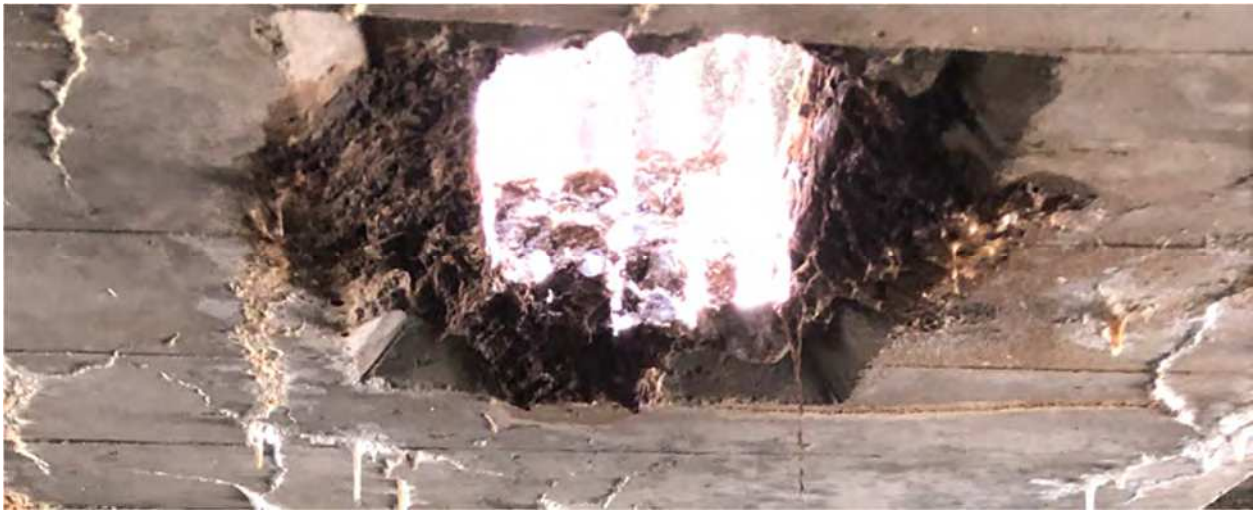
Abrasion and surface damage are visible at the roadway drainage hole near the inlet of the structure (Figure 2-13). The surrounding concrete is likely in contact with deicing salts that are draining from the roadway as well as any debris that can make its way through the grate on the roadway surface. The drainage hole near the outlet uses a PVC tube and the surrounding concrete is in better condition albeit still damaged. Rating: FAIR.

Figure 2-13: Abrasion and surface damage on the top slab at the drainage holes.

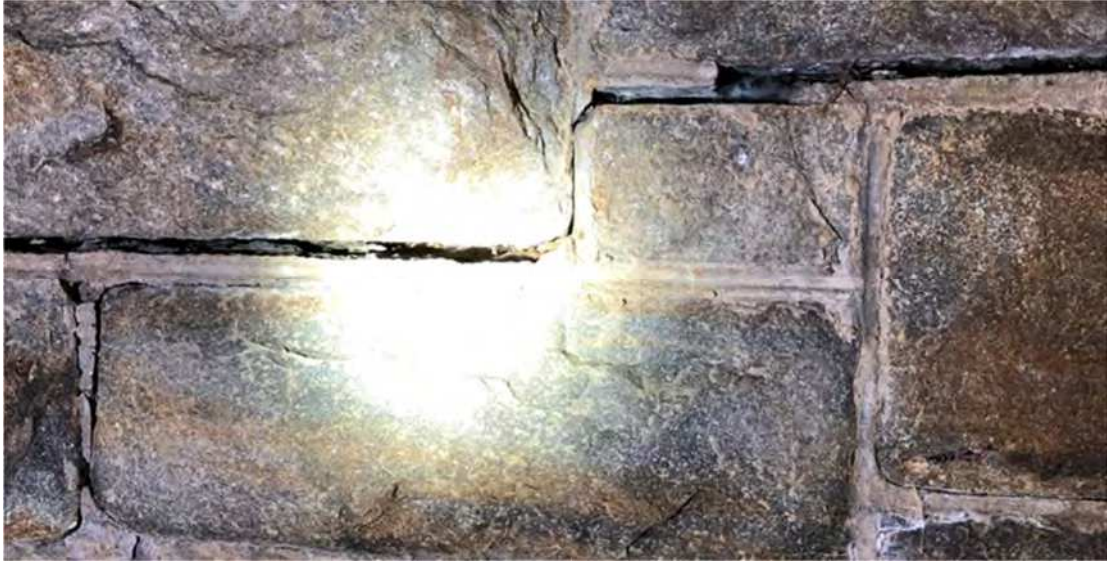
Only the walls of the culvert are stone masonry blocks. The upper half of the block walls have sections where the masonry and mortar have separated. This separation is near exclusively on the horizontal plane (Figure 2-14). This movement is most likely caused by water infiltrating from behind the walls and into the joints and the freeze/thaw is separating the masonry from the mortar. Rating: FAIR.

Figure 2-14: Separation between the masonry blocks and mortar joints.

The masonry block joints on the top portions of the walls will need to be regouted. Any damaged or loose existing grout will need to be removed and the joints will need to be repointed. Similar to the top slab, any efflorescence should be removed but no cracks are expected to be revealed. Appendix B provides the location of the damage on the masonry blocks.

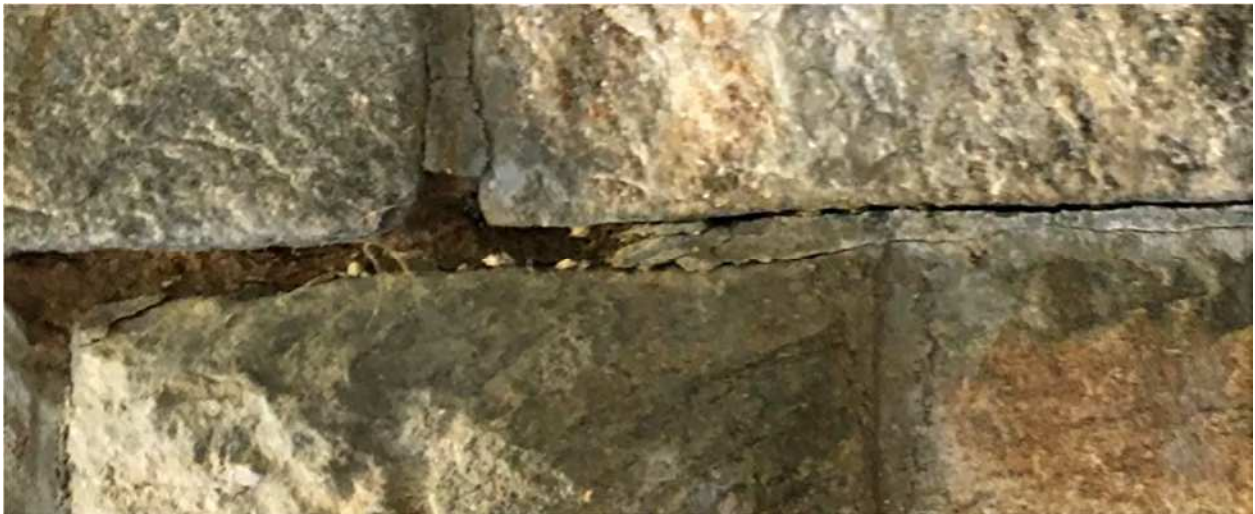
There are few and isolated sections where the mortar is cracked or missing. It is suspected that the inner mortar is a weaker lime-sand mortar that simply serves to tie the stones together and the outer mortar is stronger to act as a waterproofing. In places where the mortar is missing, the inner mortar is crumbling and falling apart and visibly looks different than the outer mortar (Figure 2-15). The deterioration of the inner mortar appears to most likely be from water infiltrating from behind the masonry blocks and the freeze/thaw is crumbling the mortar. Rating: FAIR.

Figure 2-15: Missing mortar between masonry blocks; note that differences between the outer and inner mortar.

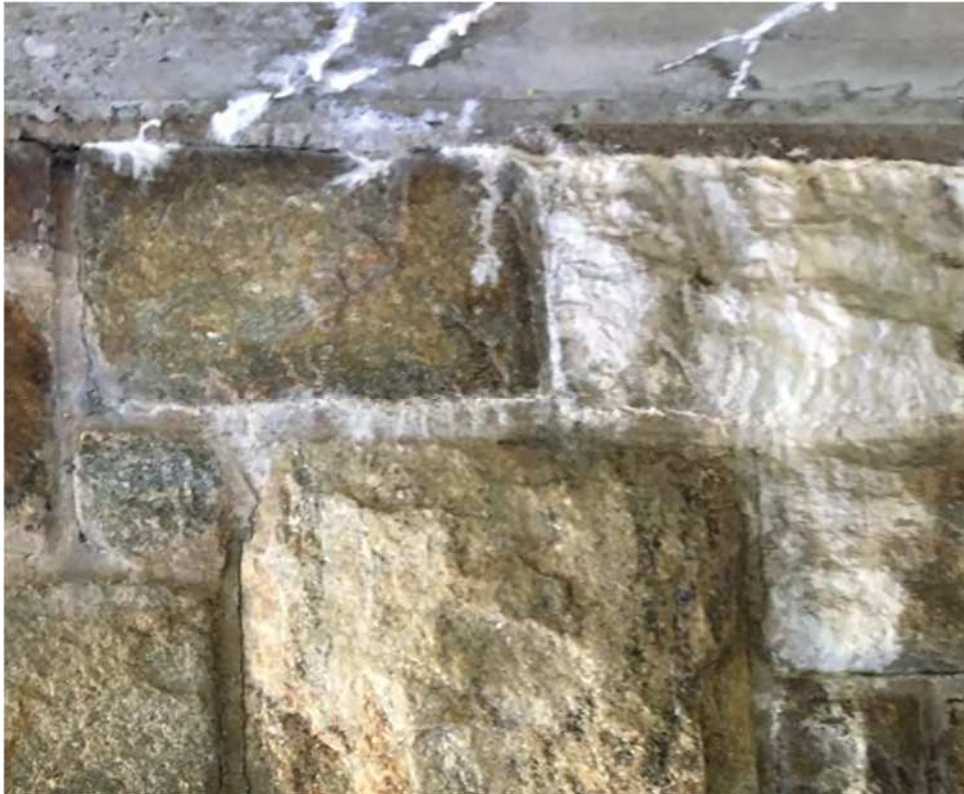
Efflorescence is primarily visible in the upper half of the walls, primarily due to the mortar issues and separation between the masonry and the mortar in those areas. The efflorescence appears to be due in part to both water making its way through the walls from the backside as well as dripping off from the top slab (Figure 2-16). Rating: FAIR.

Figure 2-16: Isolated efflorescence on the masonry.

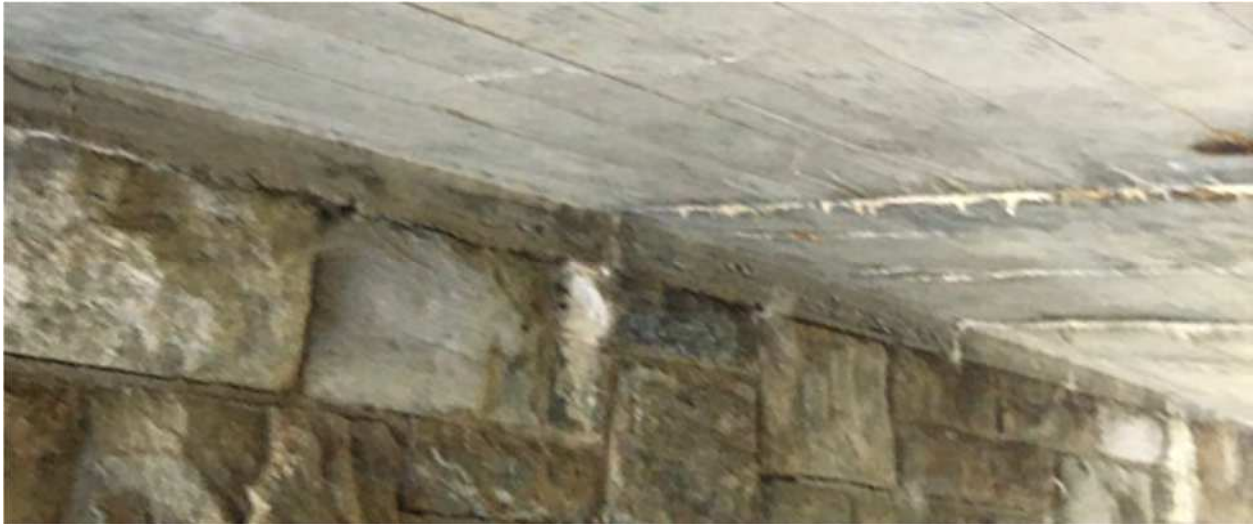
There appears to be gaps along the length of the culvert where water can pass through where concrete was poured against the top of the masonry block wall but did not adhere to the stone (Figure 2-17).

Rating: FAIR.

Figure 2-17: Joint separation where the top slab meets the masonry wall.

Rehabbing and repairing the compromised elements of the culvert to alleviate the culvert's deficiencies is possible. In order to prevent any future water damage to the top slab of the structure, the existing roadway would need to be excavated and a new waterproofing membrane would be applied to the top of the structure. With the top of the structure revealed it can be confirmed whether or not the stone masonry blocks are simply a façade for a concrete wall or they are in fact the walls themselves. Since it would not be feasible to excavate and reveal the entirety of the rear face of the culvert's walls, it is recommended that the top 3ft of the wall be revealed to wrap the waterproofing membrane to the top, affected portion of the wall.

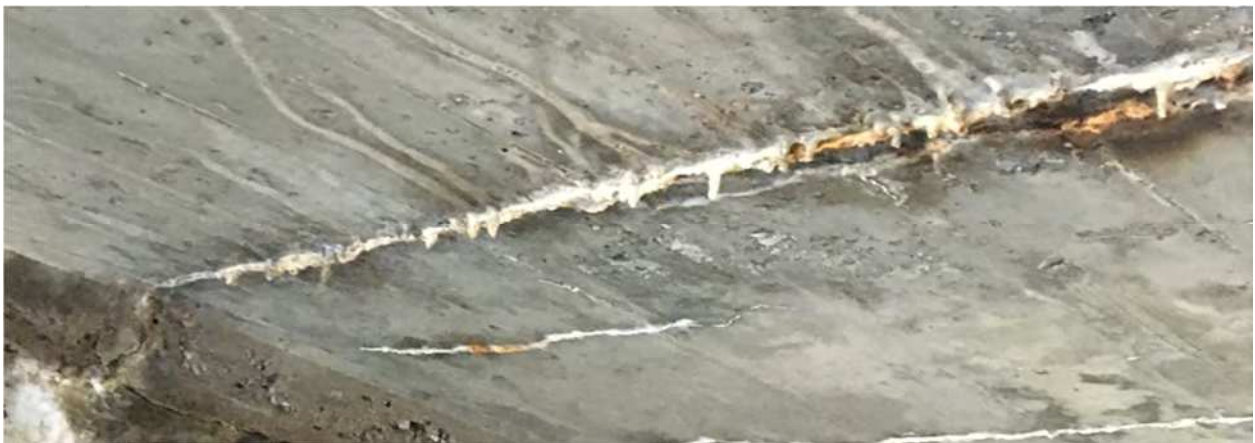
There is one joint approximately halfway through the culvert along the width of the top slab. Although there is heavy efflorescence at the joint, there does not appear to be any cracking at this location (Figure 2-18). Rating: GOOD.

Figure 2-18: Joint on top slab of culvert with heavy efflorescence but not cracking.
