Subject:  
Illicit Discharge Detection and Elimination Study  
Outfall and River Sampling Results

Date:  
November 13, 2012

Technical Memo  
Mamaroneck Outfall and River Sampling

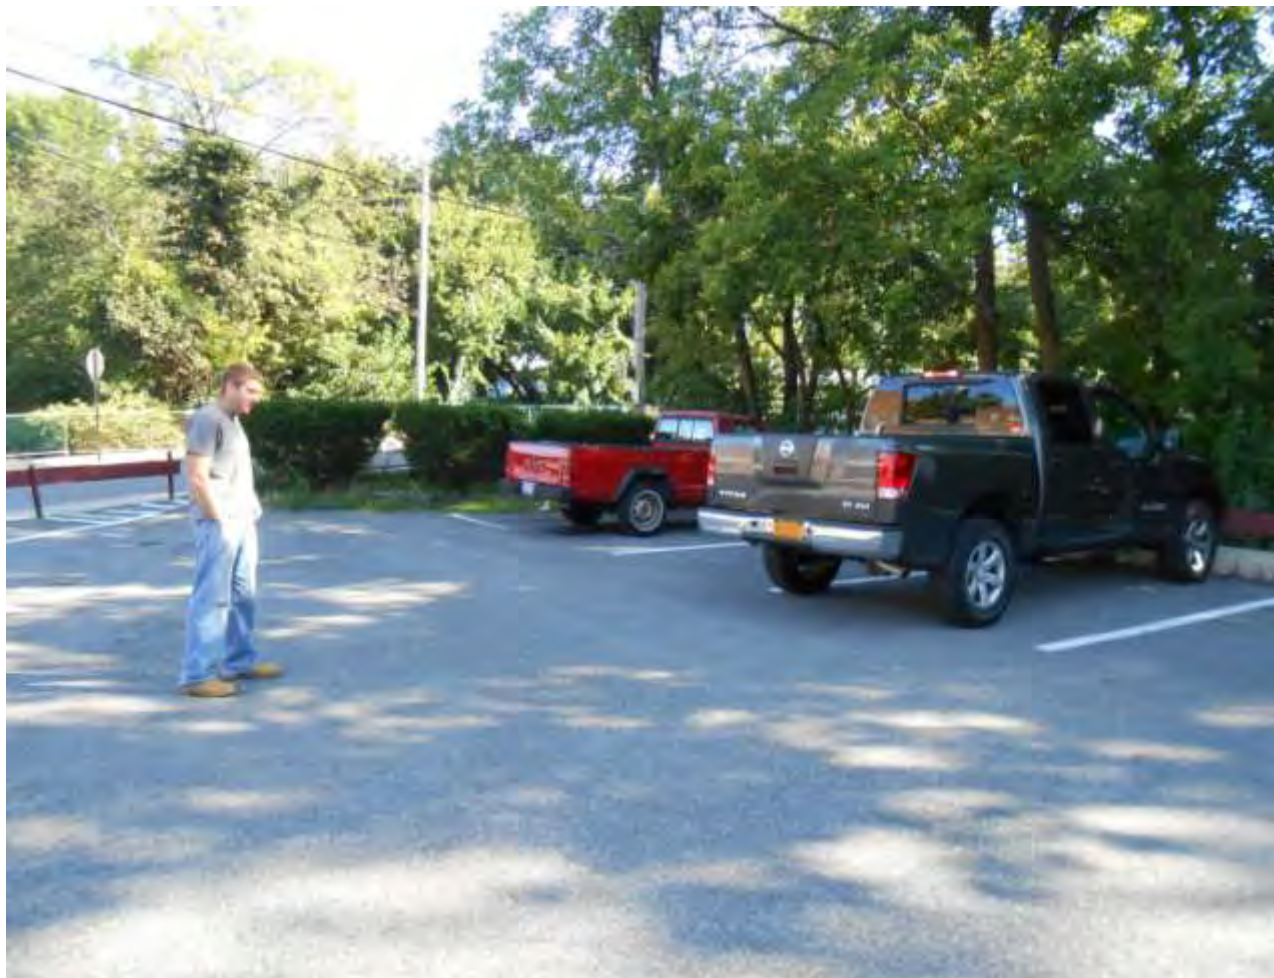
Mamaroneck River Near Harbor (MRMH)- Location 5: Parking lot along river bank, at intersection of Tompkins Ave and E Prospect Ave.

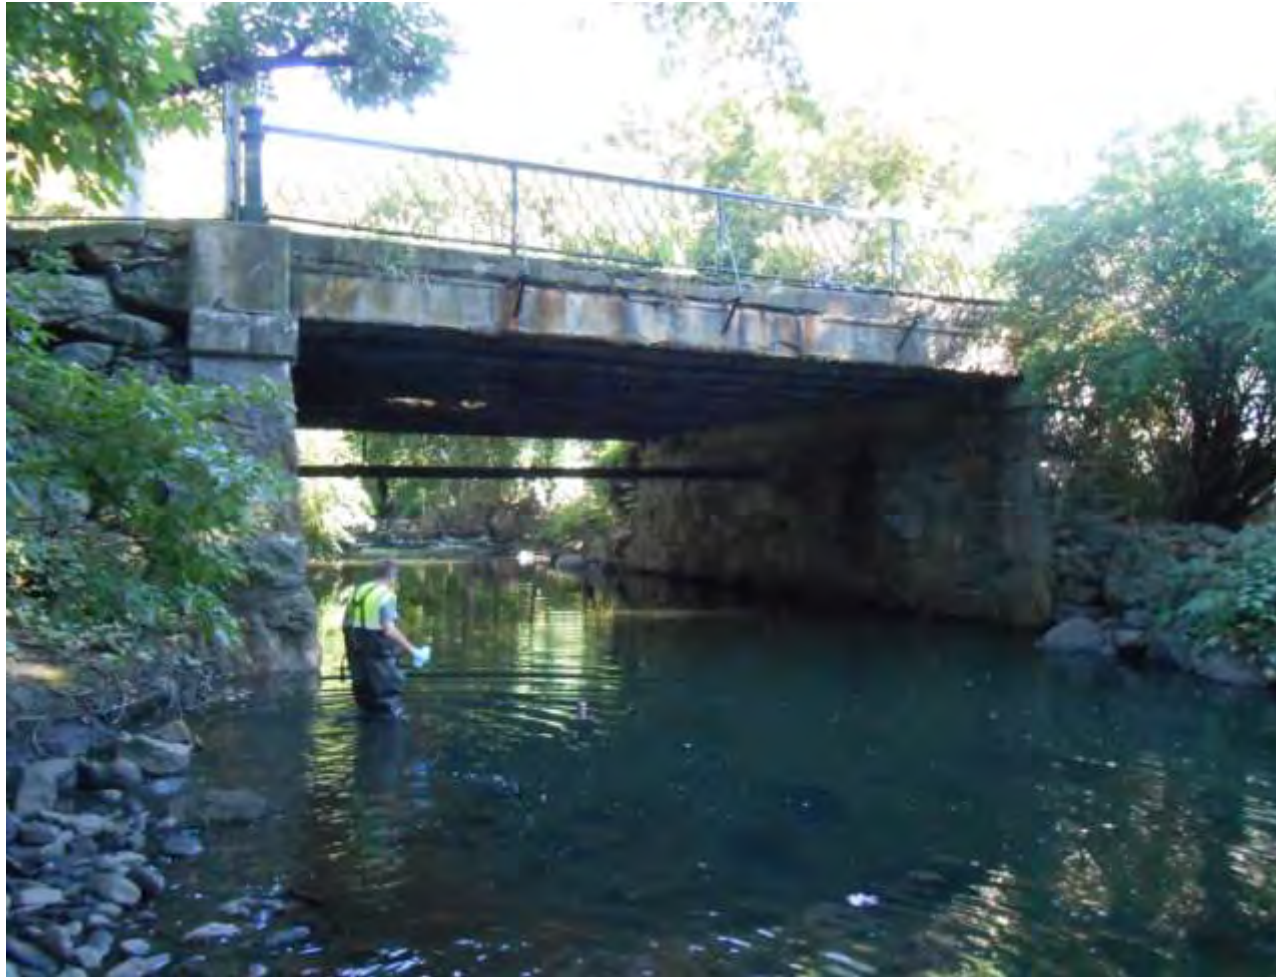
Location 5- Culvert, Tompkins Ave above. Looking upstream.

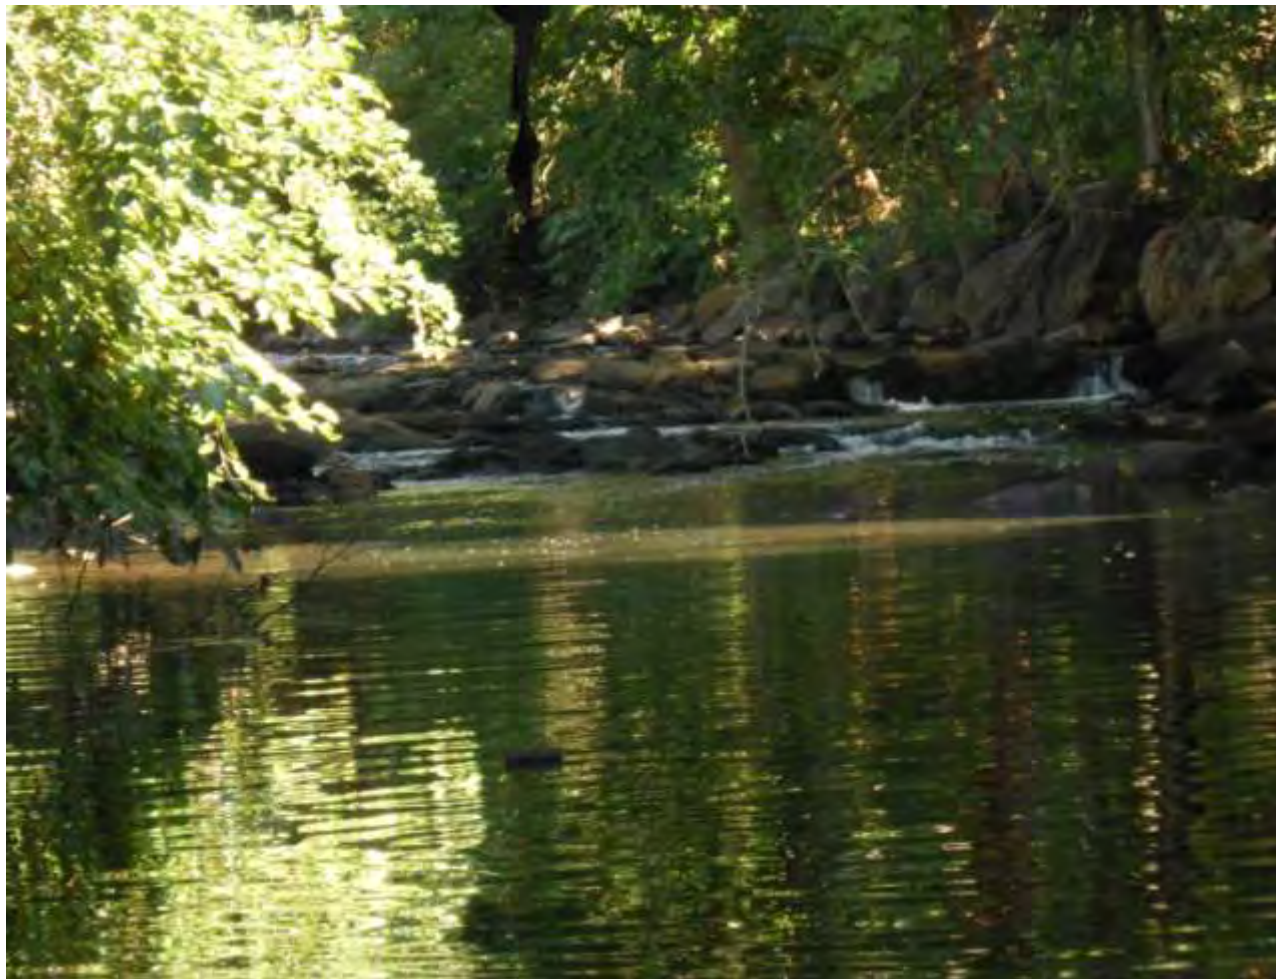
Location 5- Looking downstream.

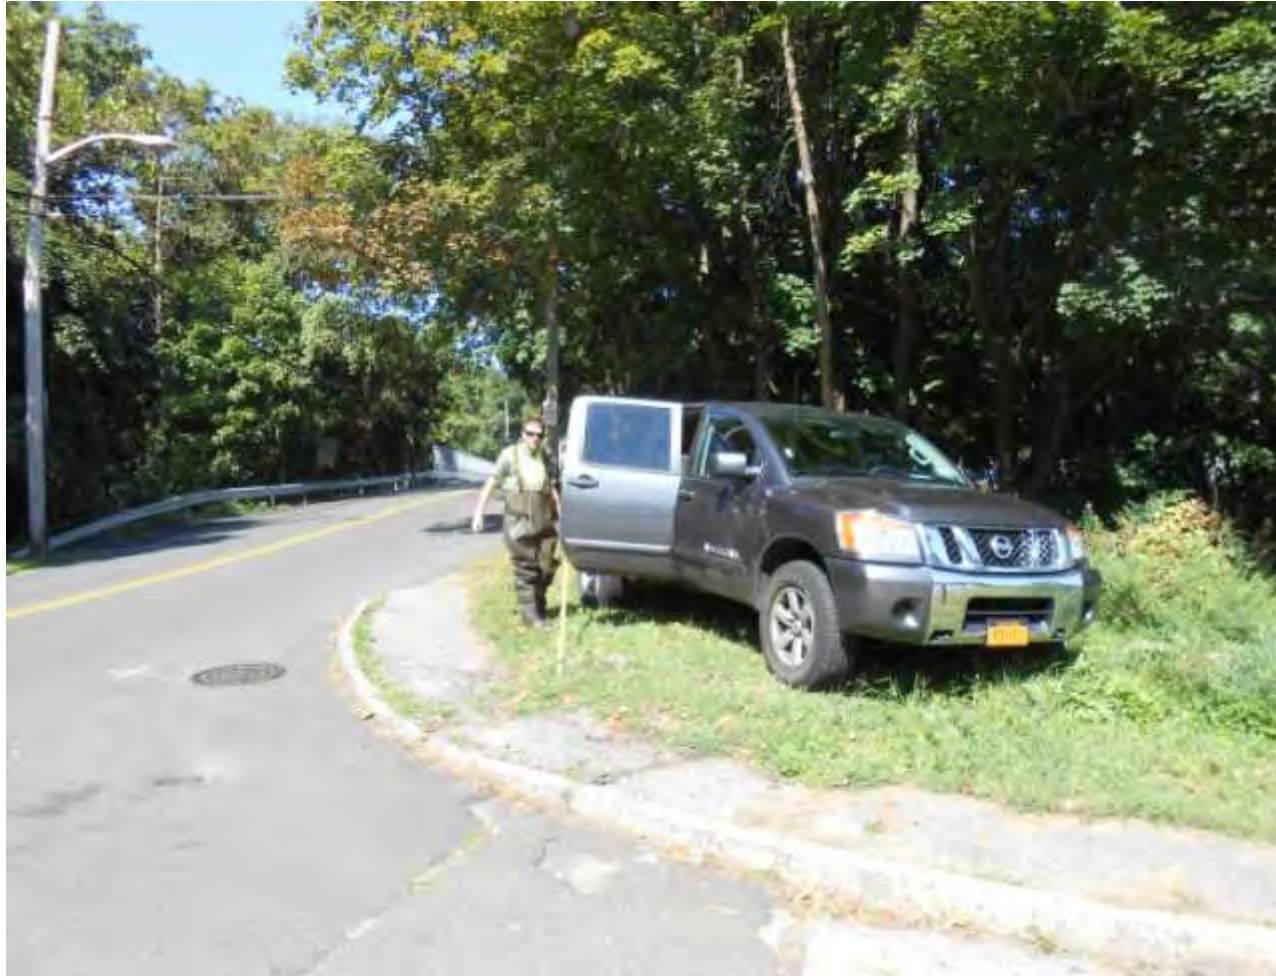
Sheldrake River at West Border (SRWB)- Location 1: Park just off road on grassy patch before bridge culvert on Rockland Ave. Near Rockland Ave, Fayette Ave intersection.

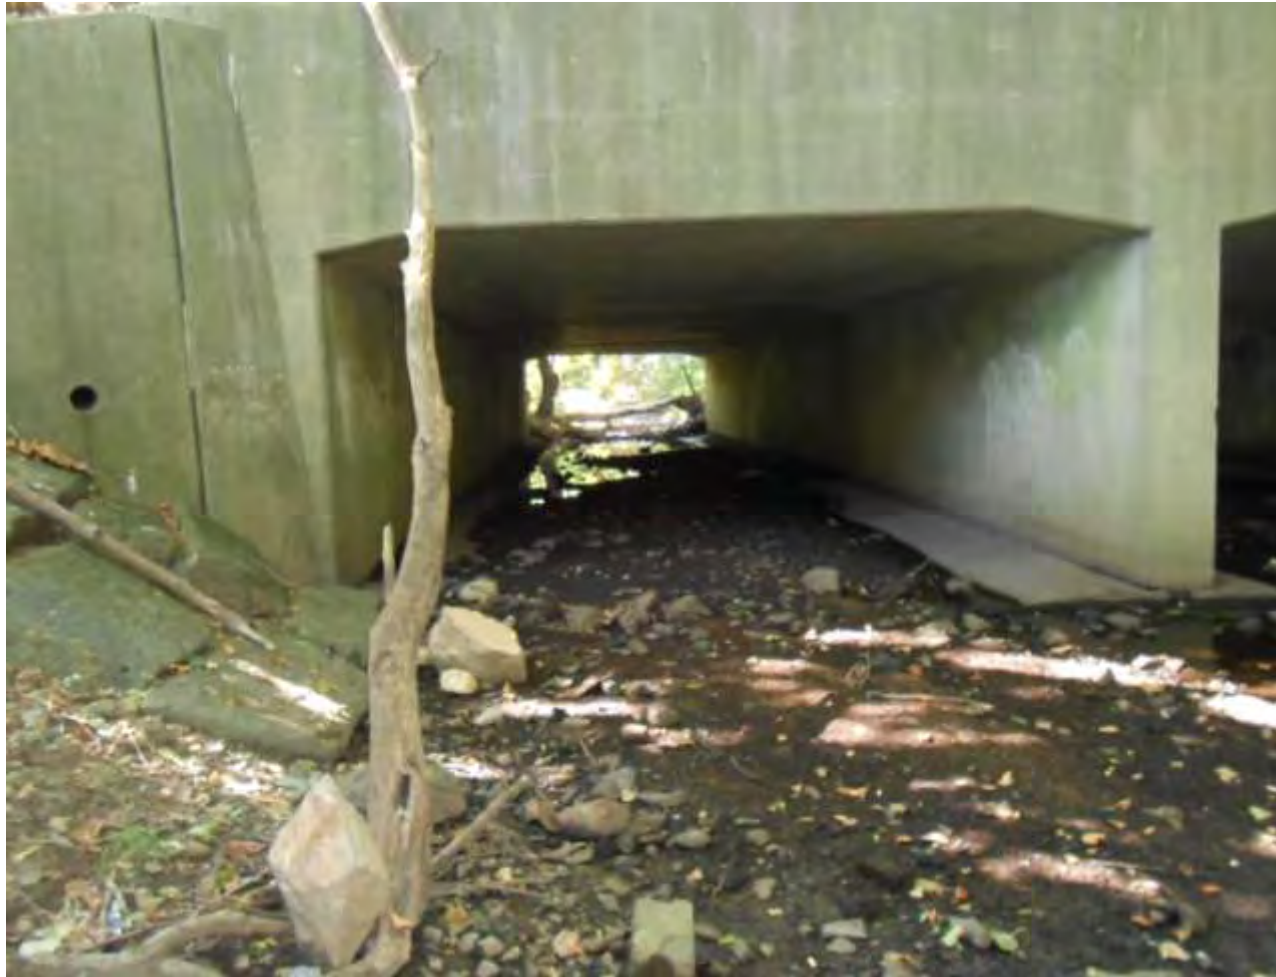
Location 1- Left culvert has no flow.

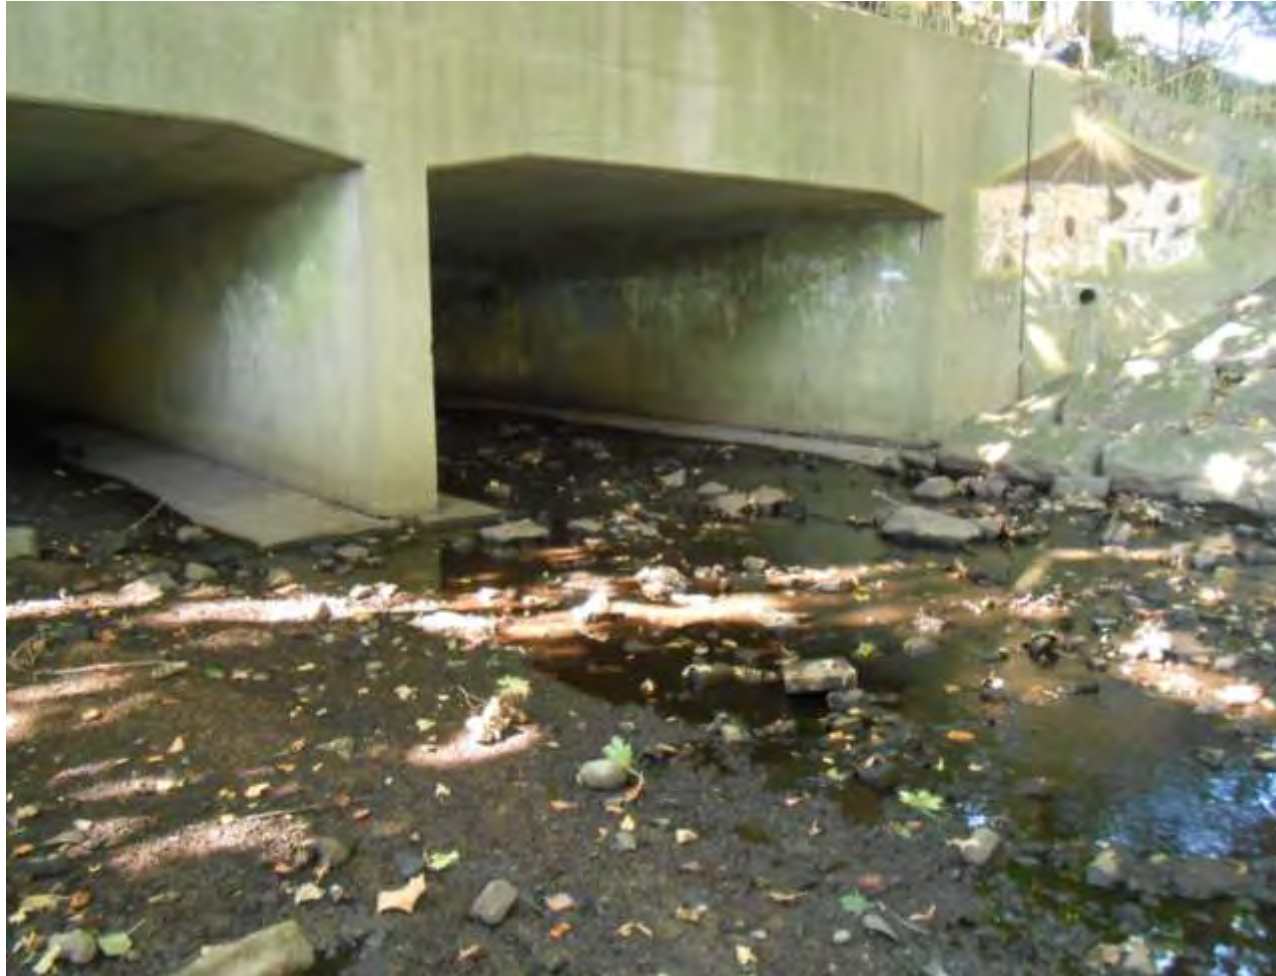
Location 1- Right culvert has minimal flow, very shallow depths with sediment buildup.

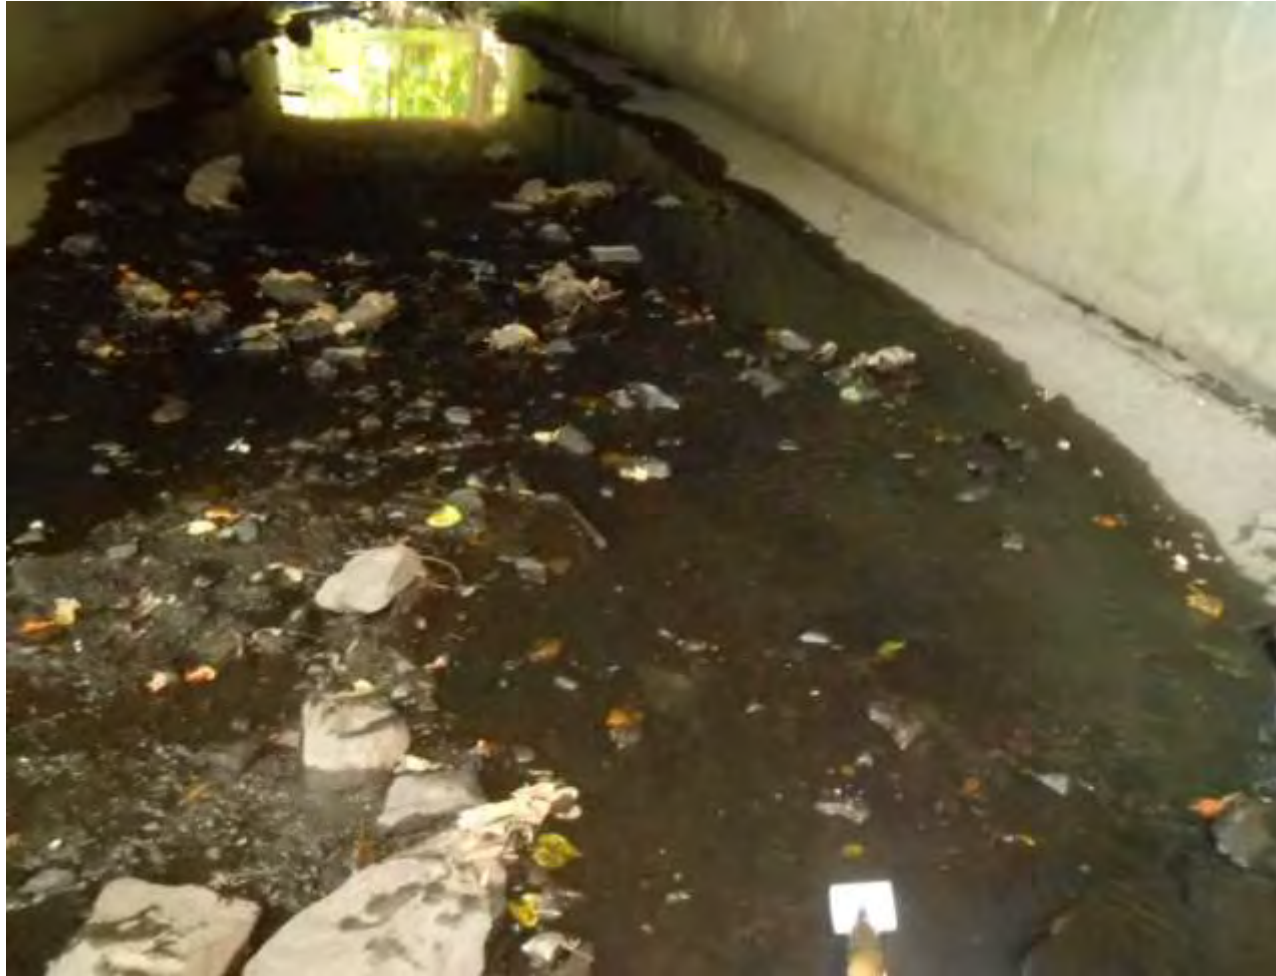
Location 1- Samples collected in area of best flow.

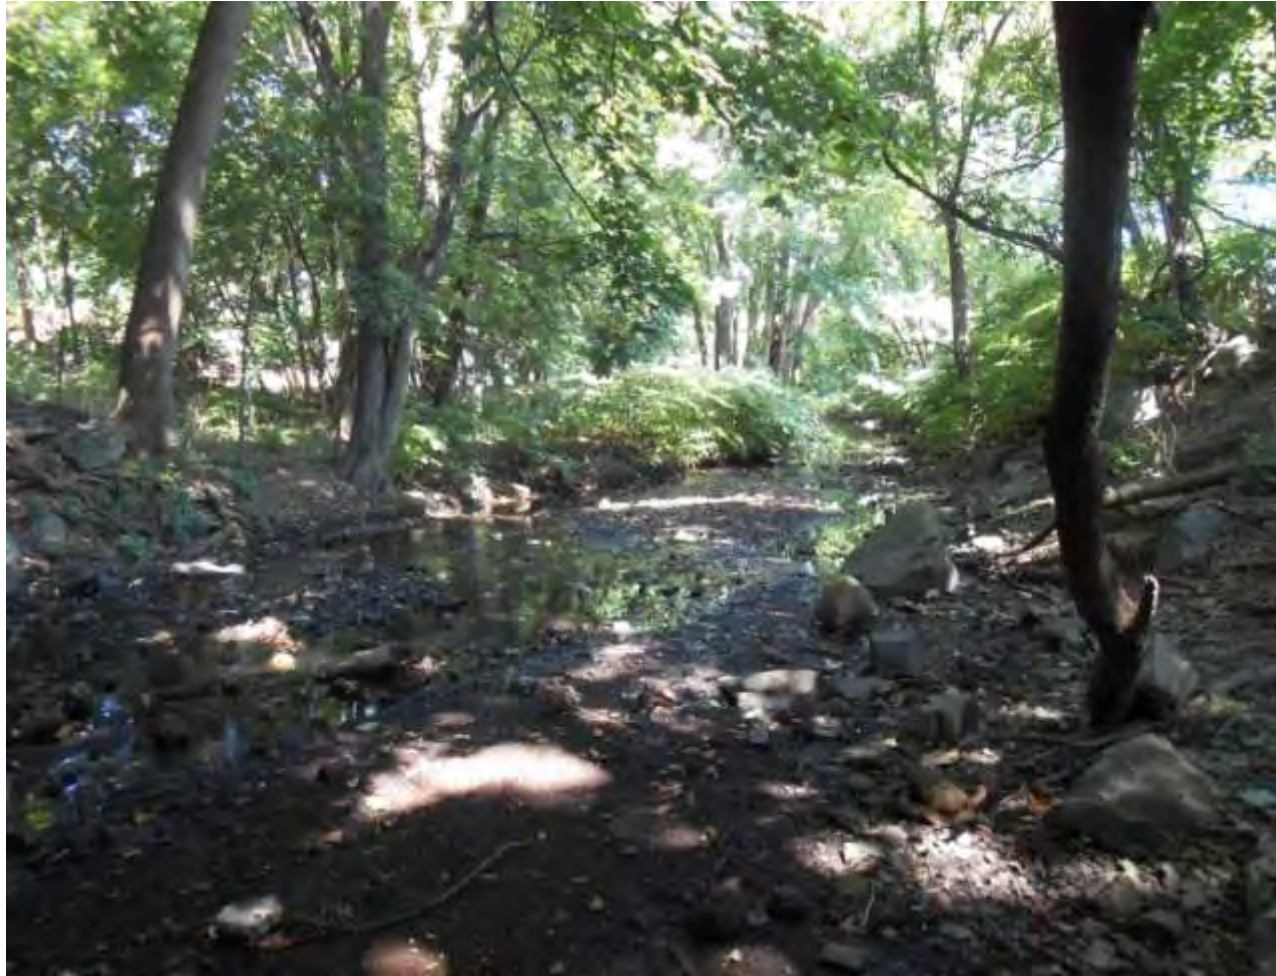
Location 1- Looking downstream.

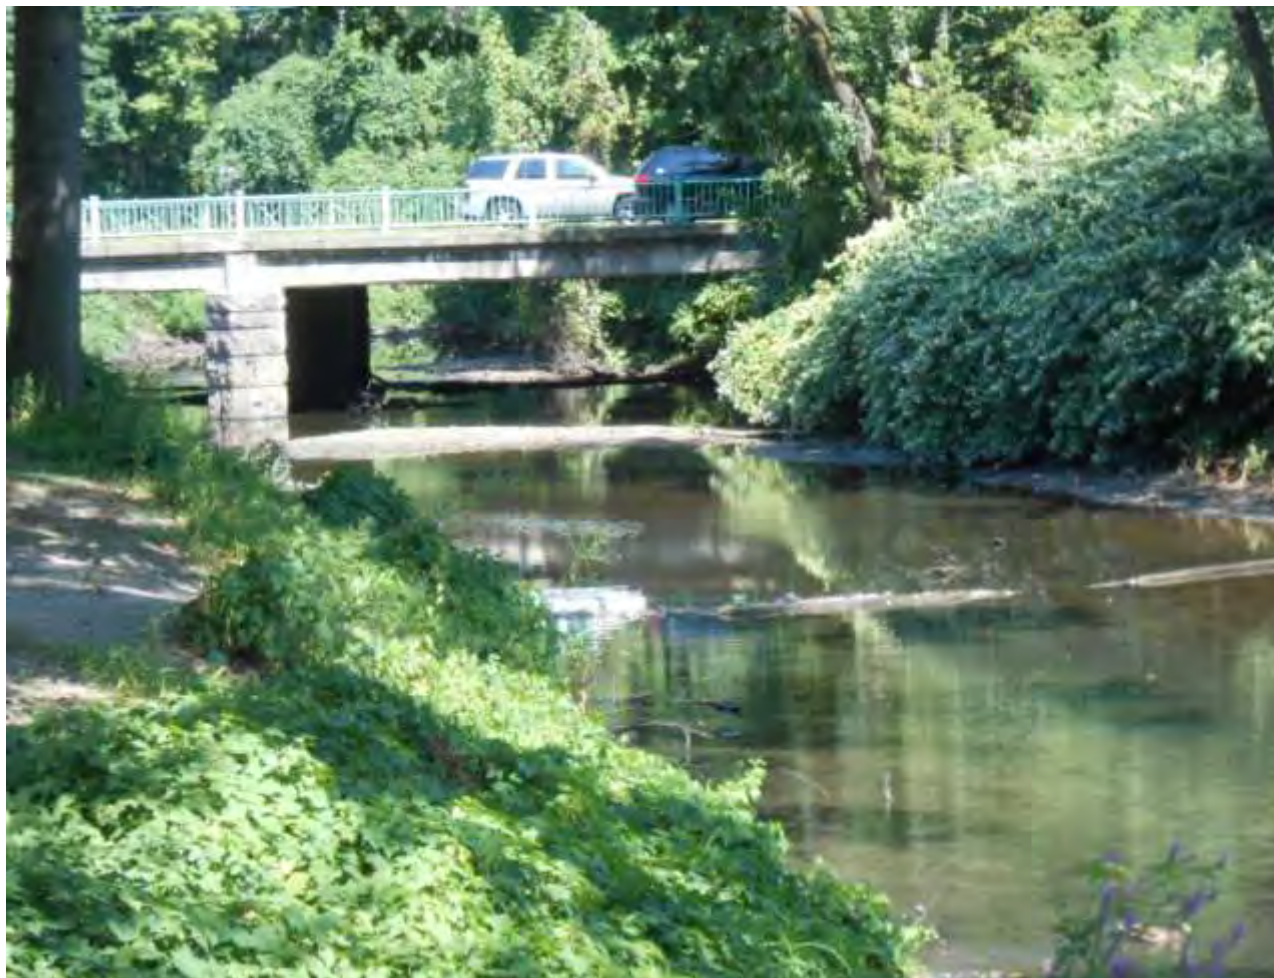
Gedney Pond Stream (GPS)- Location 2. Stream is an outfall emptying into the Mamaroneck River upstream of the confluence with the Sheldrake River. Mamaroneck River in photo.

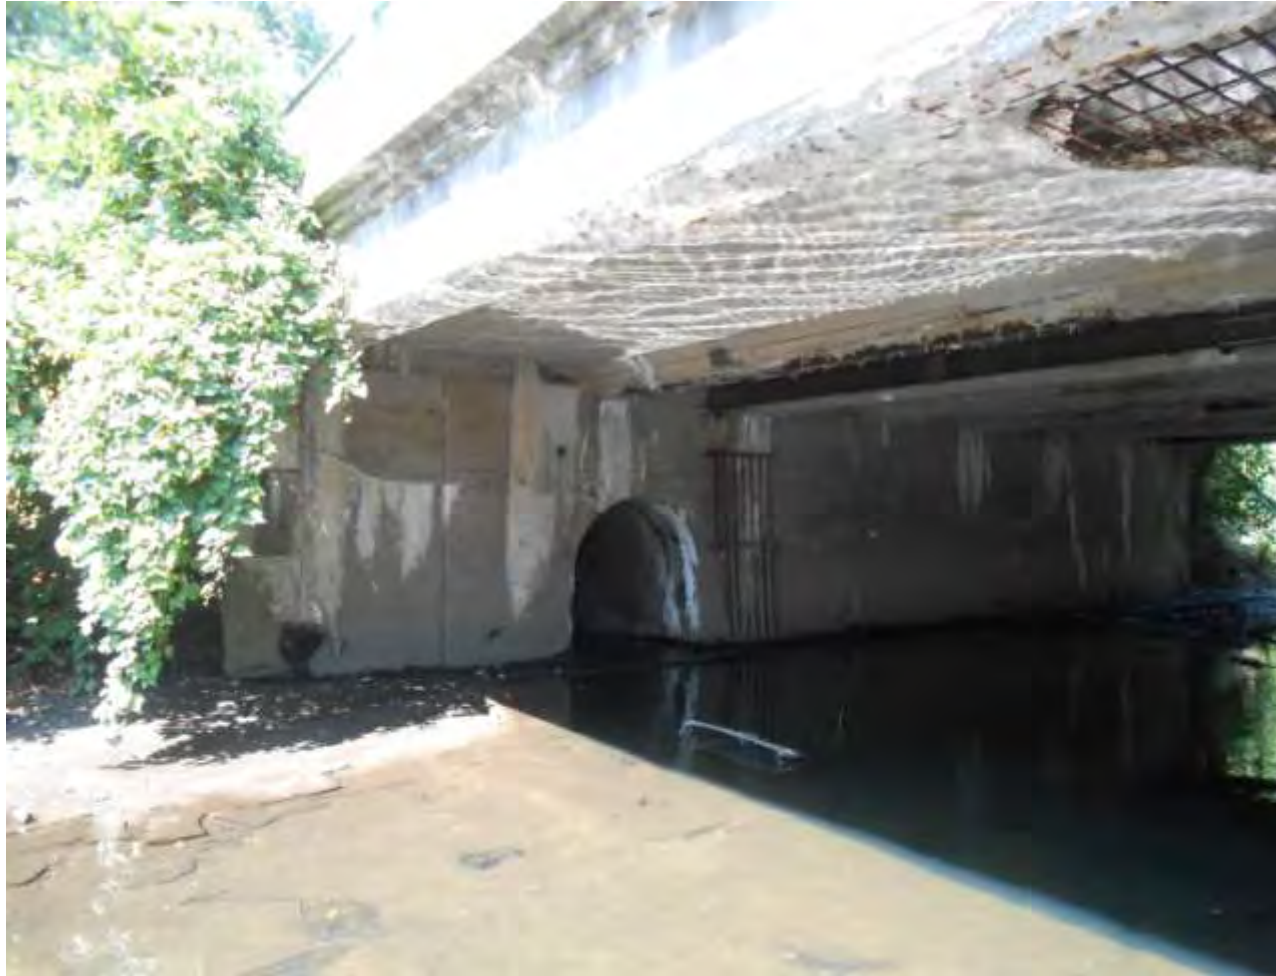
Location 2- Outfall in wall of Jefferson Ave culvert. Parking available at Columbus Park.

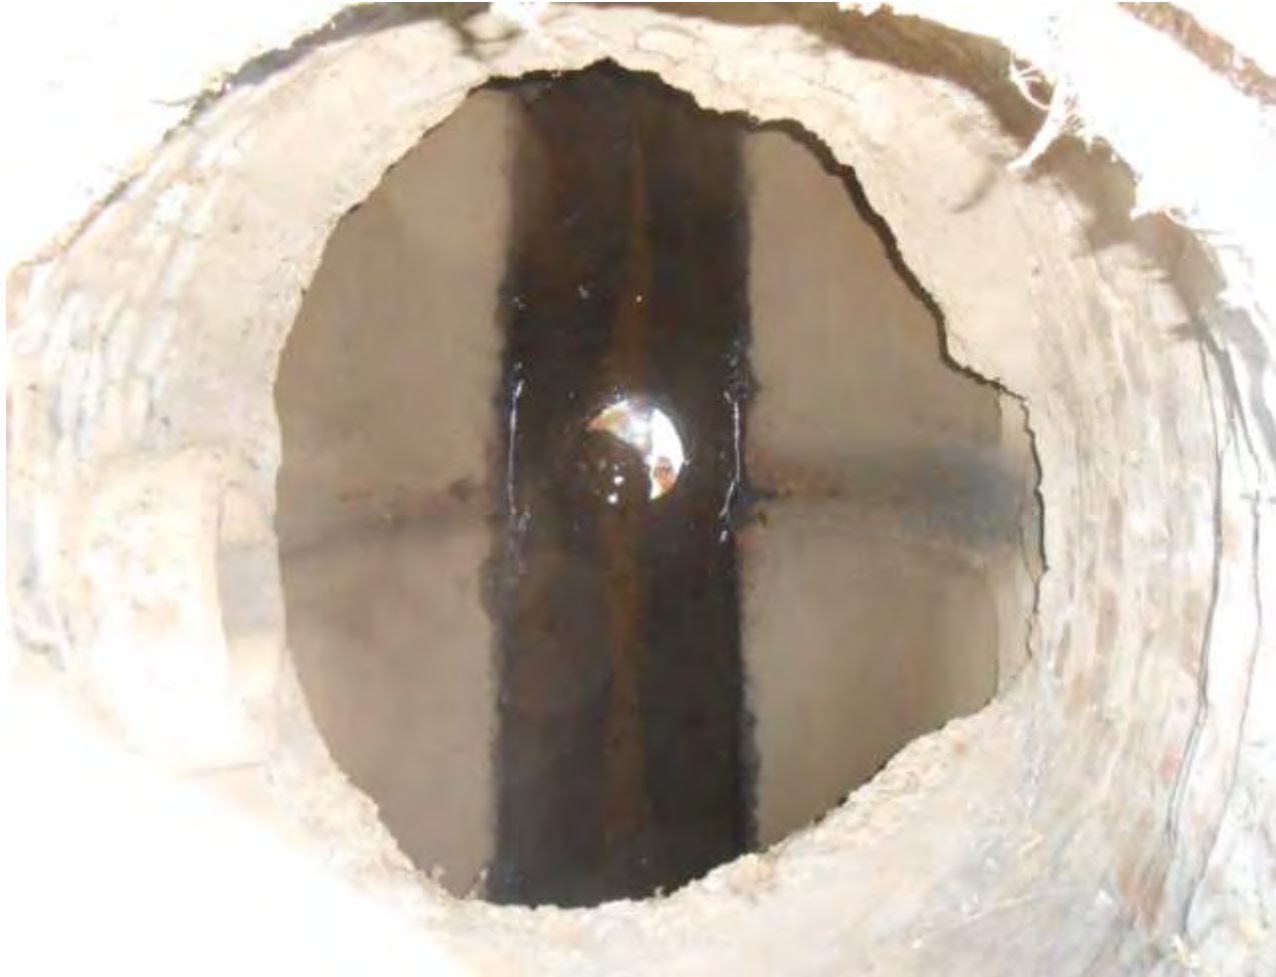
Location 2- Manhole on Jefferson Ave. Estimated pipe diameter to be 5', consistent with Location 2 outfall.

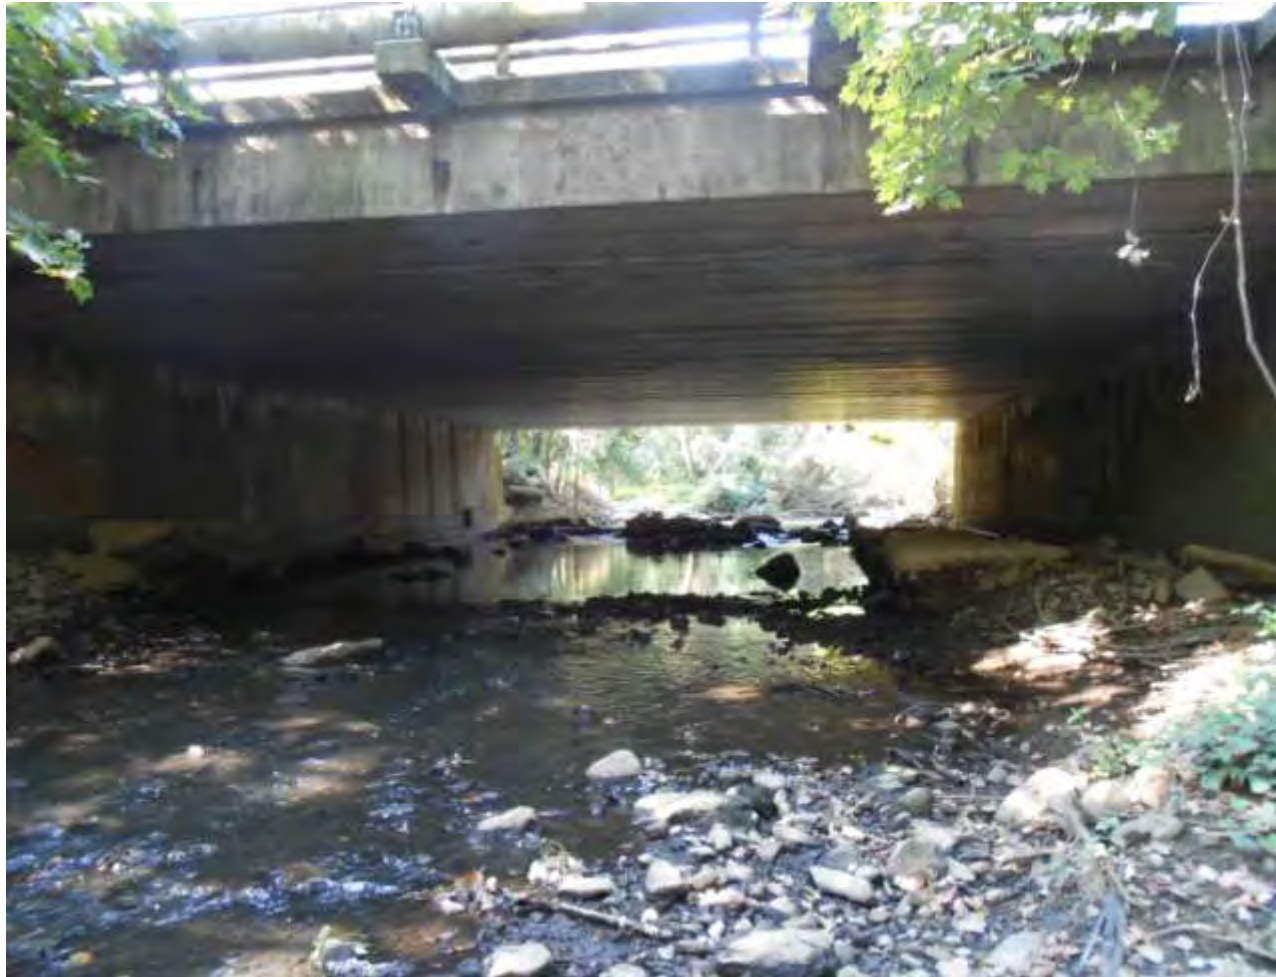
Mamaroneck River North Border (MRNB)- Location 4: Parking on concrete section of median in Mamaroneck Ave. Looking upstream.

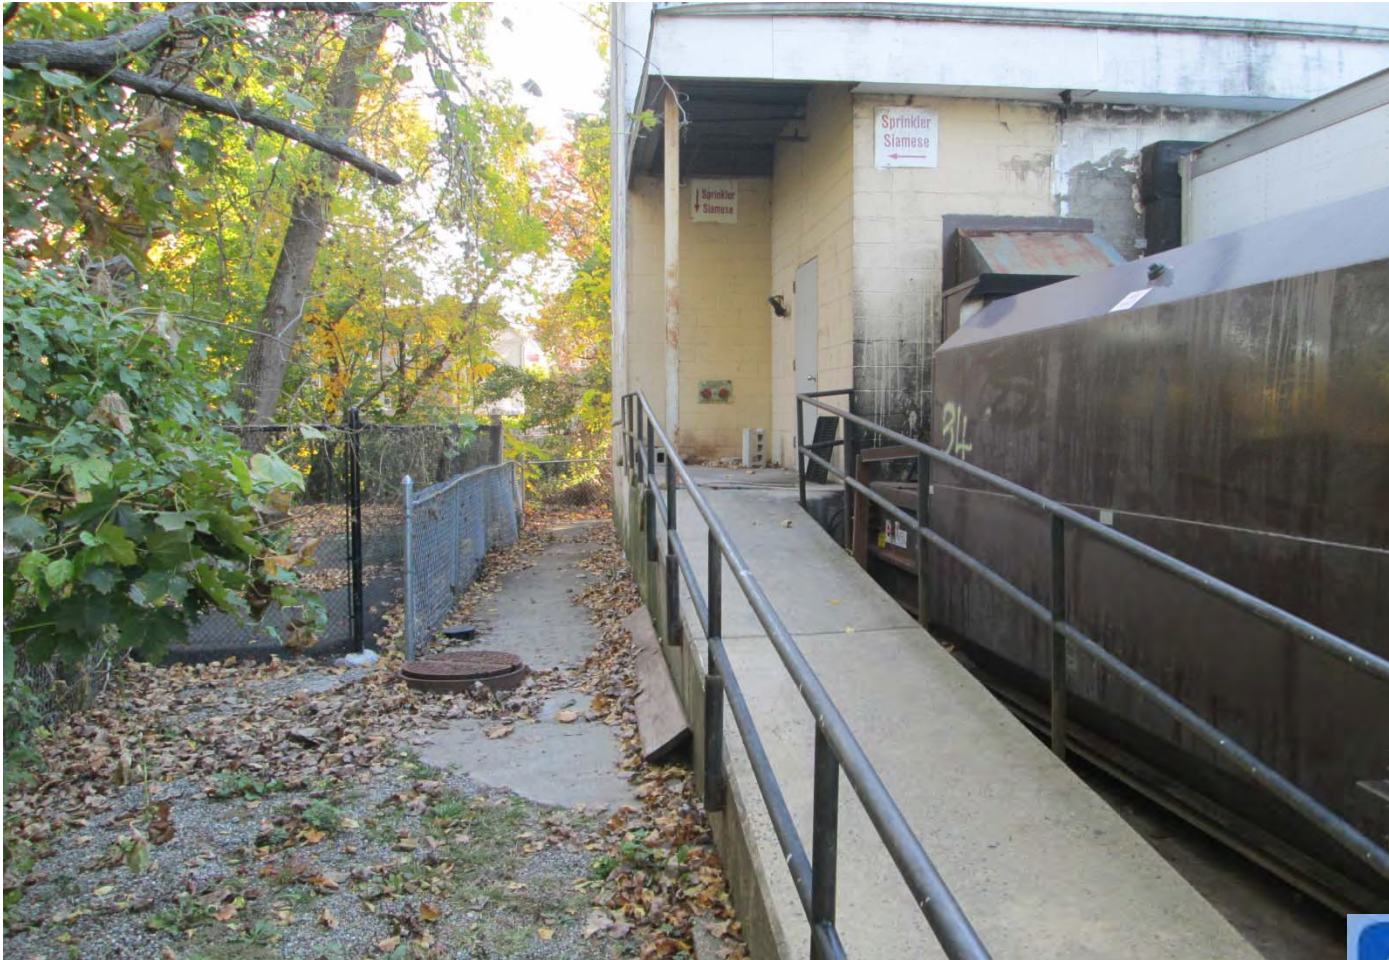
Storm manhole upstream of Outfall 5.

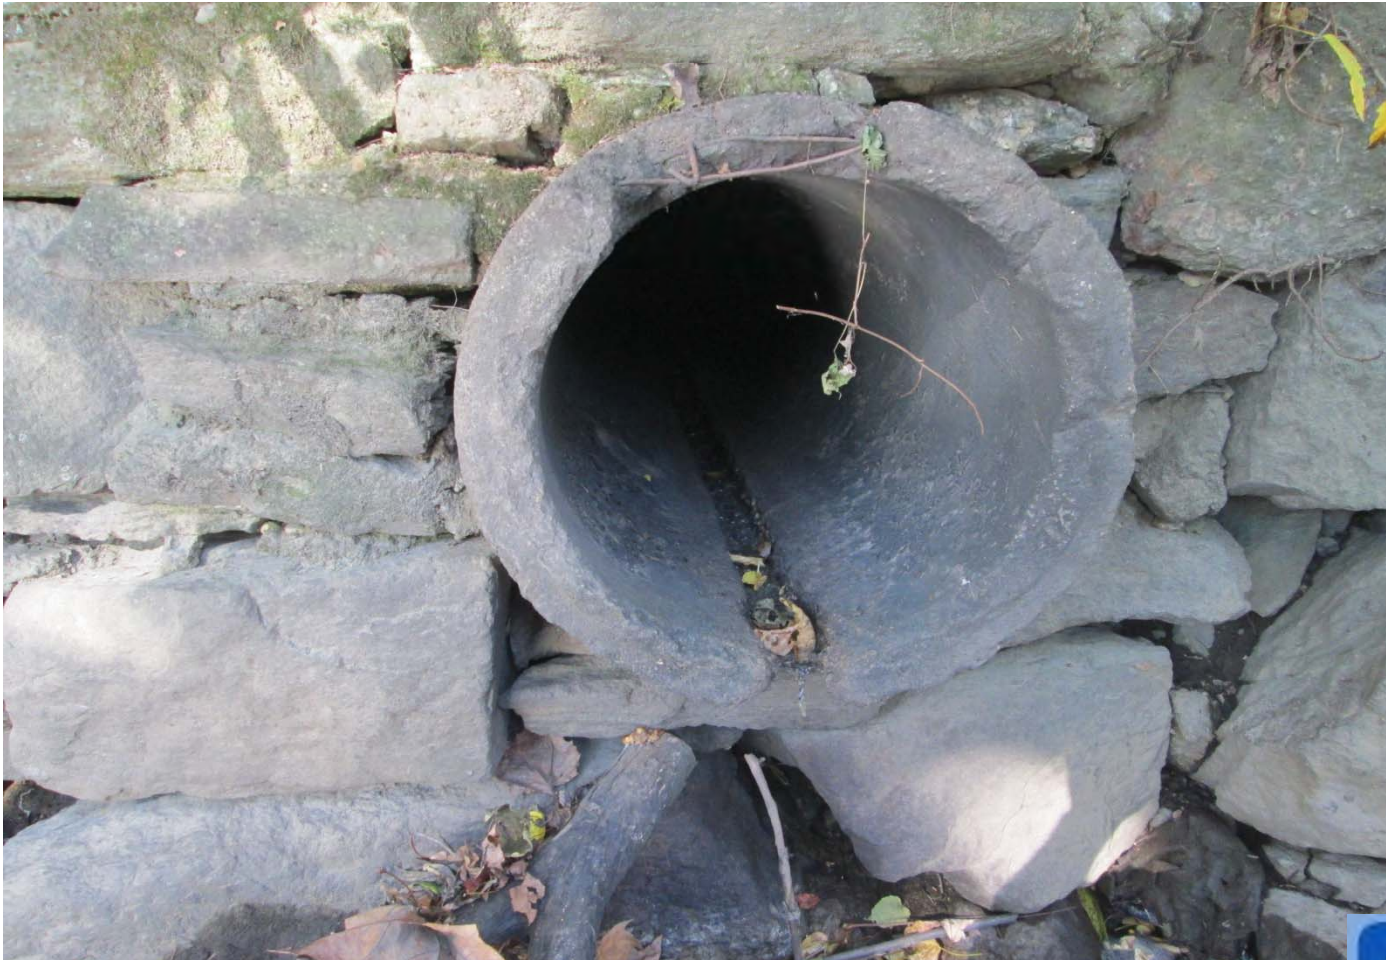
Outfall 5 in good structural condition, low flow observed in trough of pipe.

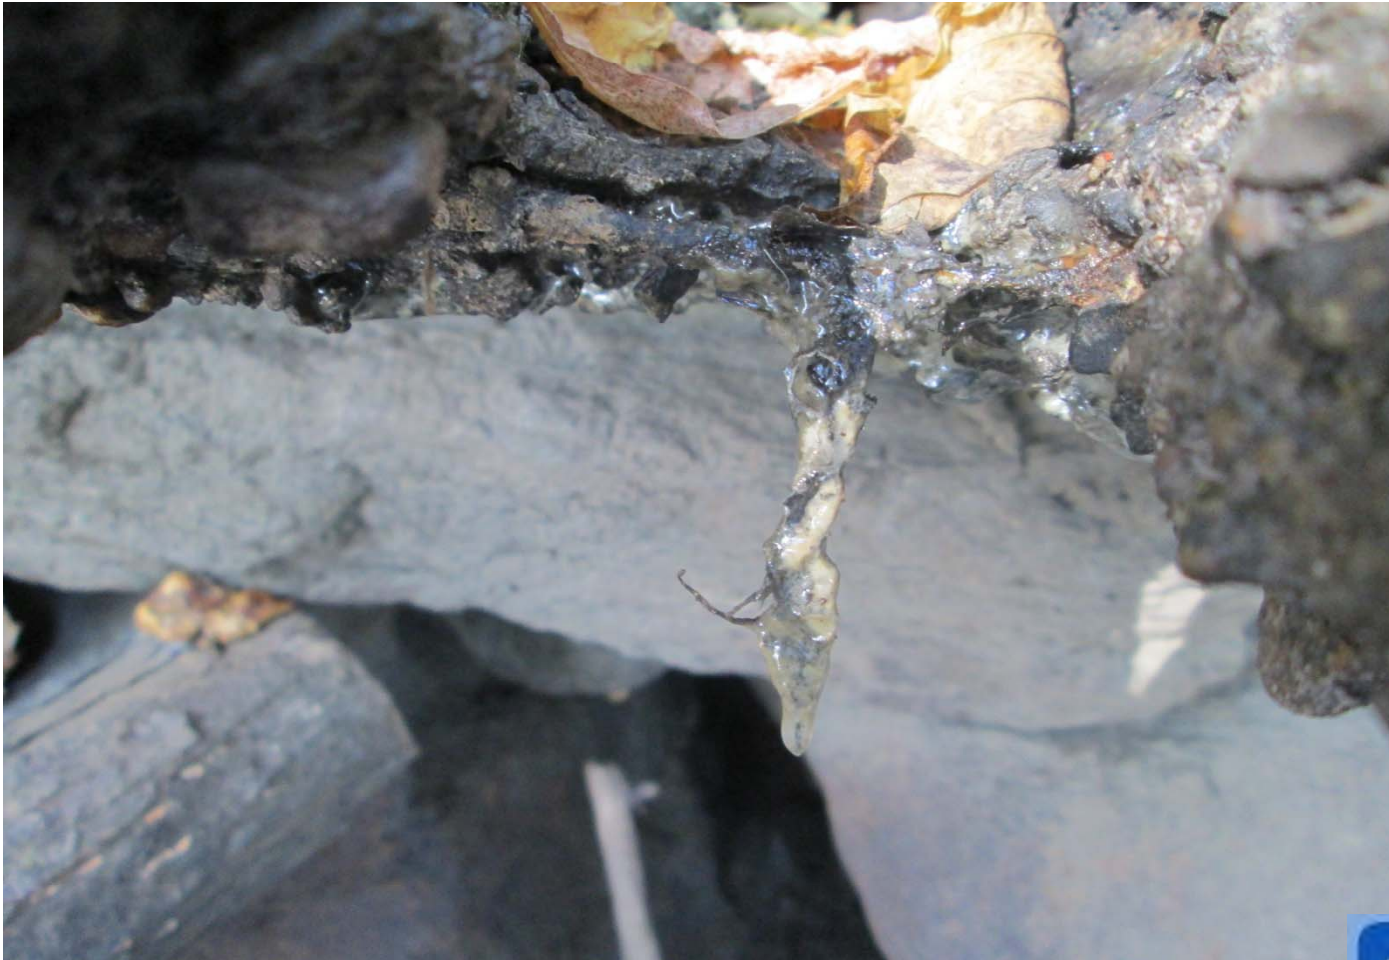
Gray bacteria and rancid sewage odor observed from outfall. Collected sample over a period of 24 hours from the dripping flow.

recommend that the Village begin an illicit discharge detection and elimination (IDDE) program in drainage areas 5, 10, 17, 25, and 26, with priority on drainage area 26. This would include additional sampling to confirm these results are replicable, sampling to track and isolate the sources of the illicit discharges, and then techniques such as dye testing, smoke testing, and video inspection to locate the sources so they can be eliminated. The other drainage areas have low flow and relatively low fecal coliform concentrations. They may need to be revisited at a later date to confirm the pollutant load is still low.

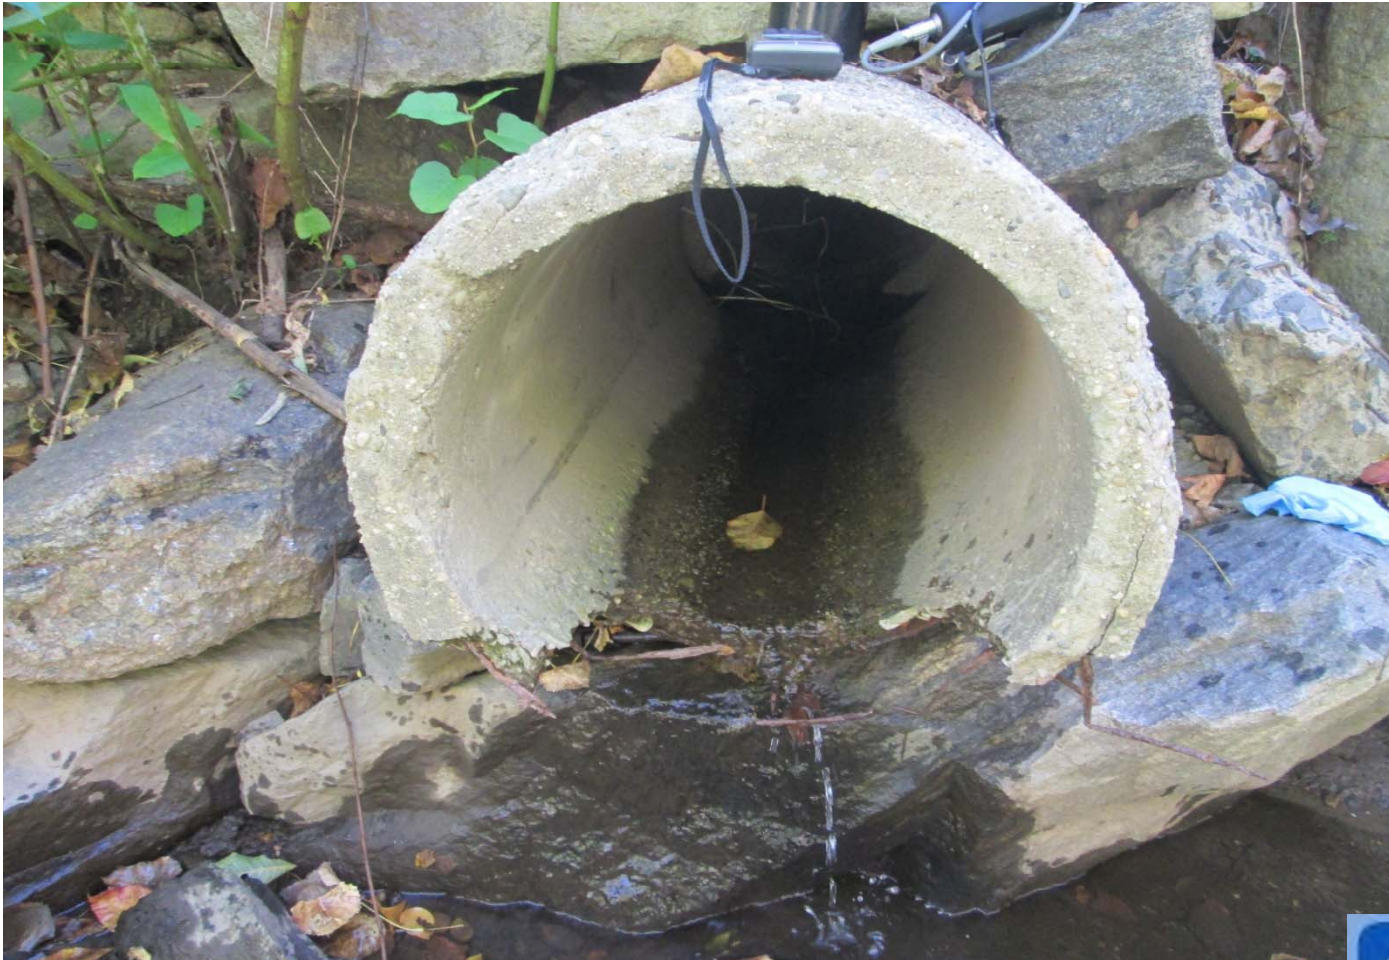
| Protruding pipe has a cracked/<br>missing bottom. | |

Outfall 4 in fair condition; base of protruding pipe cracked/ missing.

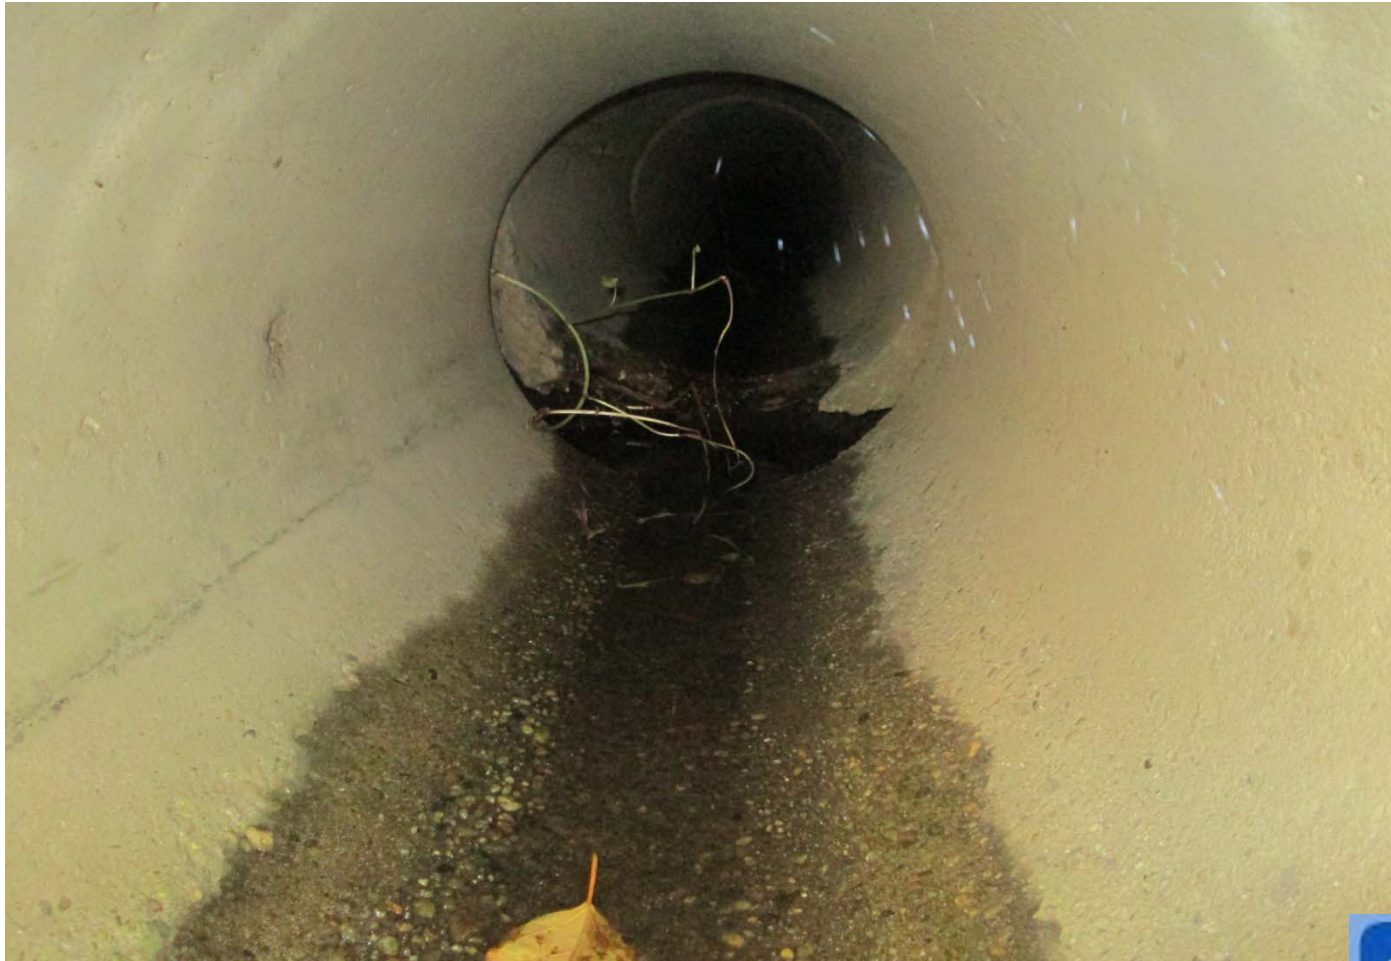
Flow observed trickling in Outfall 4 from upstream source(s).
