Subject:  
Illicit Discharge Detection and Elimination Study  
Outfall and River Sampling Results

Date:  
November 13, 2012

Technical Memo  
Mamaroneck Outfall and River Sampling

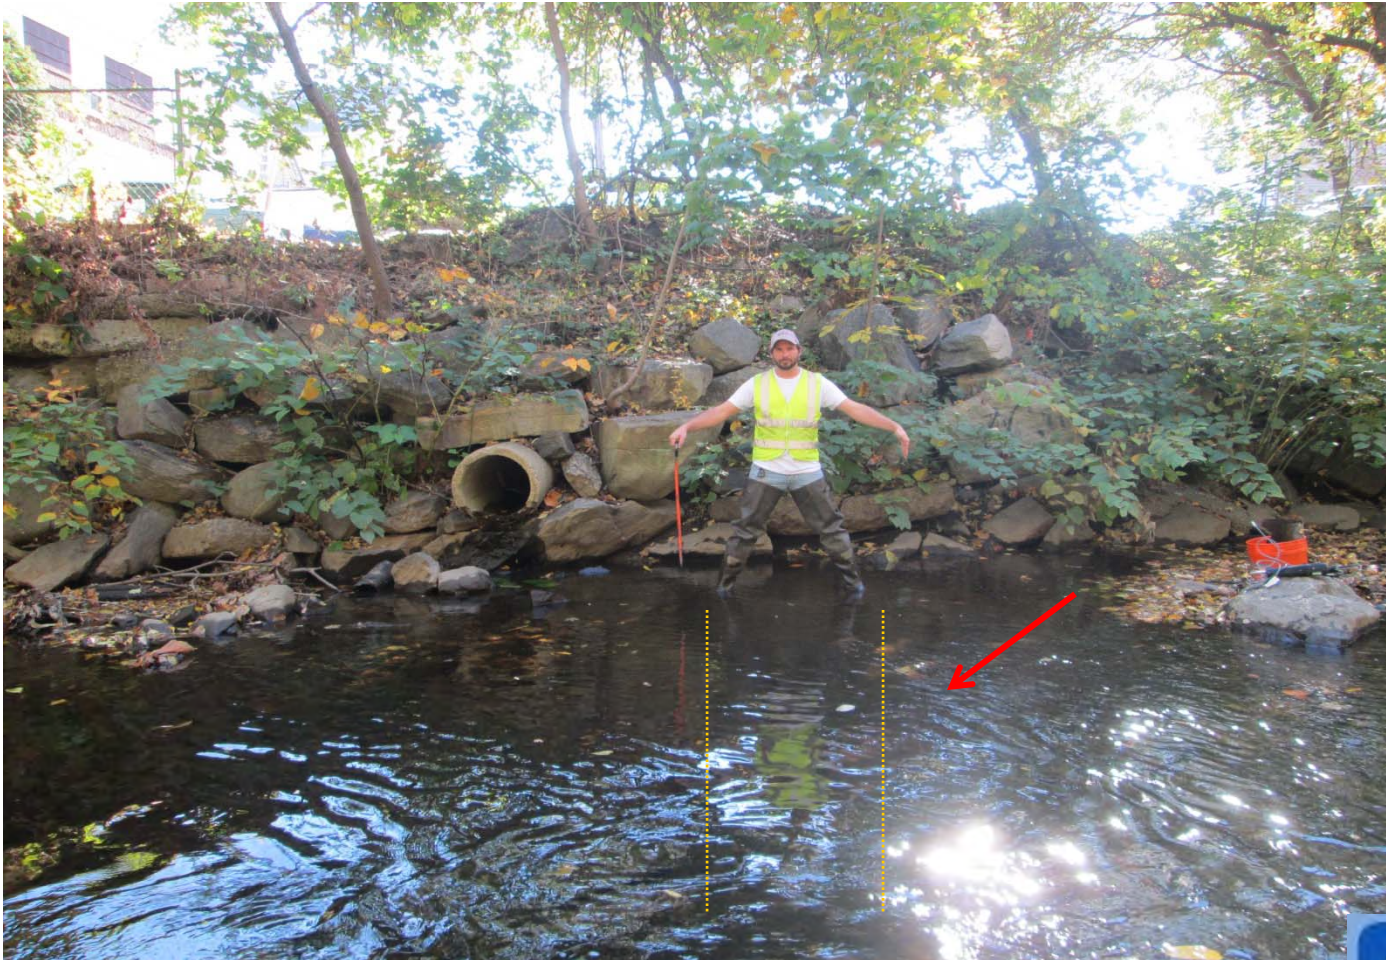
Concrete structure observed ~3 ft downstream of Outfall 4.

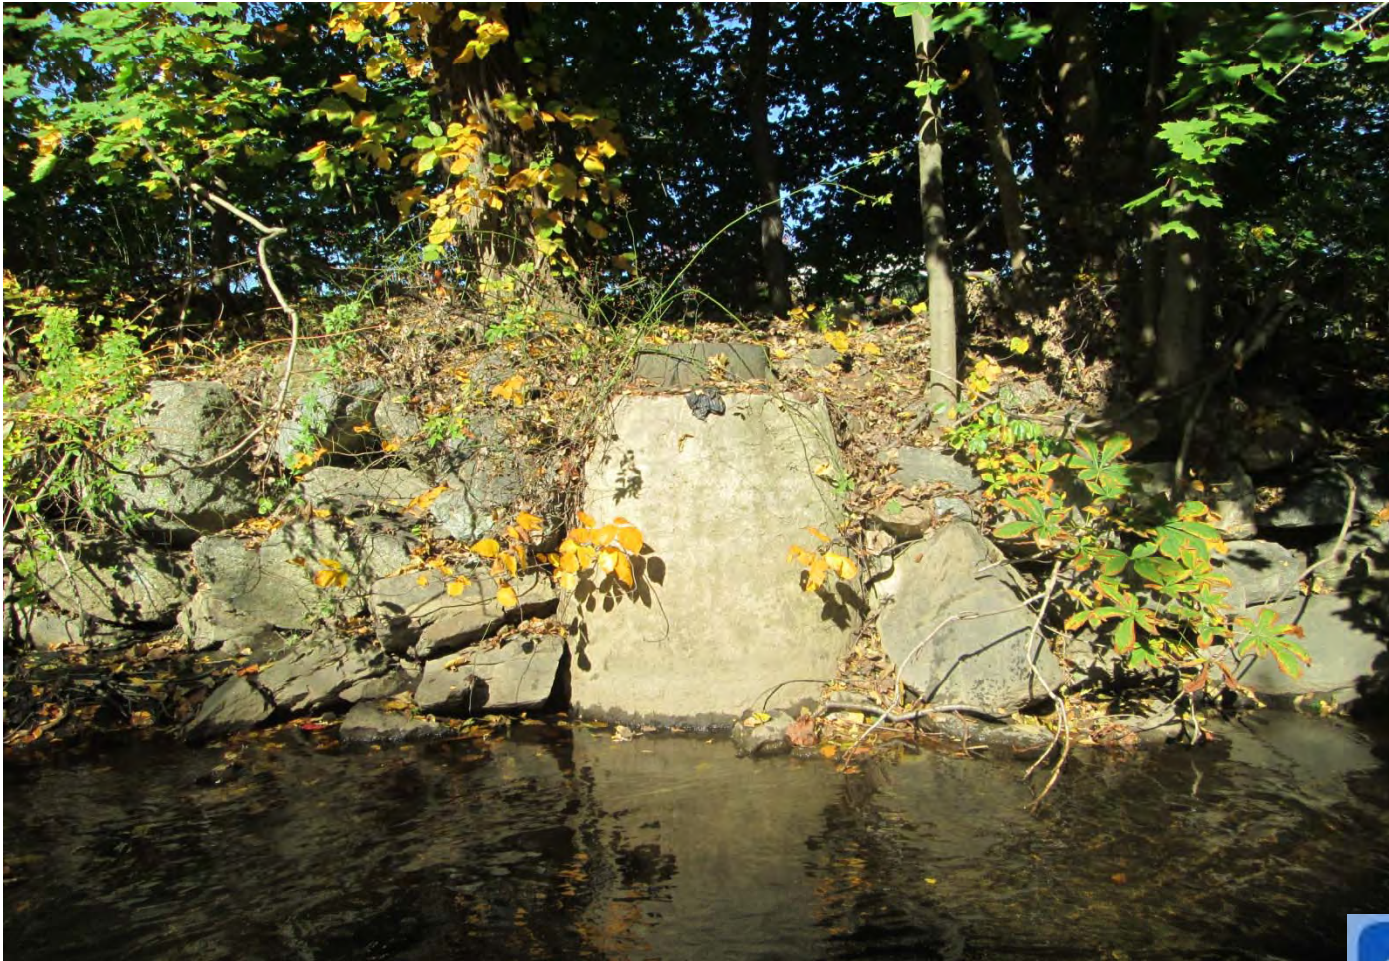
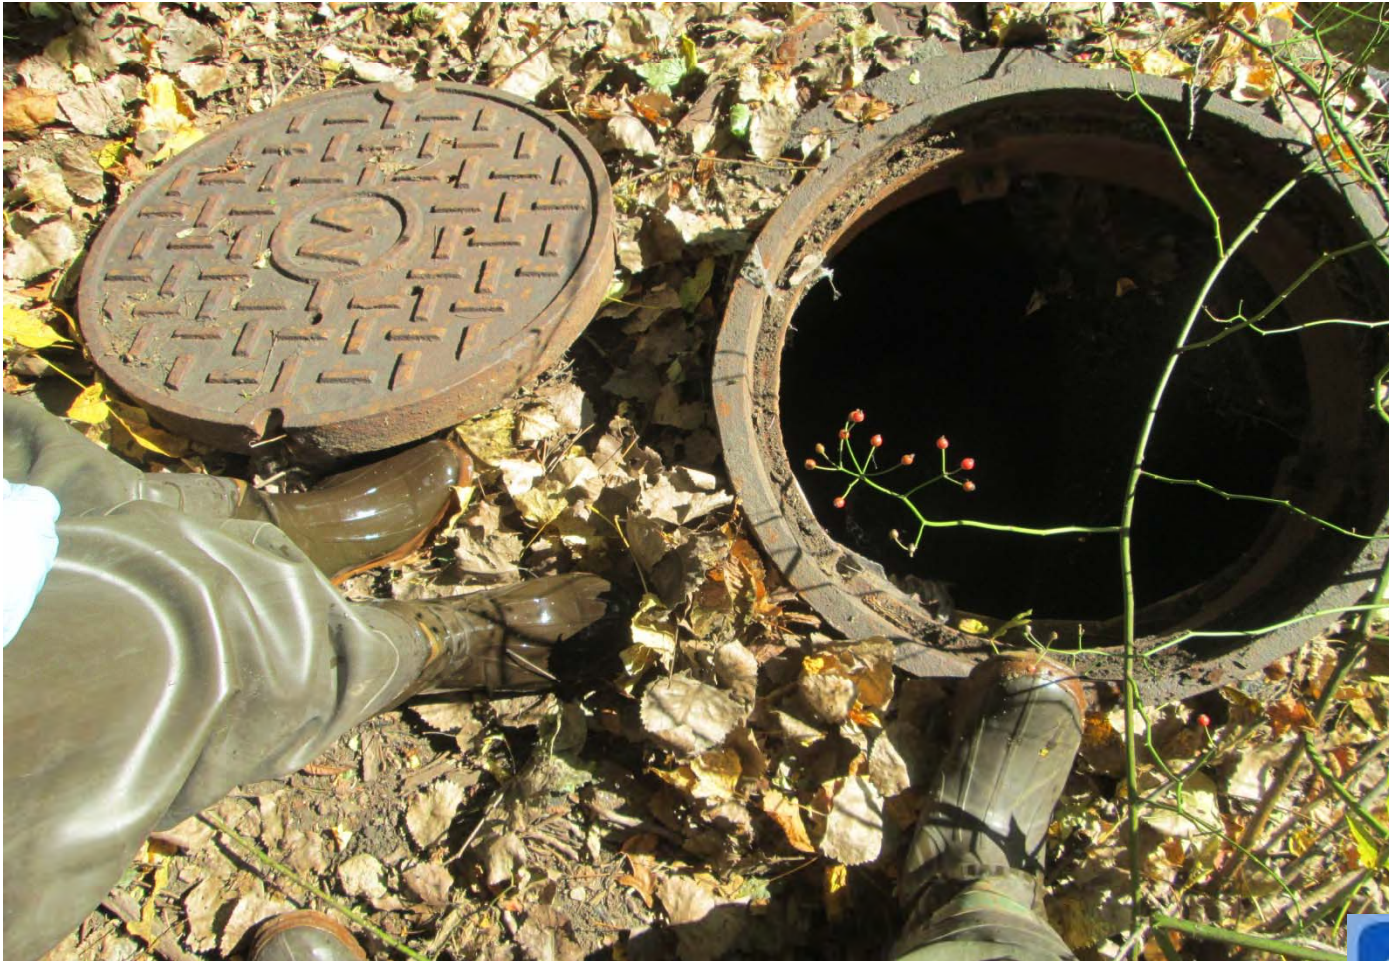
Manhole observed on left bank (when facing upstream)  
in line with concrete structure.

Manhole observed on left bank (when facing upstream) in line with concrete structure.

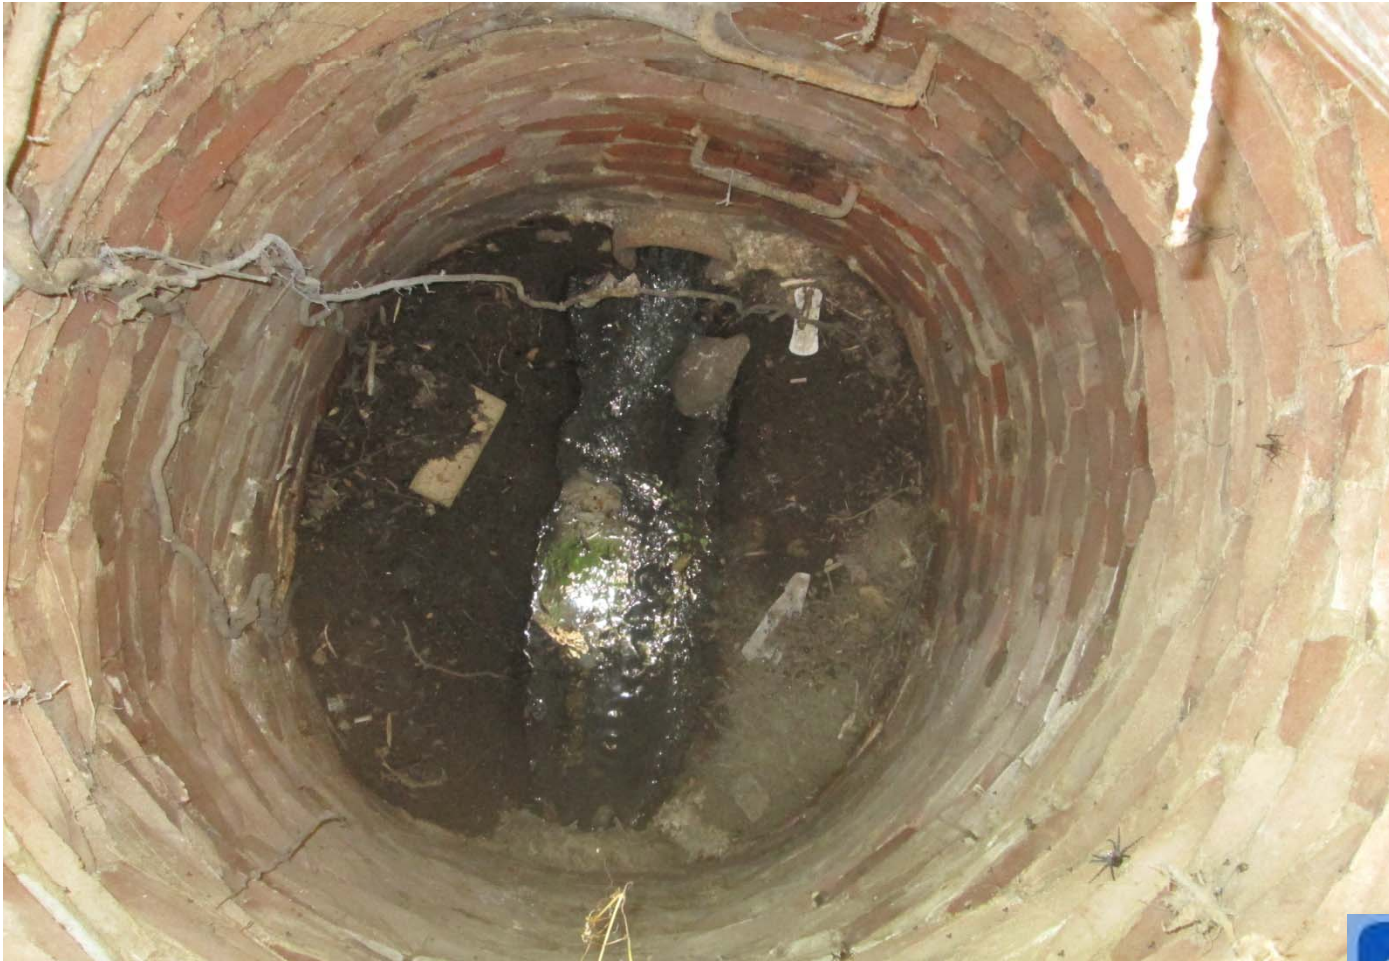
Confirmed as a sanitary manhole.

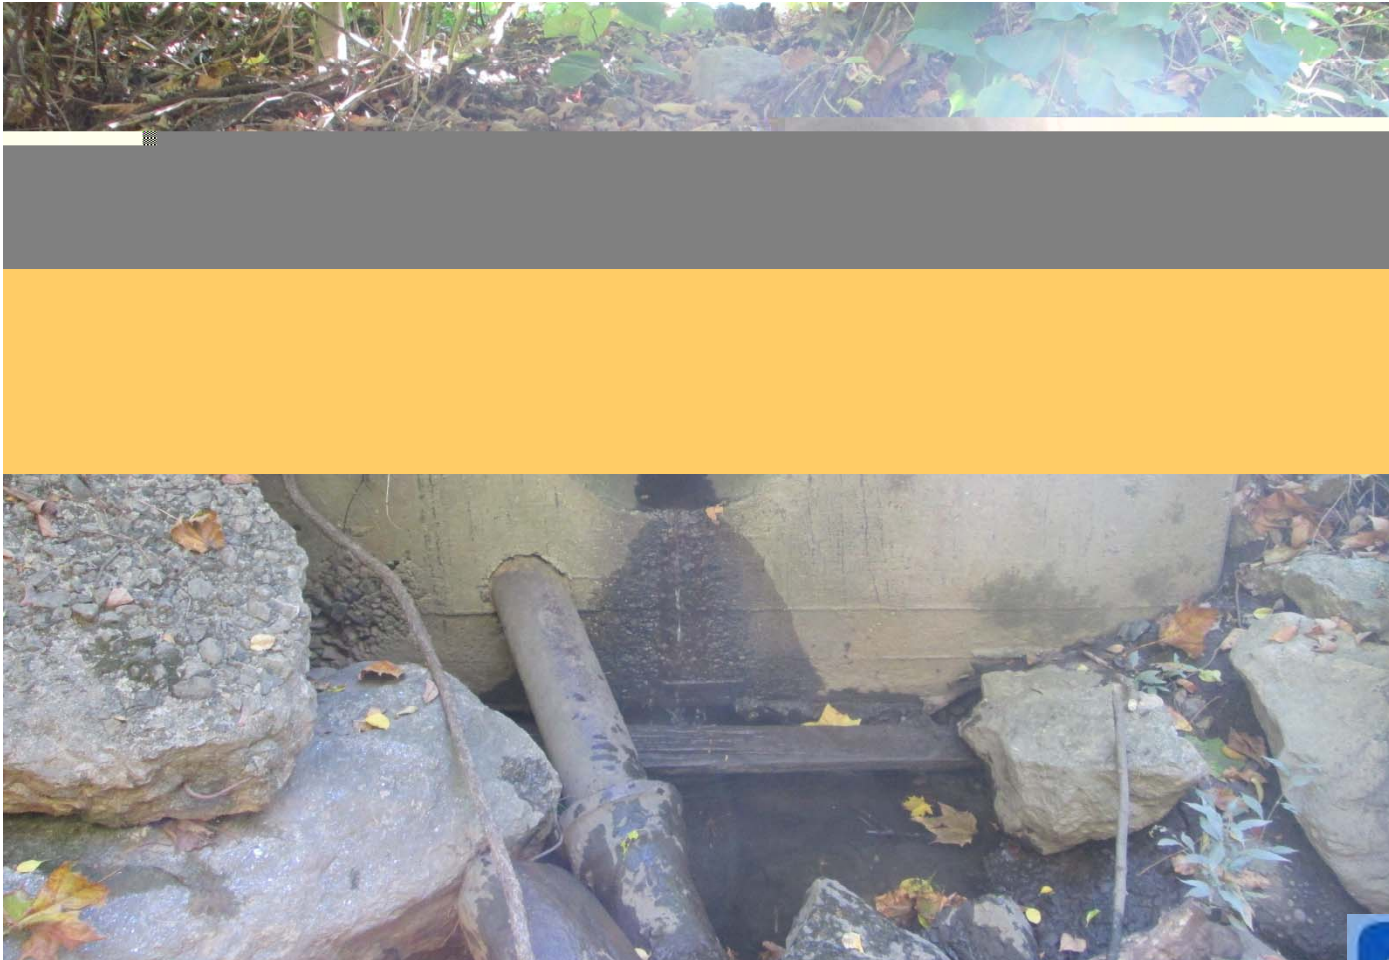
Outfall 10 in good condition. Protruding 6 inch pipe observed; possibly sanitary.

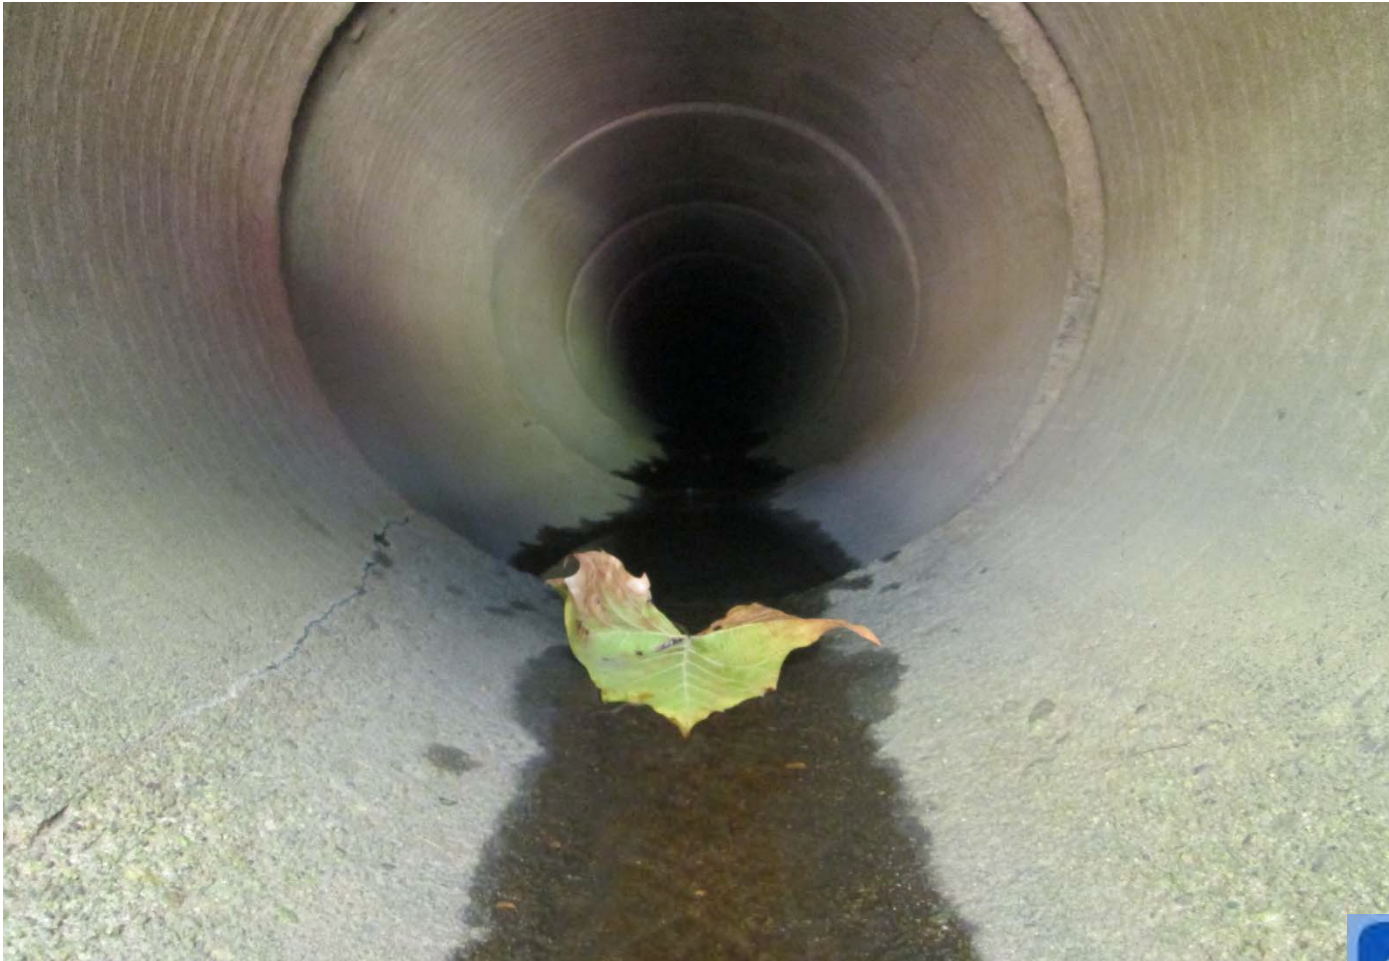
Outfall 10 flow observed as a trickle during sample collection.

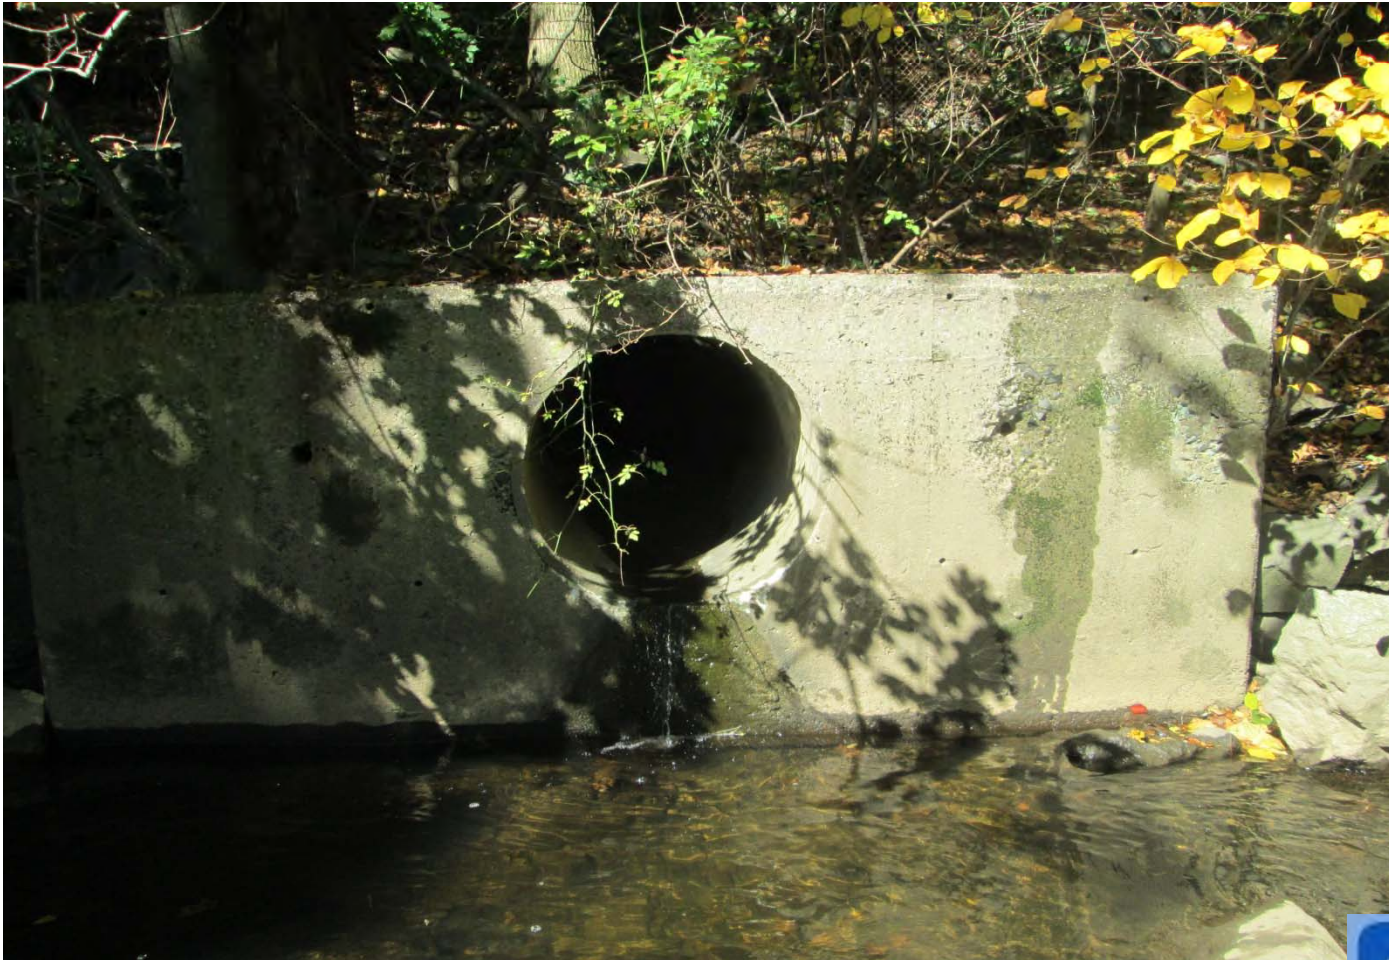
Outfall 9 flow observed as moderate during sample collection.

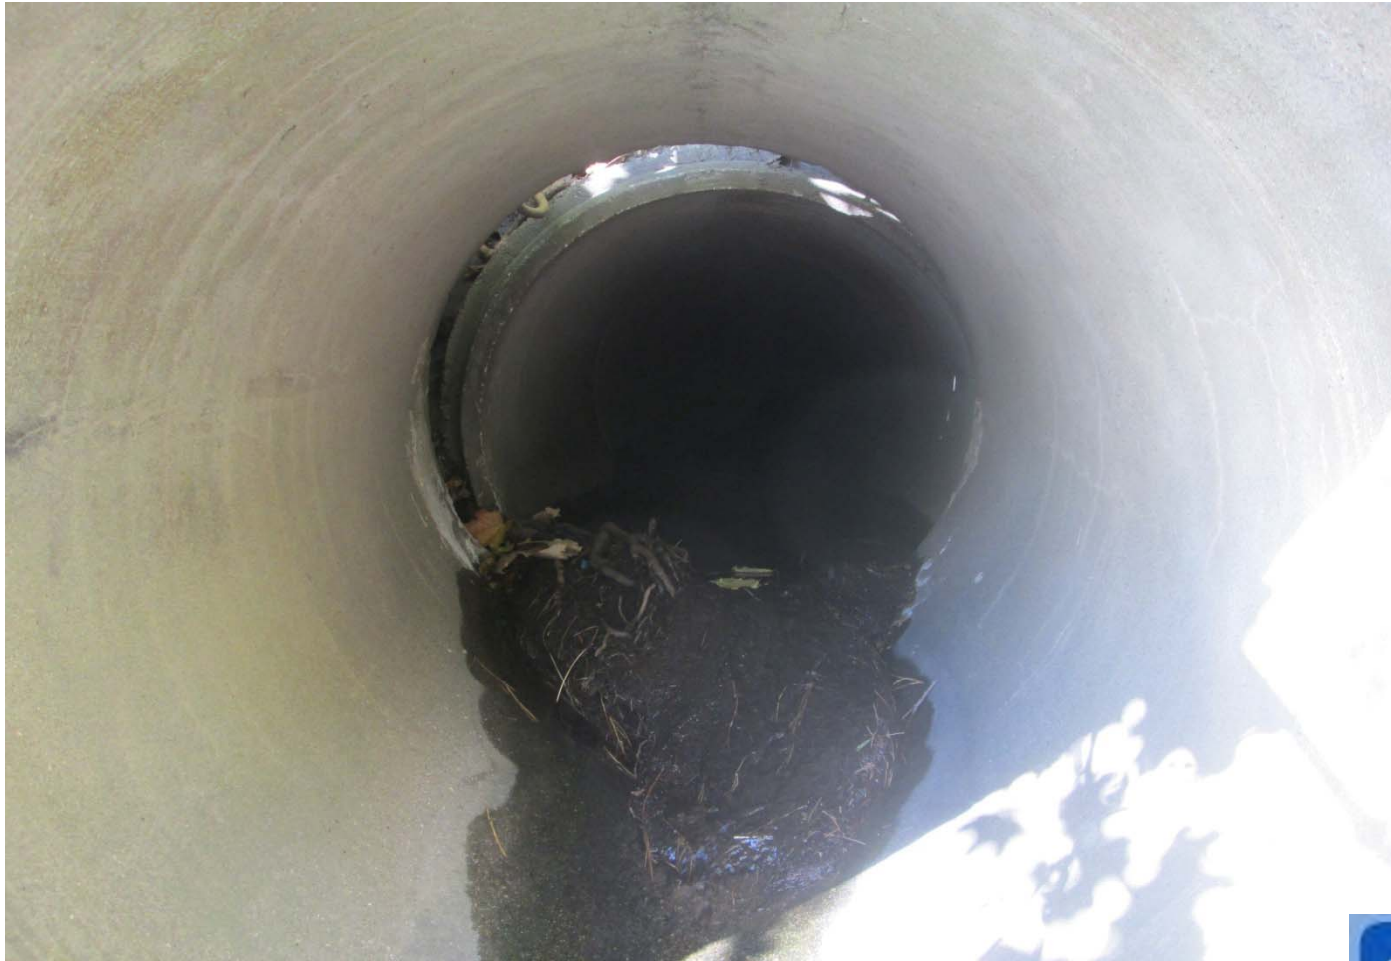
Break in joint observed 4 ft back inside pipe.

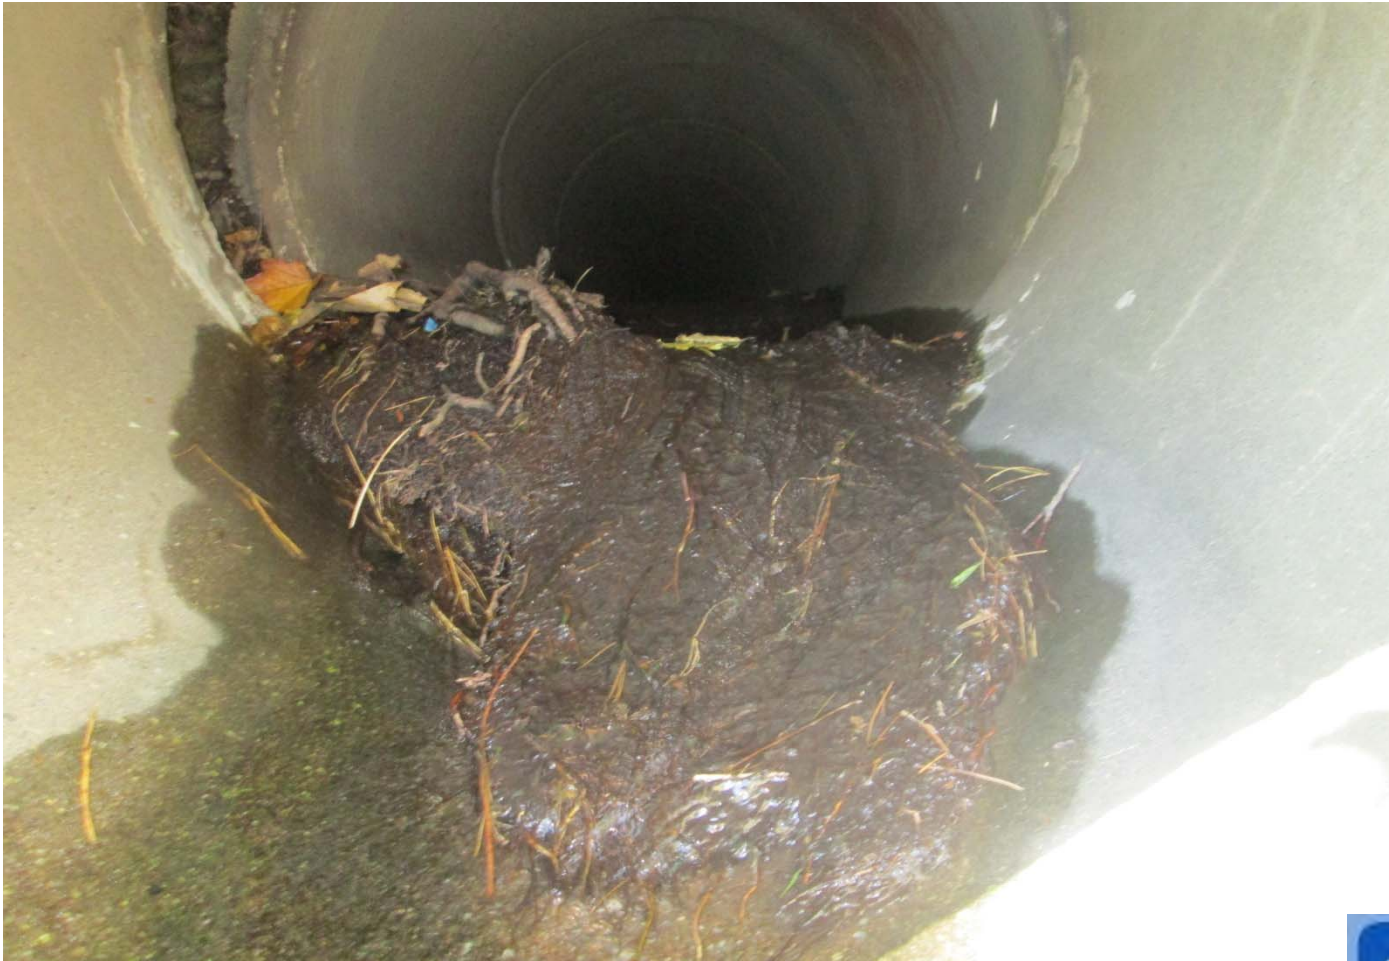
Abnormal vegetation and heavy root growth observed in Outfall 9.

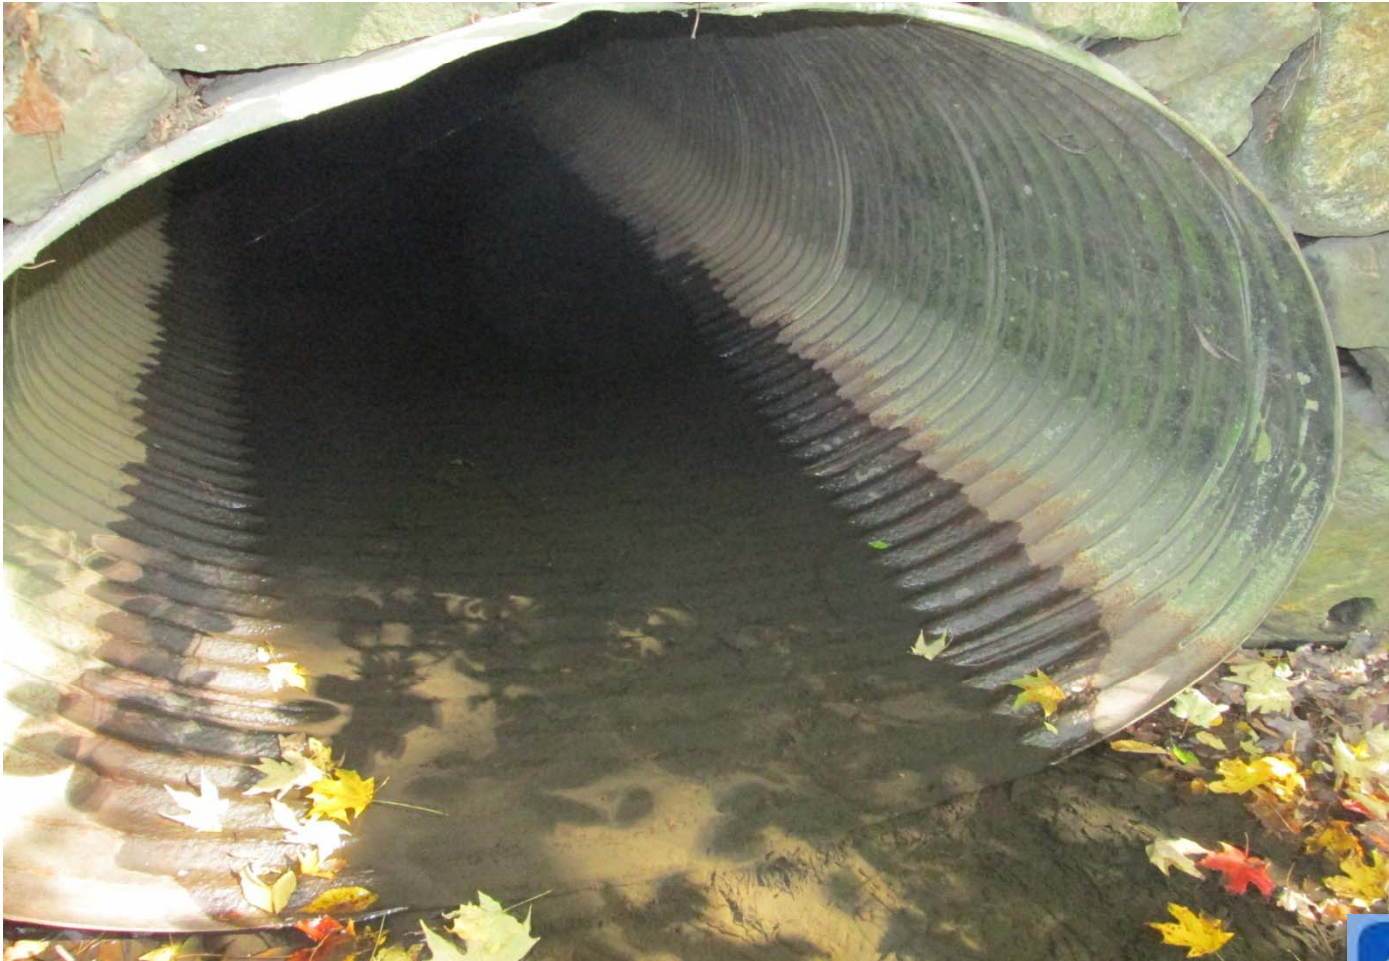
Outfall 17 in good condition. Mild sewage odor detected, and bacteria observed in base of pipe.

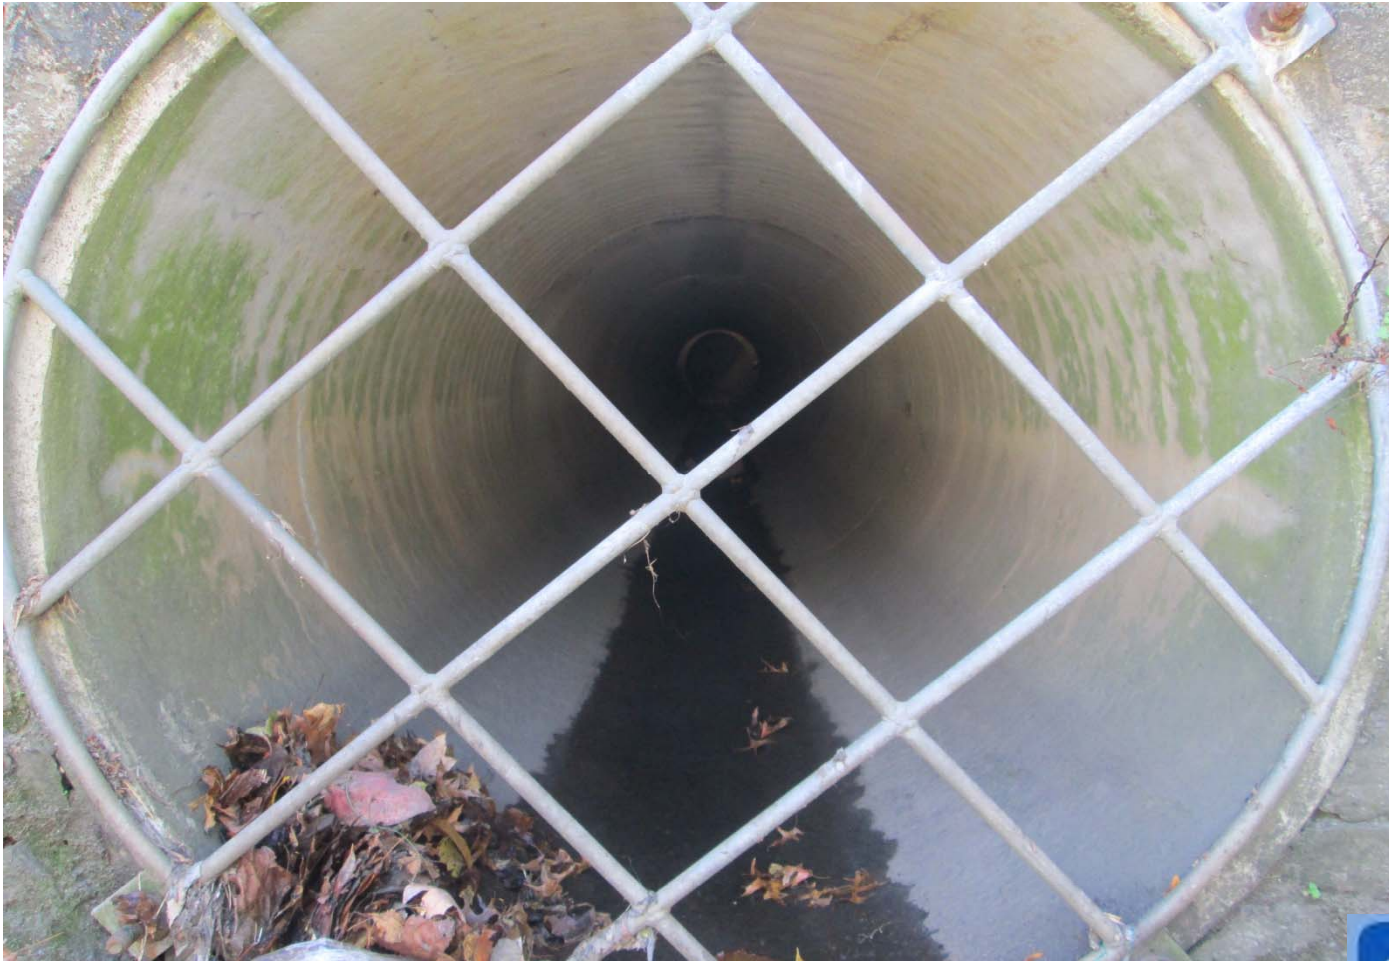
Outfall 24 pool created by debris of leaves inside outfall grate.

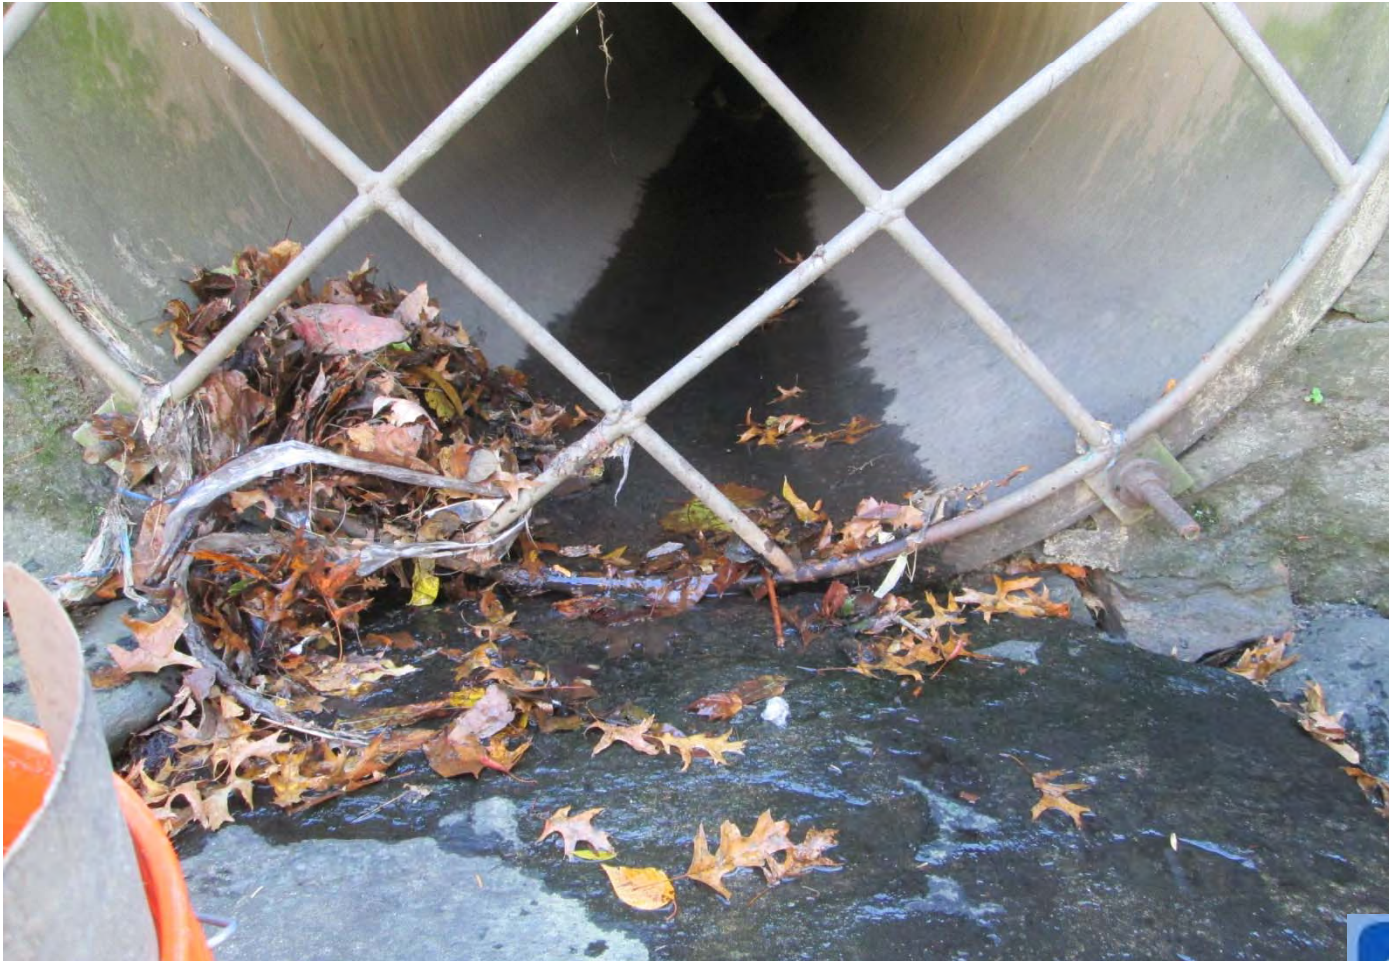
Flow observed as moderate during time of sampling.

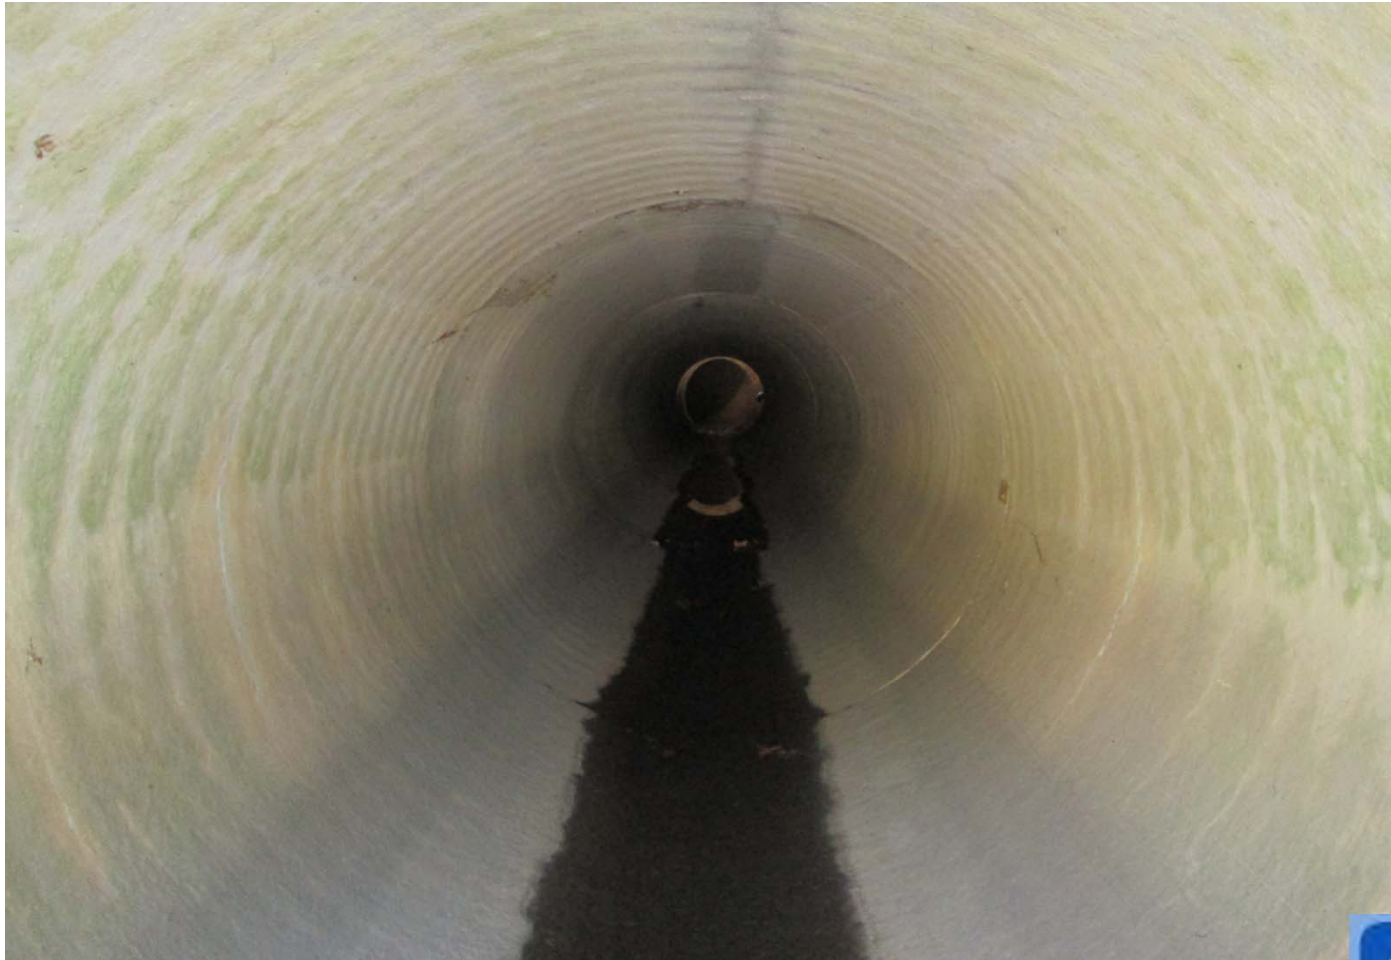
Outfall 24 in good structural condition.

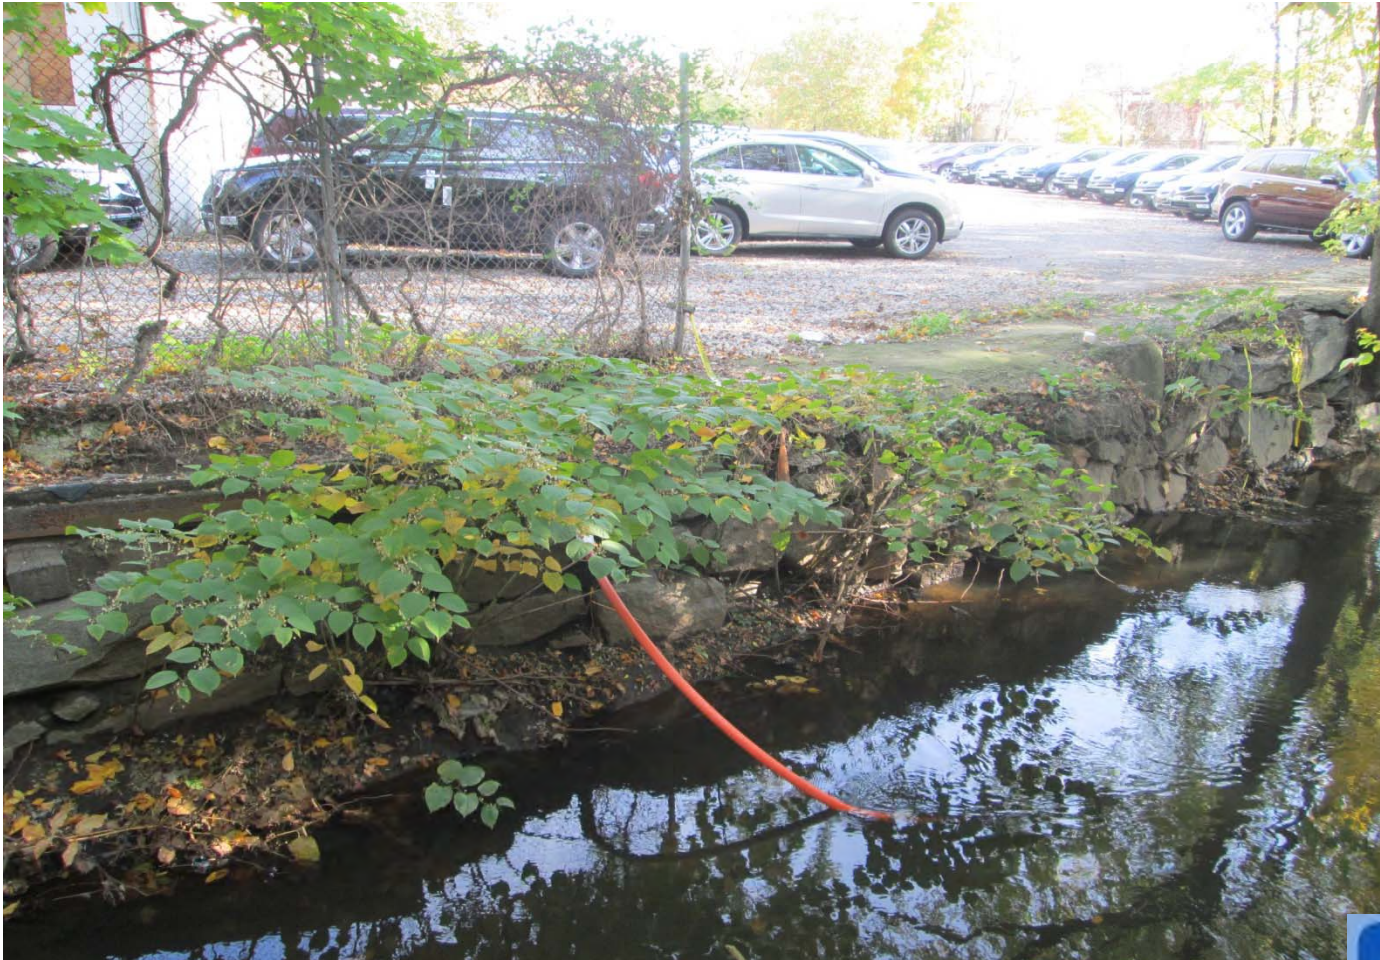
Hose observed in river upstream of Outfall 30. Assumed source is from the adjacent auto business.

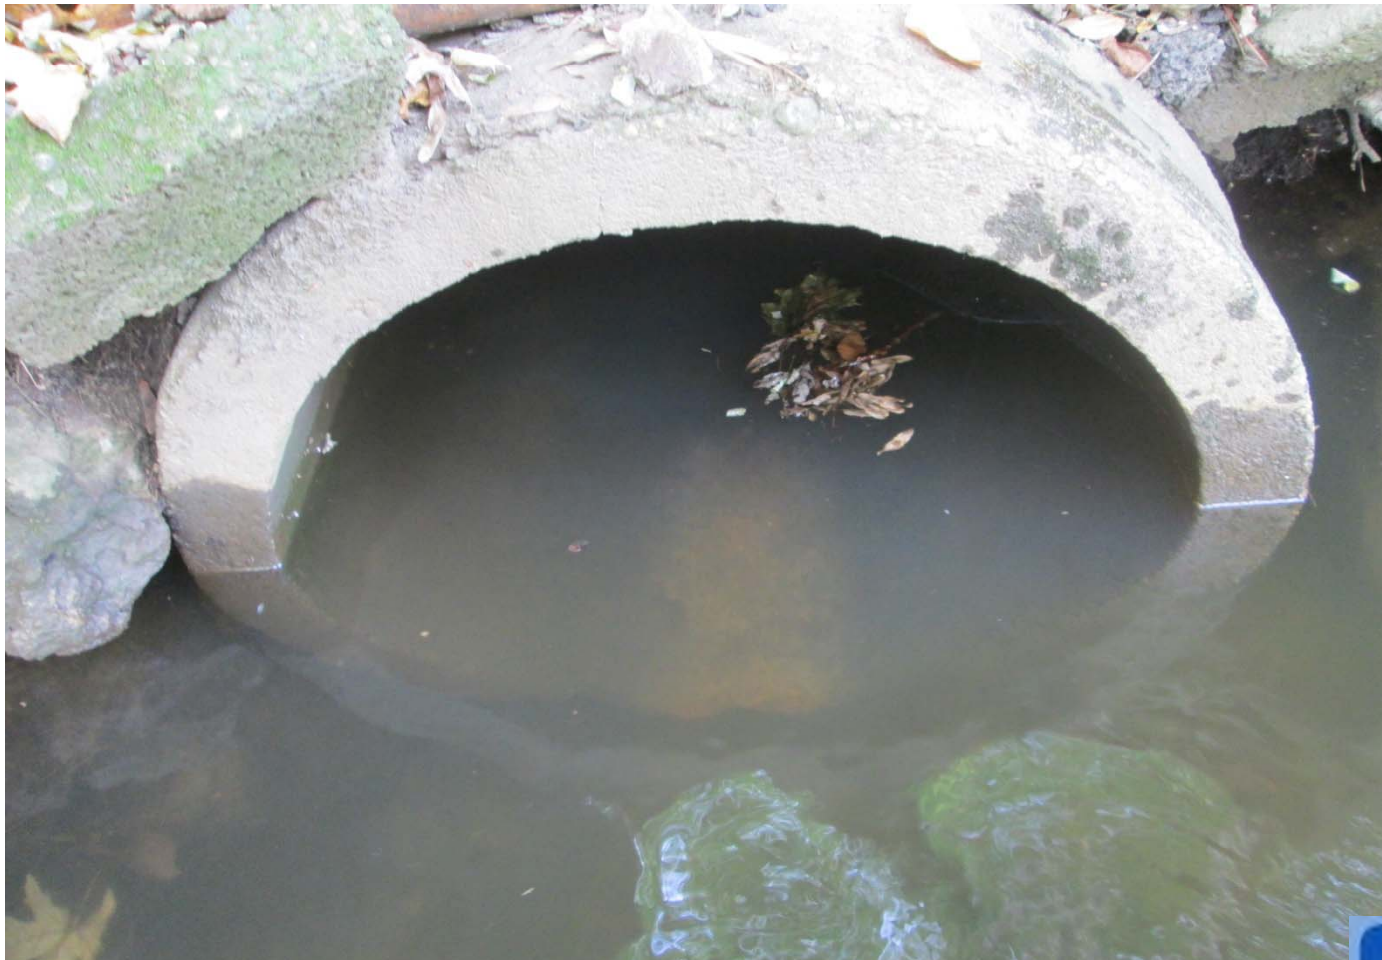
Outfall 30 submerged in water. Pipe in good condition.

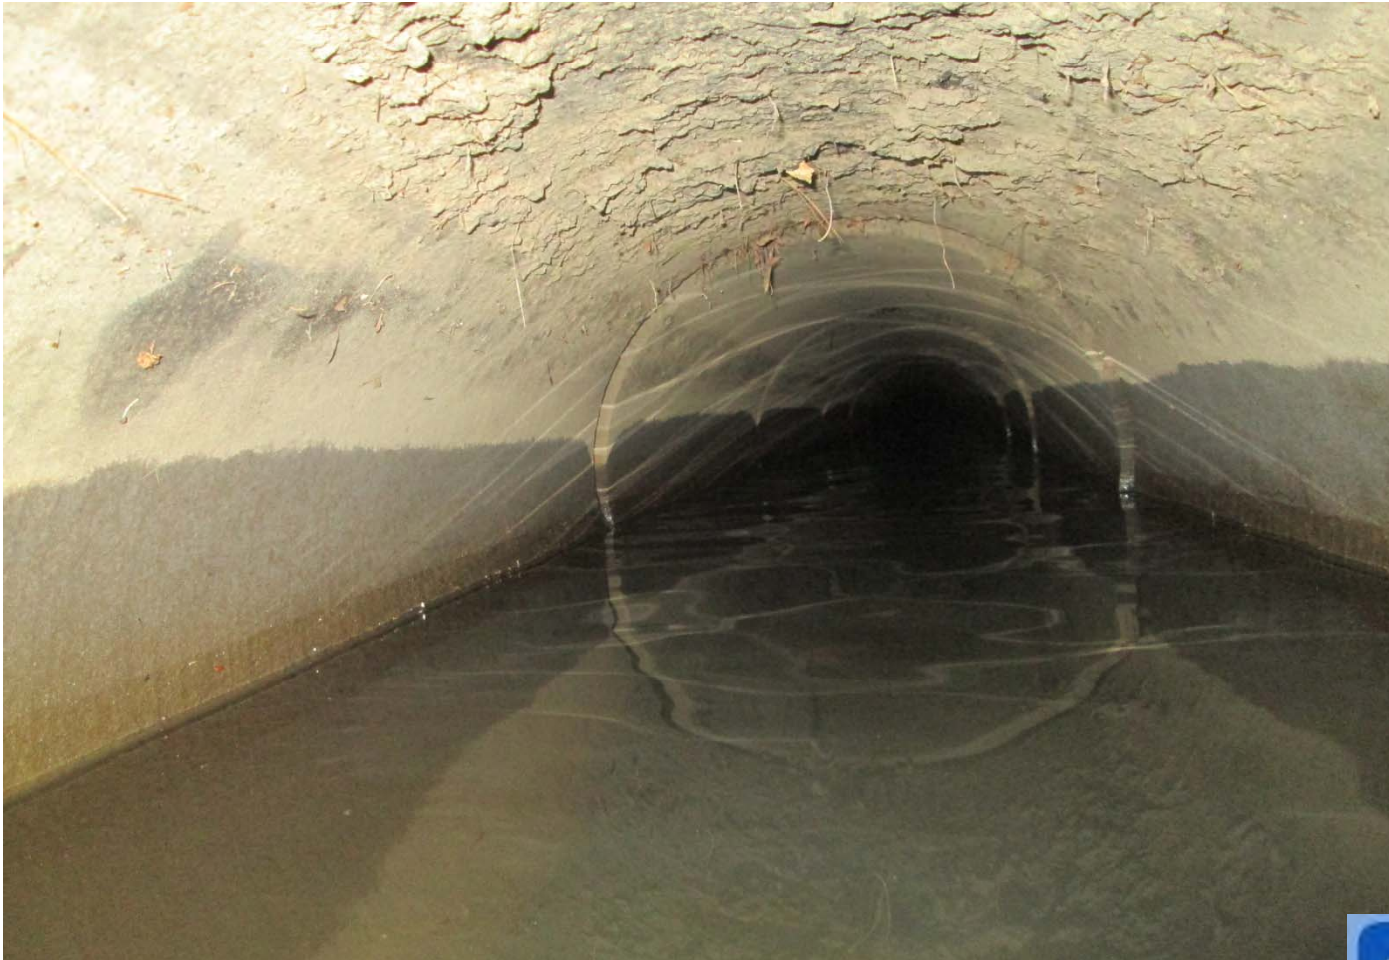
Outfall 30 inlet moderate flow.

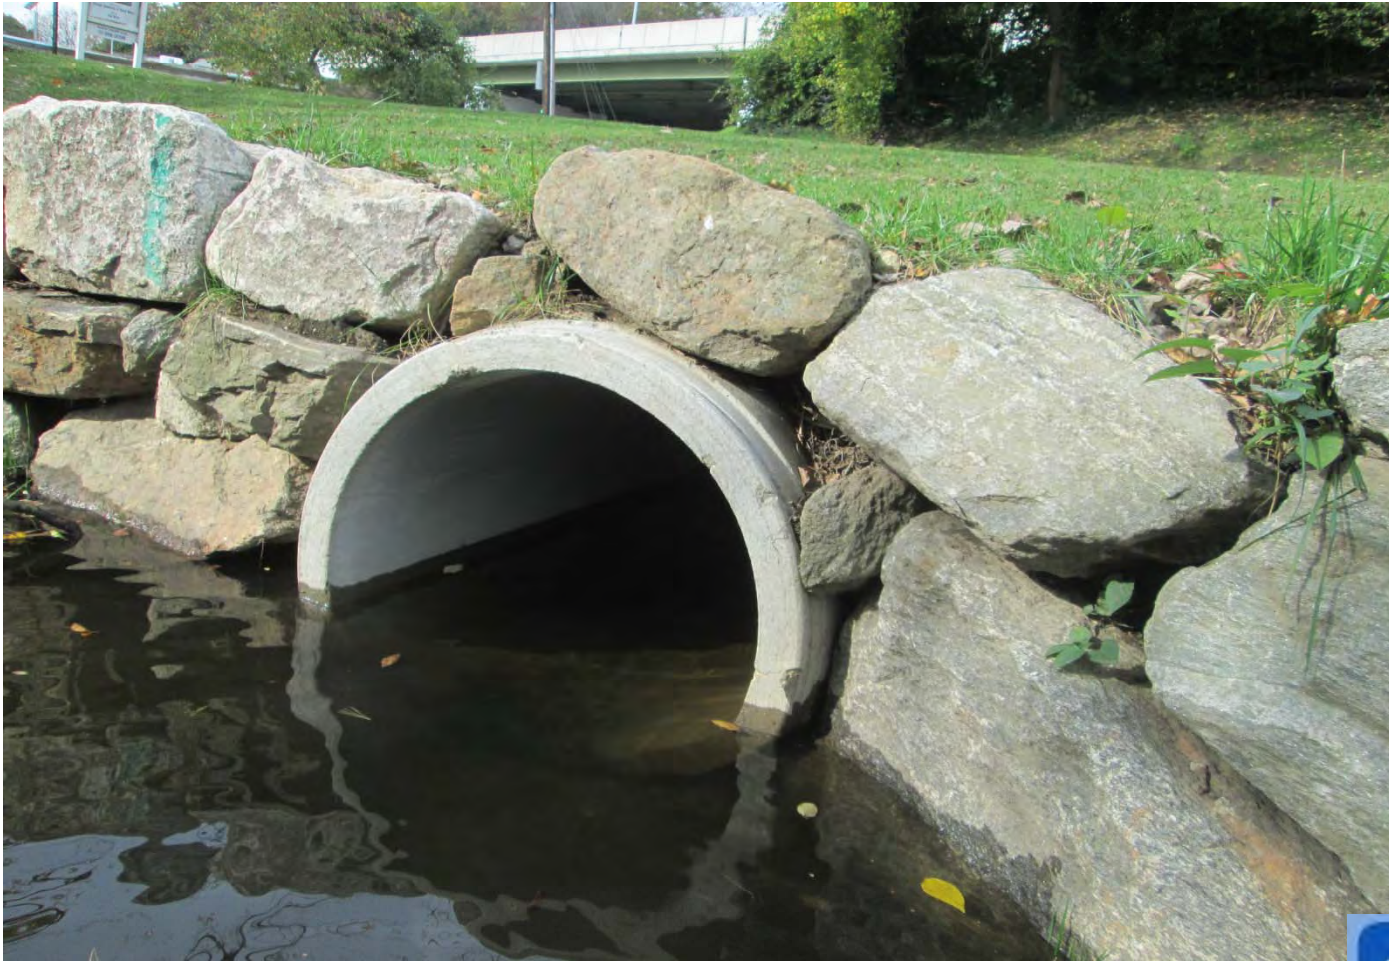
Outfall 43 has no flow. No sample collected.
