Subject:  
Illicit Discharge Detection and Elimination Study  
Outfall and River Sampling Results

Date:  
November 13, 2012

Technical Memo  
Mamaroneck Outfall and River Sampling

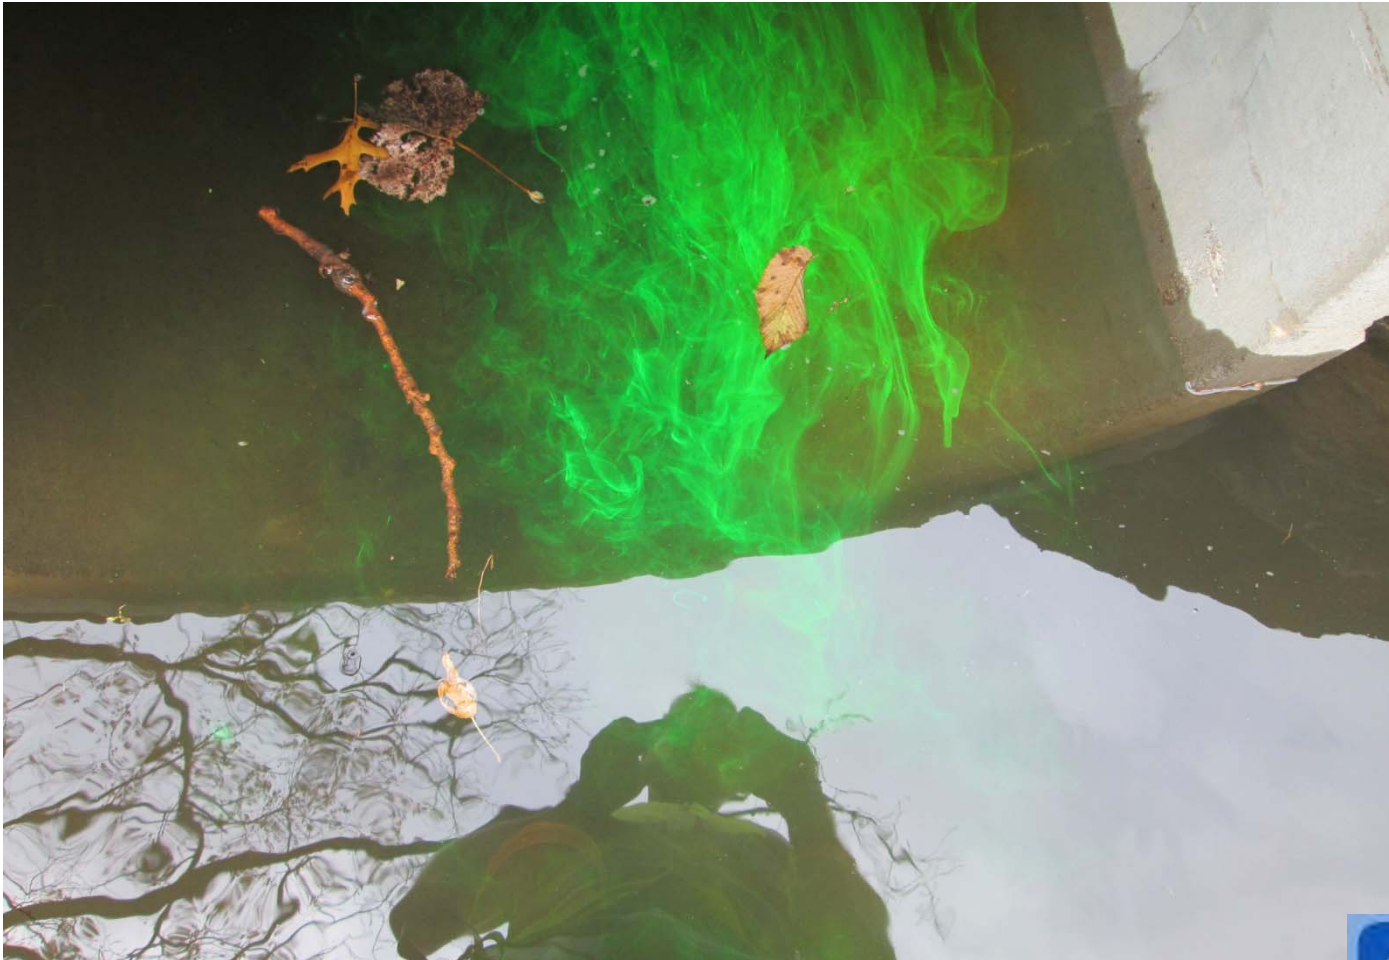
Stagnant flow from Outfall 43 confirmed using green dye. Photos show backflow.

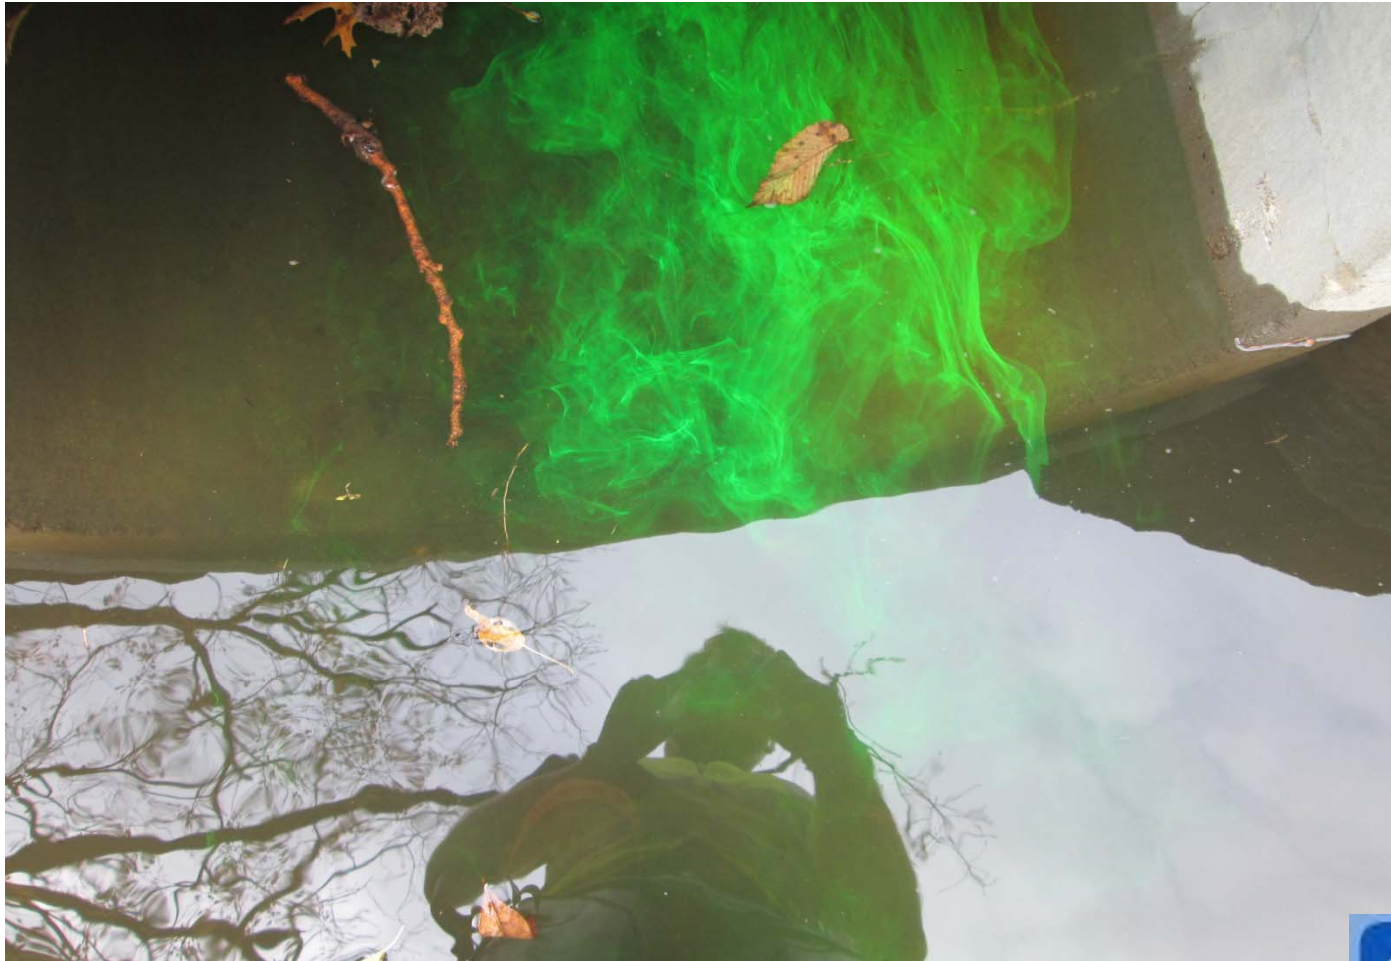
Stagnant flow from Outfall 43 confirmed using green dye.

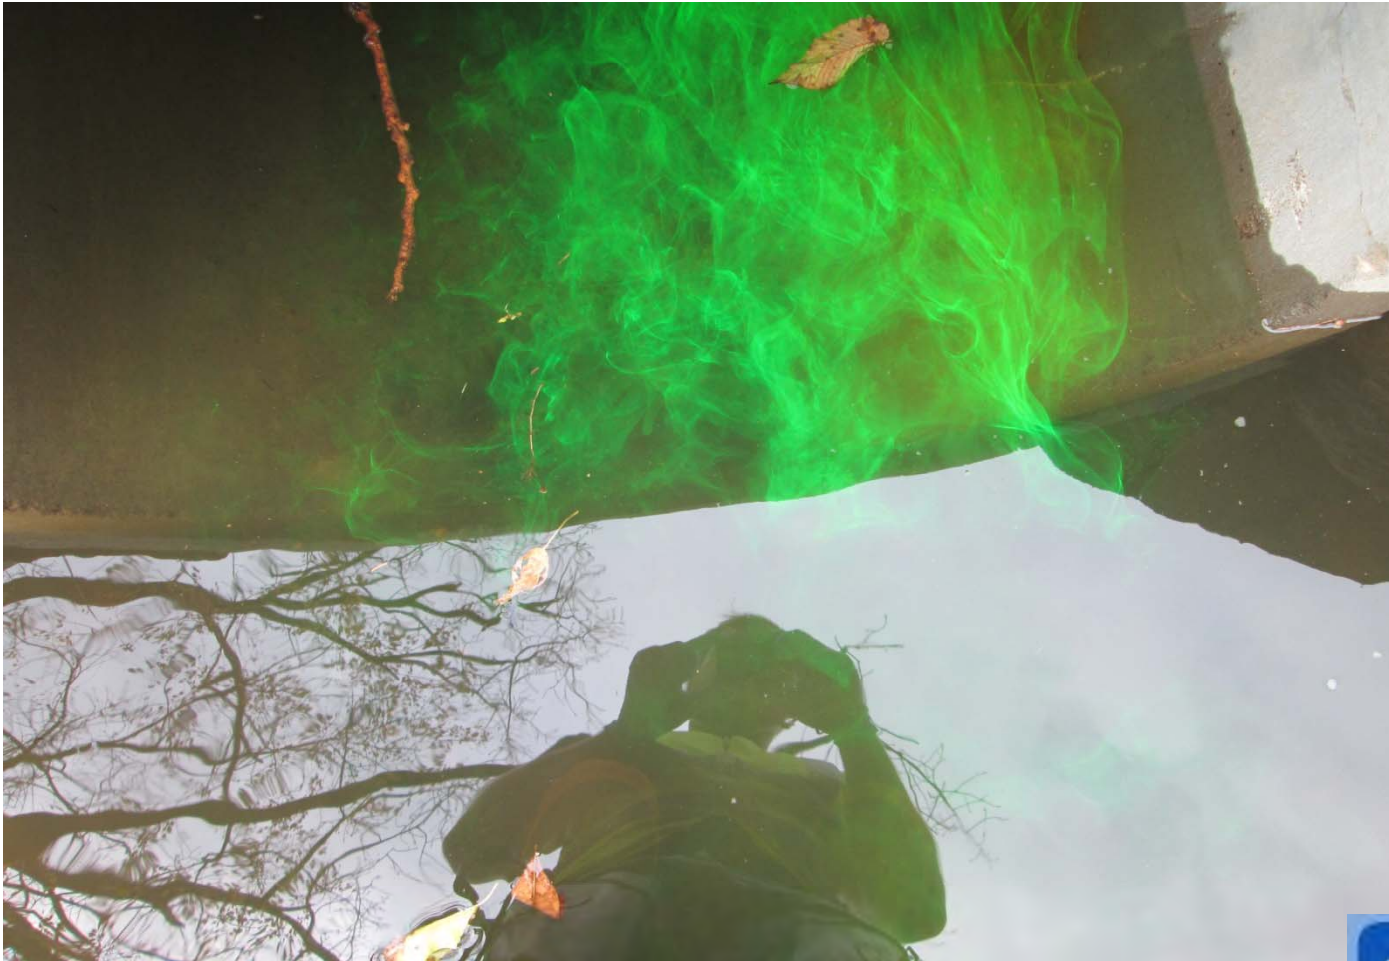
Stagnant flow from Outfall 43 confirmed using green dye.

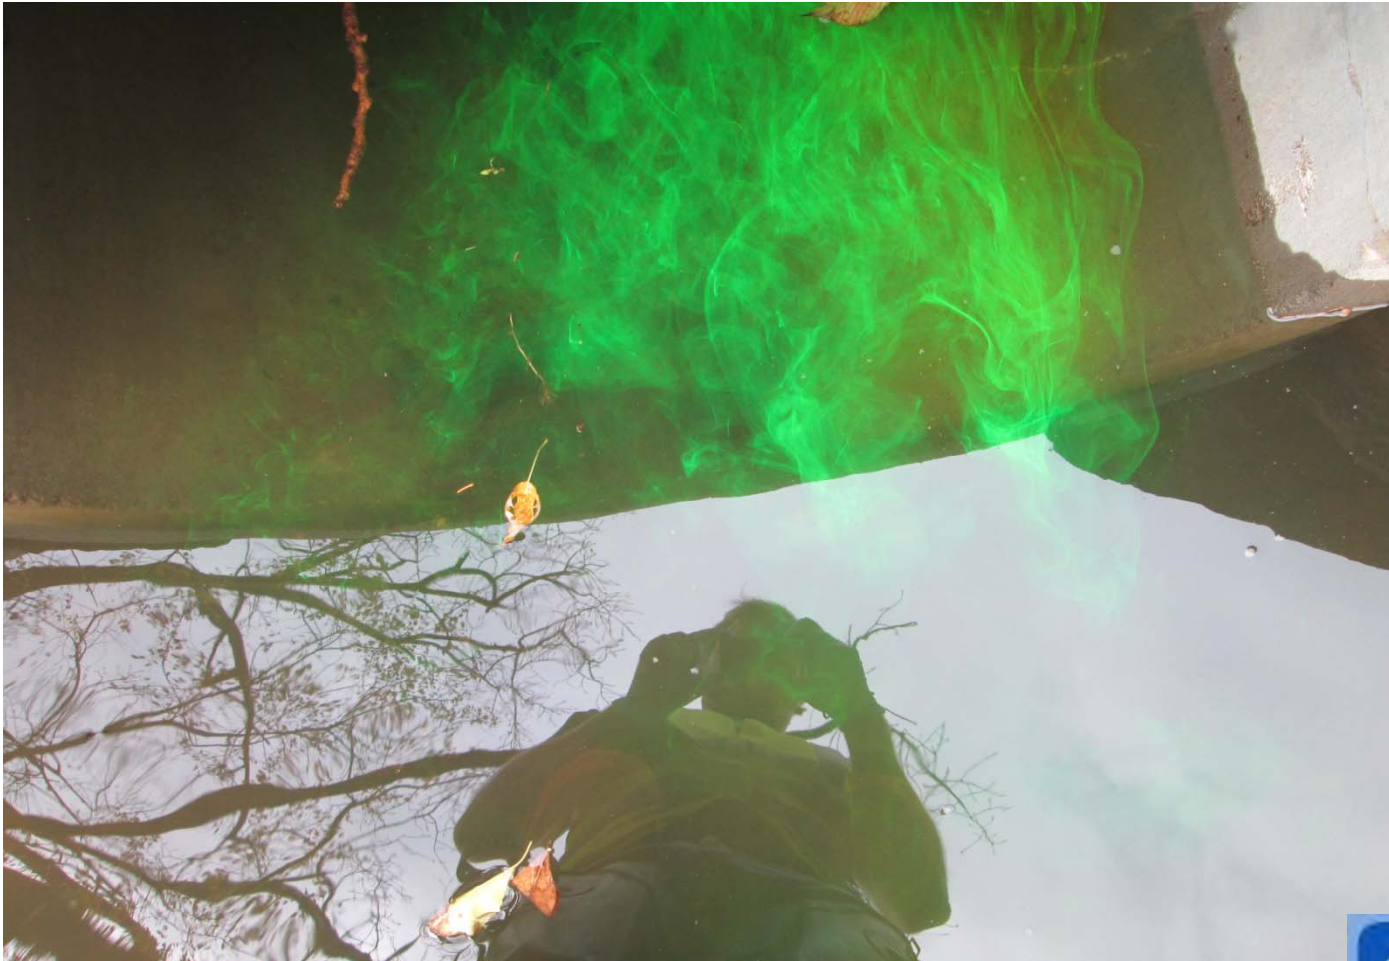
Stagnant flow from Outfall 43 confirmed using green dye.

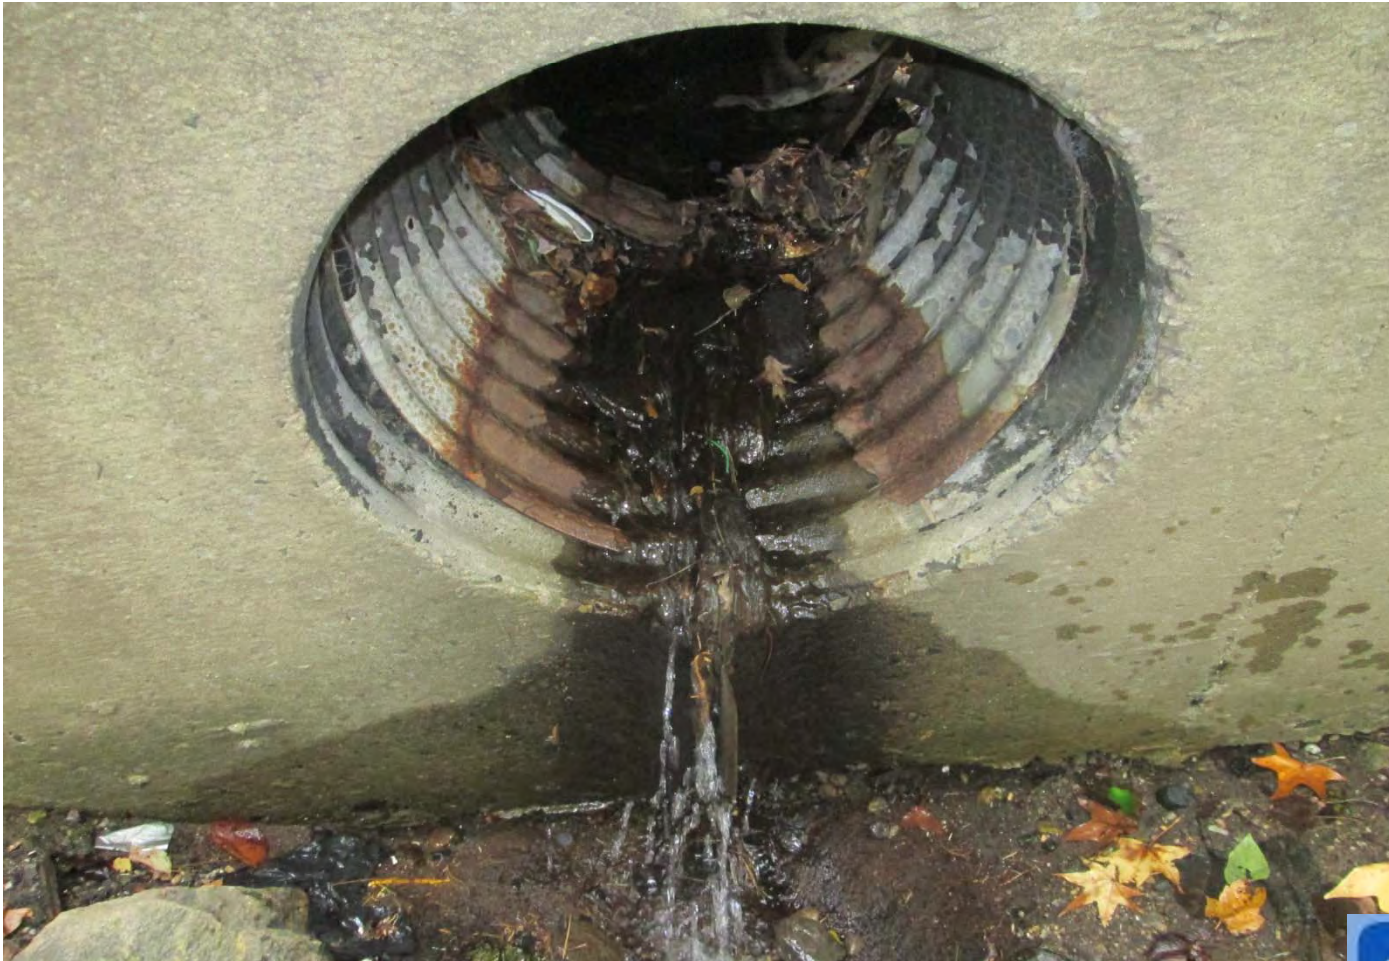
Outfall 47 has a trickle flow during time of sample collection.

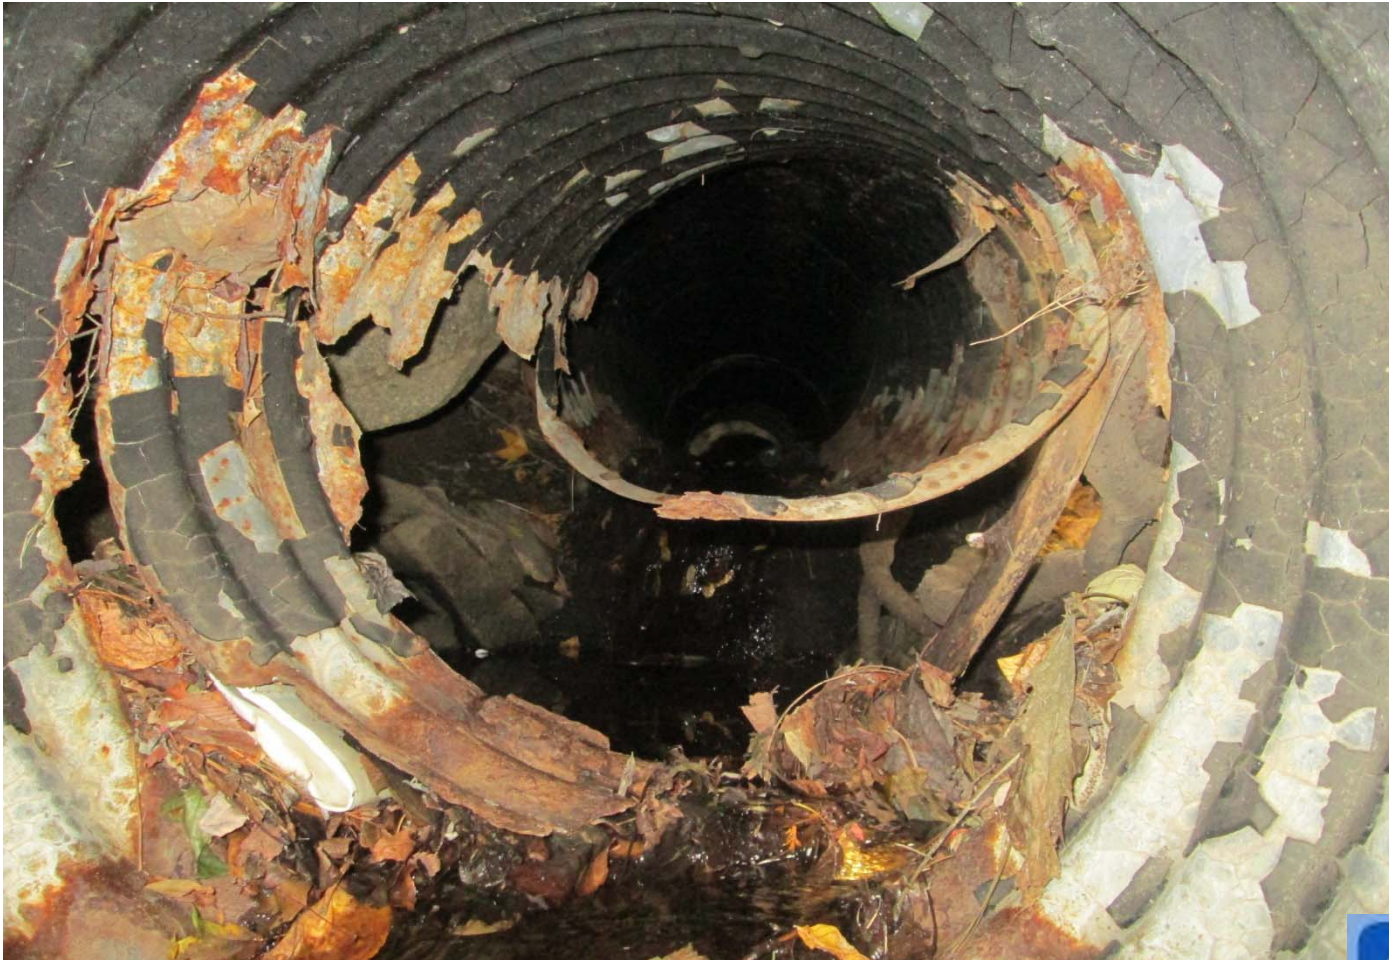
| Outfall ID | Date | Time | Flow Determination | Evidence of Illicit Discharge | Structural Problems | Flow (gpm) | Analytical Results | Pollutant Load <sup>(2)</sup> |
|---|---|---|---|---|---|---|---|---|
| 47 | 10/23/2012 | 11:45 | bucket | Mild mildew odor, cloudy | Poor condition | 2.50 | 1,200 | 0.164 |

Outfall 47 in poor condition. Steel pipe is shifted. 18 inches into pipe bottom it discontinues for 5 ft.

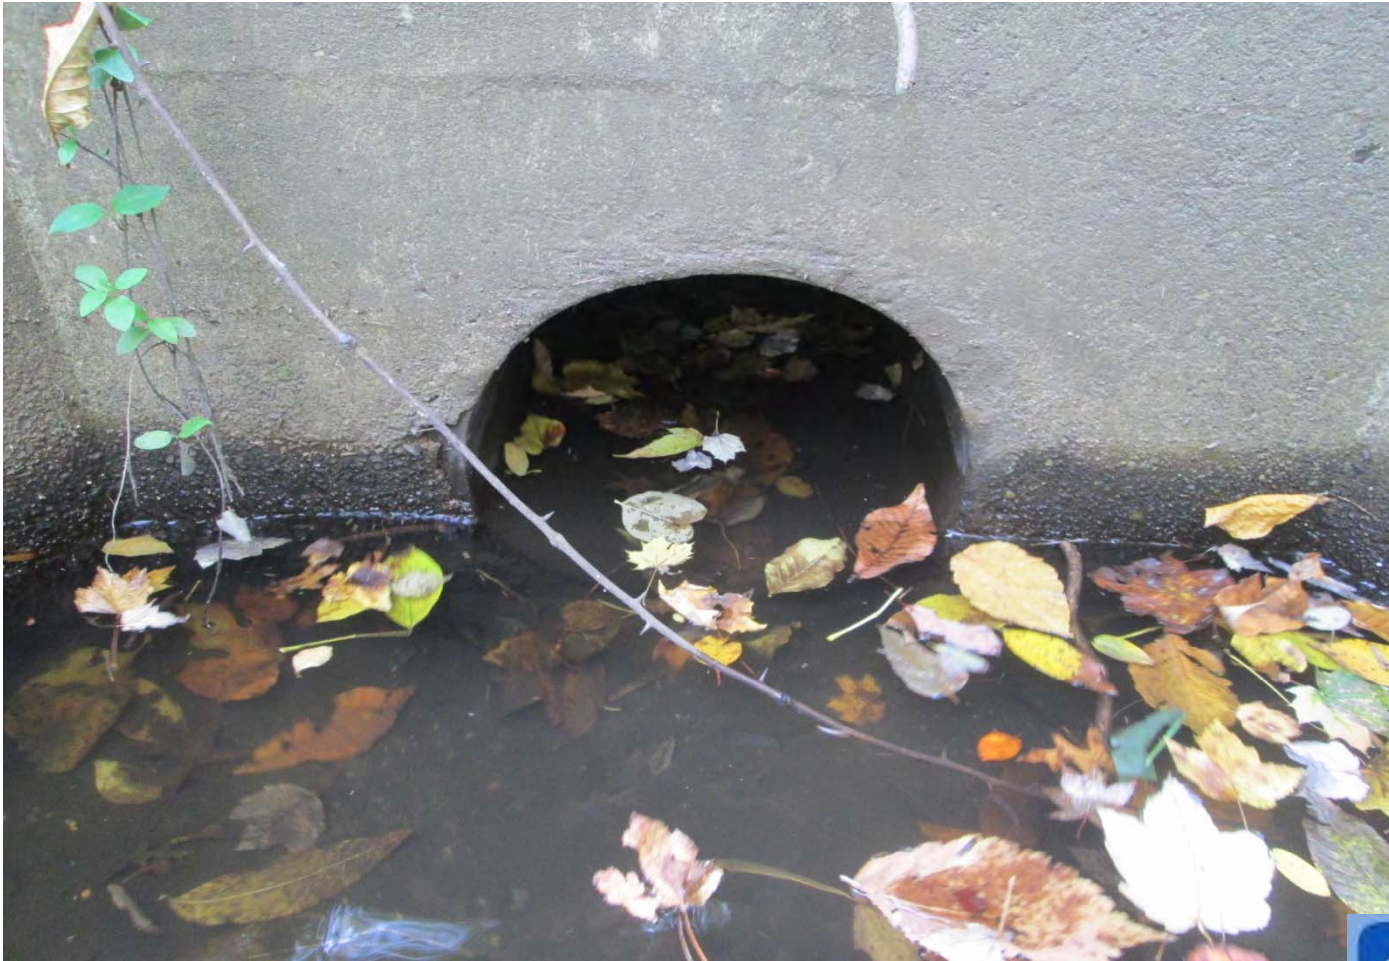
Outfall 55 is surcharged into the pipe.

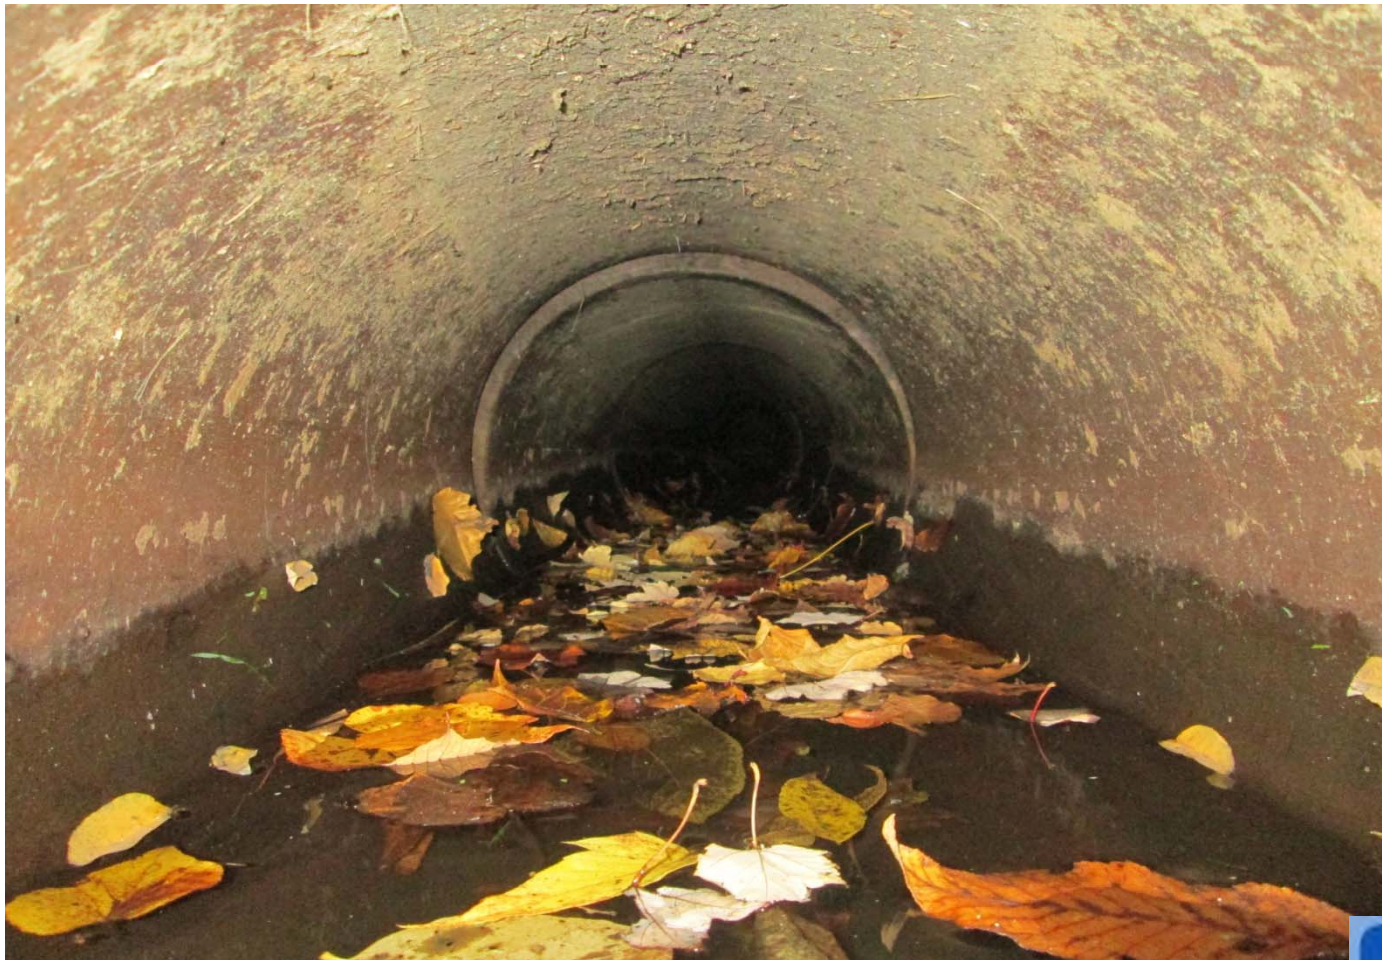
No flow observed; heavy in debris and leaves. No sample collected.
