Village of Mamaroneck

**Illicit Discharge Detection and
Elimination Study**

**Sewer System Investigation –
Draft Phase 4 Report**

January 2015

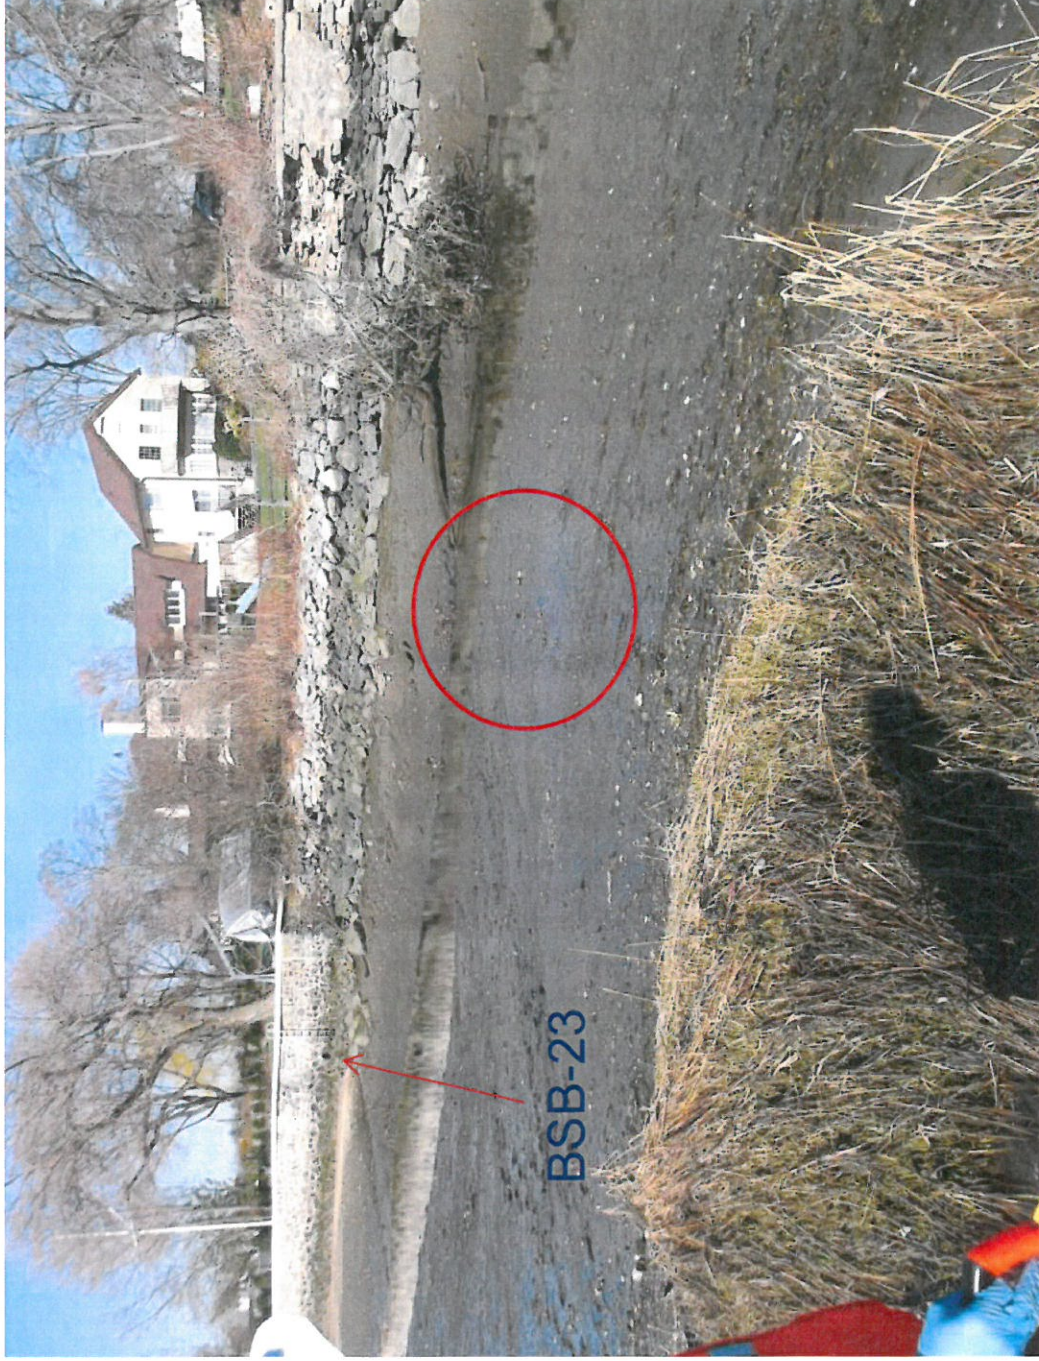
Outfall BSB-23 and stream sampling location SHB.

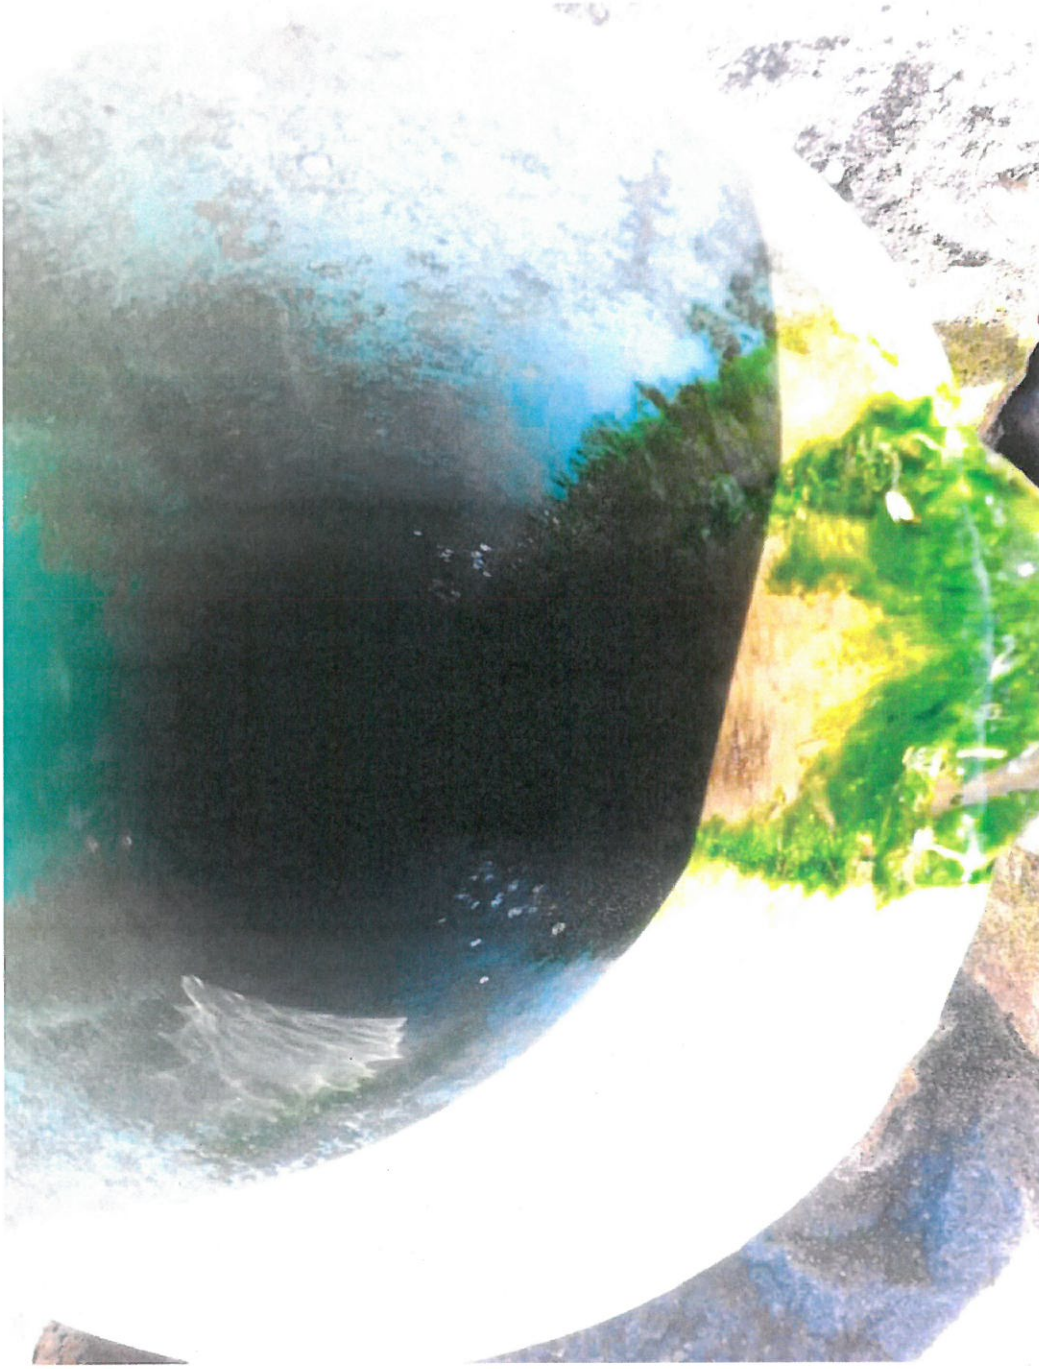
Outfall BSB-23, ST drains from Alda Rd. Flow rate 0.5 gpm.

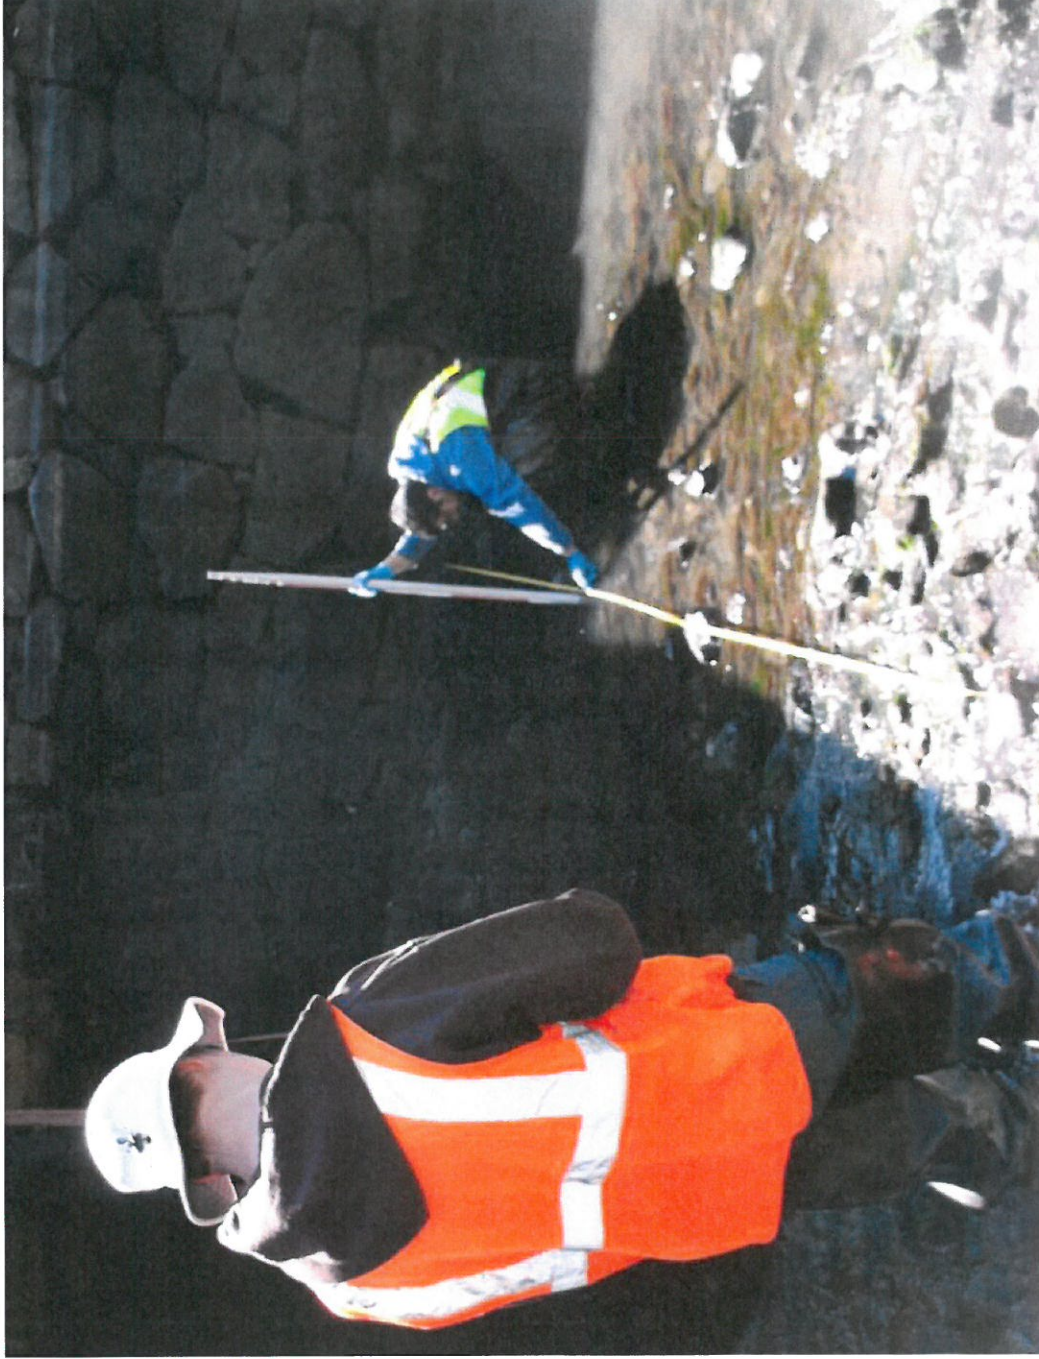
OC_Barry stream cross-section and sampling location.

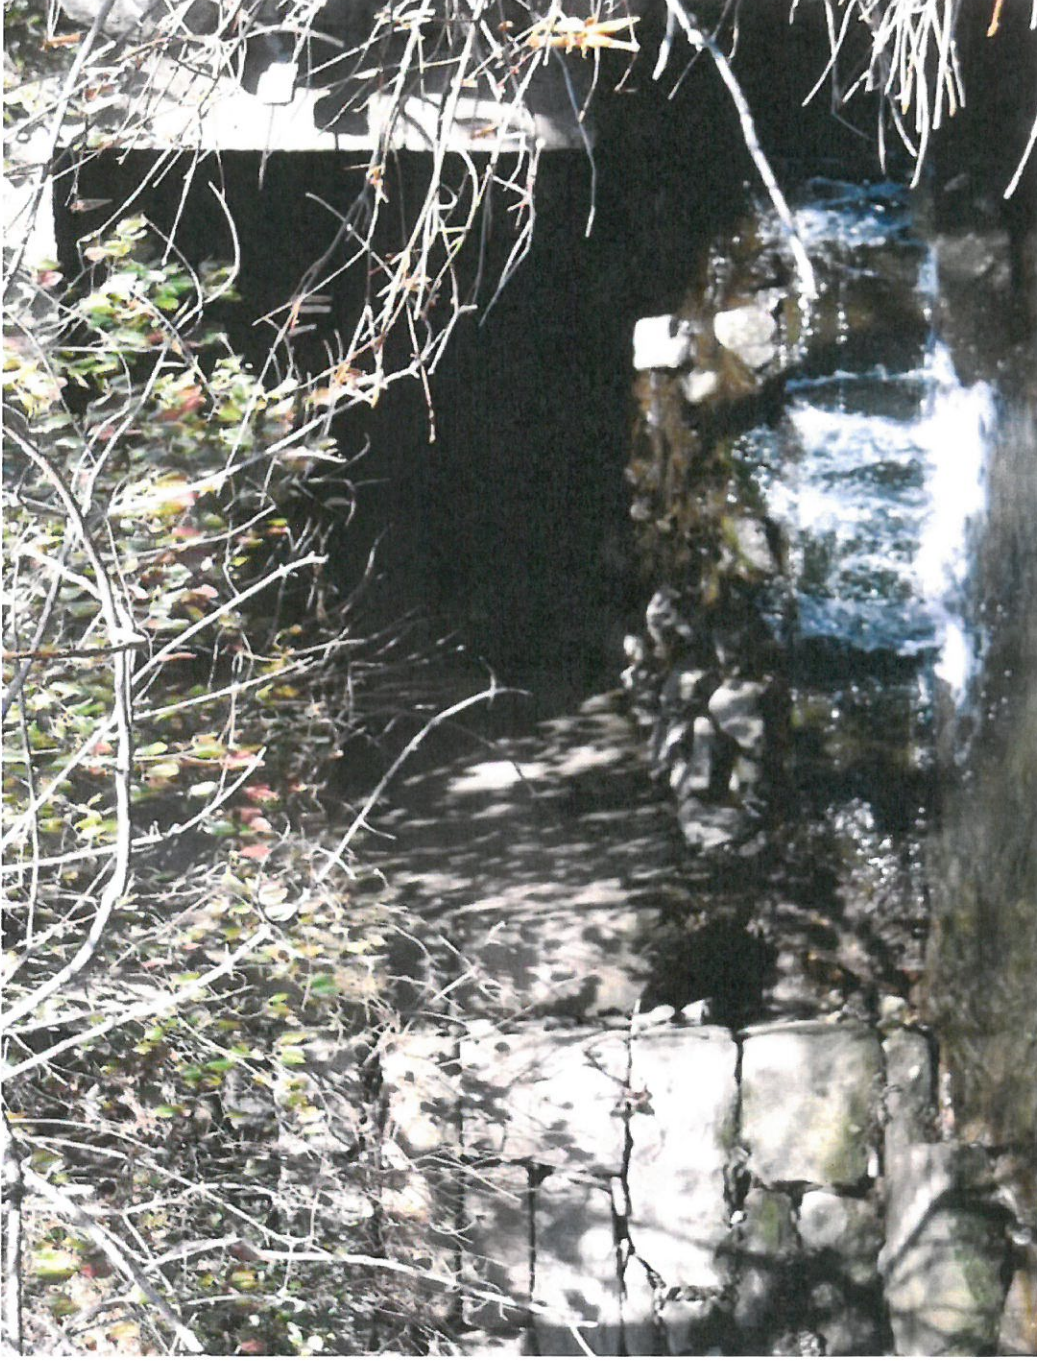
Outfall VJ-04. Flow rate 93 gpm. Light odor and some algae growth.

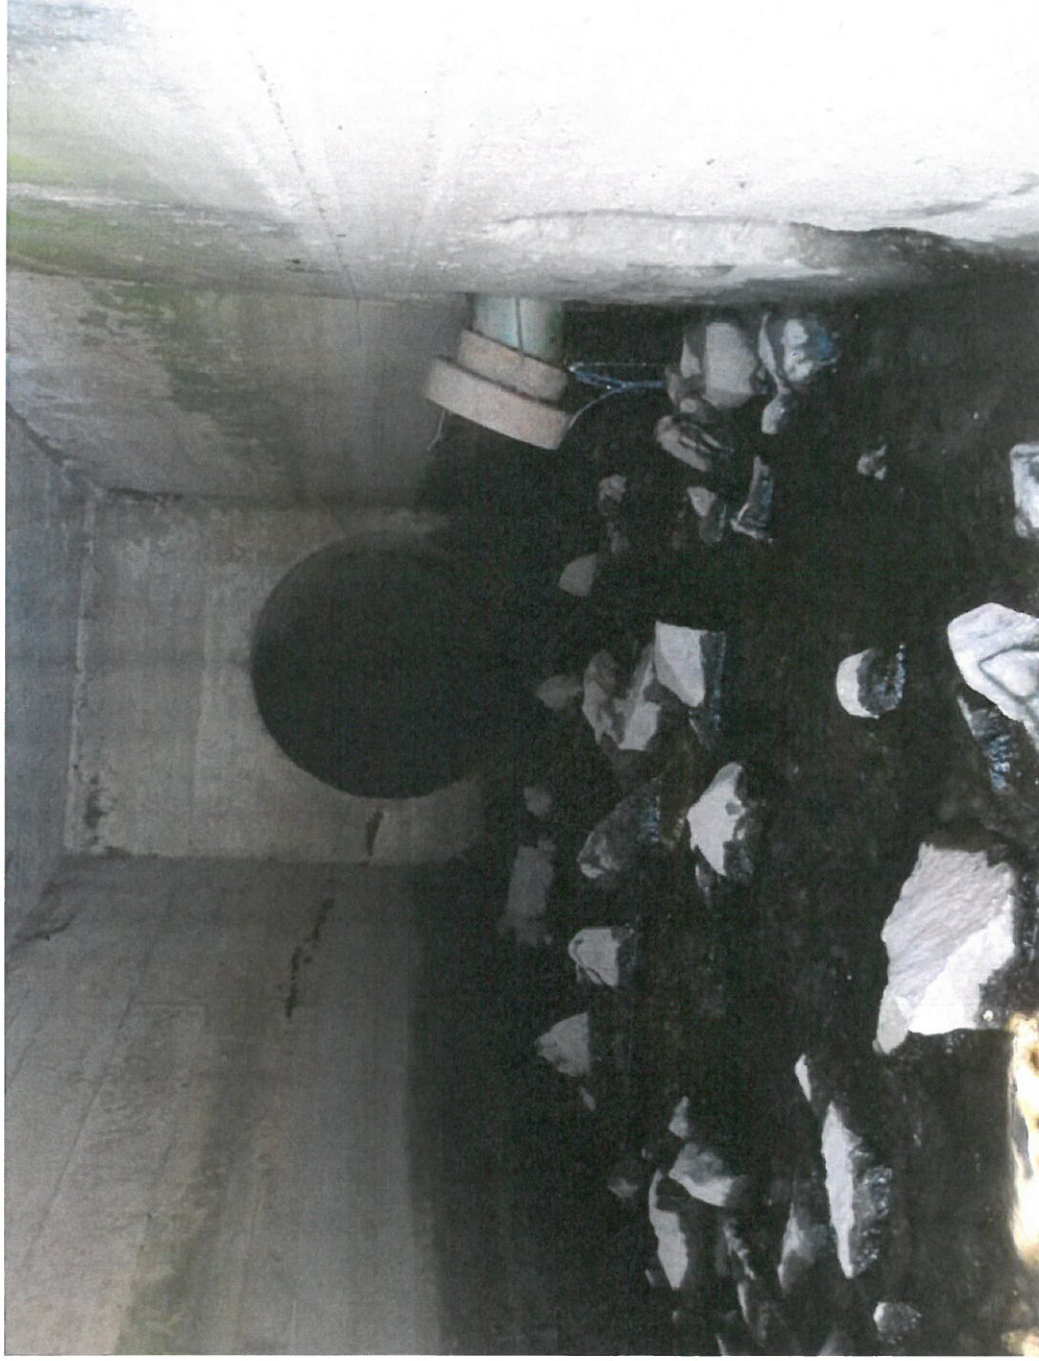
VJ-04 interior. Two additional inlets at 3 o'clock.

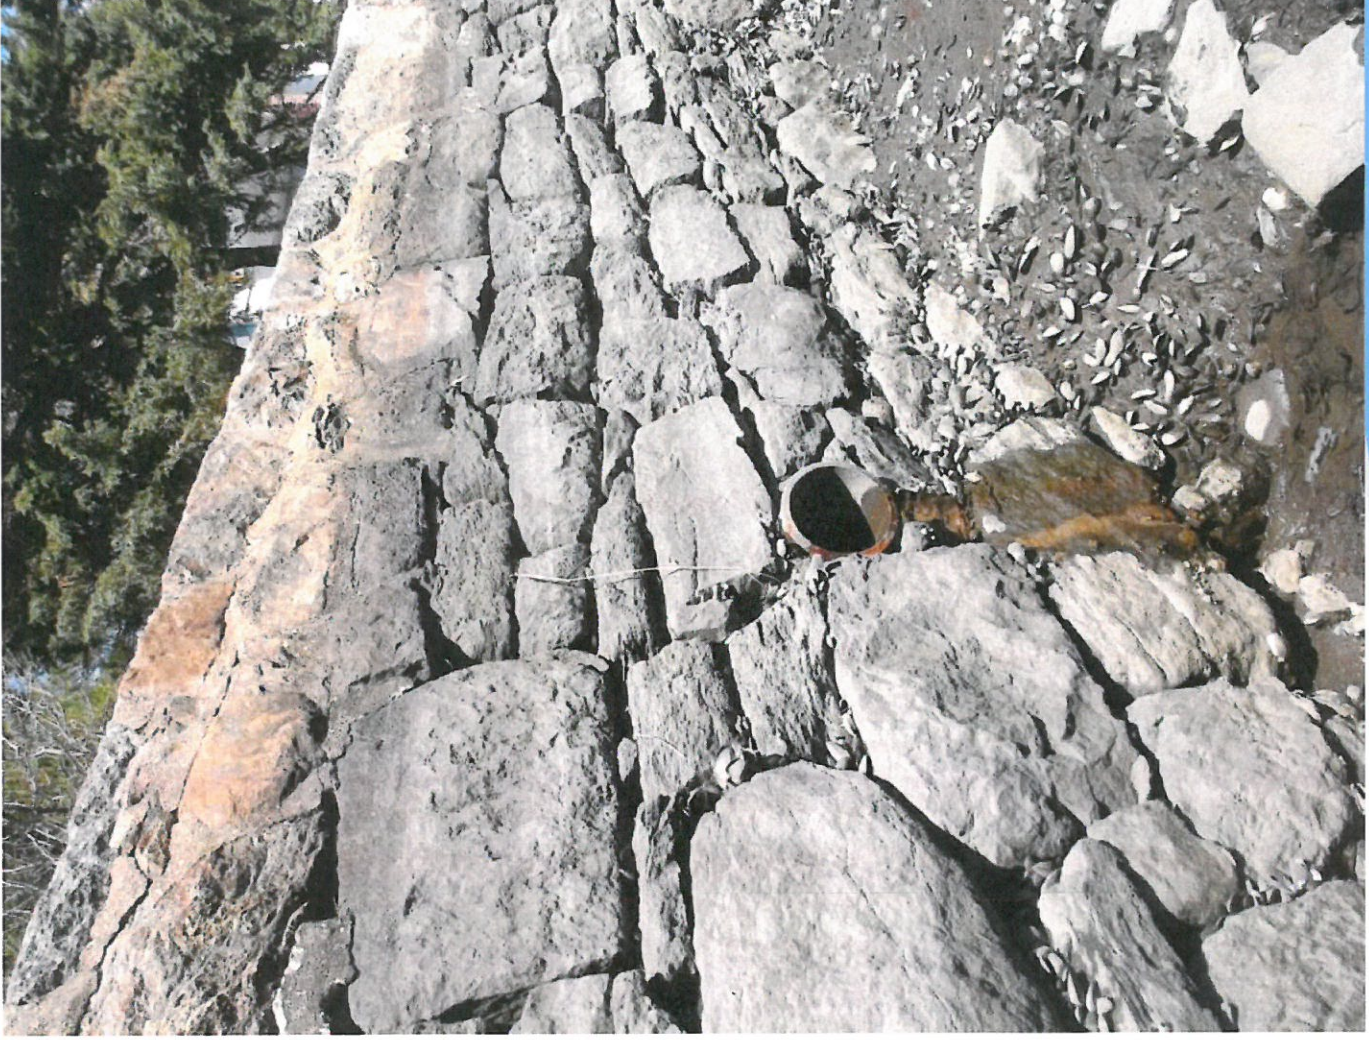
BSB-27, wet pipe
and wall face. No
flow.

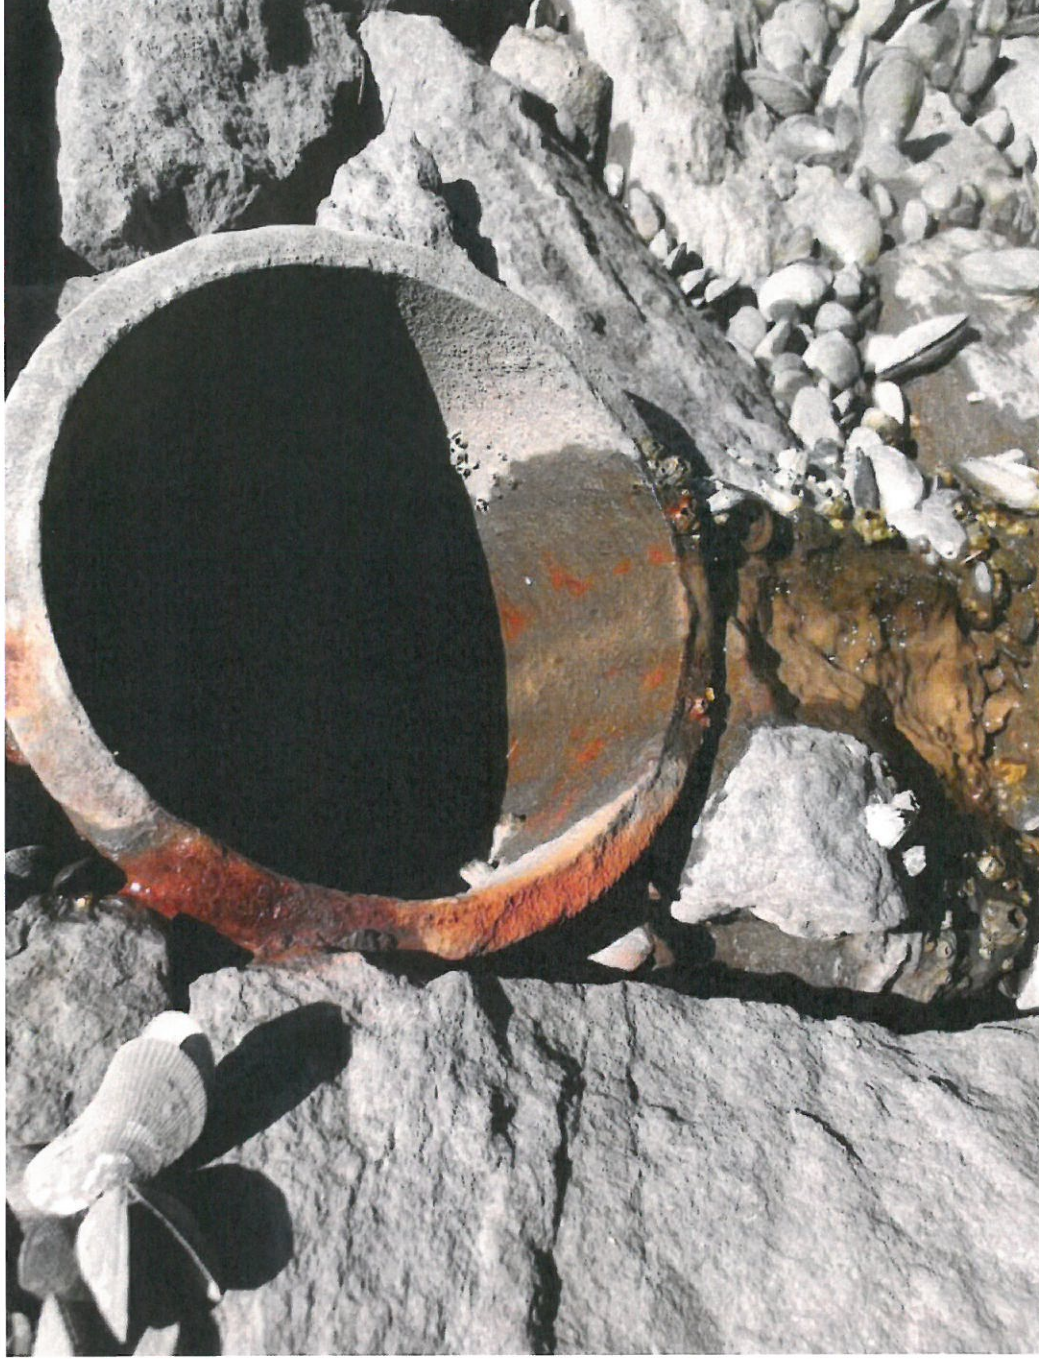
BSB-27, closeup.

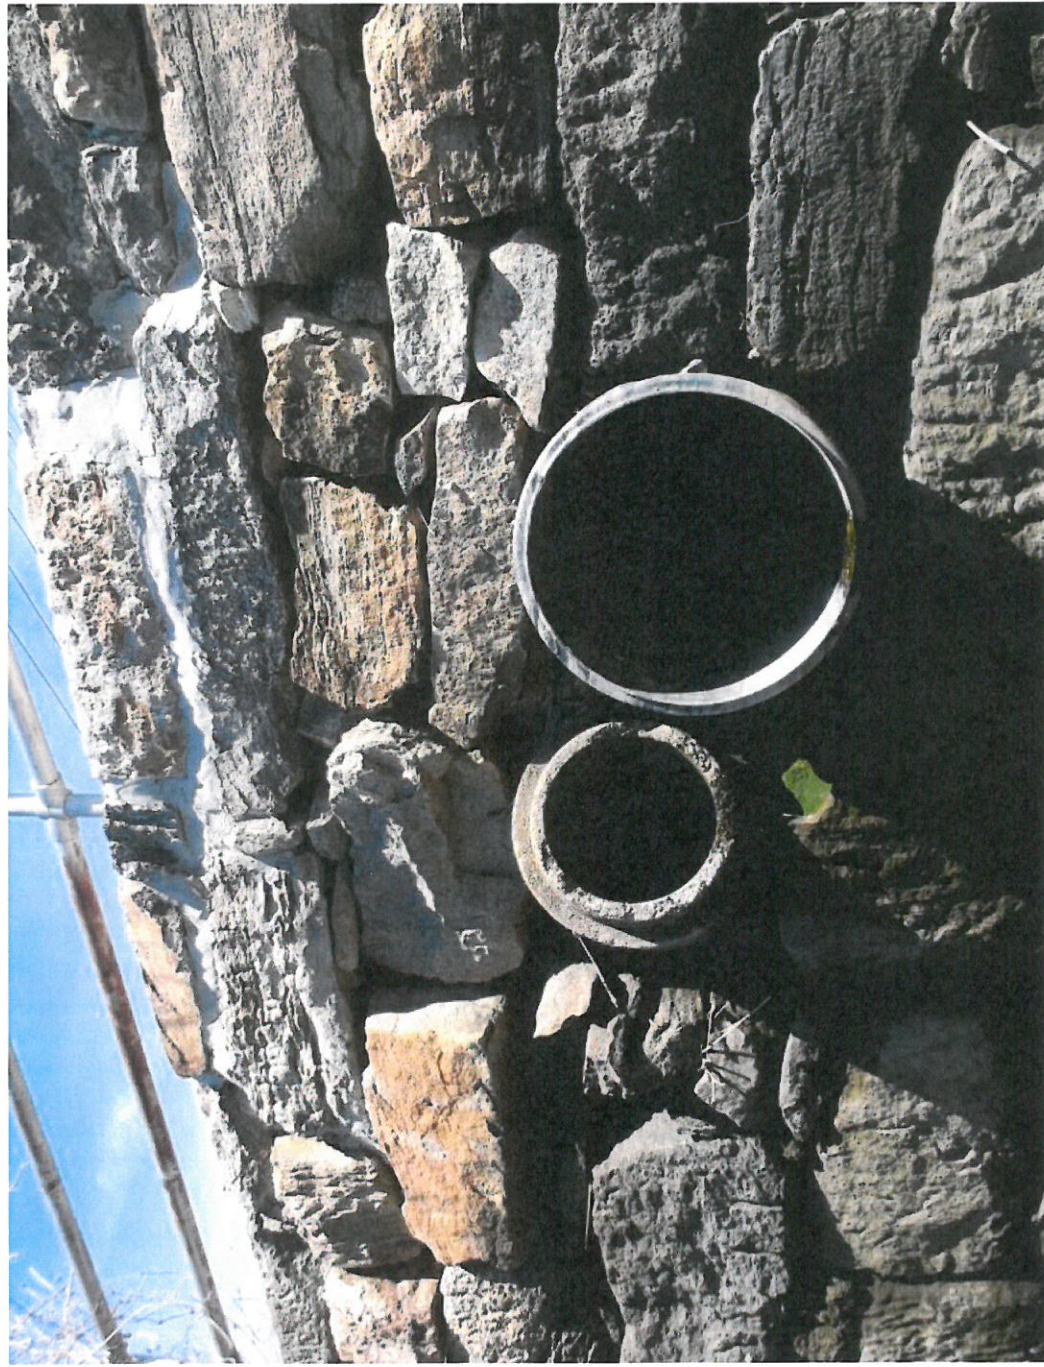
VJ-57 wet pipes and wall face. Very slow dripping. Outfall from S Barry Ave at bridge.

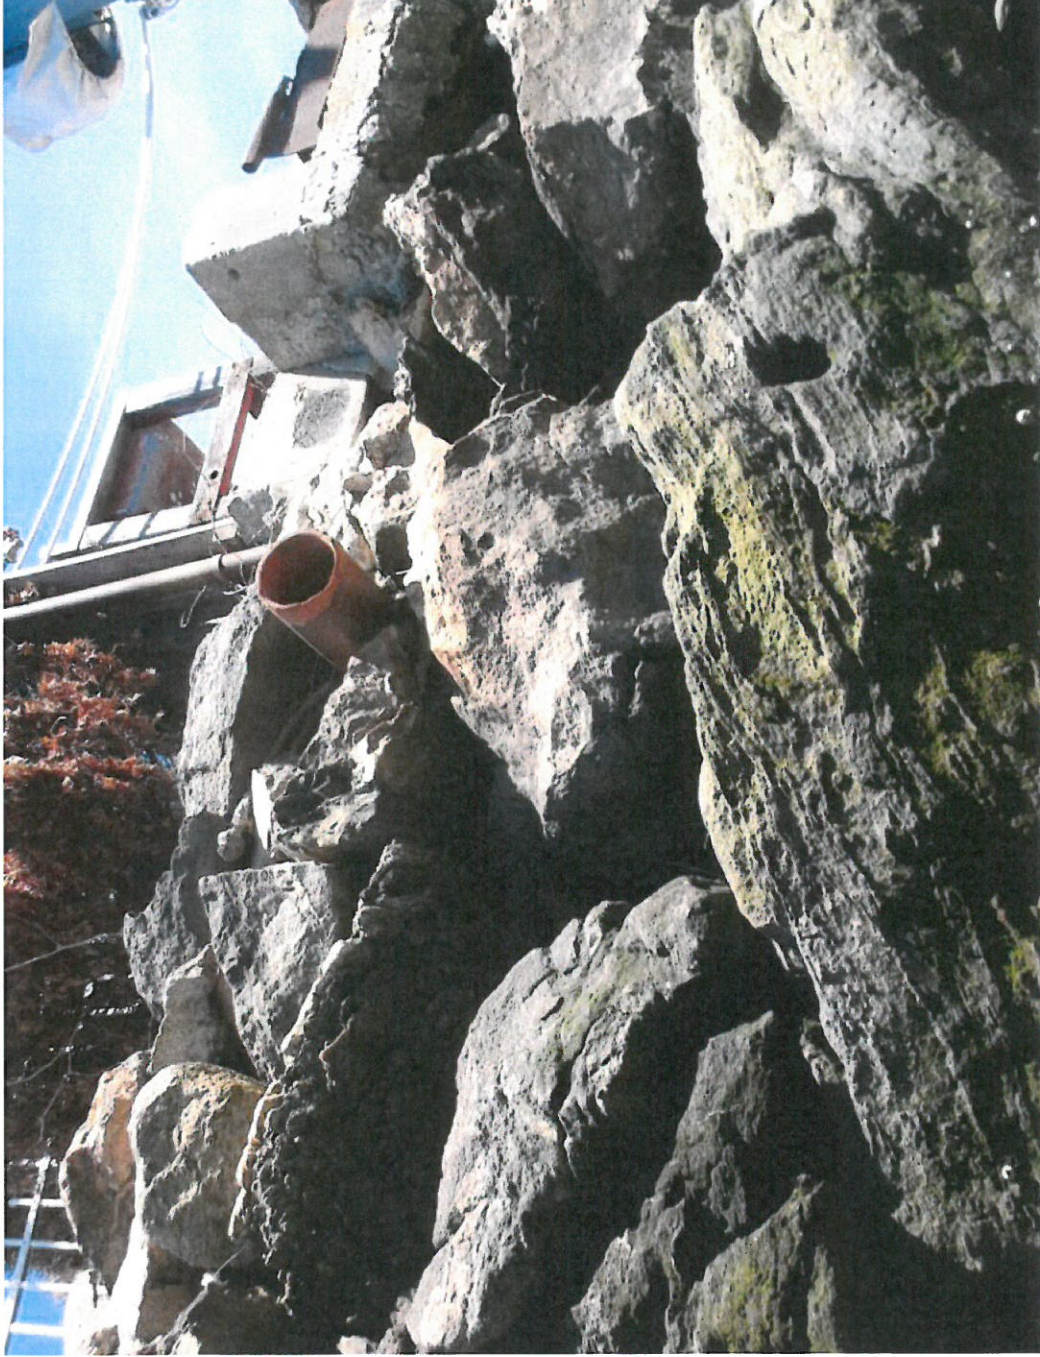
VJ-31. Lawn drainage from house on Guion Dr.

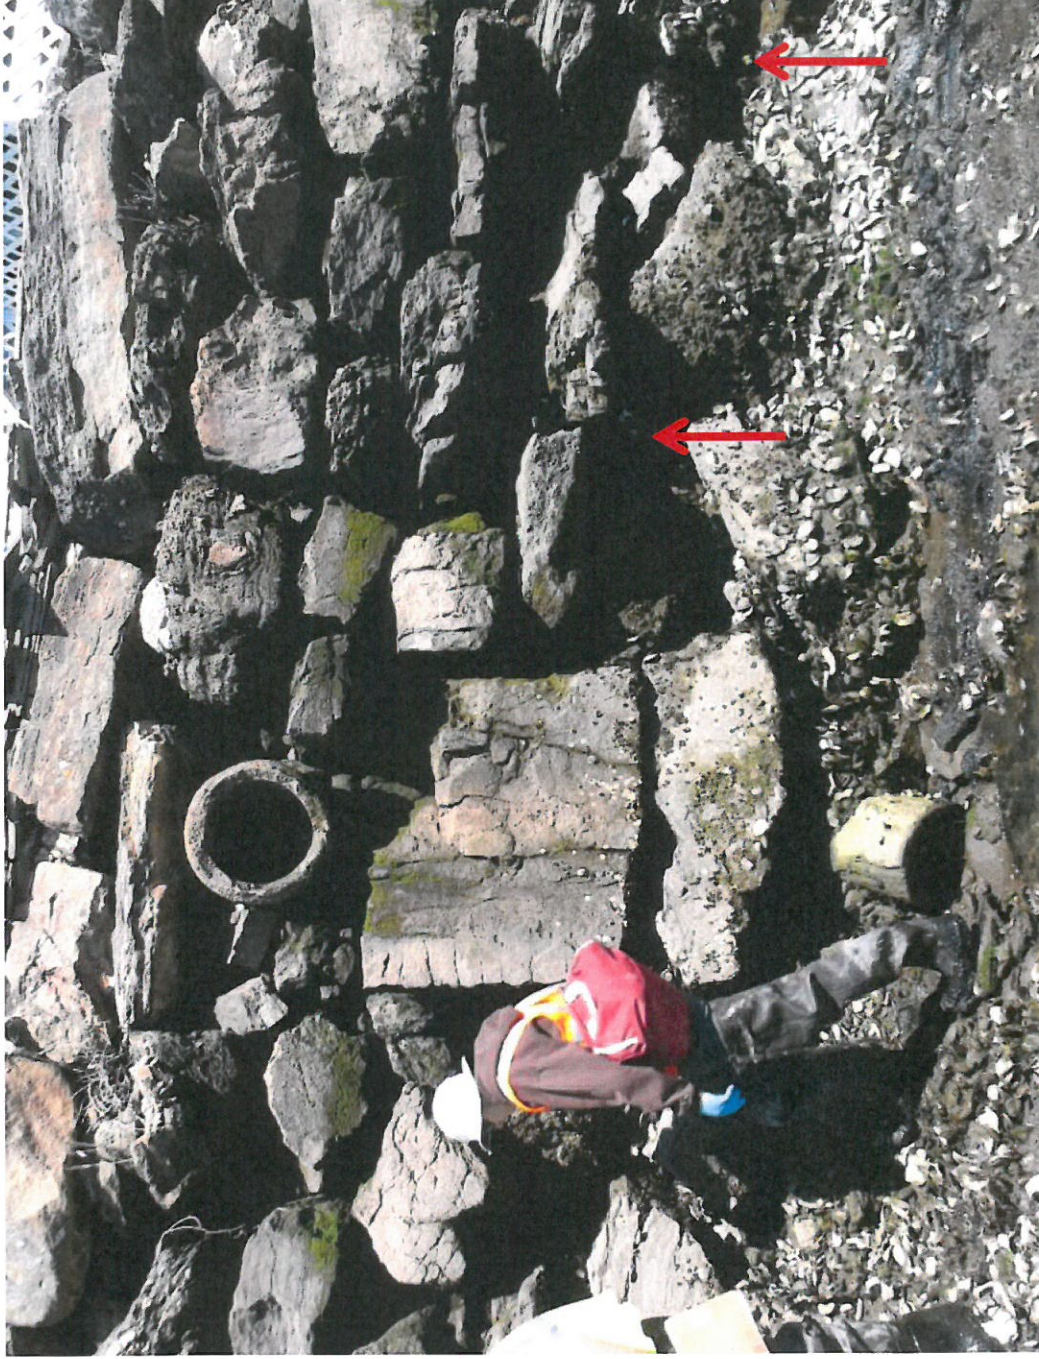
VJ-54a Outfall exterior at low tide. Flow visible through retaining wall face.
Outfall from Guion Dr and Lawn Terrace intersection.

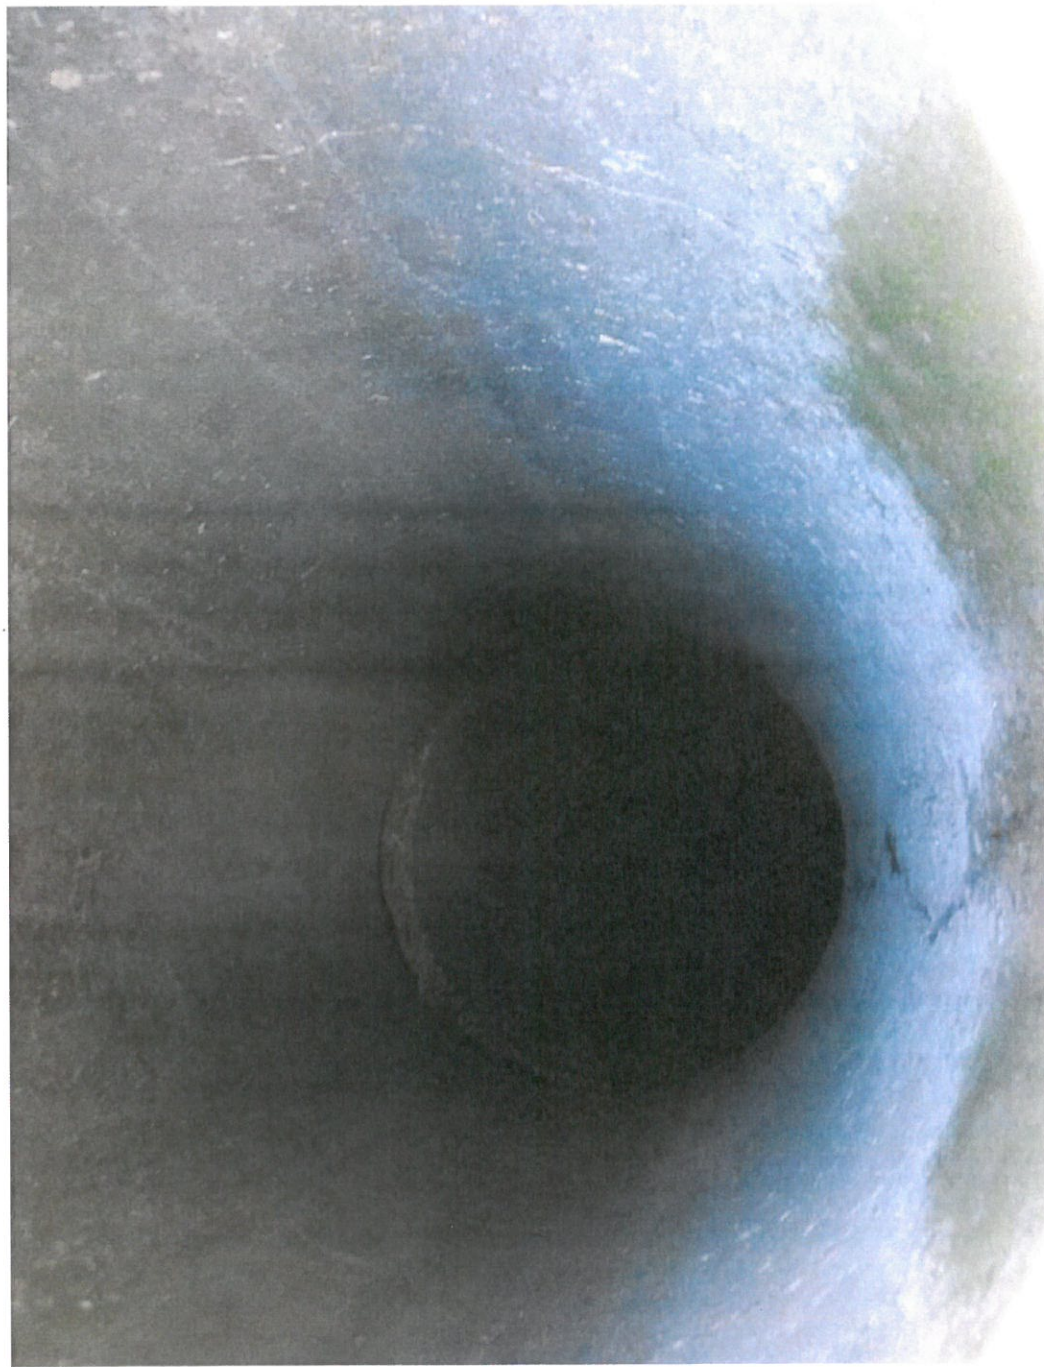
VJ-54a interior. Pipe is separated 7ft. in from outfall, allowing flow into retaining wall.

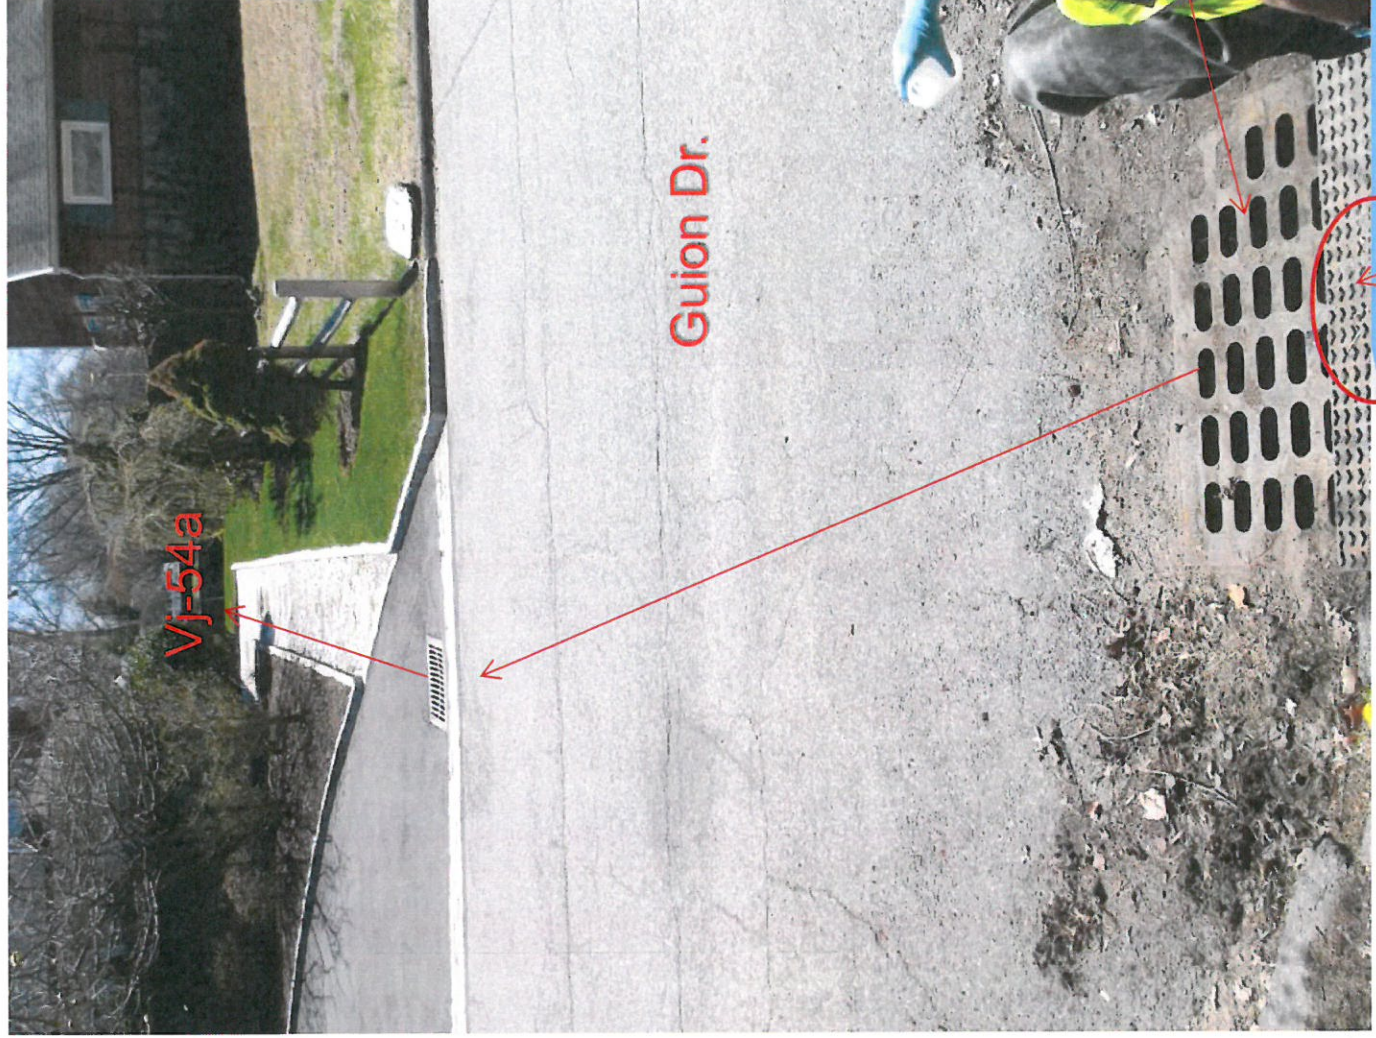
Catchment basins upstream Vj-54a. Sampling point indicated. All other inflowing lines in the two basins were surcharged and had bacteria growth present. Not all flow is represented with the sample.

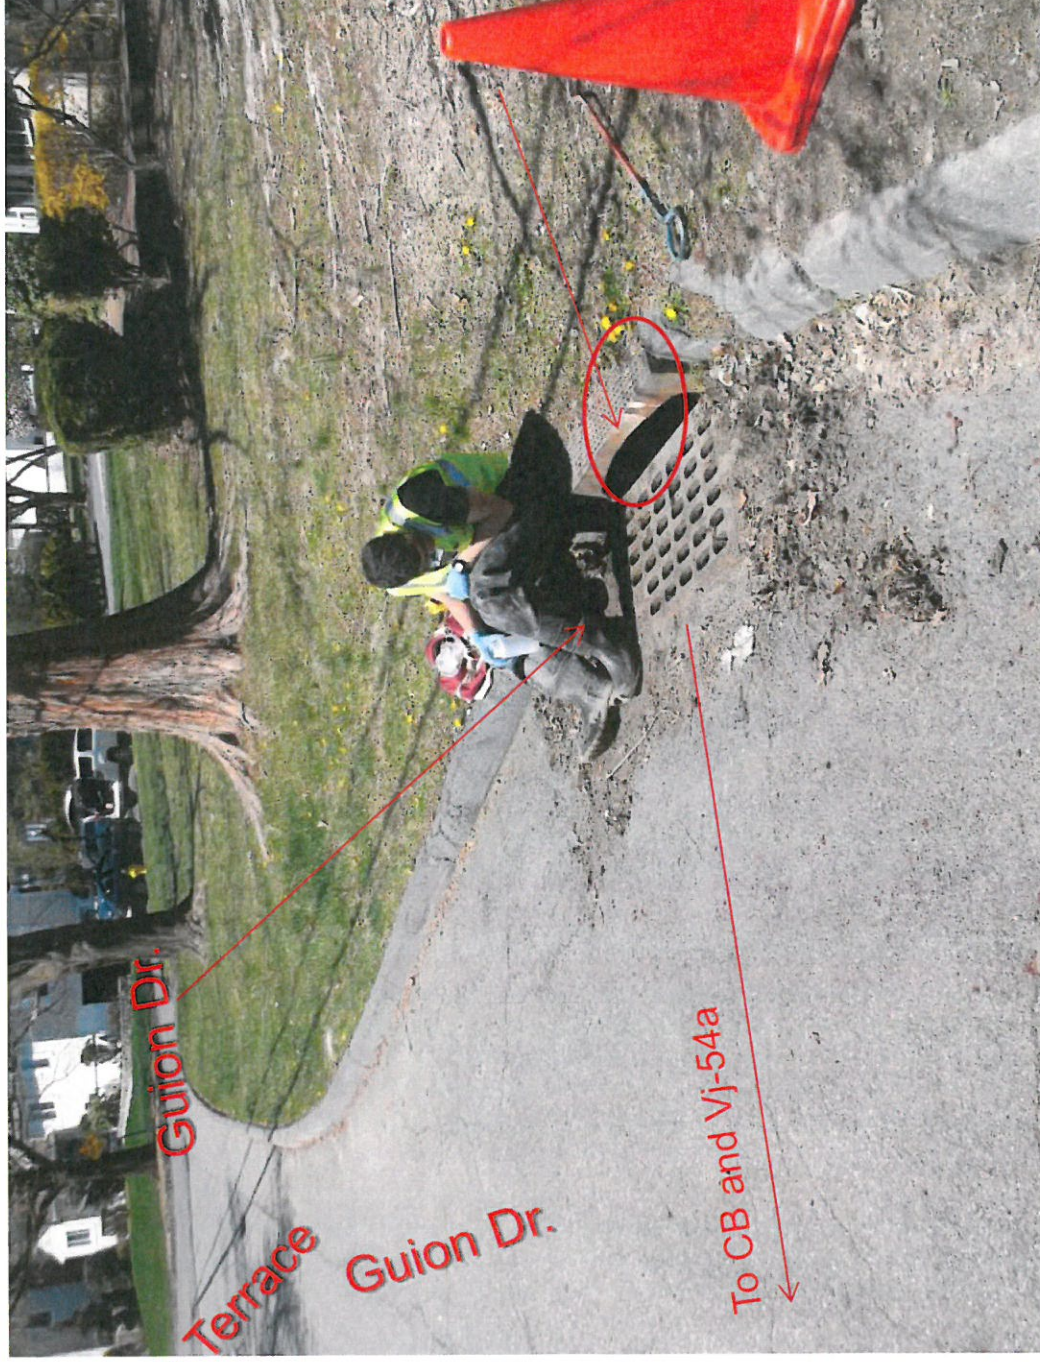
Second upstream catchment basin for VJ-54a, sampling point indicated

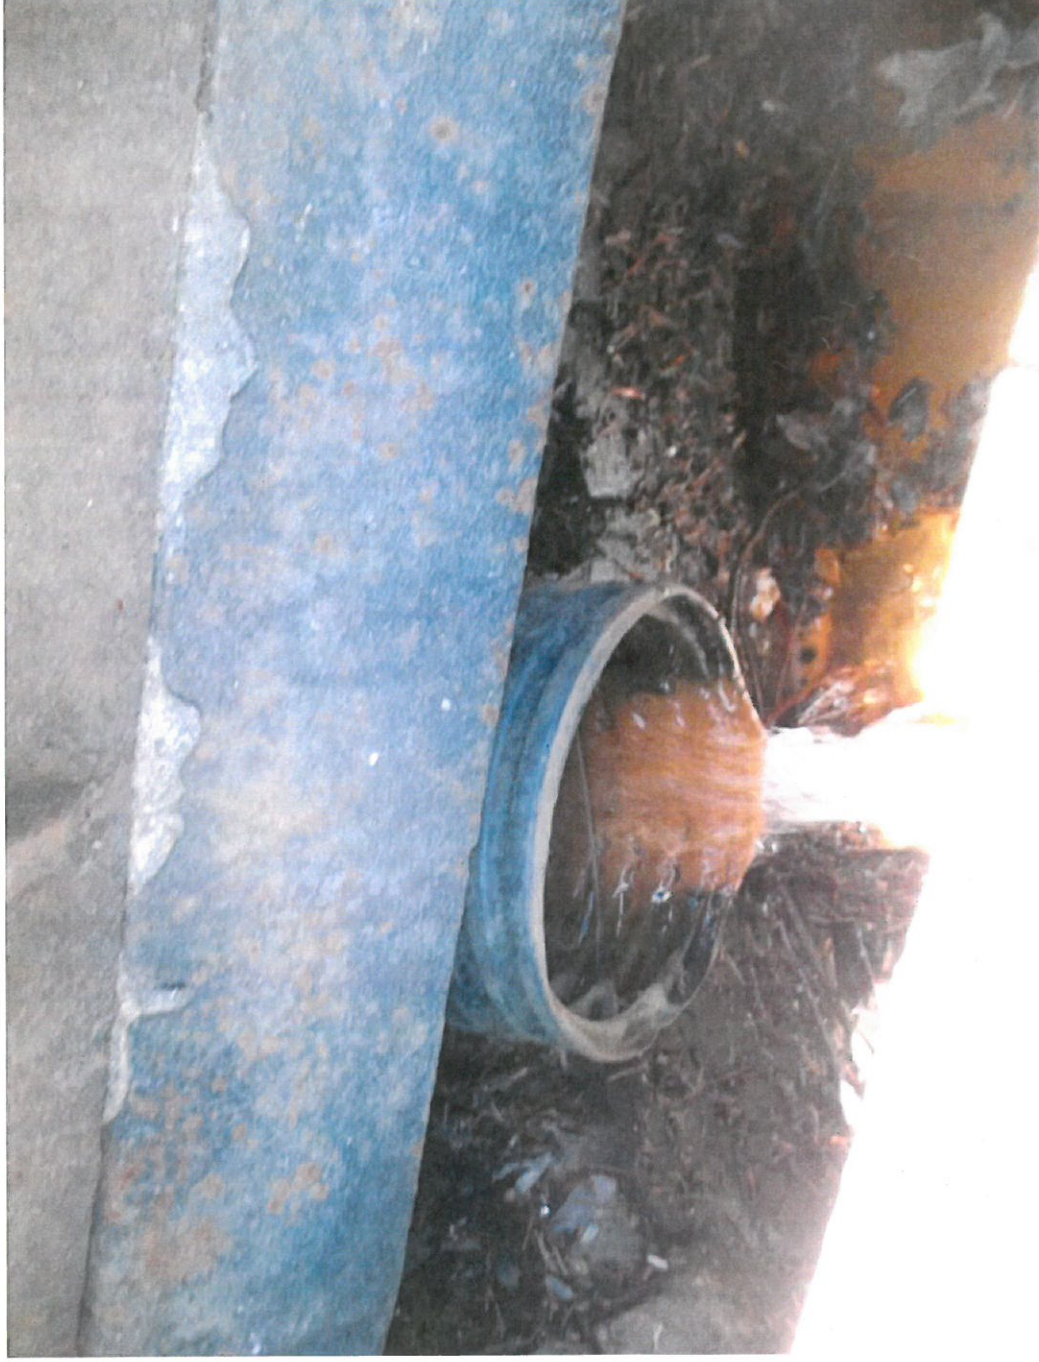
Sampling point for VJ-54a. Bacteria growth present.

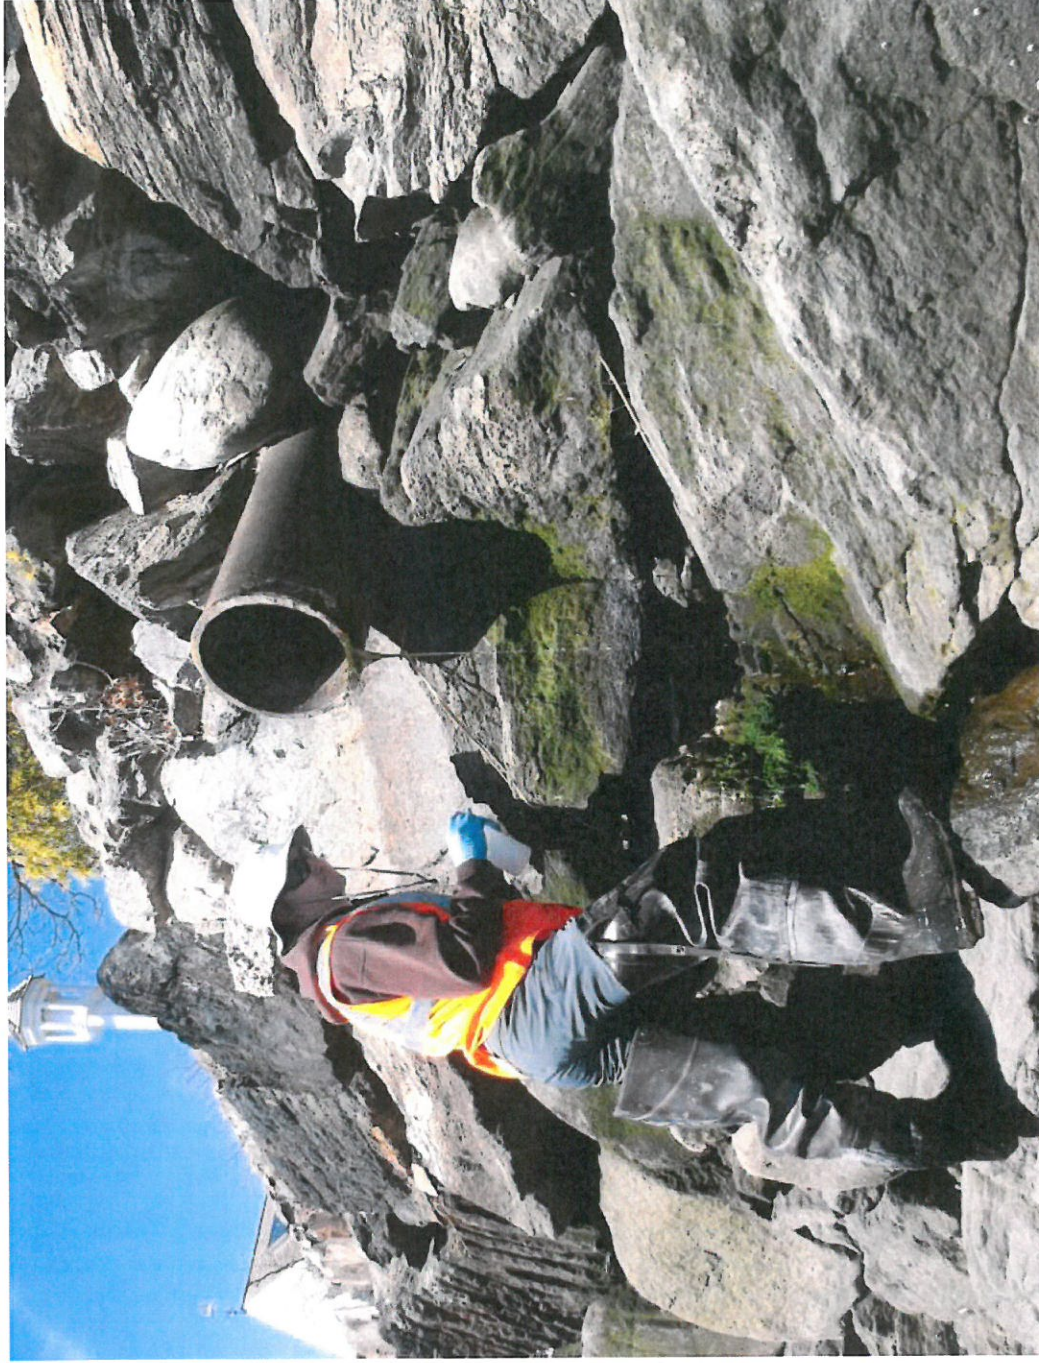
BSB-28, Flow rate 0.1 gpm. Algae growth present.
Outfall from Lawn Terrace.

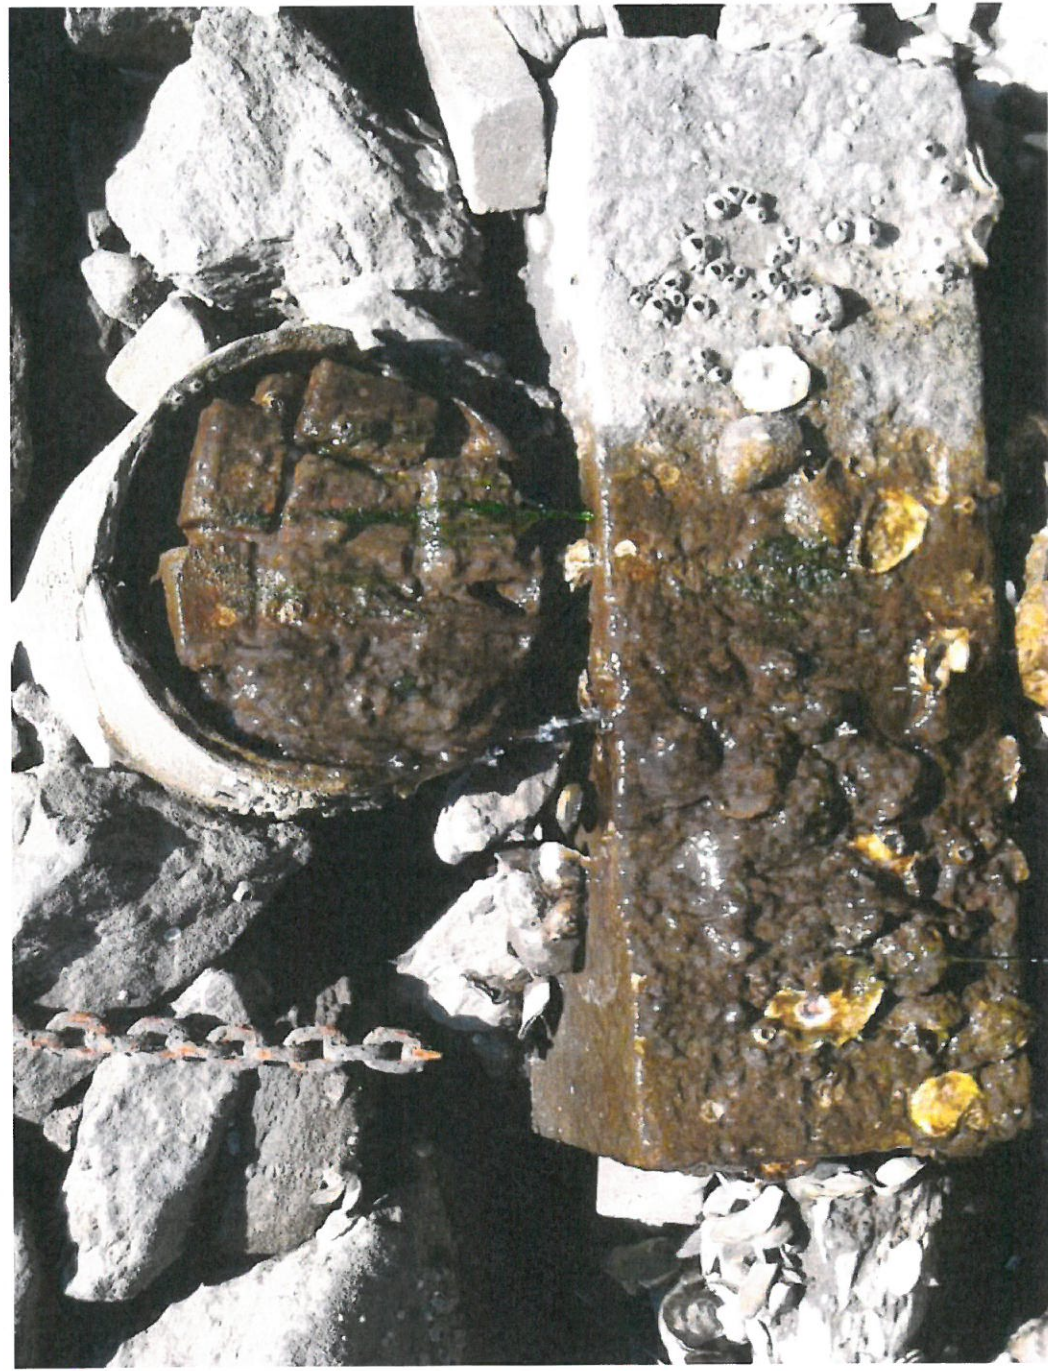
Inspector	MV	Air Temperature (F)		INSPECTION EVENT COMMENTS Line apperas abandoned filled with bricks and cement, but cracked and leaking
Date	4/21/2014	Rainfall, Past 24 hrs (in) ..	0	
Time	11:47	Rainfall, Past 48 hrs (in) ..	0	
Photo Numbers.....				BSB-29

BSB-29, Flow measured at 0.36 gpm, maybe more from cracks in pipe.
Outfall from Lawn Terrace.
