Village of Mamaroneck

**Illicit Discharge Detection and
Elimination Study**

**Sewer System Investigation –
Draft Phase 4 Report**

January 2015

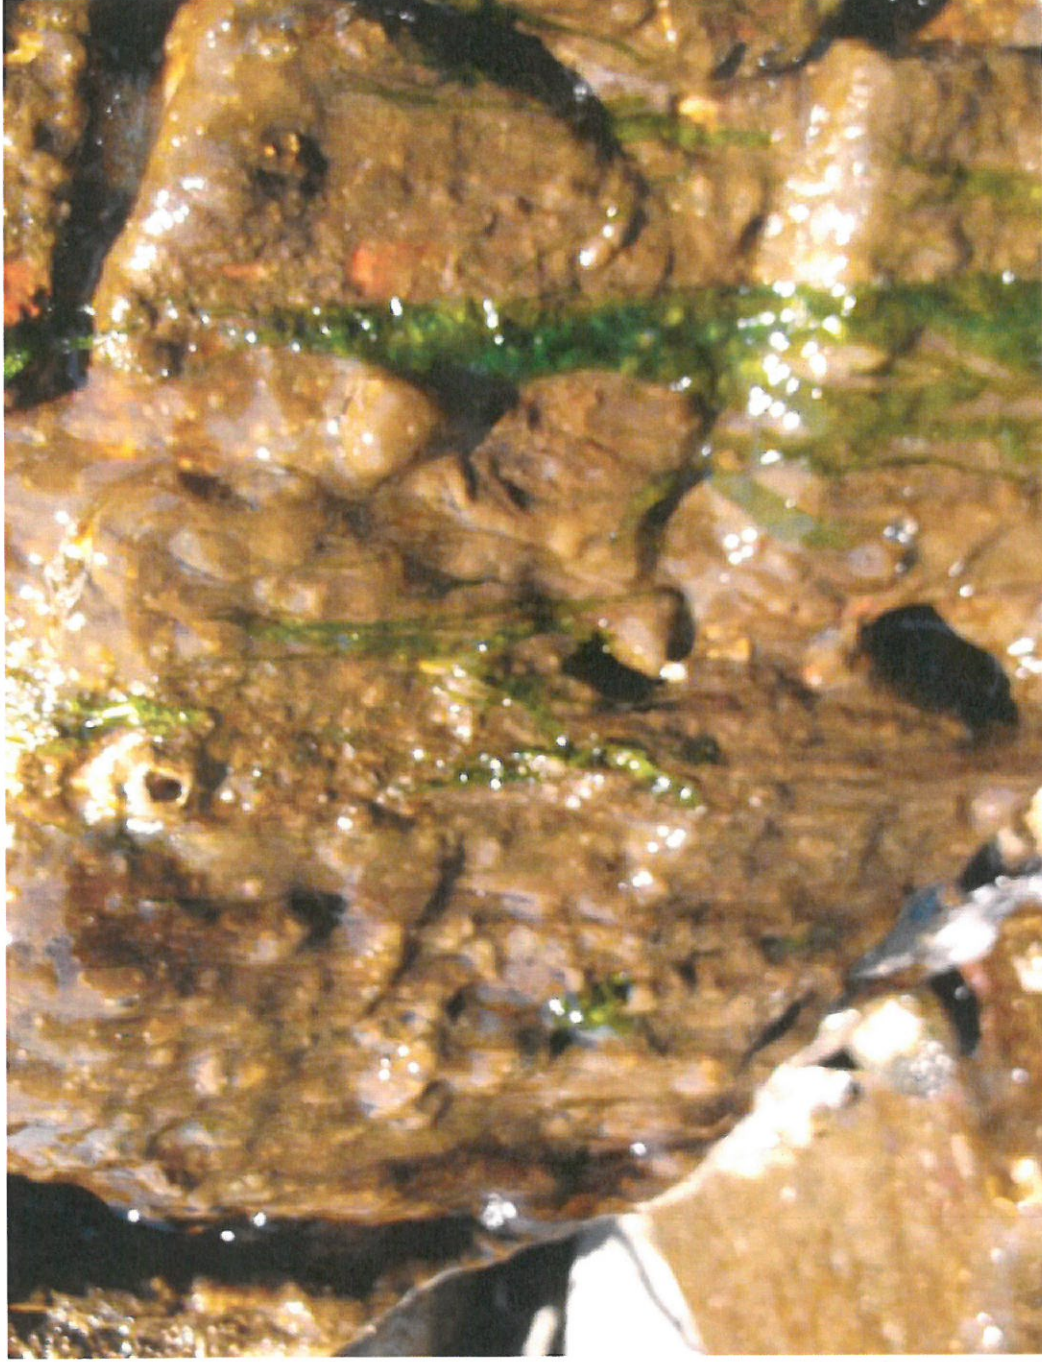
Close-up of BSB-29, heavy bacteria and algae growth present

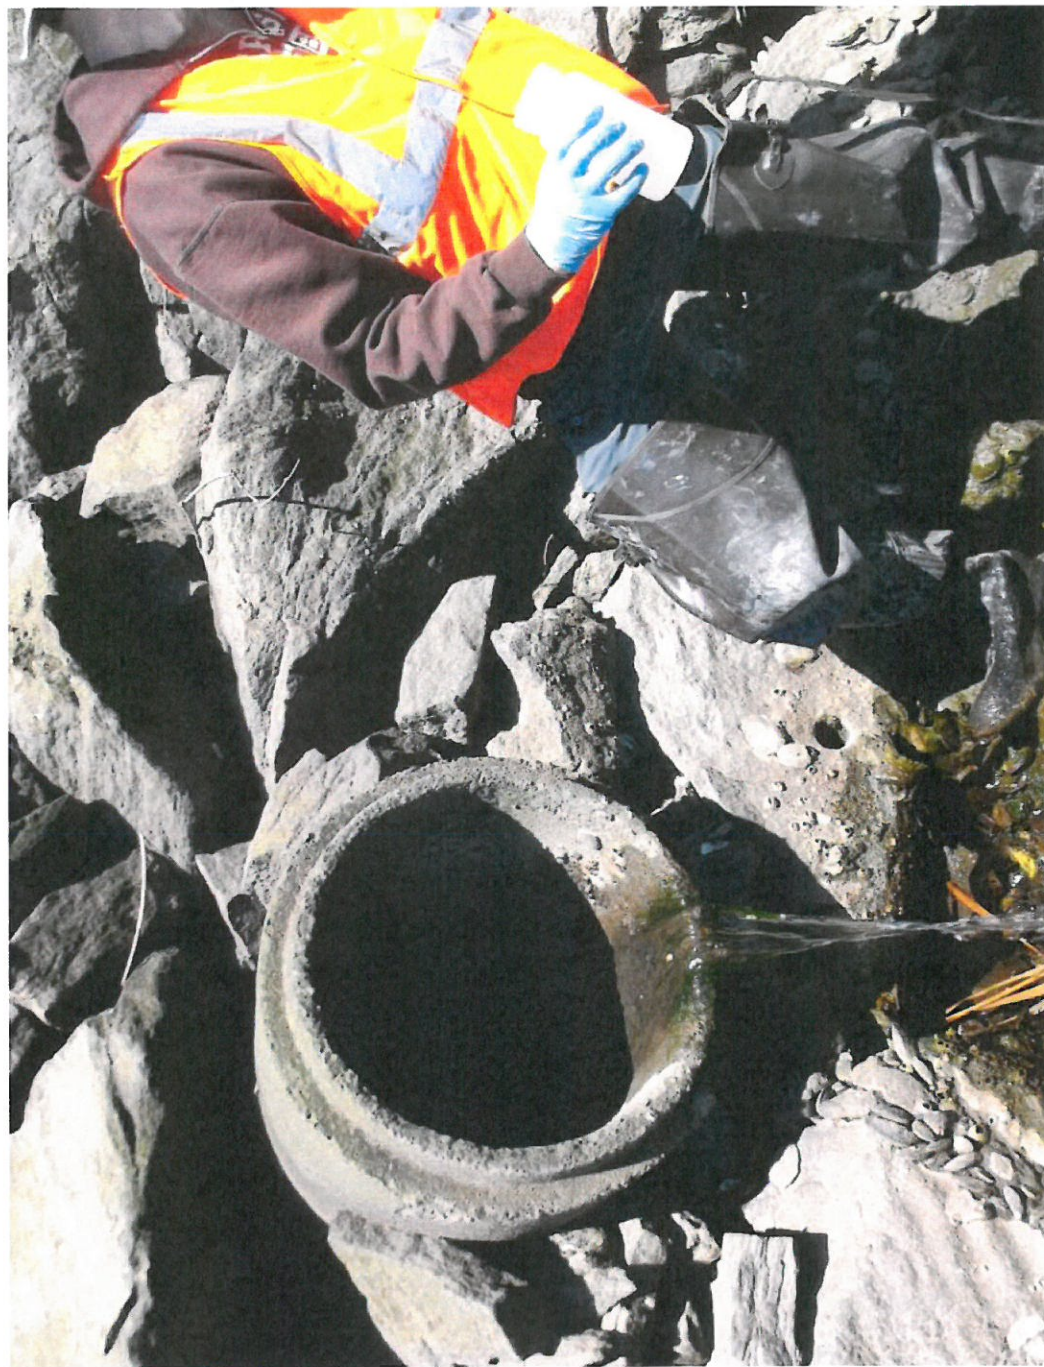
VJ-58, Flow measured 2.6 gpm, algae and light bacteria growth.
Outfall from Lawn Terrace.

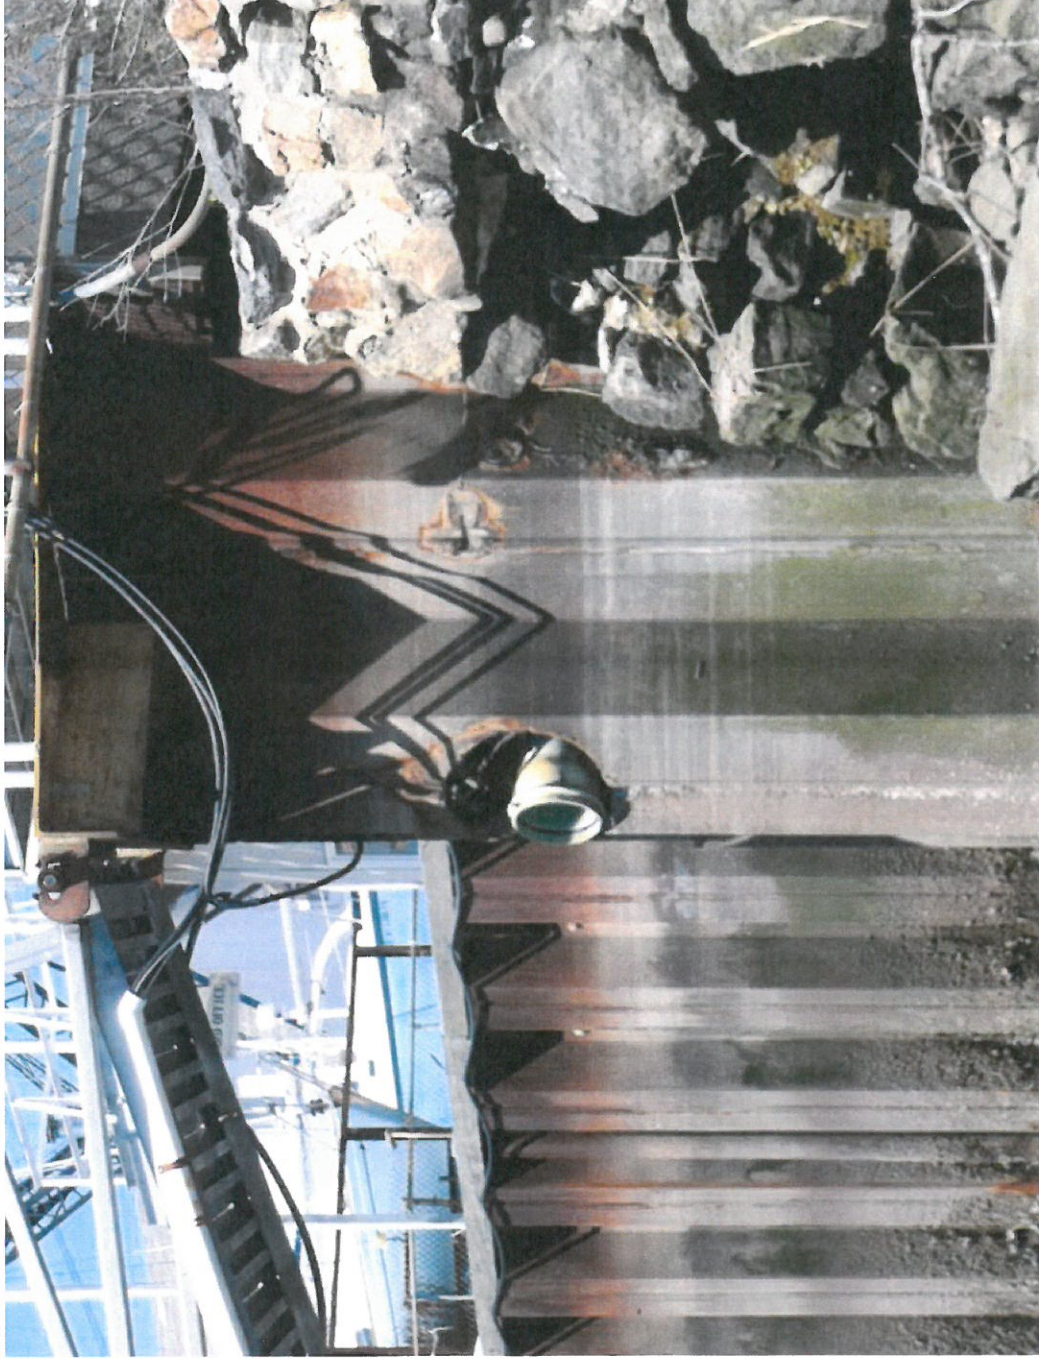
BSB-30, from Harbor property. No flow.

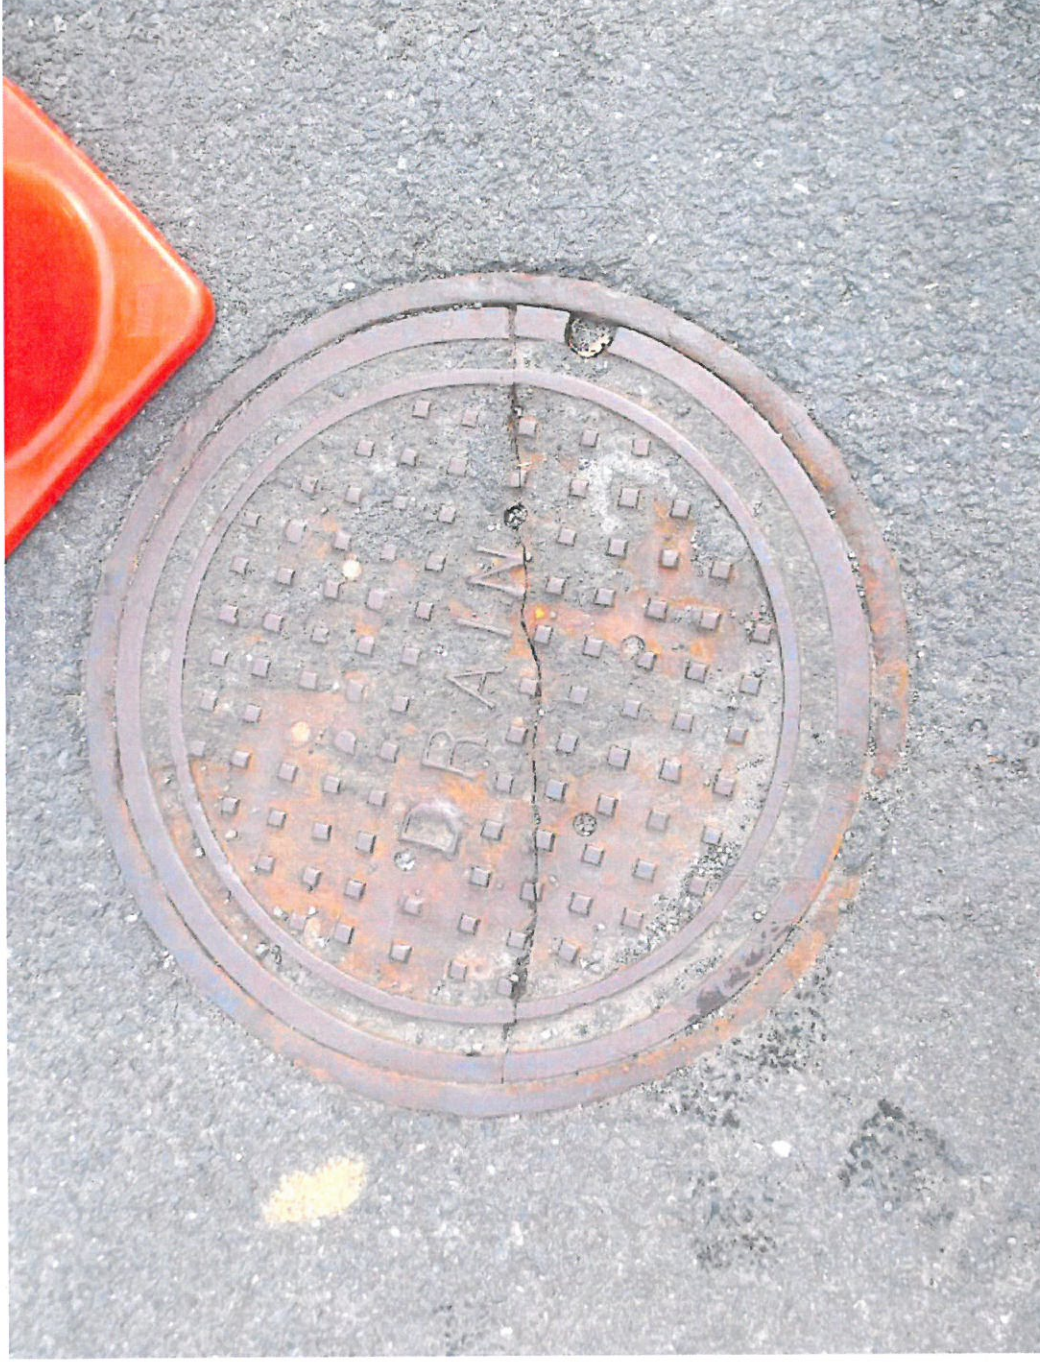
USMH_VC-18, exterior. Lid cracked in half.

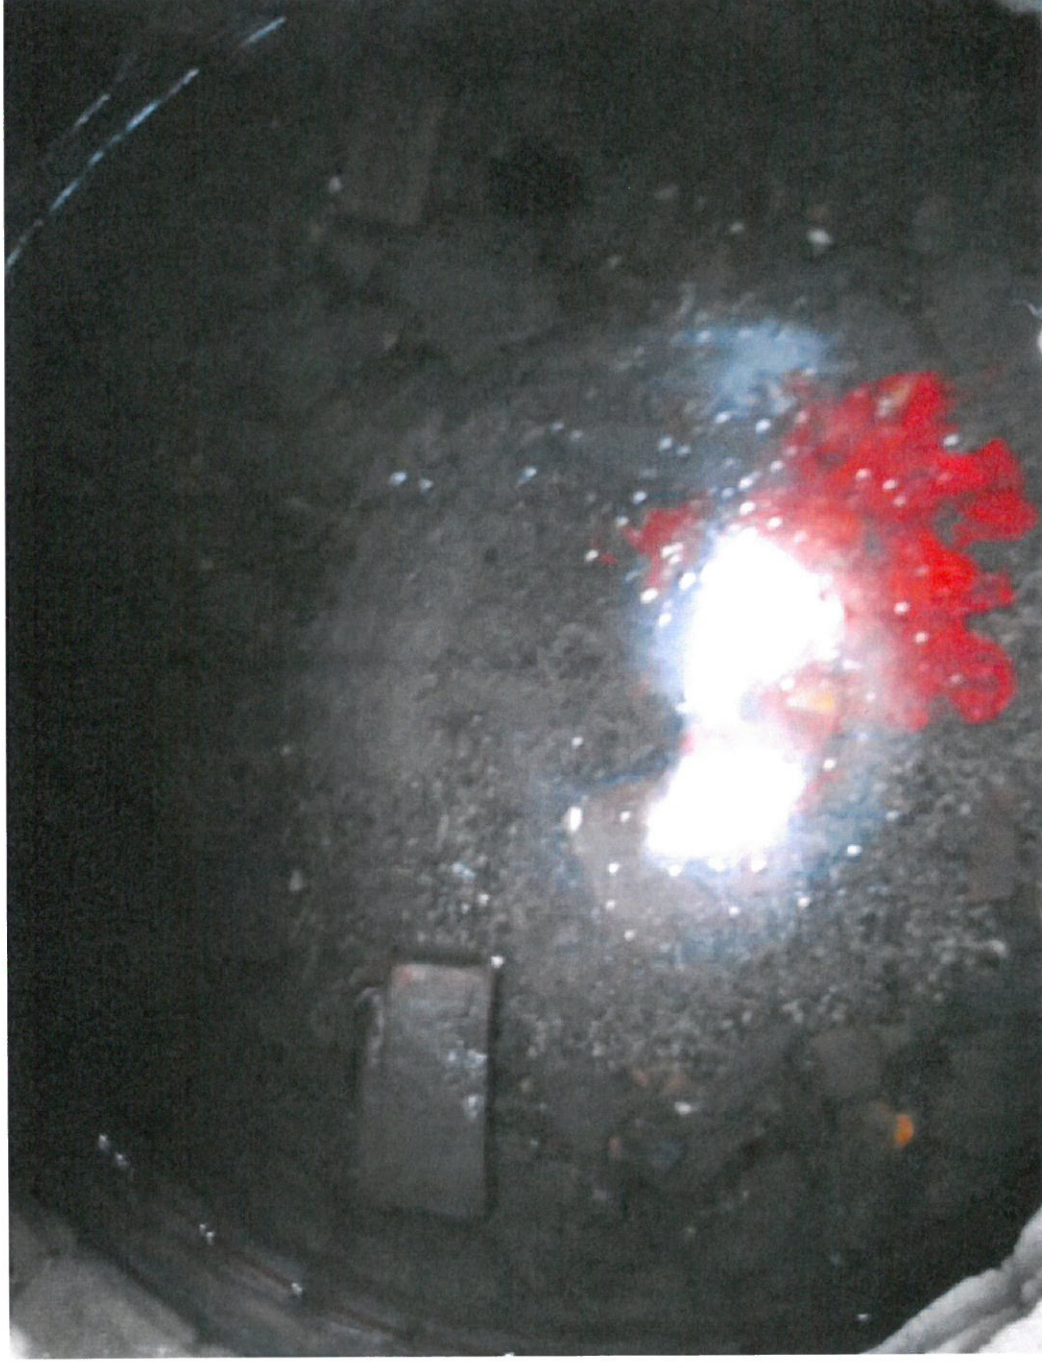
USMH_VC-18 interior. No flow into MH, dye tested pool of water. No outgoing flow.

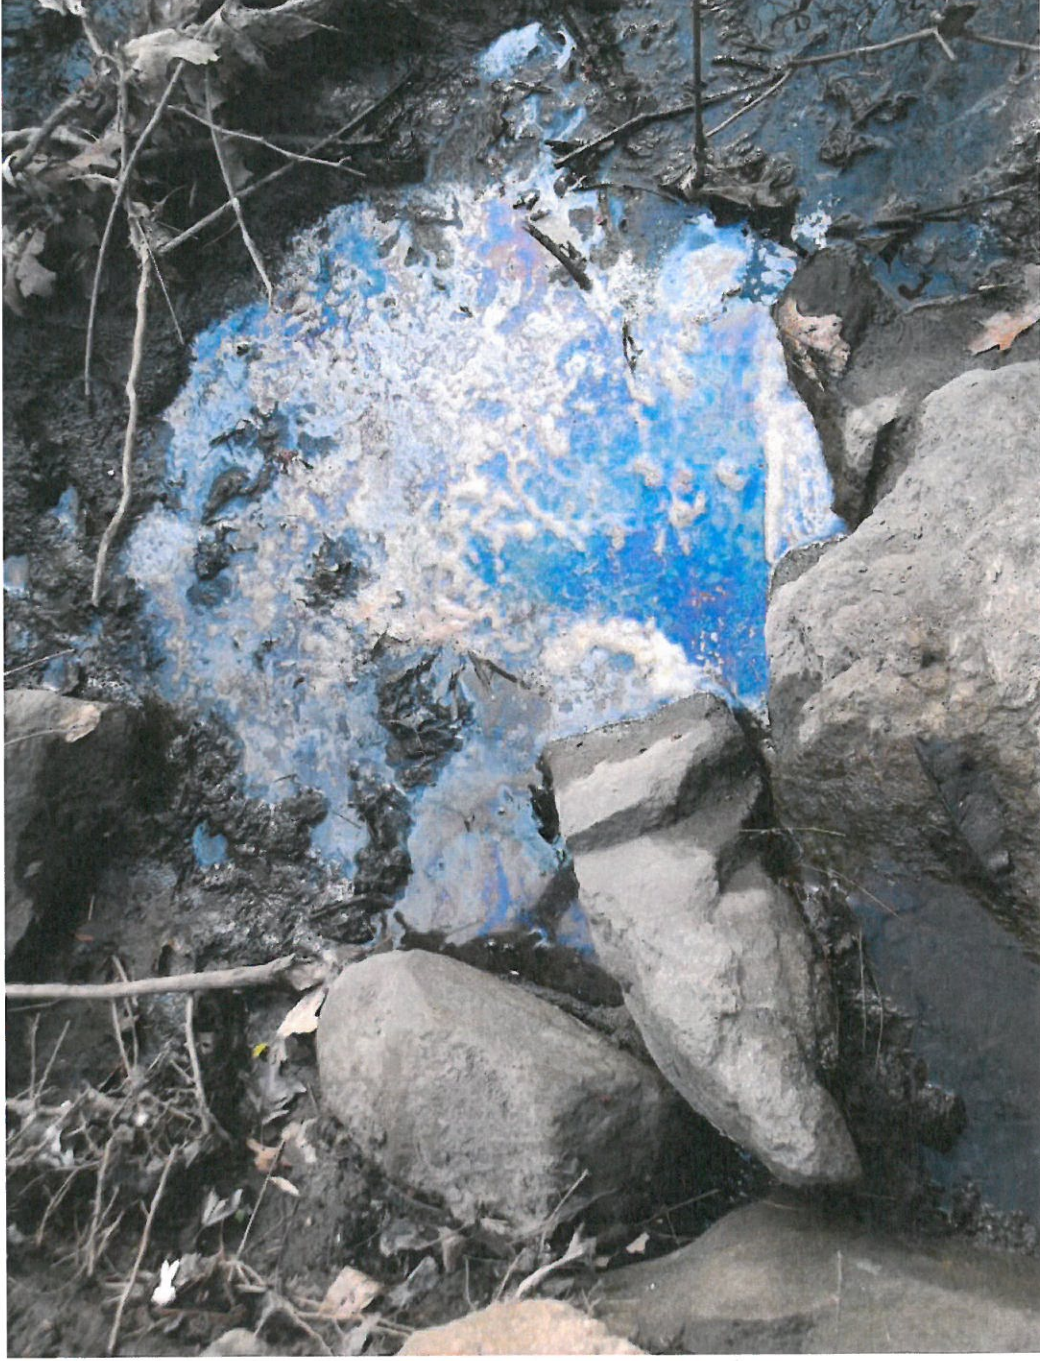
BSB-03 pool before creek. Rainbow sheen and suds present.

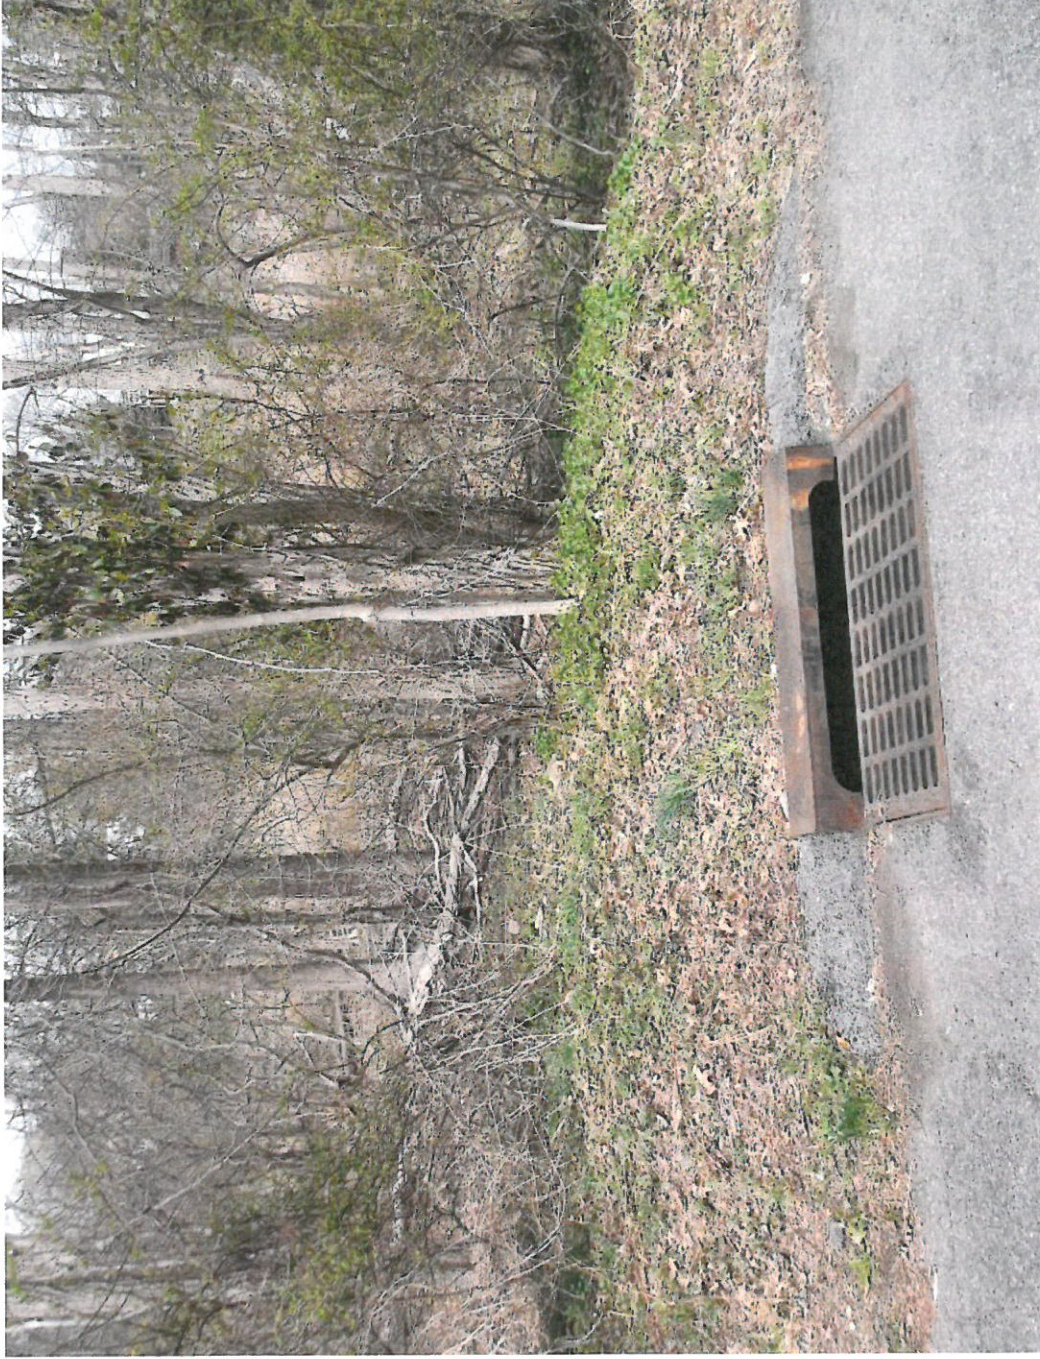
VJ-65 catch basin. Dye tested, but could not confirm connection to outfall (not pictured).

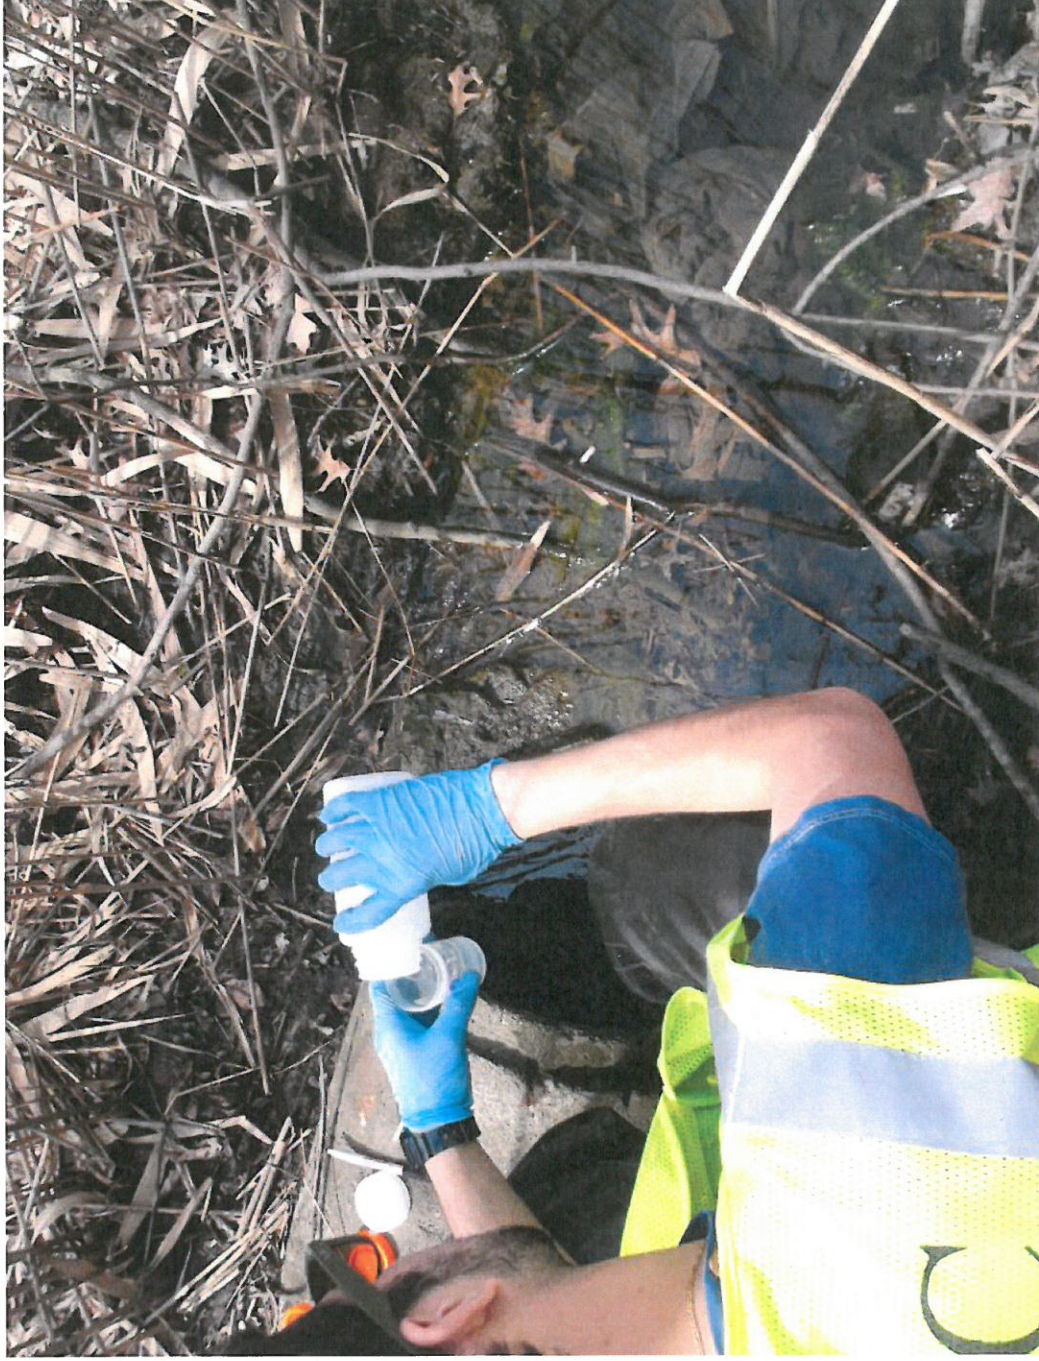
VJ-61 outflow sampling location. Algae growth present.

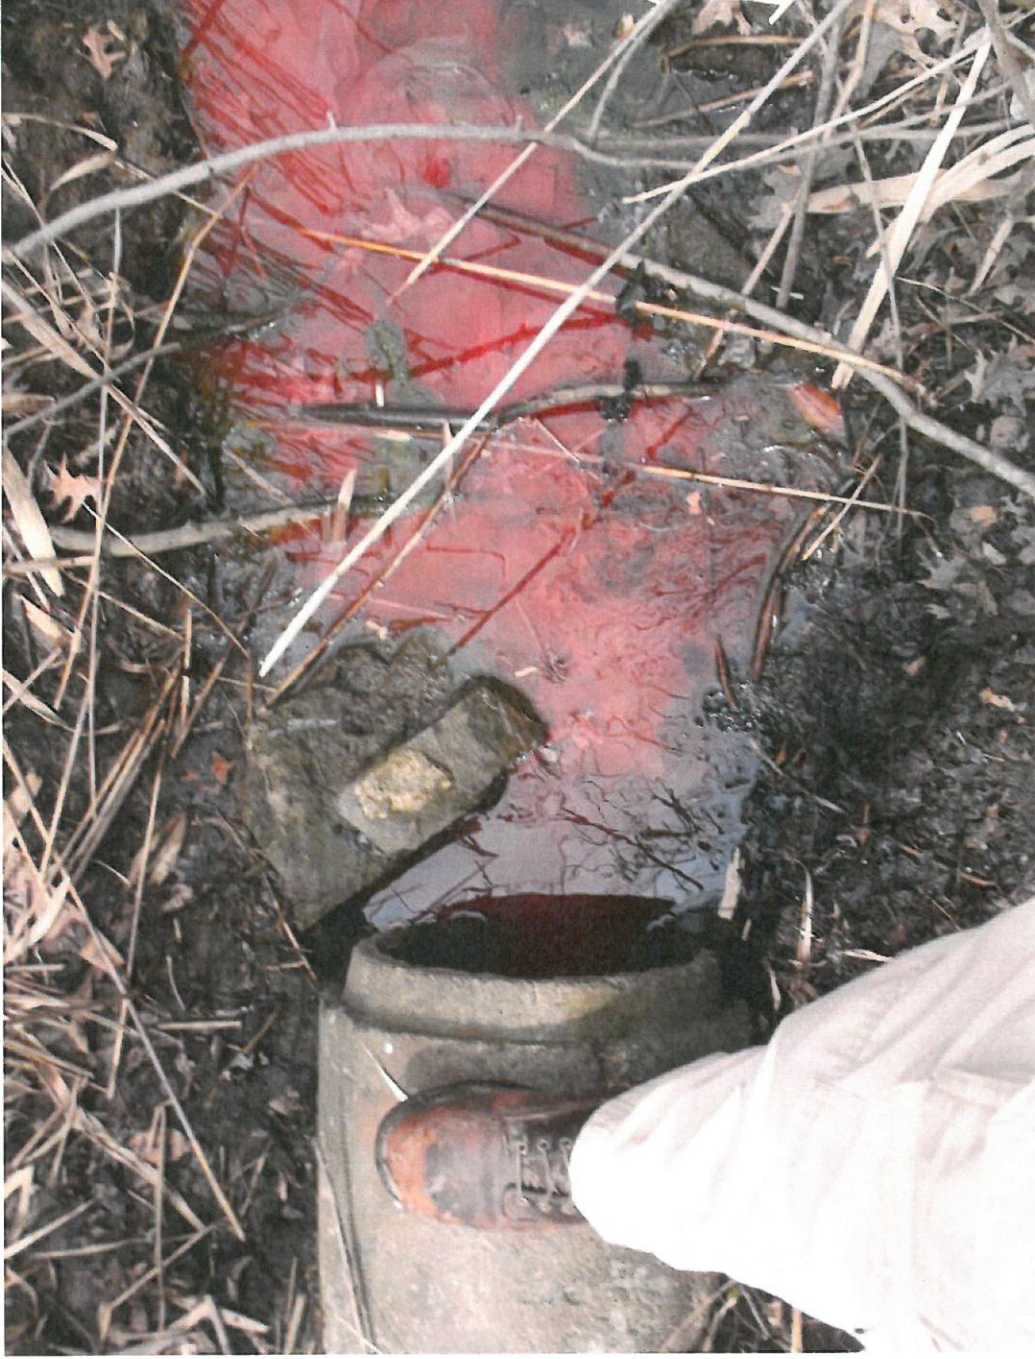
VJ-61 dye tested to confirm US CB.

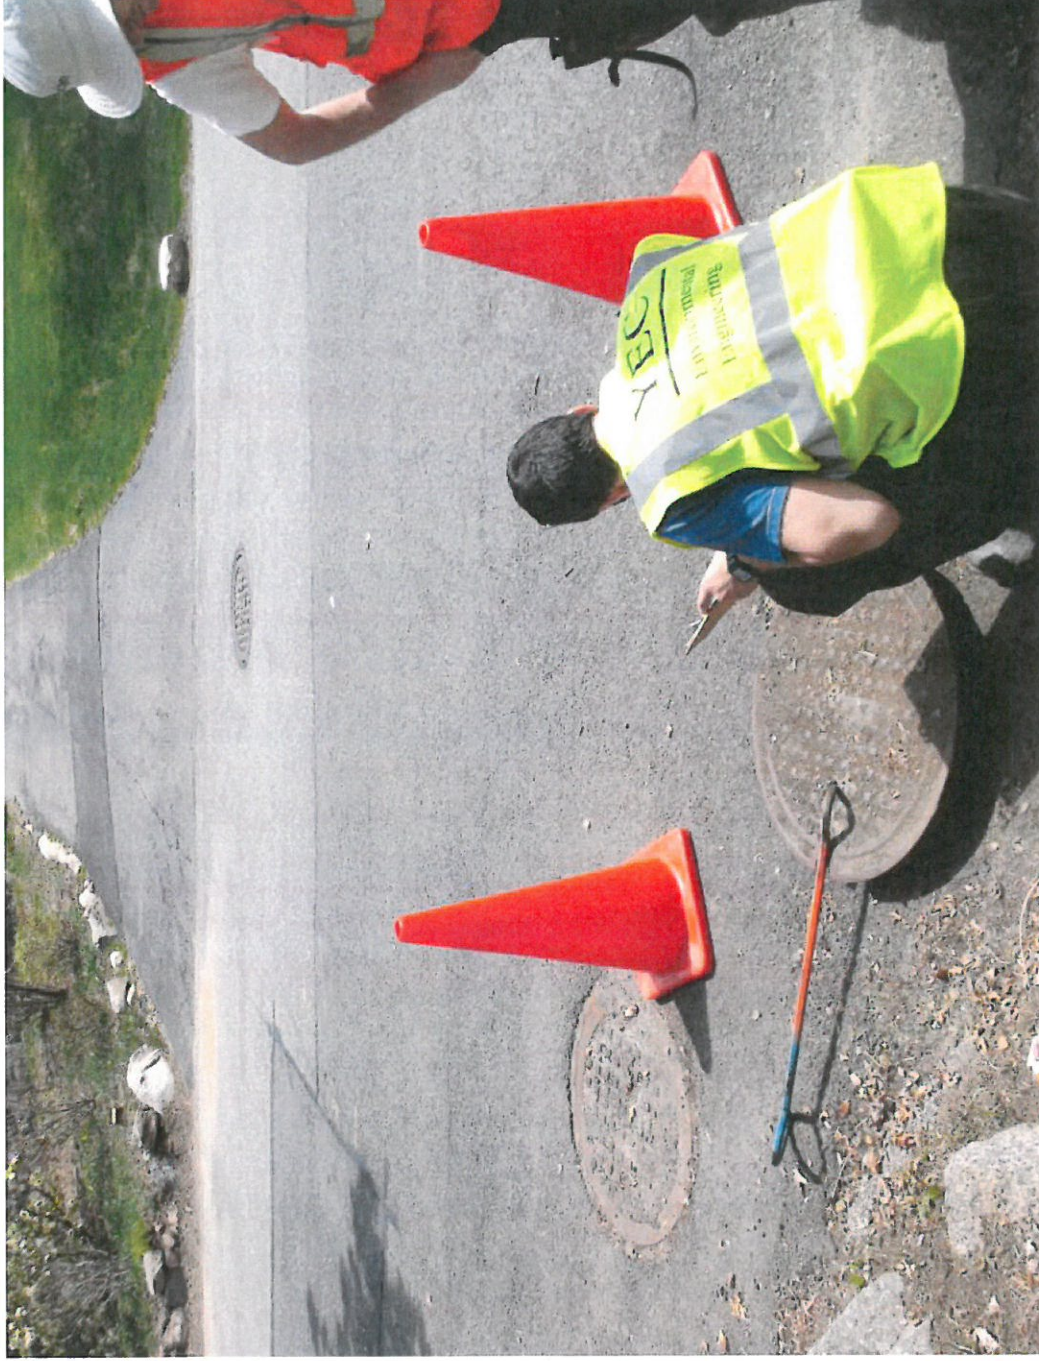
MH US VJ-62 exterior, no flow.

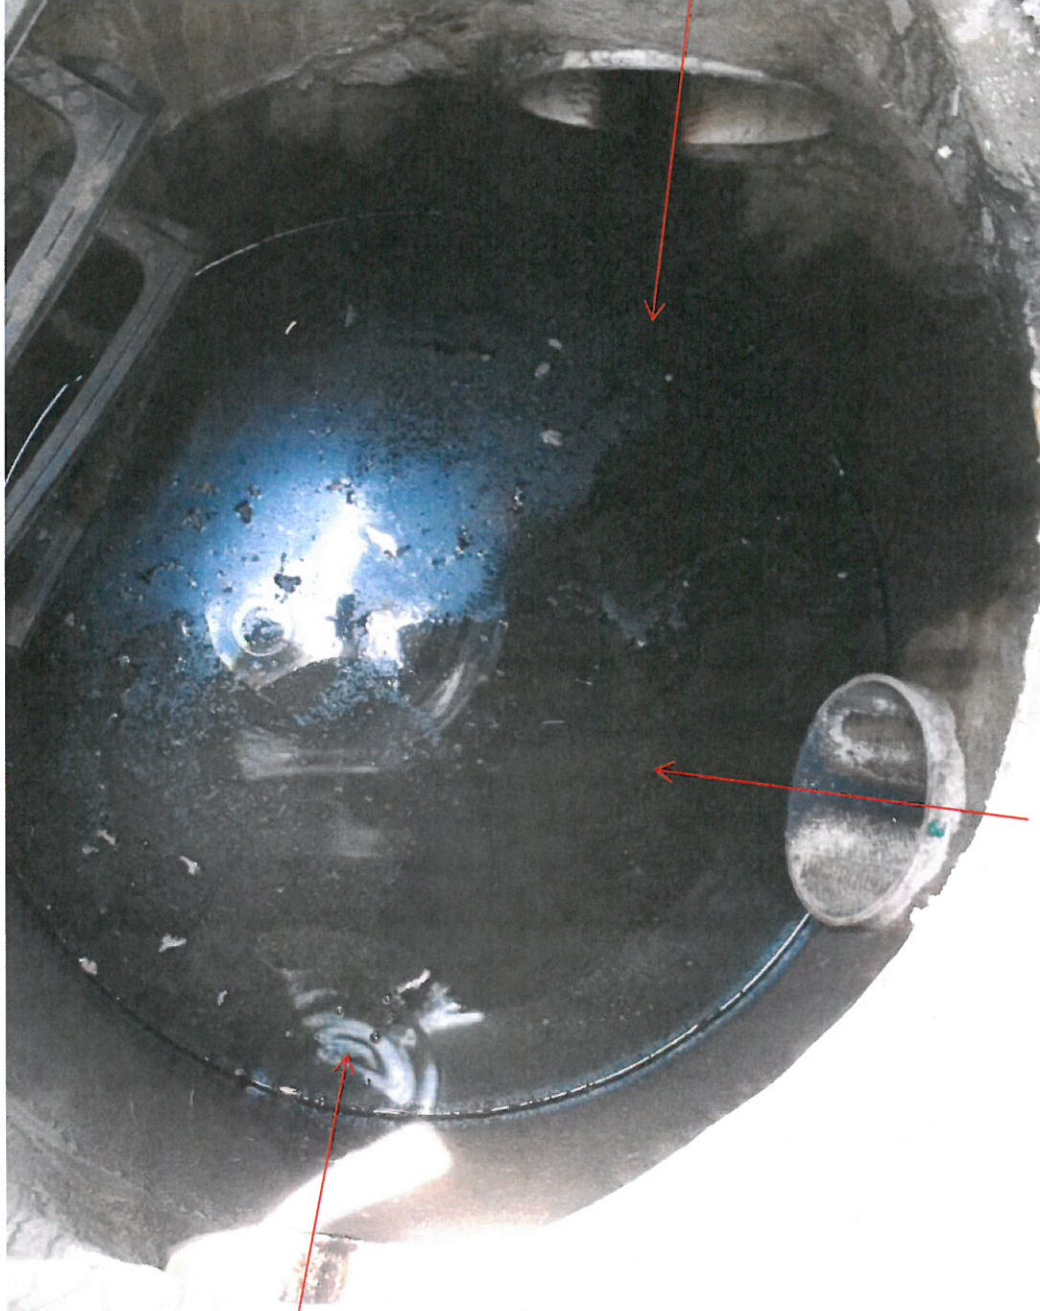
VJ-62 interior. 3 o'clock inlet wet, 6 o'clock inlet dry and 9 o'clock inlet dripping. No flow to outfall.

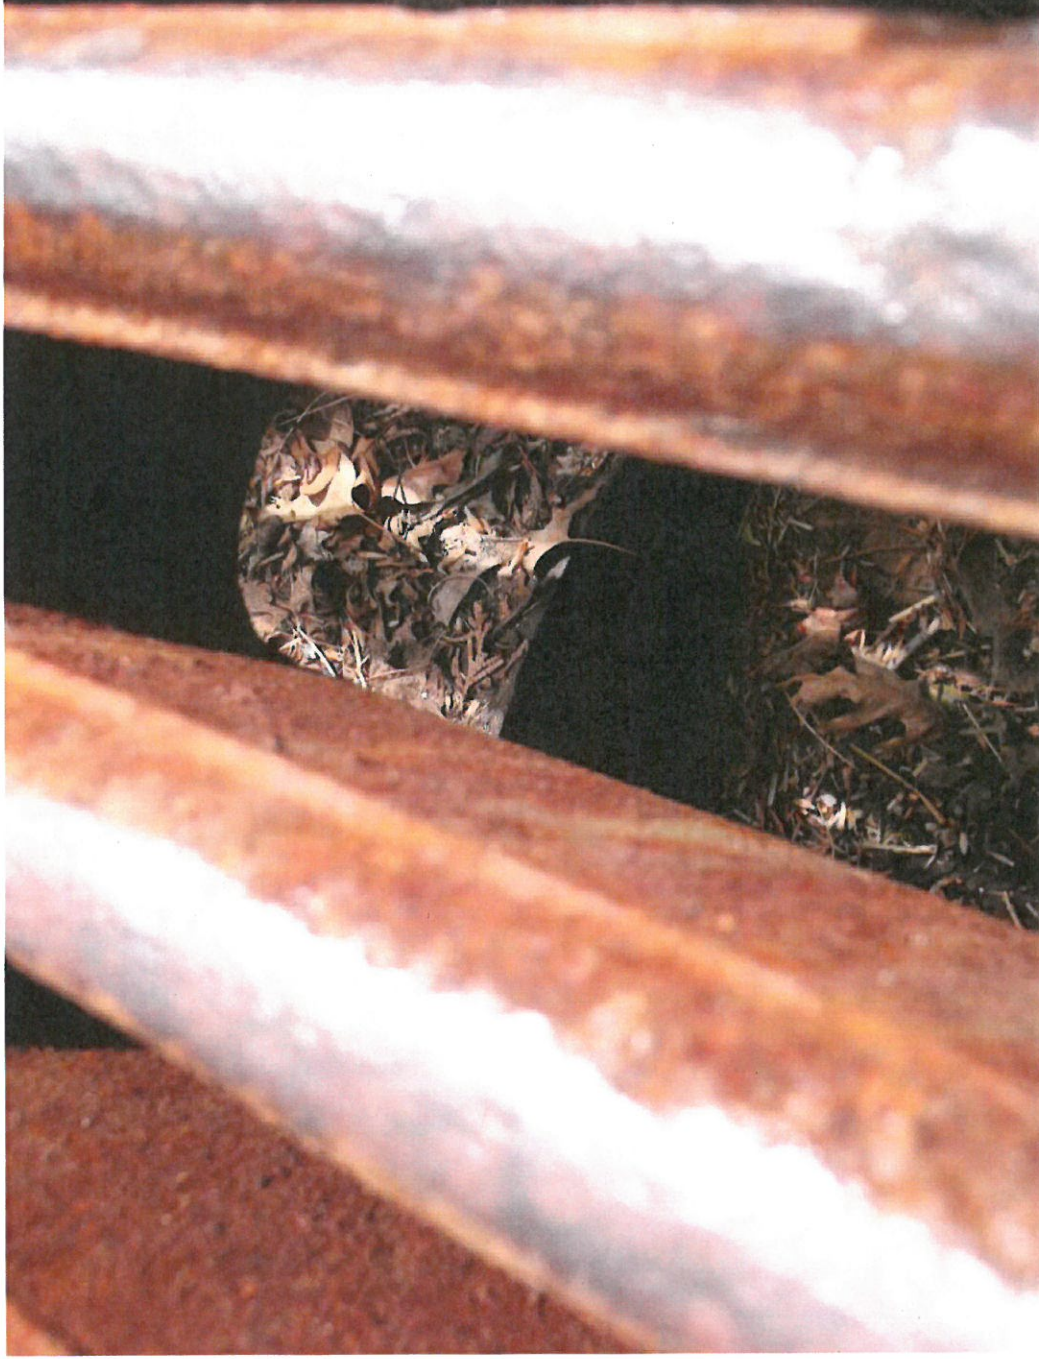
BSB-24 upstream catchment basin. Dry with metal cap over outlet. Filled with leaves and debris.

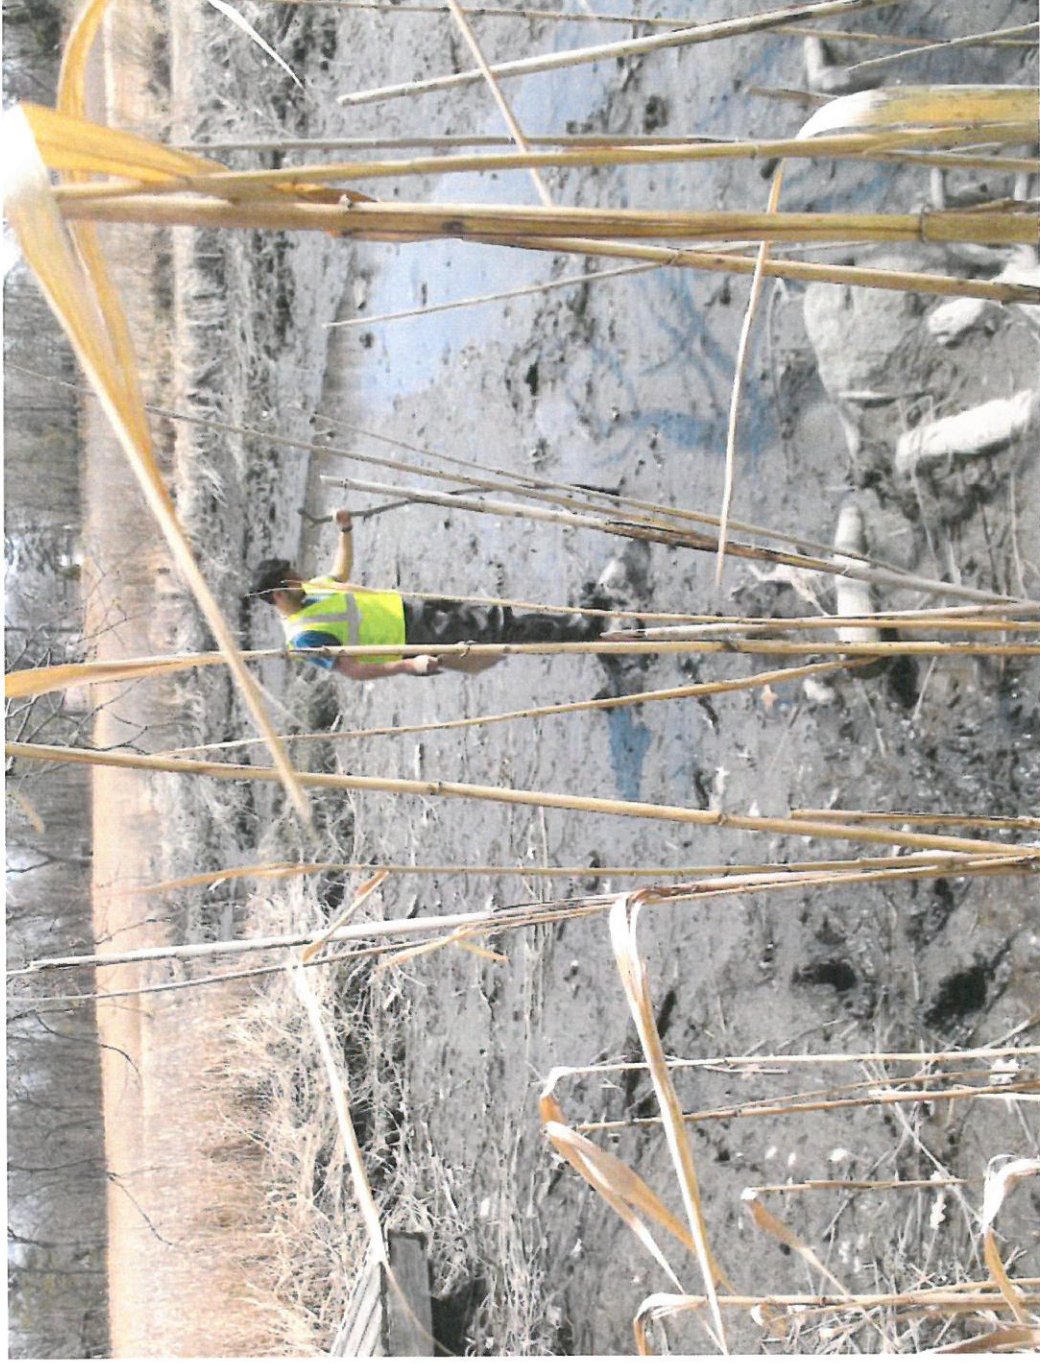
Could not locate BSB-24 outfall.

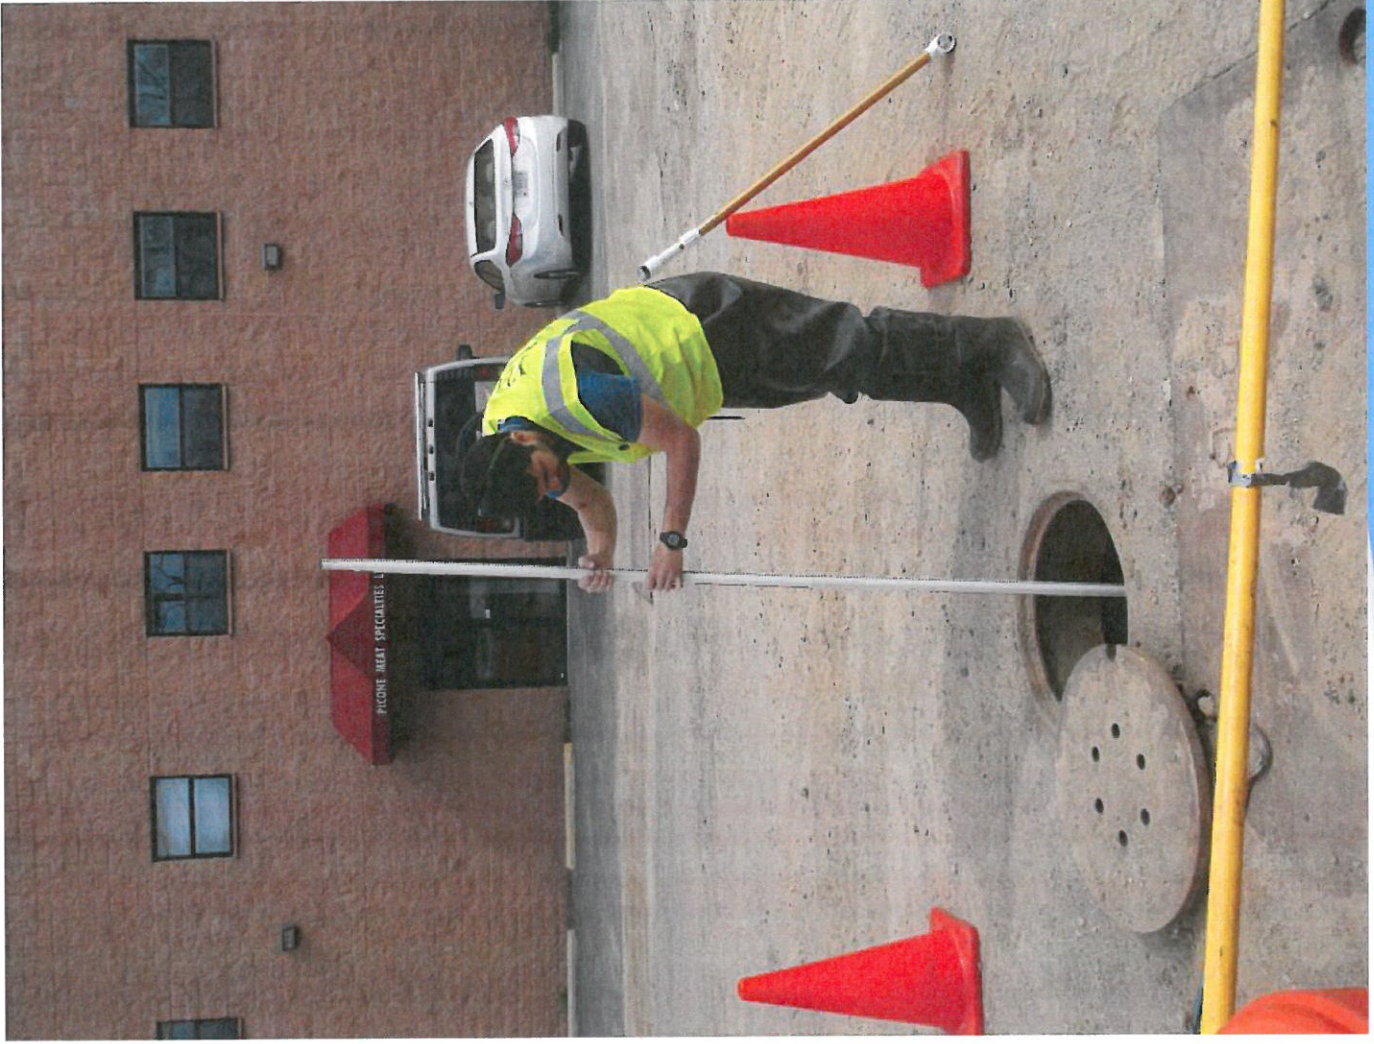
USMH_Jefferson OF
and sample location.
MH Depth 9.28 ft.
DTW 8.94 ft.

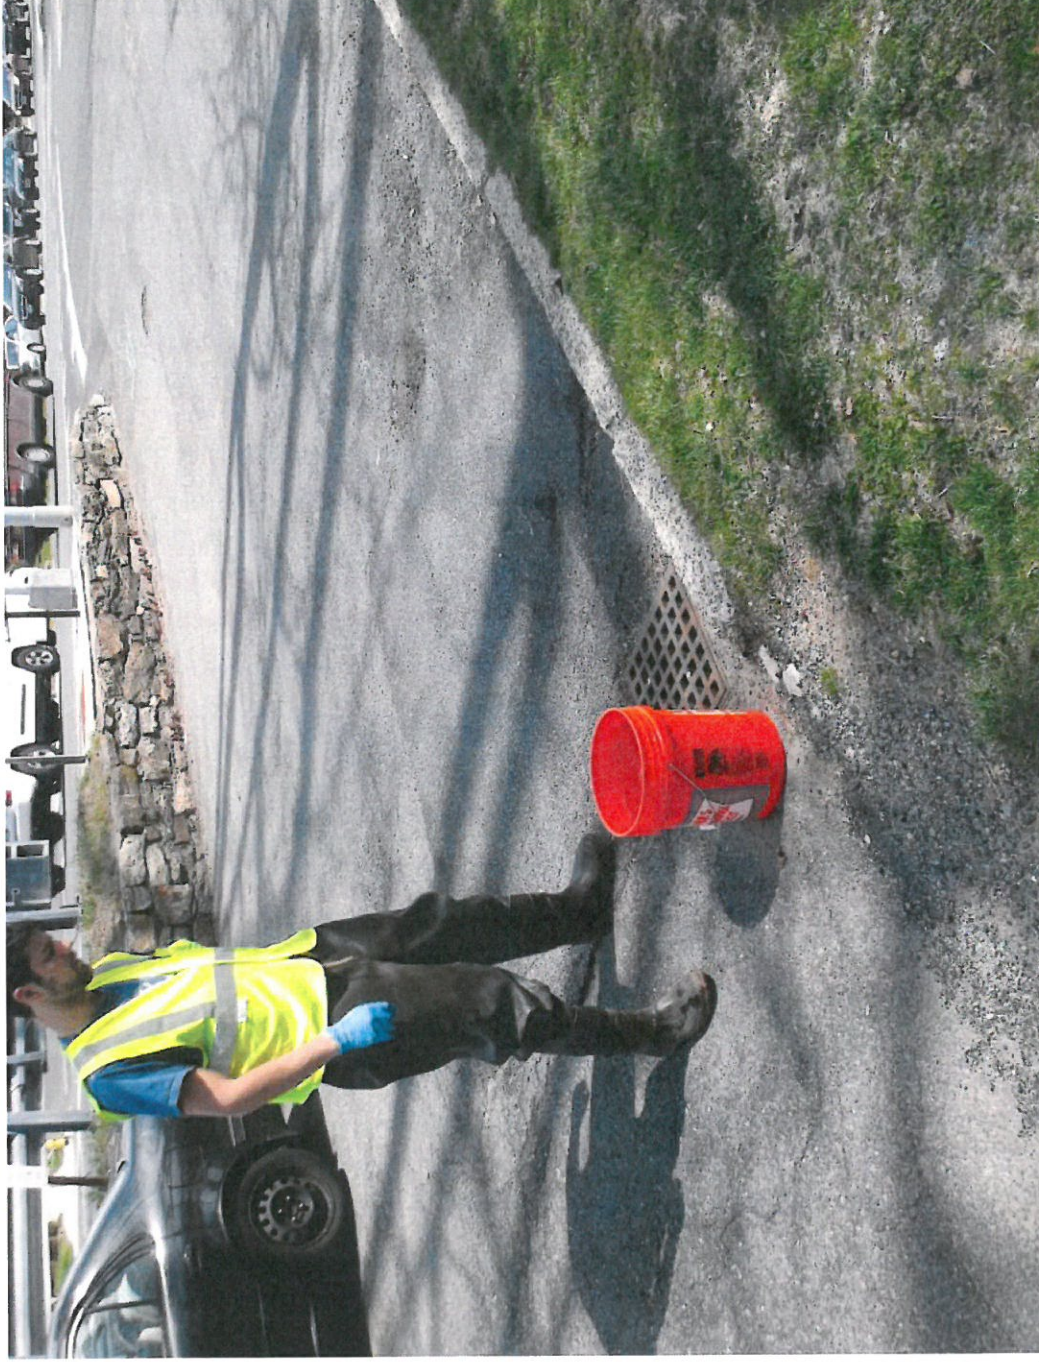
Catchment basin US BSB-17. Tested connection with water from creek, but could not confirm.

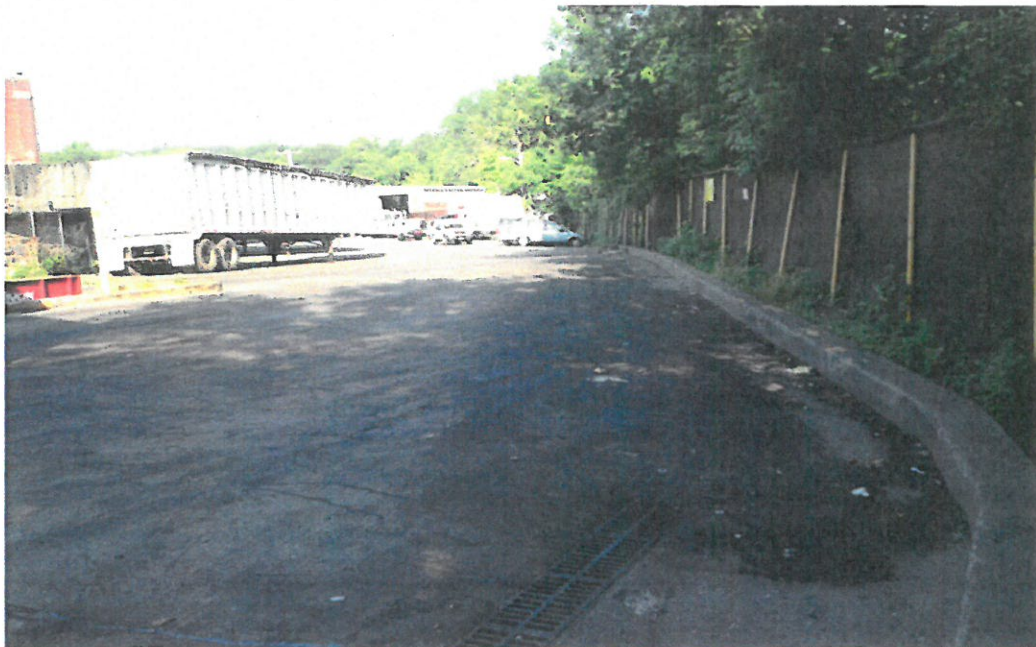
3

Photo #3: Transfer Station curtain drain at the north end of Fayette Avenue – facing west

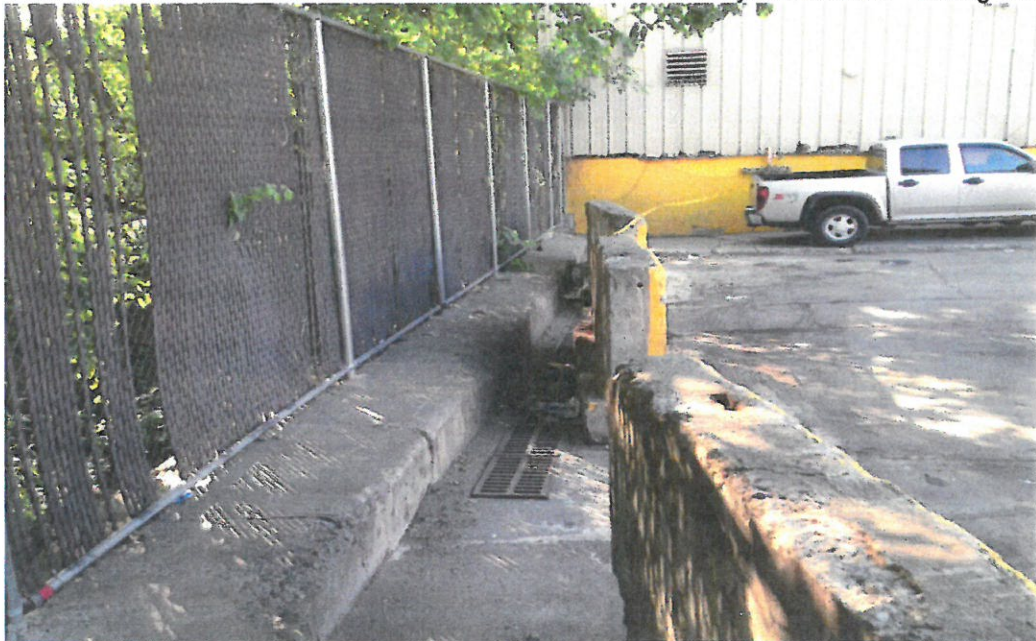
4

An outfall that is downgradient from these facilities on Fayette Avenue is constantly flowing, even during dry weather conditions. The only source of inflow observed during the investigation was from a pipe that reportedly discharges groundwater from around the transfer station. The flow from the outfall was sampled and the results showed a low fecal coliform concentration of 300 CFU/100 ml. The plumbing was appropriately connected to the sanitary sewer and the fecal coliform concentrations were low. No additional investigation is recommended at this time, based on the results of the investigation and sample collected.

Photo #4: Transfer Station curtain drain at the north end of Fayette Avenue – facing east. Outfall and Sheldrake River located to the left of photo (not shown)
