Village of Mamaroneck

**Illicit Discharge Detection and
Elimination Study**

**Sewer System Investigation –
Draft Phase 4 Report**

January 2015

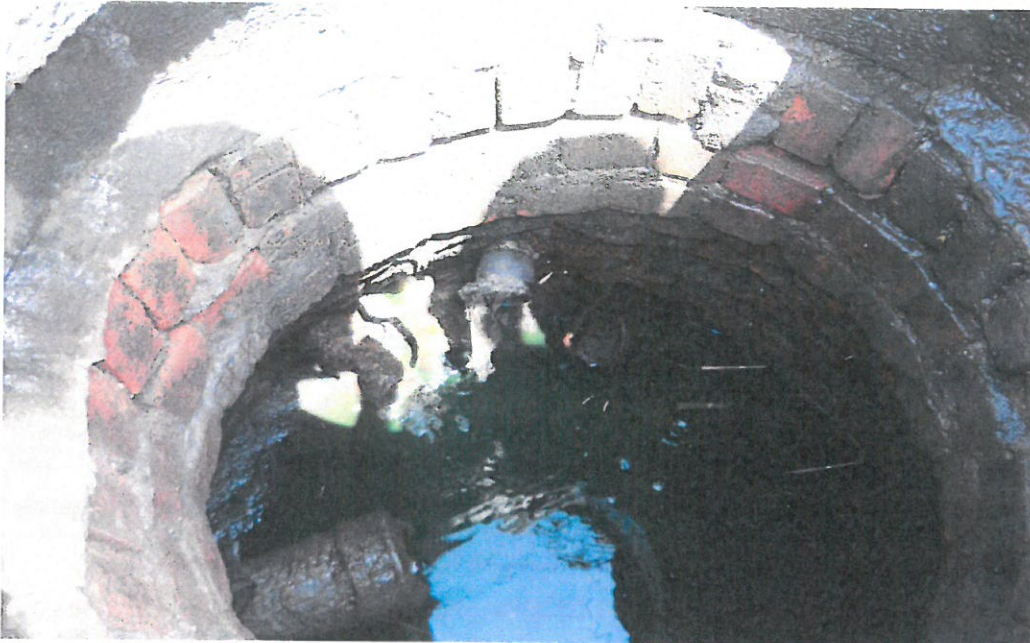
6

The Village DPW Garage has small drainage basins in the center of each building. Dye was added to one of the catch basins in a garage bay and was observed discharging to the sanitary sewer manhole, as appropriate. The sanitary sewer manholes and the storm drain manholes were inspected and the small diameter floor drain pipes were observed entering the sanitary sewer manhole. The storm drain manholes were inspected and there were no unaccounted for pipes connected to the structure, nor

Photo #6: Sanitary sewer manhole in front of Village DPW Garage – Green dye from dye test of curtain drains at north end of Fayette Avenue and DPW Garage floor drains. Incoming pipes from Village DPW Garage floor drains and the transfer station pump station shown at the top of the photo.
