Village of Mamaroneck

# ILLICIT DISCHARGE DETECTION AND ELIMINATION – PHASE 5 REPORT

Mamaroneck, NY

February 4, 2016

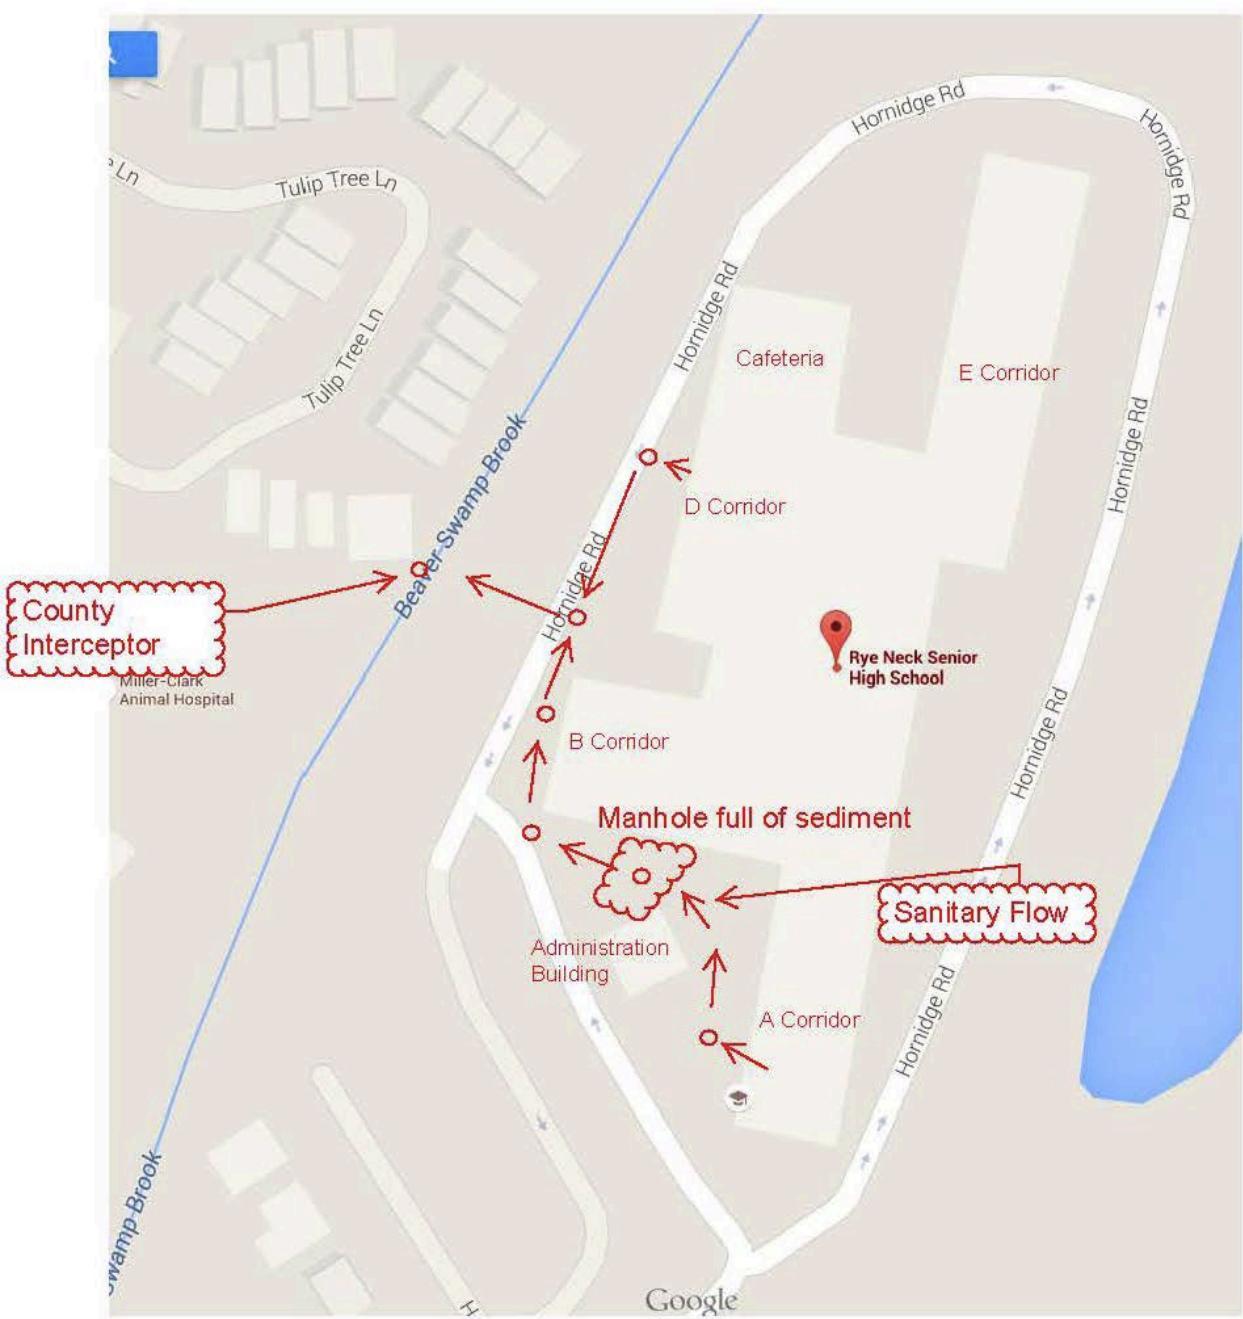
Figure 1. Rye Neck High School Sewer Schematic

On September 2, 2015, Arcadis returned to the school to dye test the A Corridor bathroom again and the Administration Building to confirm proper discharge. For each location, dye was visible in the sanitary manhole and no flow was observed in the storm sewer or outfalls.

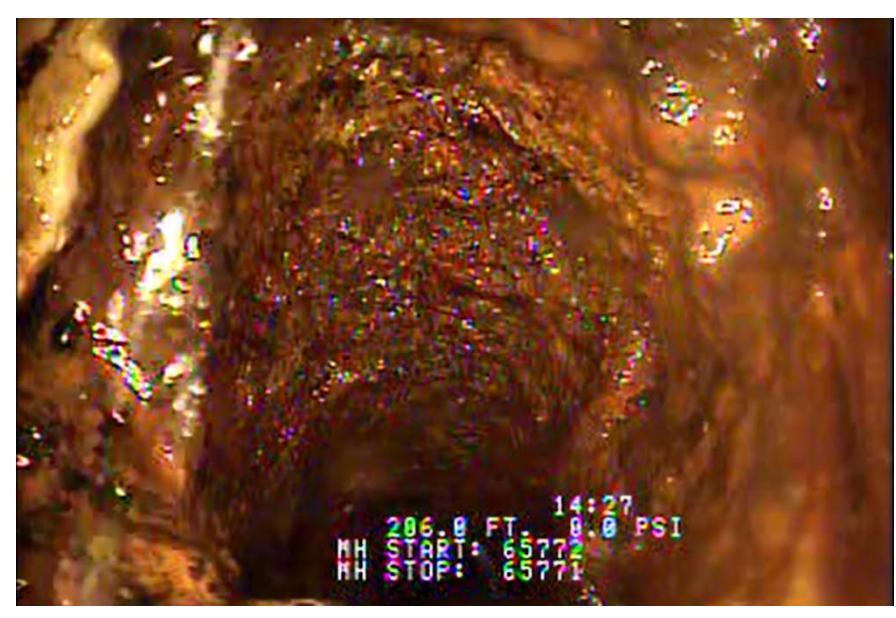
Photo 1 - Example of tuberculation with the 16-inch cast iron pipe

Several problems arose while the contractor was attempting to complete lateral grouting. The main issue was heavy tuberculation along the main trunk. Tuberculation is localized corrosion resulting in knob-like mounds on the inside of the pipe, which make the pipe out of round and reduces the internal diameter. An example of the tuberculation observed during the grouting pilot program is shown in Photo 1 below. The 16-inch cast iron pipe was found to have

heavy tuberculation which impeded mobility of the grouting packer through the pipe. There were additional obstructions that caused the packer to get stuck in the main line. An example of a pipe obstruction is shown in Photo

The pilot provided valuable information for the Village for the full scale program. Attempting to grout sewer lateral pipe connections in a cast iron pipe for the full scale program is not recommended. Cast iron pipe is typically not as common a construction material in older sewer systems as vitrified clay pipes. Based on a review of the historic Village drawings, most of the pipes in the area planned to be grouted are vitrified clay pipe. Pressure testing and grouting vitrified clay pipe should not present a problem unless the pipe has structural defects or offset joints. One alternative to quickly confirm pipe material and condition would be to use a sewer zoom camera to inspect the pipe segments from the manhole surface prior to developing the final plan for pipe segments to will be grouted. One other potential problem is with pipes that have been previously lined with cured-in place liner. If the holes for the laterals were not trimmed back properly the grouting contractor may need to spend some time making the pipe condition right for air testing and grout sealing.

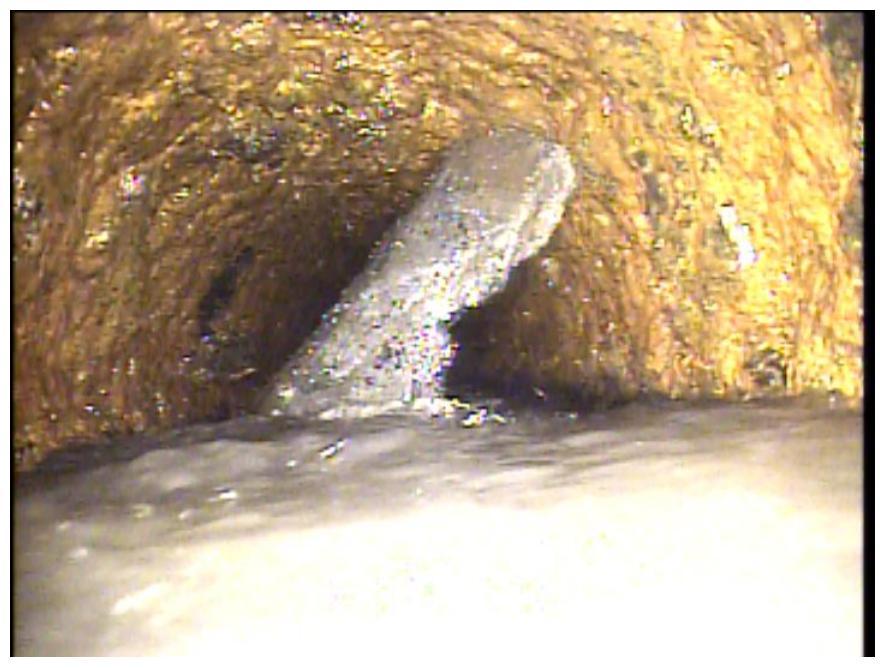
#### Photo 2 - Example of obstruction

2, above. The 10-inch cast iron line had been lined previously with a cured-in place pipe. However, this pipe was also corroded with tuberculate, so the same problems applied when attempting pass the packer through the pipe to grout the laterals.

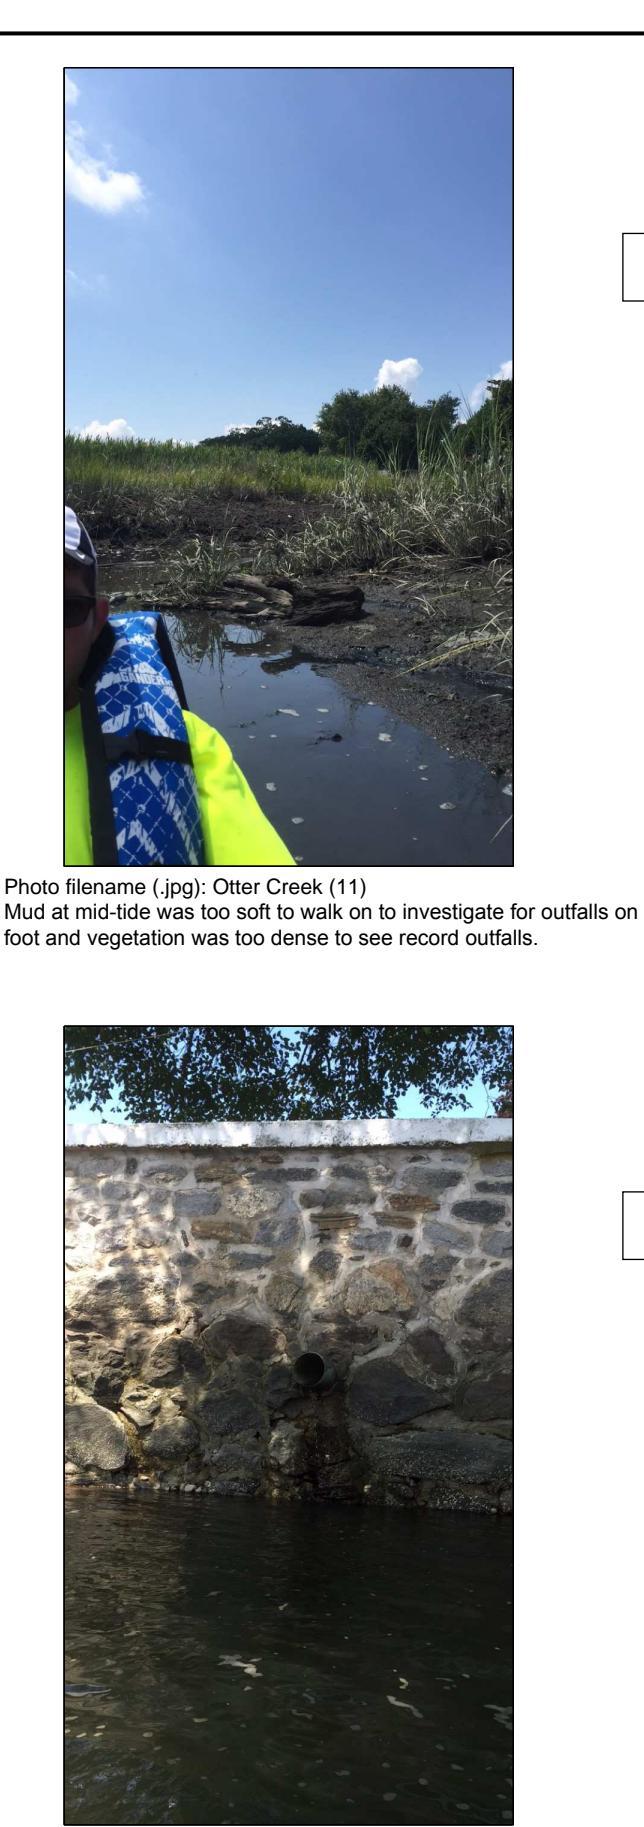
Photo filename (.jpg): BSB 23 Arcadis staff located one outfall, at the mouth of Otter Creek, close to the Harbor.

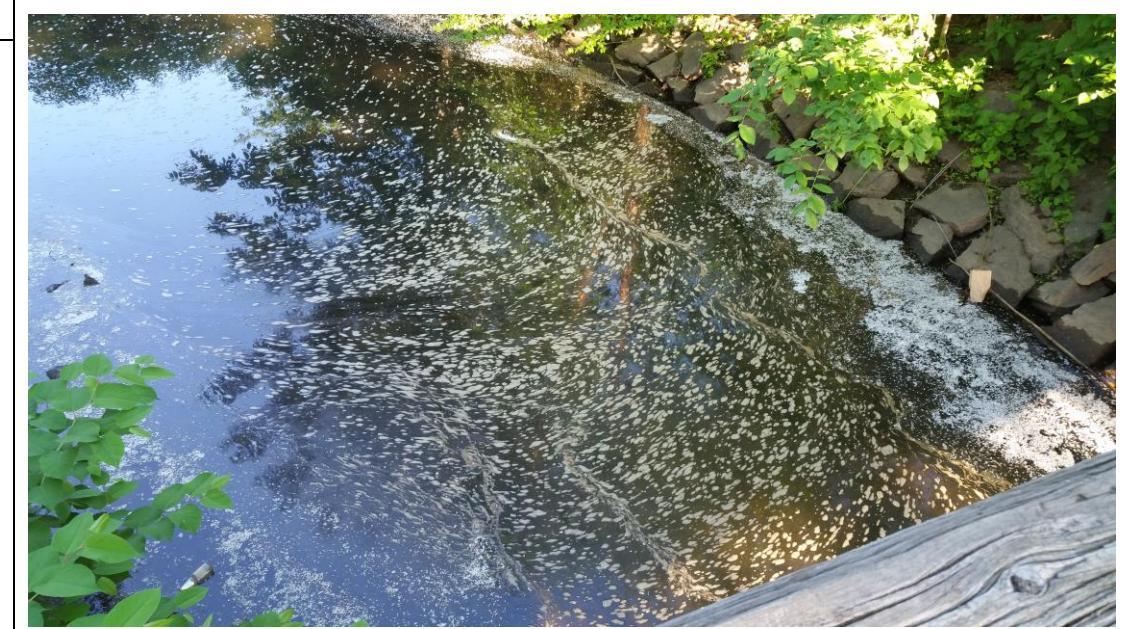
Sheldrake River at the confluence of Mamaroneck River (looking west). Heavy foam visible.

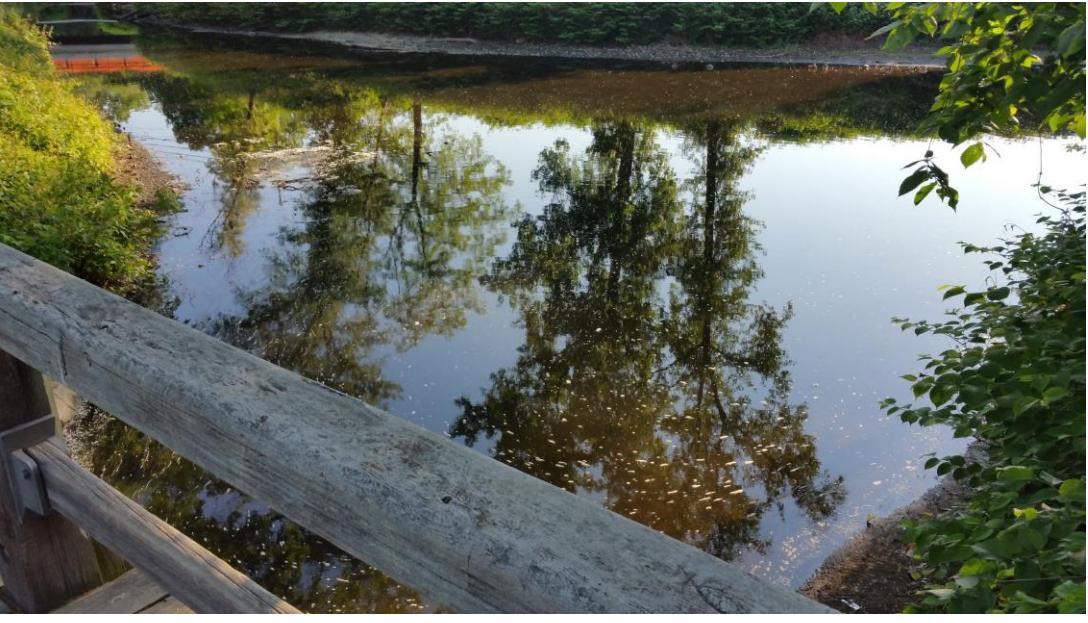
Sheldrake River at the confluence of Mamaroneck River (looking east). Heavy foam visible.

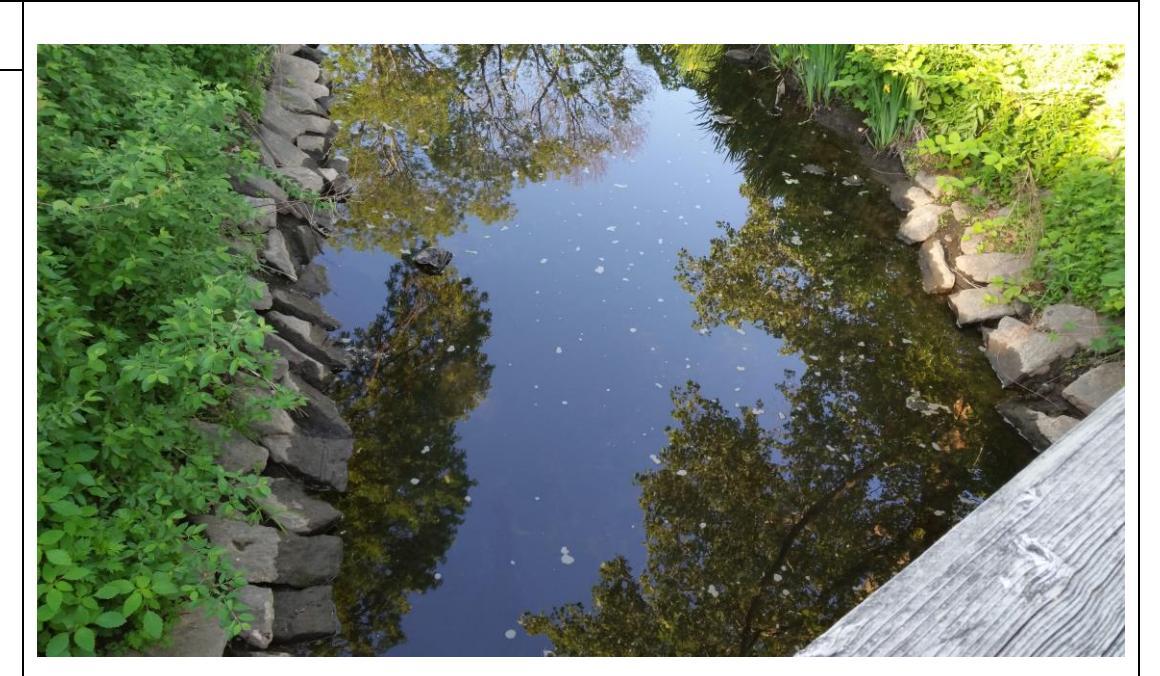
Sheldrake River at footbridge halfway to Mamaroneck Ave. (looking west). Foam visible.

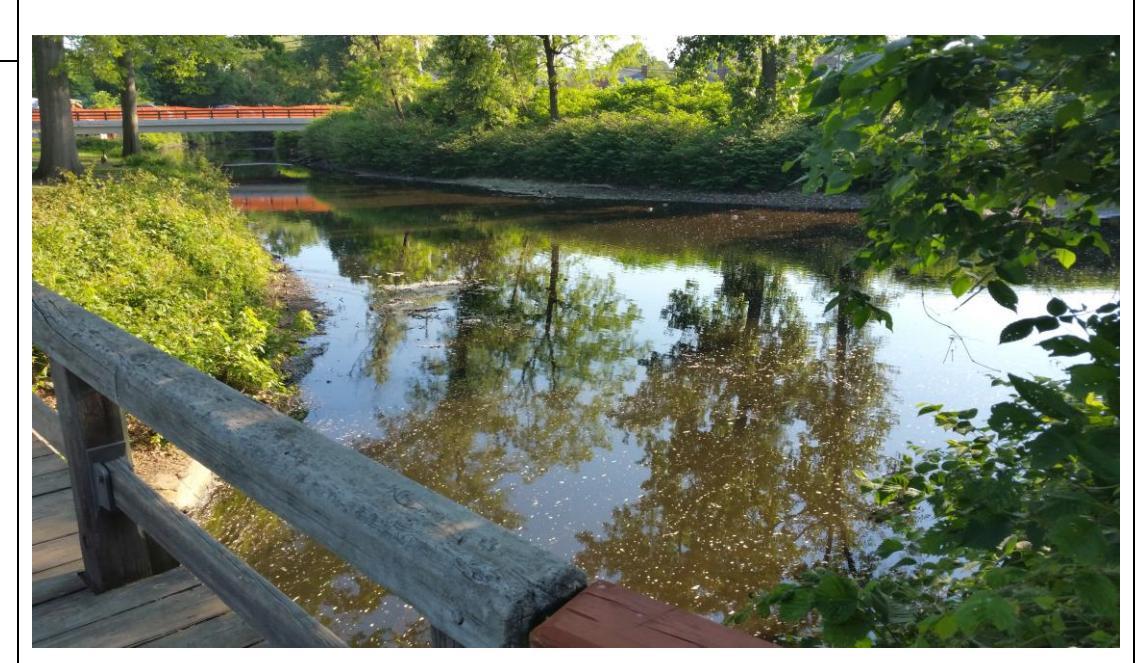
Mamaroneck River at the confluence of Sheldrake River (looking east). Heavy foam visible.

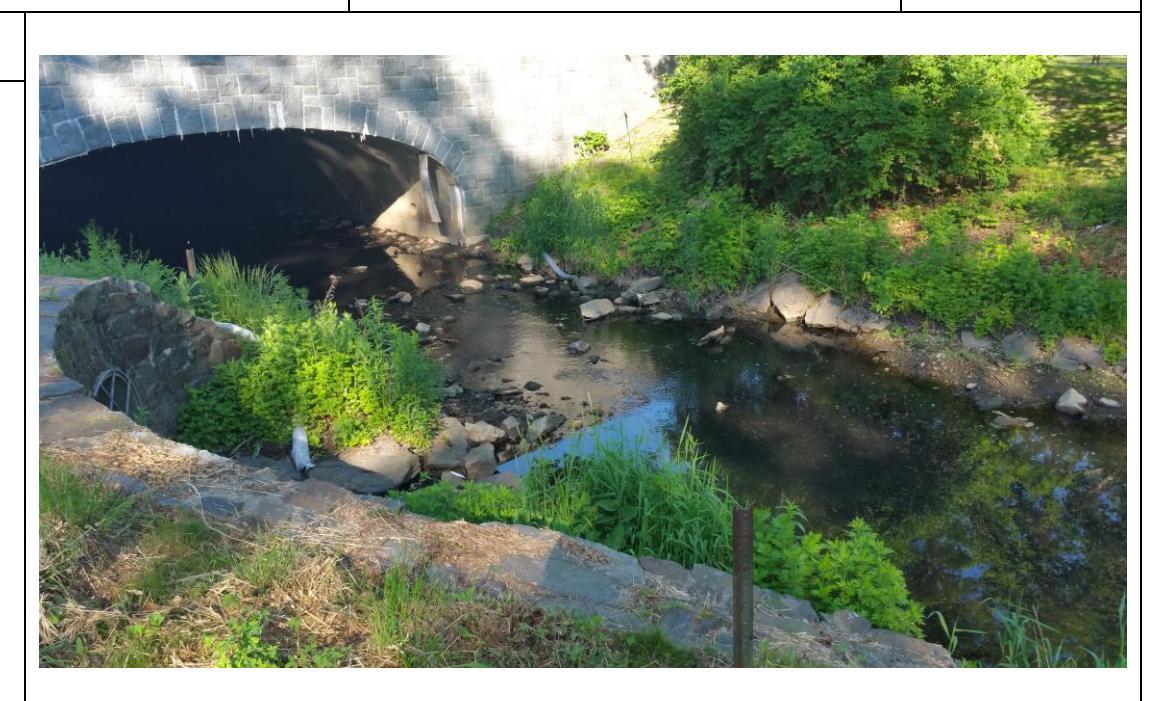
Sheldrake River at Mamaroneck Ave. bridge (looking west). Foam visible.

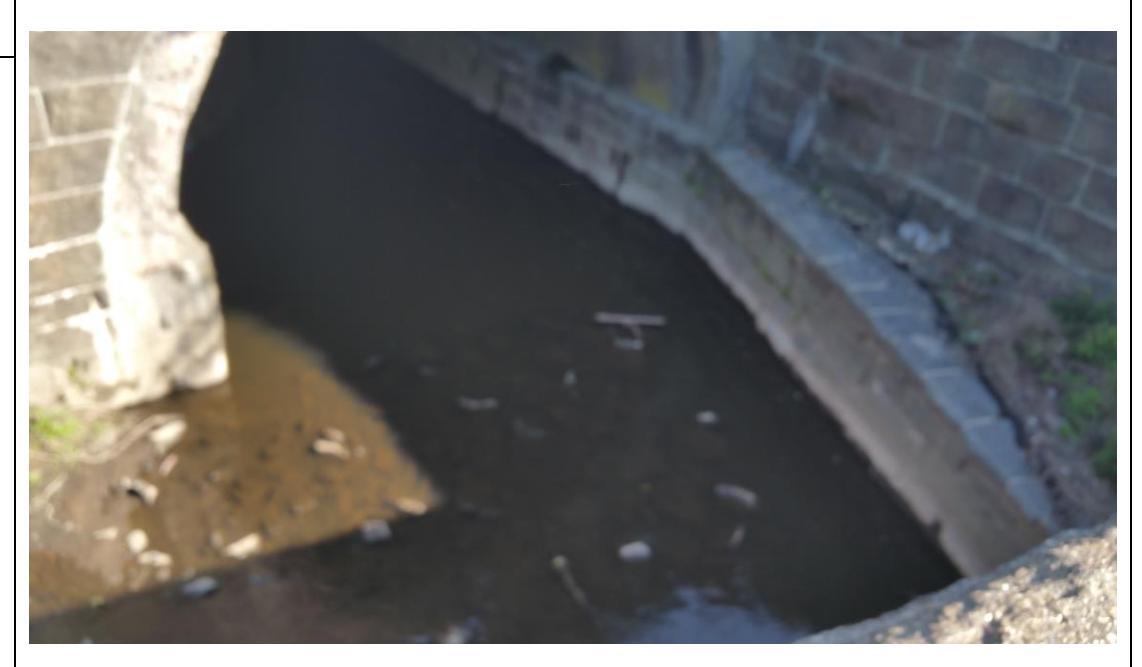
Mamaroneck River at Halstead Ave. railroad bridge, south side, looking northeast. Minimal foam visible not much turbulence in the moving water.

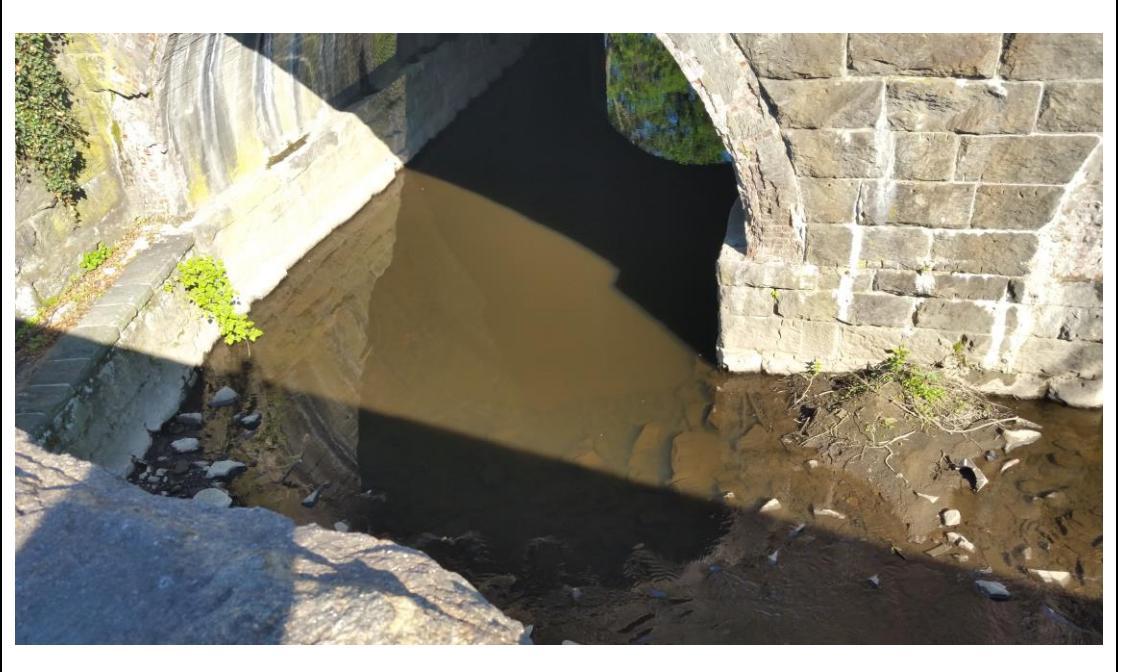
Mamaroneck River at Halstead Ave. railroad bridge, south side, looking northwest. Minimal foam visible not much turbulence in the moving water.

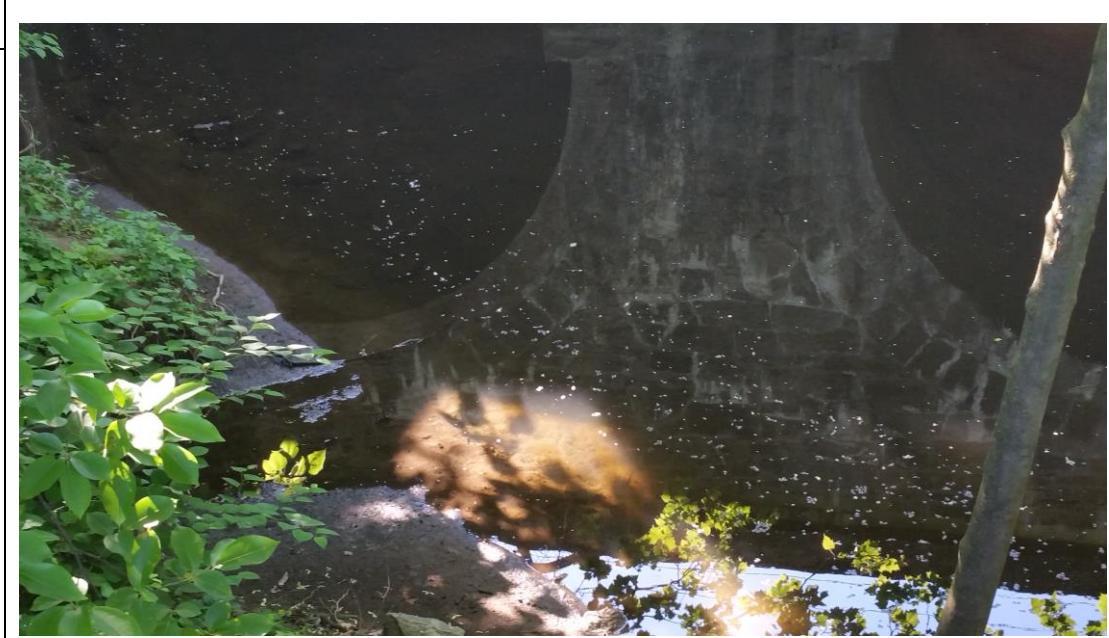
Mamaroneck River just north of railroad bridge, eastern shore (looking south). Foam, organic matter visible.

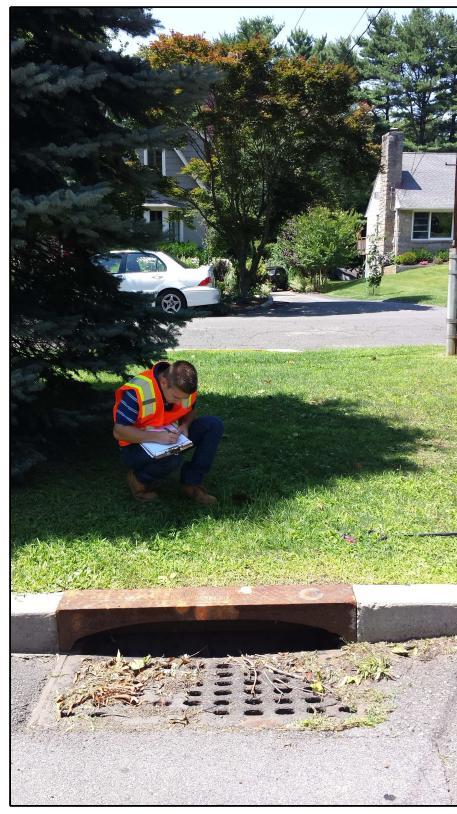
Photo filename (.jpg): CB1 Catch basin was dry but had sediment buildup. No odors, flow, or evidence of oil or gasoline present.

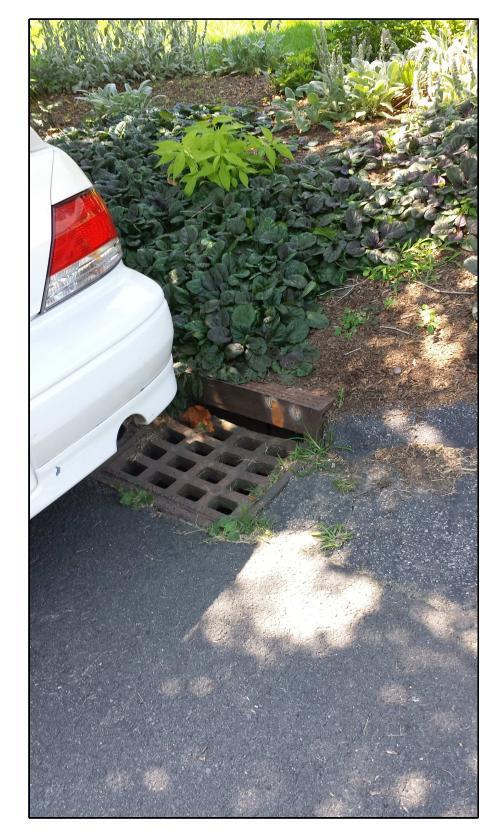
Photo filename (.jpg): CB4 Catch basin was dry. No odors or evidence of oil or gasoline residue.

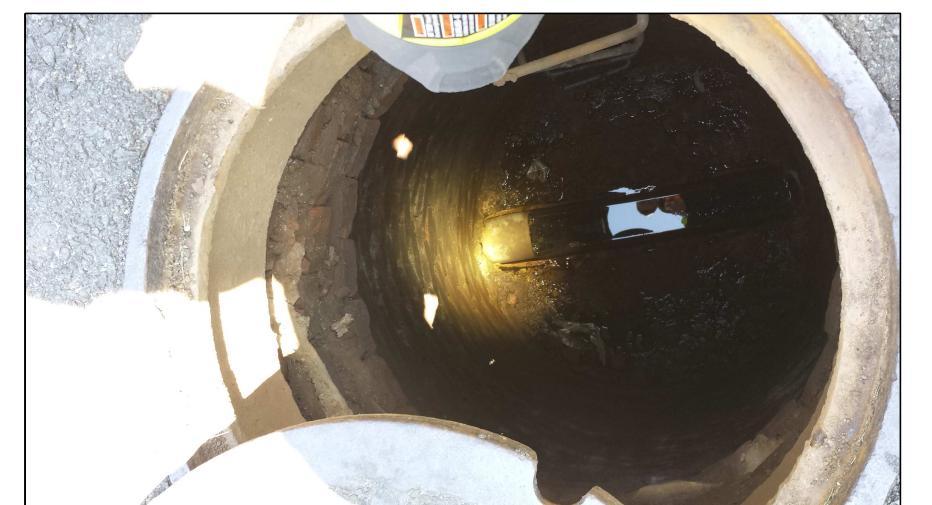
Photo filename (.jpg): Sanitary Manhole 1 No evidence of oil or gasoline. No odd smells. Recent construction activity in vicinity of manhole.

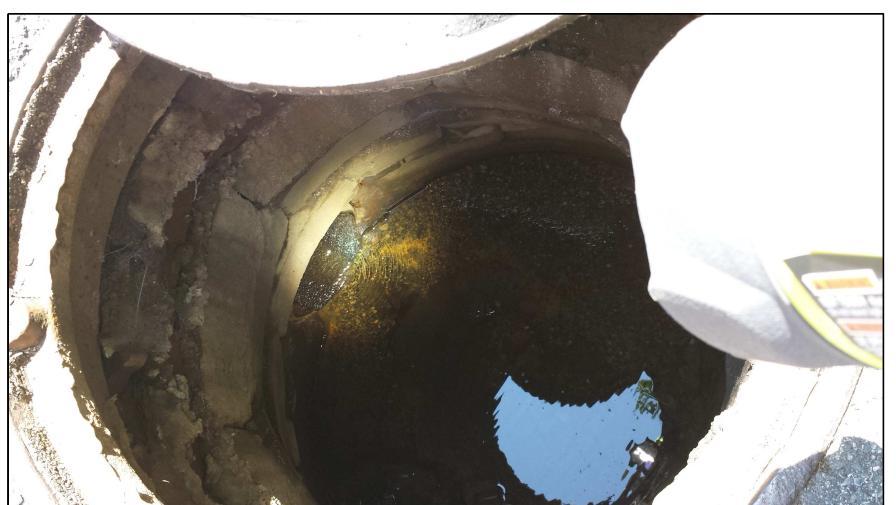
Photo filename (.jpg): Storm Manhole No odor and no evidence of oil, grease, or gasoline.

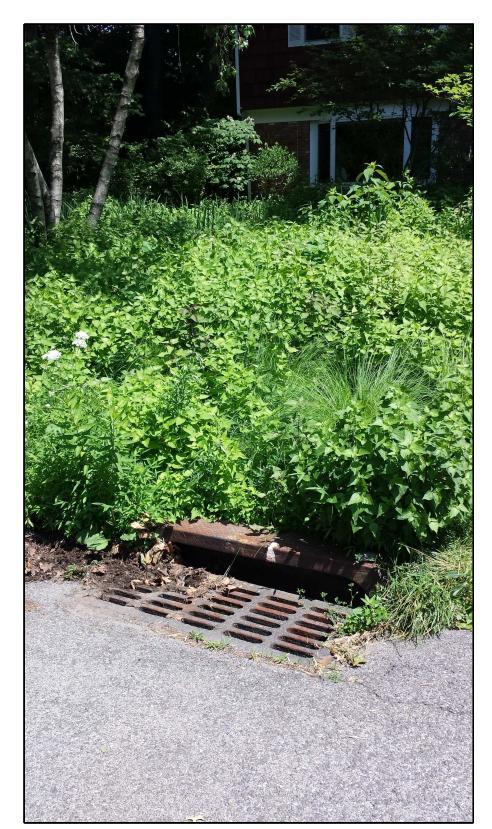
Photo filename (.jpg): CB6 Catch basin had some stagnant water and sediment and leaf buildup. No odors or evidence of oil or gasoline. 12

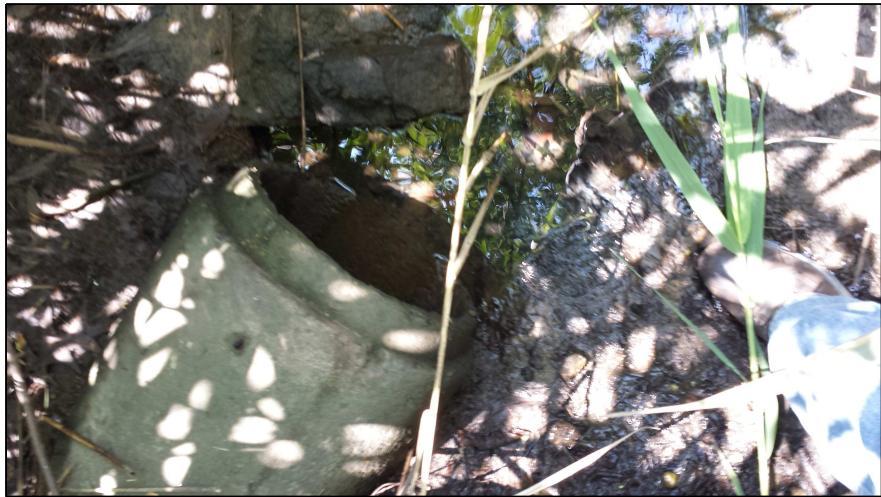
Photo filename (.jpg): Outfall Outfall was wet, but there were no signs of gasoline, oil or grease. It was very muddy and smelled like a swamp or marsh, but there were no abnormal smells.
