Hampshire Country Club Planned Residential Development
Village of Mamaroneck,
Westchester County, New York
Draft Environmental Impact Statement

B Wetland Functional Assessment

Hampshire Country Club Property

July 2016

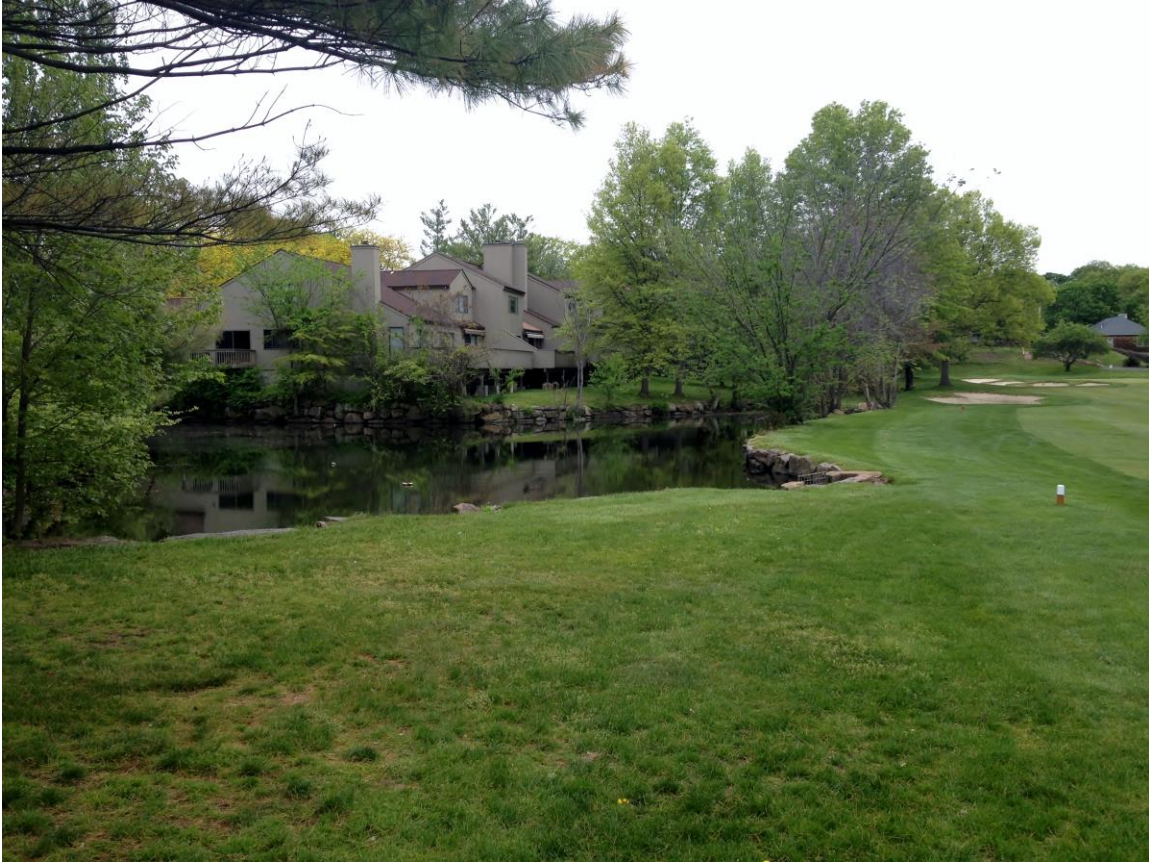
Photograph No. 1: Pond 16 of Golf Course Drainage System 1 (May 17, 2016).

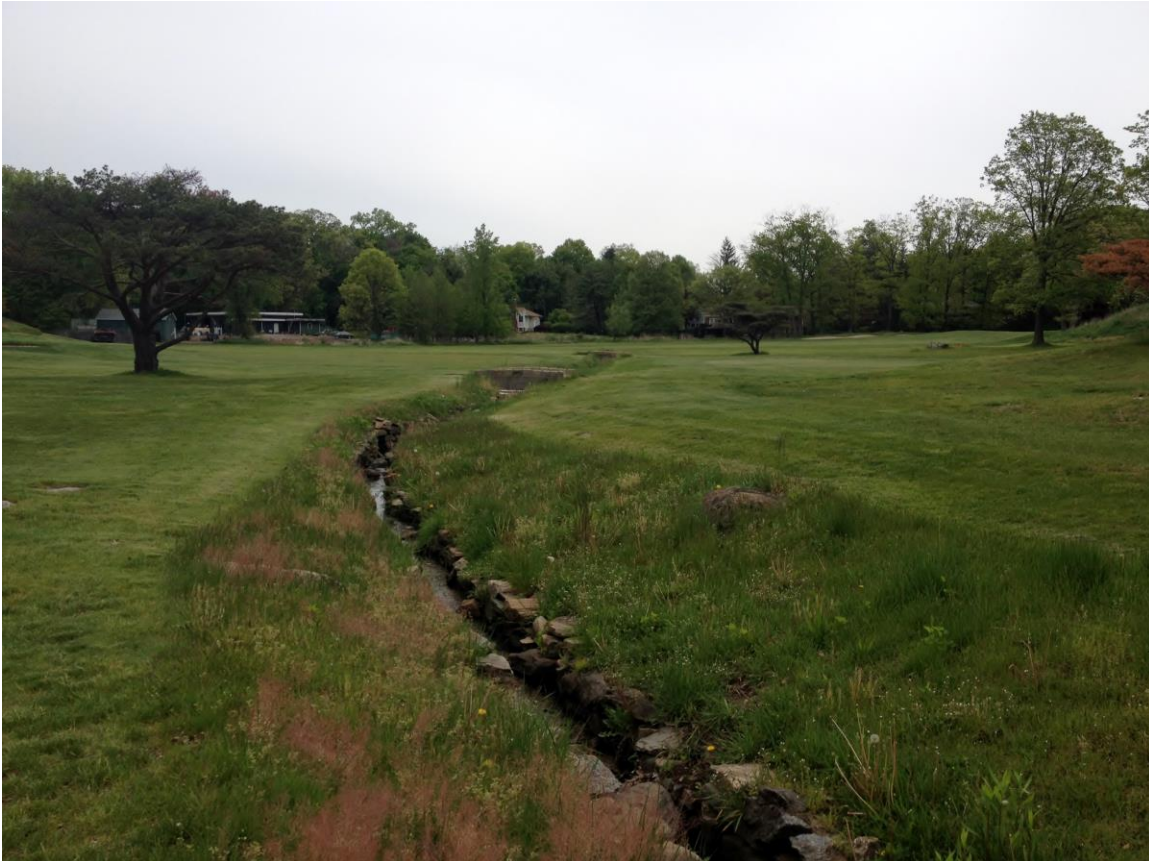
Photograph No. 2: Ditch 1 of Golf Course Drainage System 1 (May 17, 2016).

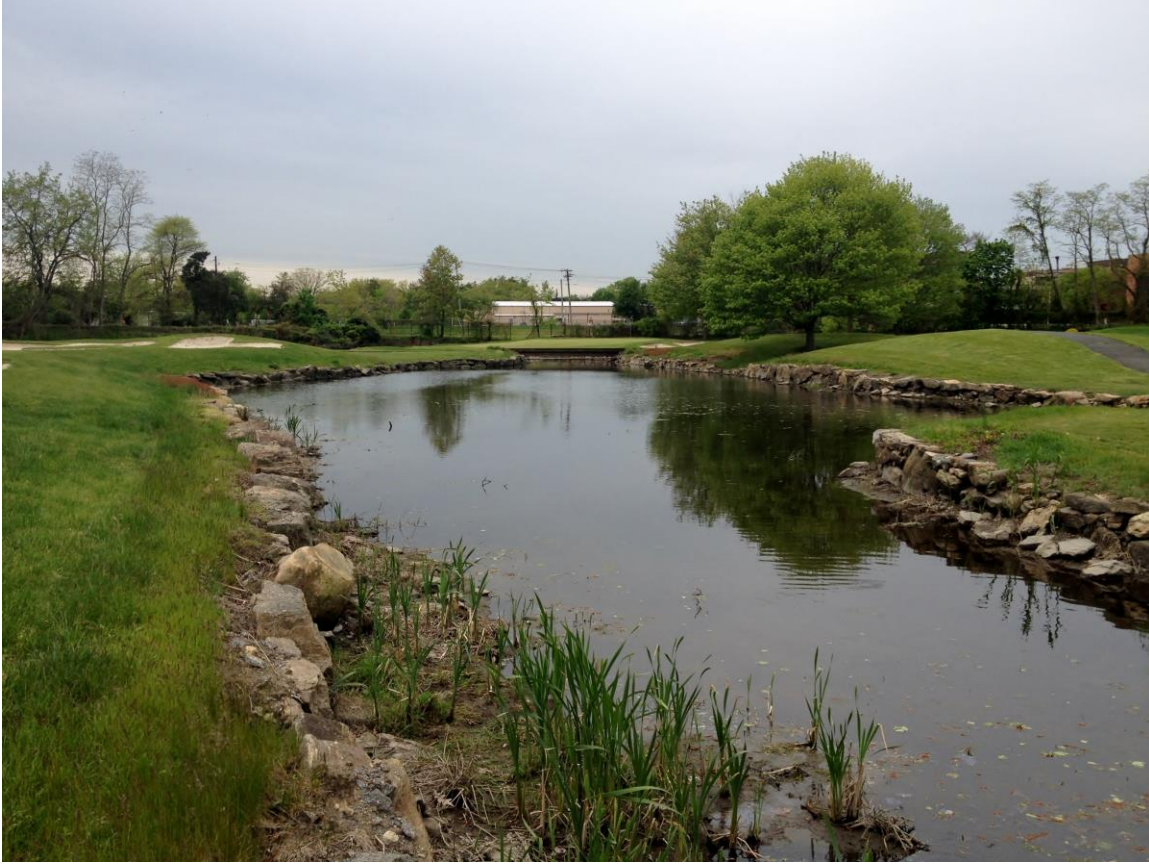
Photograph No. 3: Pond 13 of Golf Course Drainage System 1 (May 17, 2016).

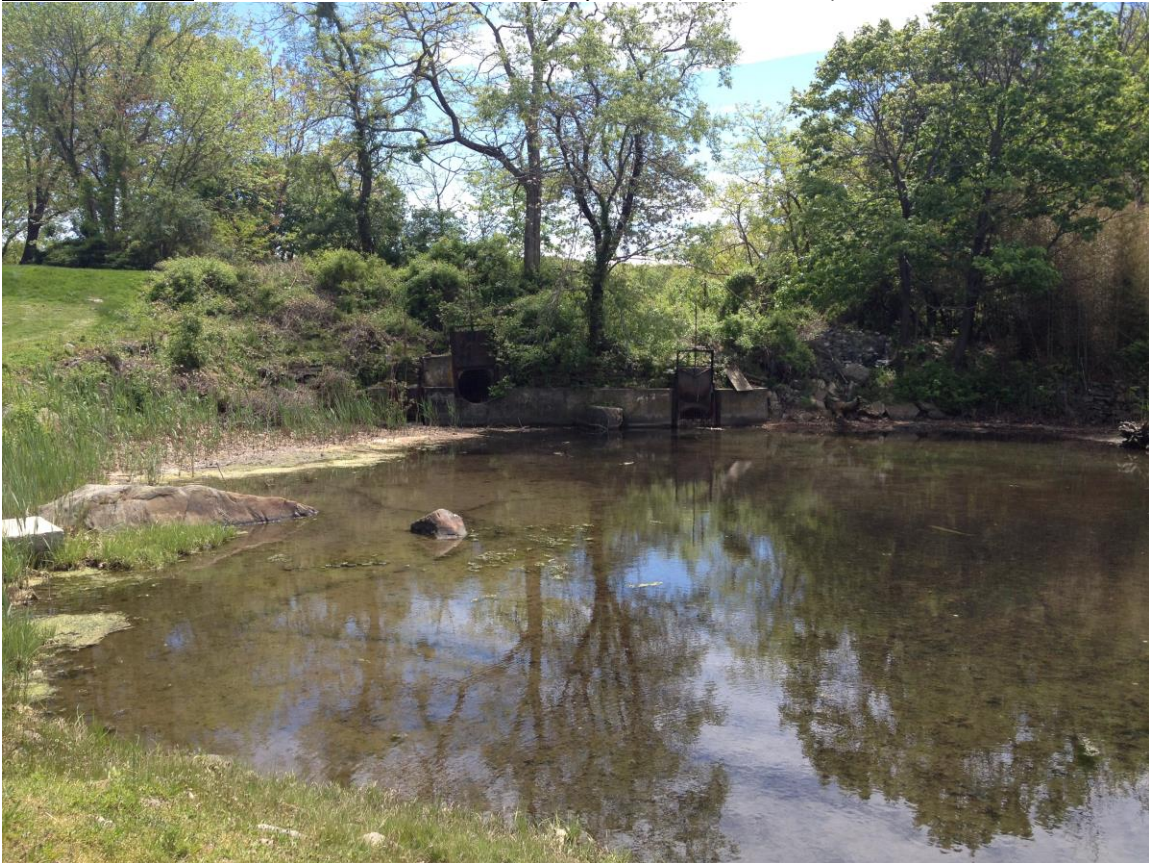
Photograph No. 4: Culverts with gate valves at the western end of Pond13, within Golf Course Drainage System 1 (May 17, 2016).

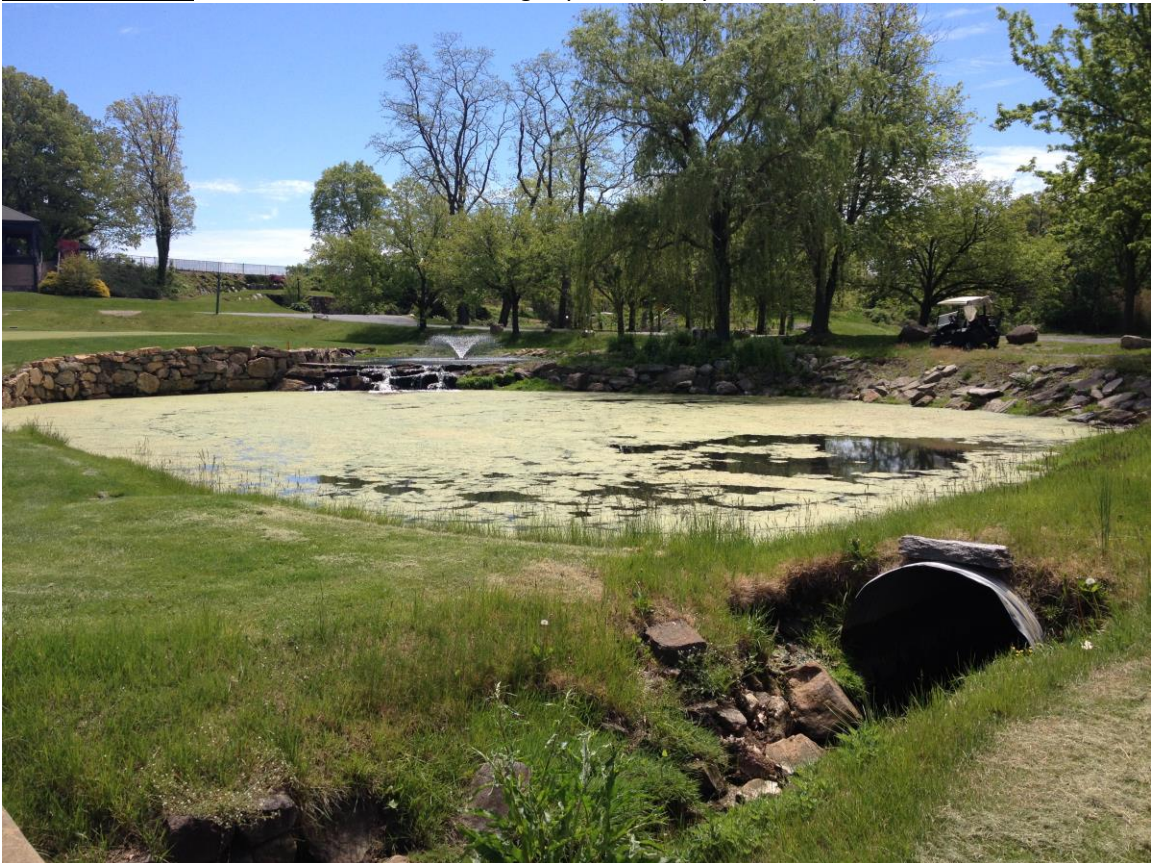
Photograph No. 6: Lower level (foreground) and upper level (background, with fountain) of Pond 18 of Golf Course Drainage System 3 (May 17, 2016).

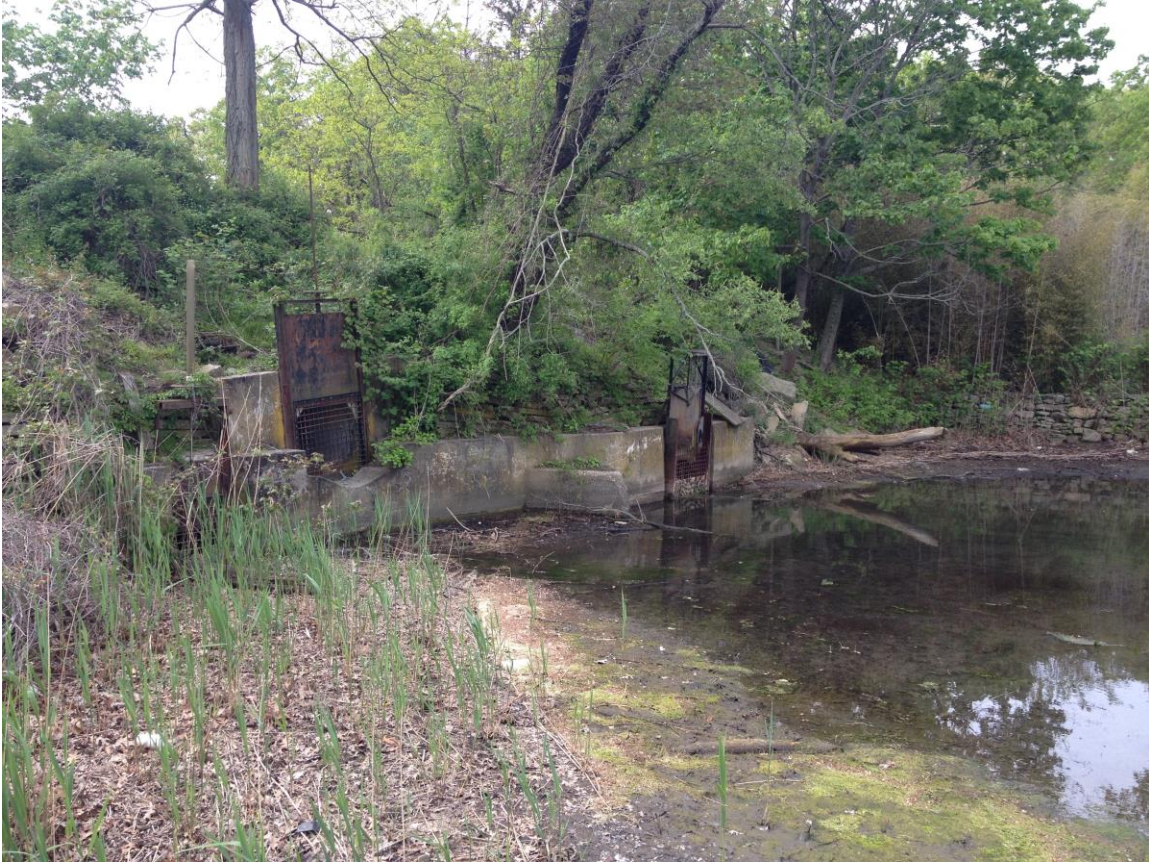
Photograph No. 7: Gate valves at the southeastern end of Pond 10. of Golf Course Drainage System 3 (May 18, 2016).

Beyond Pond 18, Ditch 2 crosses beneath Eagle Knolls Road and empties into Pond 10, located at the southern end of the golf course. Pond 10 is reportedly a natural feature that has been modified in association with the golf course. The pond is a shallow and largely unvegetated feature that appears to receive intermittent tidal water via three culvert outlets equipped with manually-operated gate valves. The culverts are set at different elevations within a concrete headwall located at the southeastern end of the pond. The gate valves were all observed to be in the open position at the time of the wetland assessment. The three culverts are connected to concrete control structures with tide gates set at different elevations within an embankment located along the shoreline of Delancey Cove. The control structures and tide gates appear to have been designed to allow for drainage from Pond 10 to Delancey Cove to occur during storm events, while preventing tidal waters from entering Pond 10. However, at the time of the wetland assessment, water was observed discharging to Pond 10 through two of the three culverts, and evidence of tidal wetland flora was observed within portions of the pond.

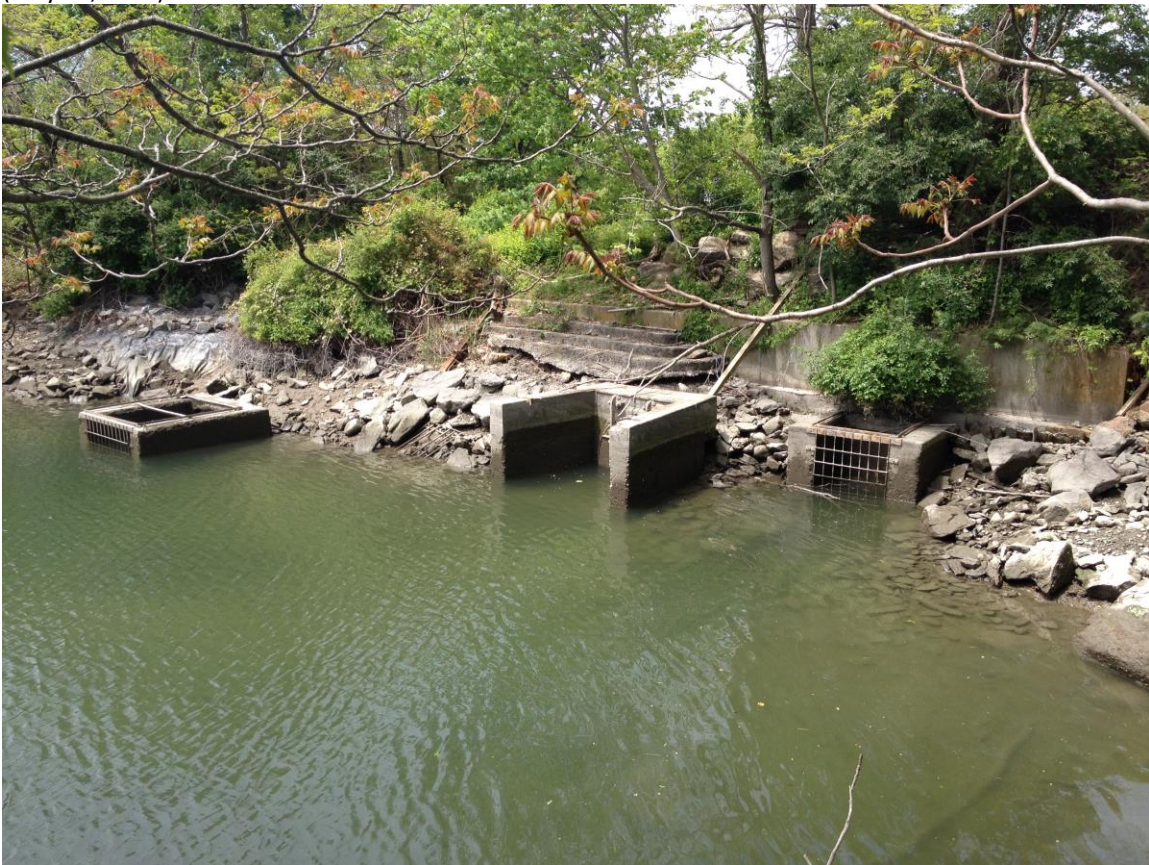
Photograph No. 8: Concrete control structures located along the shoreline of Delancey Cove. The control structures allow intermittent tidal flow to Golf Course Drainage System 3 (May 18, 2016).

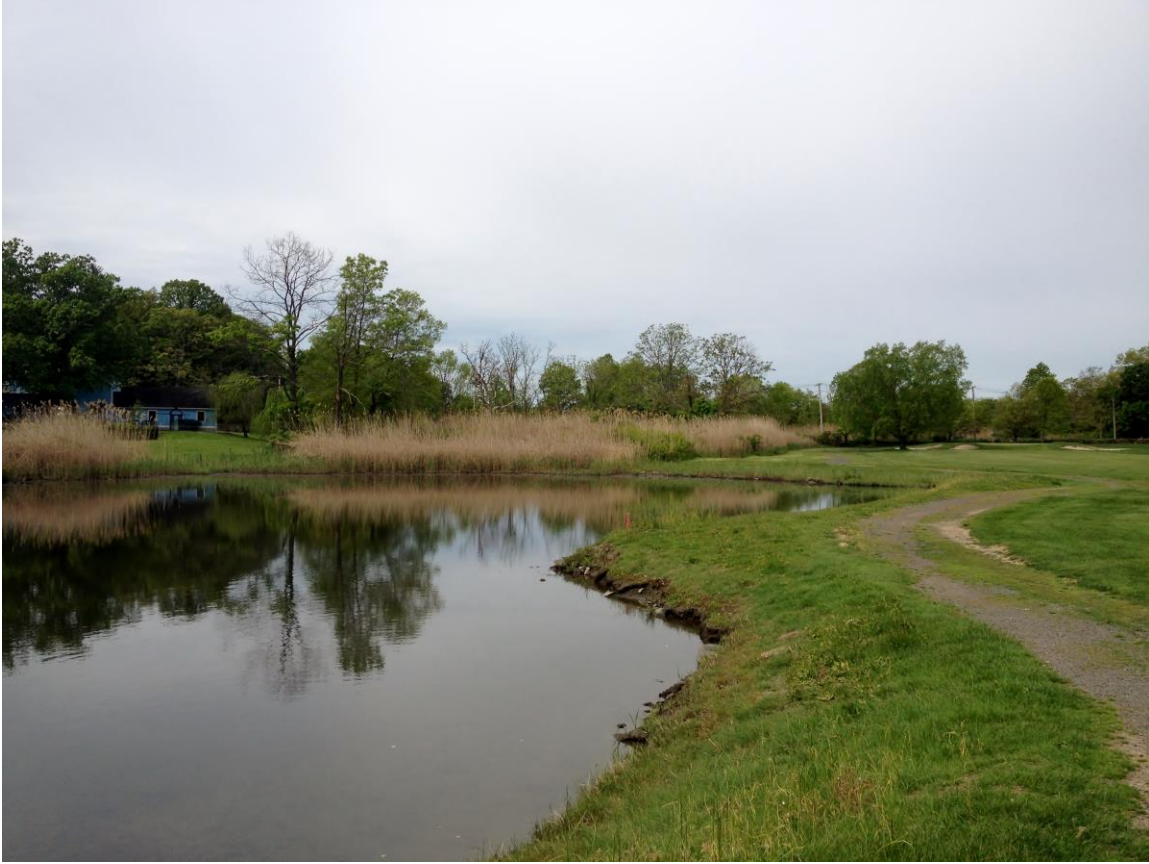
Photograph No. 9: Pond 10 (foreground) and contiguous vegetated wetland (background) of Golf Course Drainage System 3 (May 18, 2016).

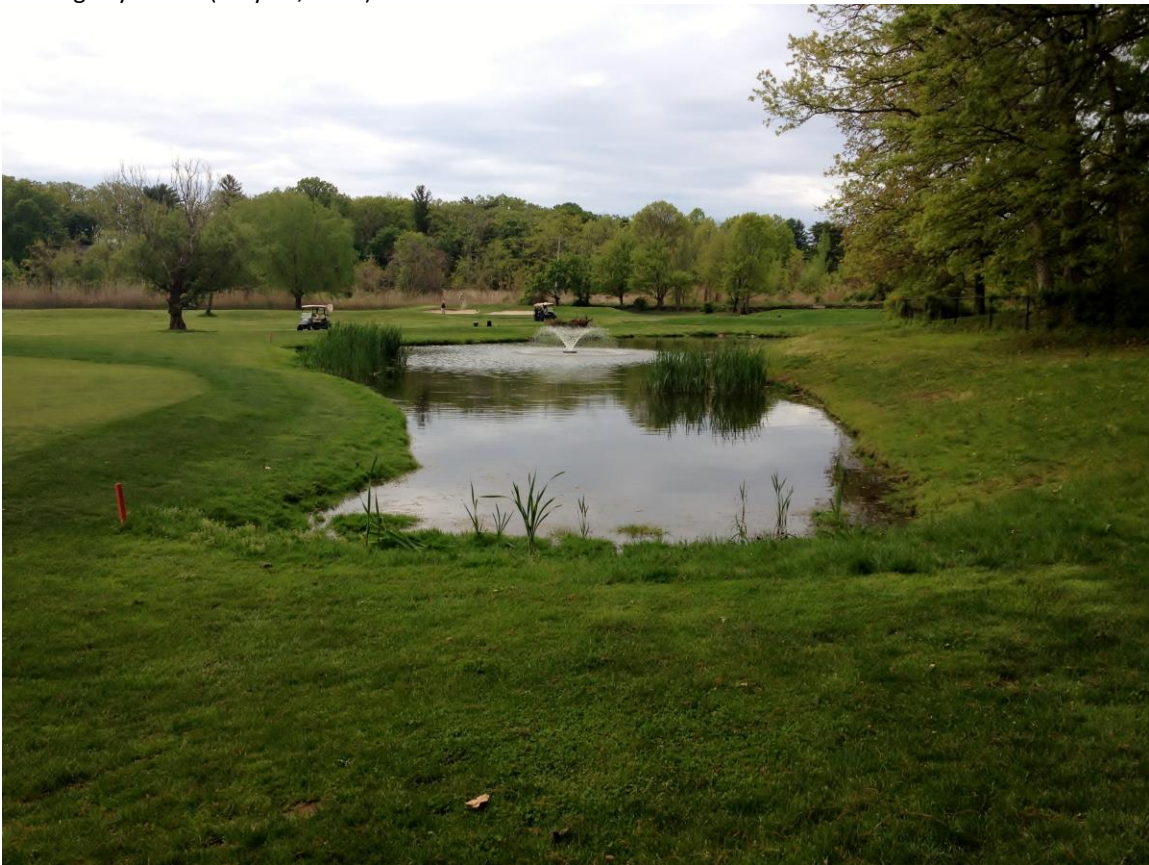
Photograph No. 10: Pond 11 of Golf Course Drainage System 3 (May 18, 2016).

the golf course. Scattered emergent vegetation, submergent vegetation, algal growth and organic matter were observed within the Pond 11 at the time of the wetland assessment.

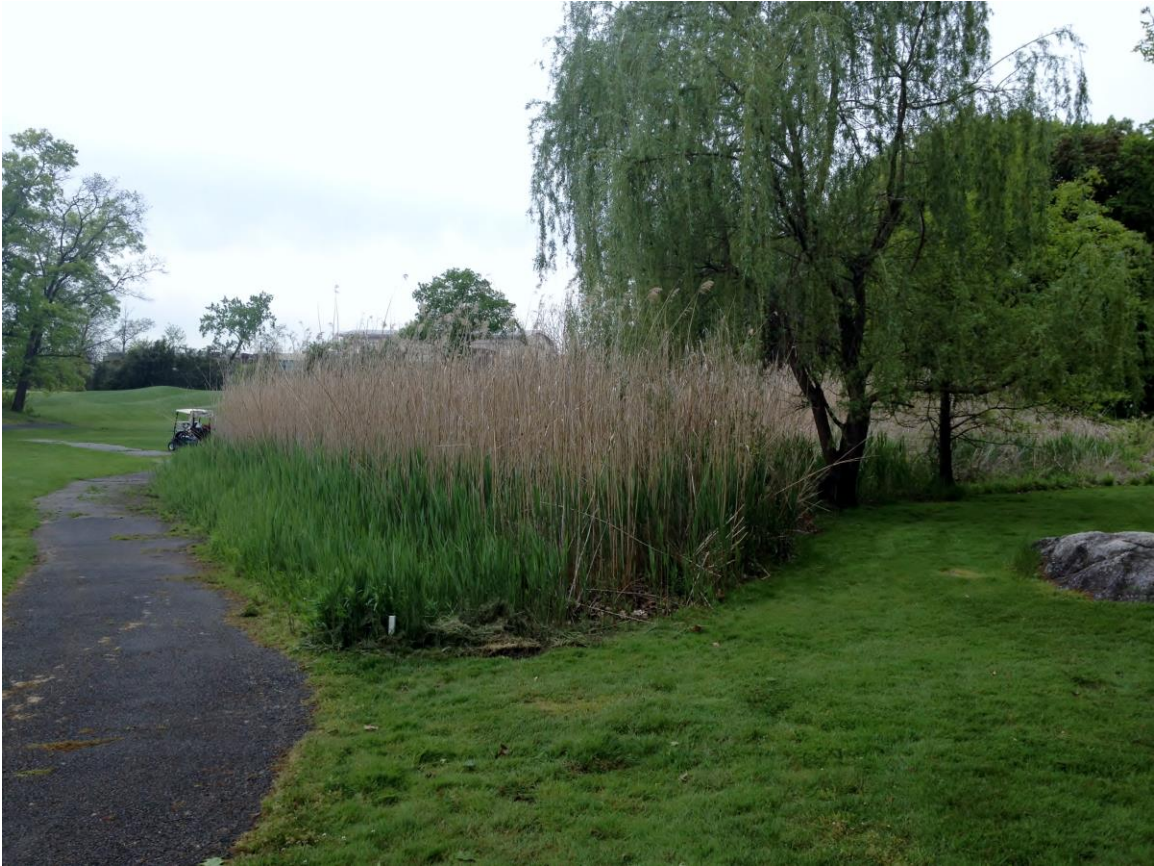
Photograph No. 11: Isolated Wetland A (May 17, 2016).

Isolated Wetland A is a common reed-dominated emergent marsh located along the northwestern property boundary with the adjacent residential development. Unlike the three golf course drainage systems, Isolated Wetland A was not constructed or altered for stormwater purposes, although the feature appears to receive overland flow from higher topography within the immediate surrounding area. No surface water was observed within the feature at the time of the wetland functional assessment, however saturated soils were observed several inches below the surface. Evidence of historic clearing was observed along the border of the wetland with the adjacent residential properties.

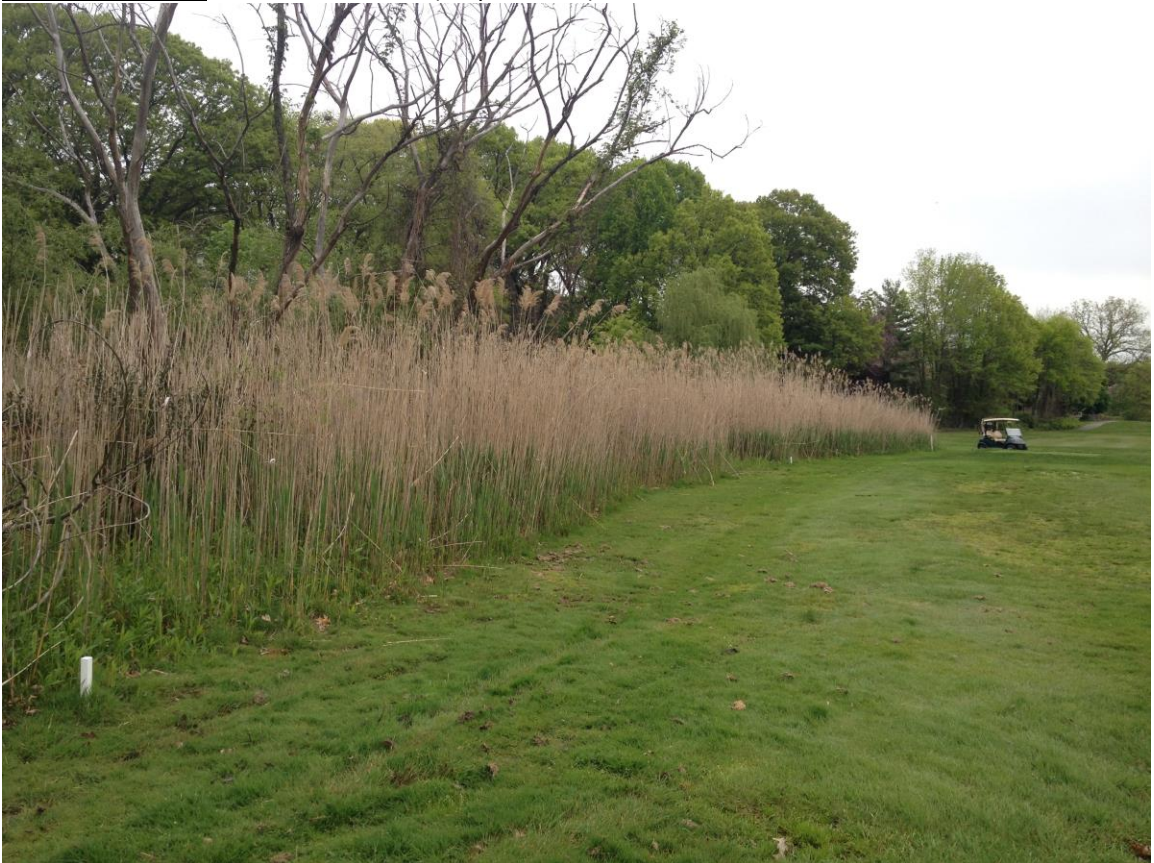
Photograph No. 12: Emergent wetland vegetation along the boundary of Isolated Wetland A (May 17, 2016).

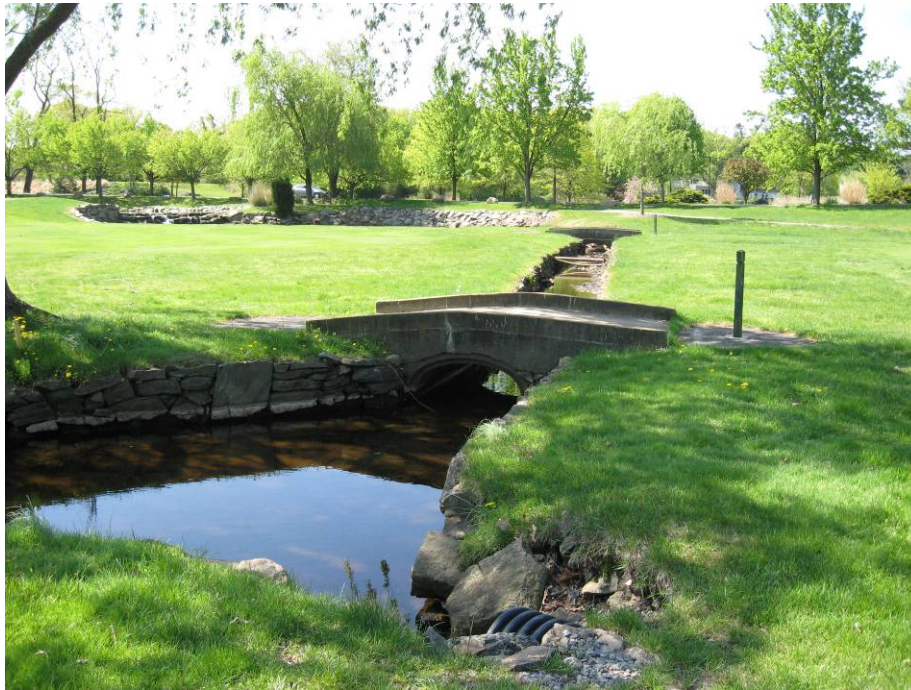
Rock-lined stream

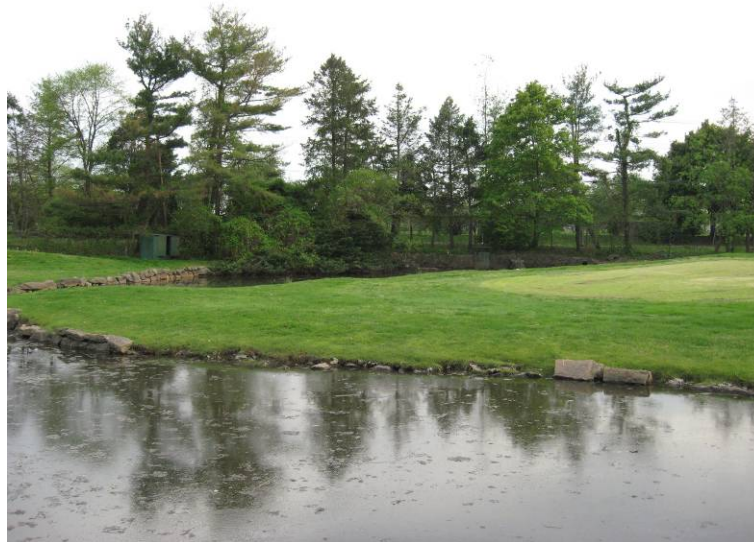
Review of historic aerials suggest that Pond #13 was a naturally occurring system that was modified and expanded between 1960 and 1976. Pond #13's connection to the athletic field on the west side of Hommocks Road is apparent as a pipe beneath Hommocks Road was visible at the western edge of this pond.

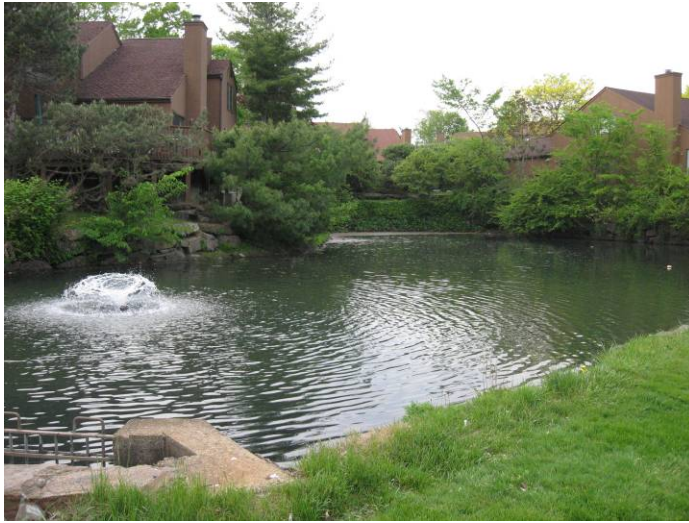
Fairway Green Townhouses pond (Pond #16).

The connection between Pond #13 and Pond #16 was evident also during field inspections. Underground piping and culverts from the Pond #16 were found to be contiguous with the stream which enters Pond #13. Pond #16 was reportedly built in 1982 for use by both the townhomes to the north and the golf course. This pond has notable silt and organic sediment build-up. An illicit discharge from a commercial use located to the north was previously detected and was

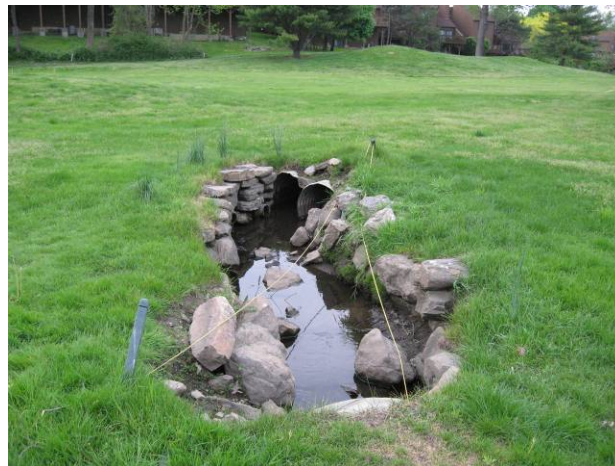
The southern pond, identified on the survey as “Prickly Pear Inlet,” or Pond #10 has a concrete control structure which separates it from the tidal wetlands of Delancey Cove immediately south of the property. The control structure contains two pipes which are set at different elevations so that one is partially submerged during low tides, while the other is raised higher though still within the range of tidal influence. On the landward side of this control structure, the lower pipe appeared to be closed, but the higher elevation pipe is currently in the open position. This pond is also a naturally occurring feature that has been modified over time.

On the seaward side, this higher elevation pipe also appears to potentially be partially open and may allow some restricted connection of tidal flow. Though primarily freshwater, Prickly Pear Inlet does appear to have some evidence of saltwater influence based upon macroalgae characteristics observed in the lower portion of the inlet stream to the pond and trace evidence of what appeared to be former salt marsh vegetation (currently dead) along the inner fringe of the pond near the control structure.

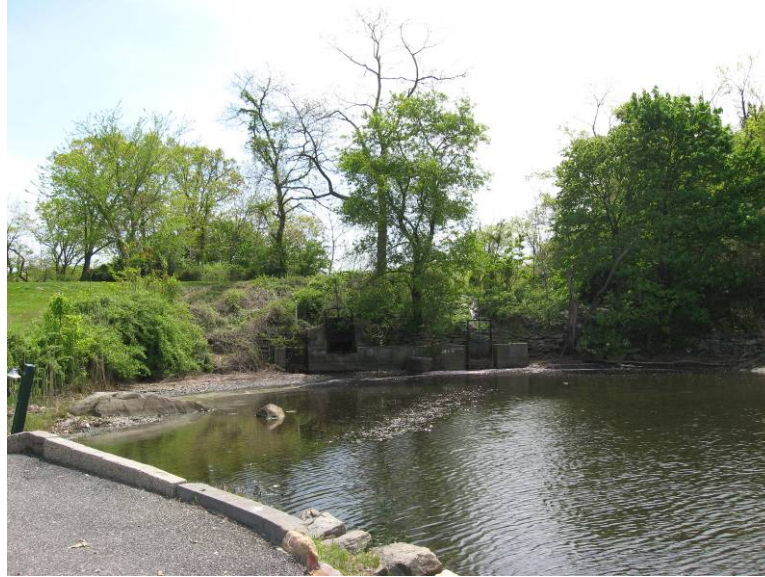
Pond #10 control structure

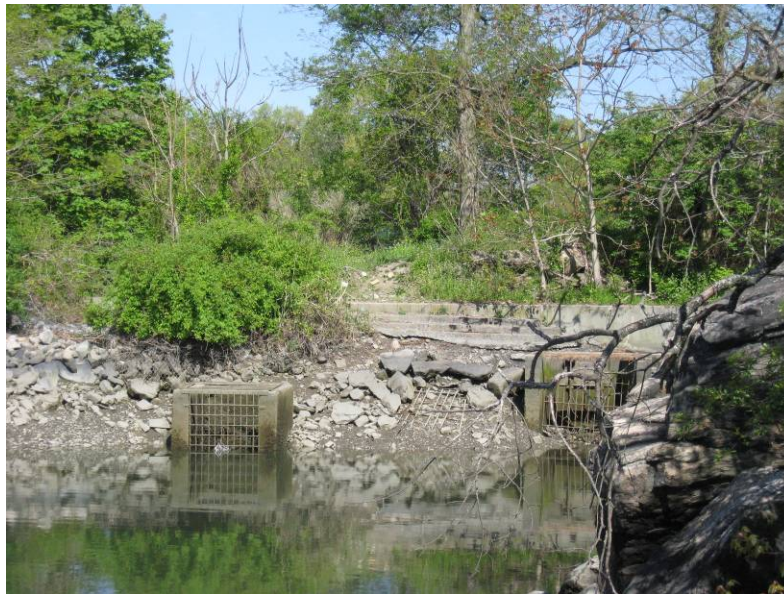
Cove side of control structure

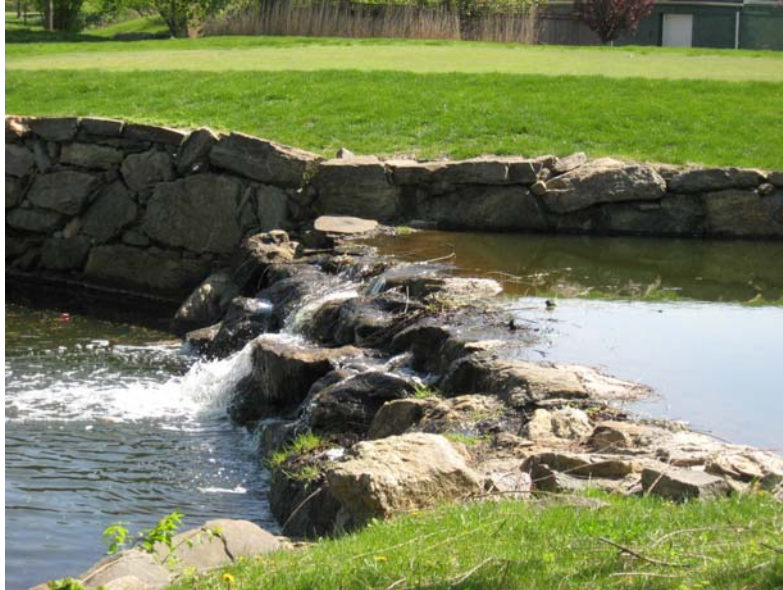
Pond #18 located to the northwest of the existing clubhouse (individually referred to as “Upper Pond” and “Lower Pond”) are the water features in closest proximity to the clubhouse. Lower Pond was constructed in 1998 and is not lined. Upper Pond was added in 2005 with a waterfall feature that spills to Lower Pond and is also unlined. The maximum depth encountered in each pond is approximately 6 feet. Water levels within

View of the waterfall structure on Pond 18

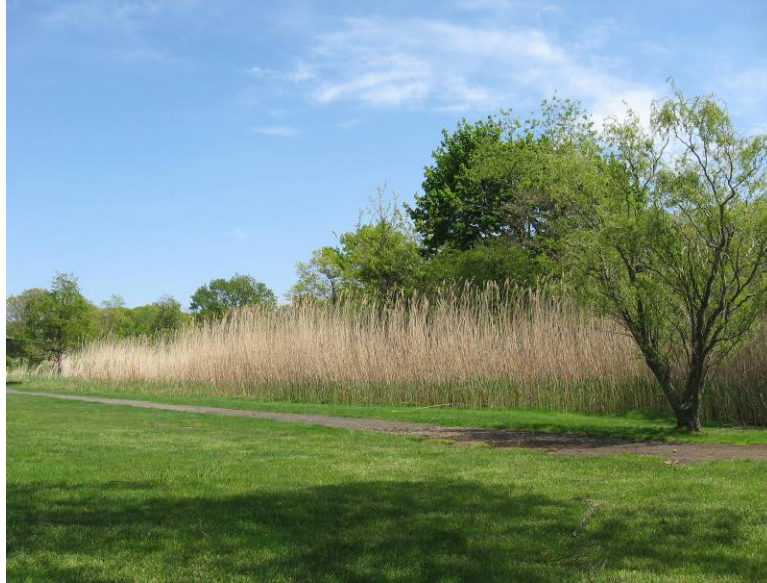
Adjacent to the west of Prickly Pear Inlet, an additional wetlands area was identified and field located with a hand-held Geographic Positioning System (GPS). This area is best characterized as an emergent marsh dominated by the invasive strain of common reed (*Phragmites australis*), a common wetland plant. The wetland area exhibited varying degrees of saturated soils and standing water, organic hydric soils and hydrophytic vegetation contiguous with the adjacent pond. Several specimens of bastard oak (*Quercus sinuata*), which is a southern tree characteristic of moist habitats, were also observed growing upon the drier hummocks within this marsh area.

Southern vegetated marsh

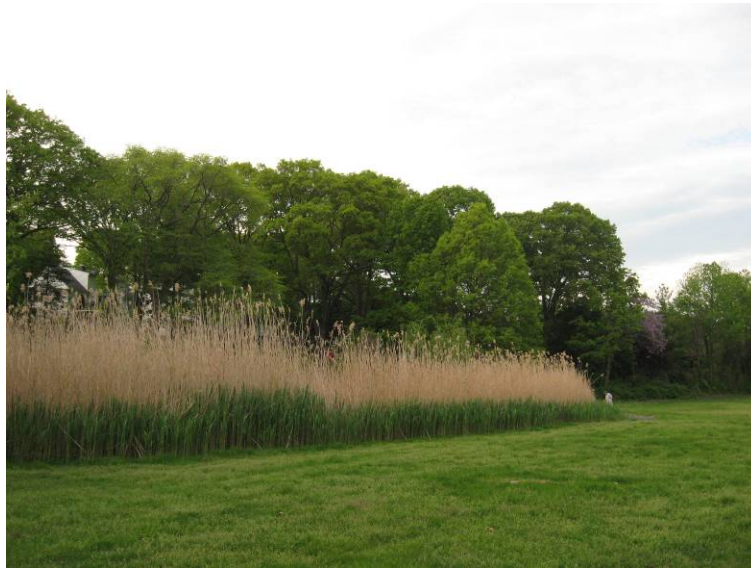
The vegetated wetland area in the northwestern corner of the site is also an emergent marsh dominated by *Phragmites australis* as well as jewelweed (*Impatiens capensis*), another hydrophytic species. This marsh also contained black willow (*Salix nigra*) and pussy willow (*Salix discolor*), both of which are characteristic of wetland conditions.

Northern vegetated marsh

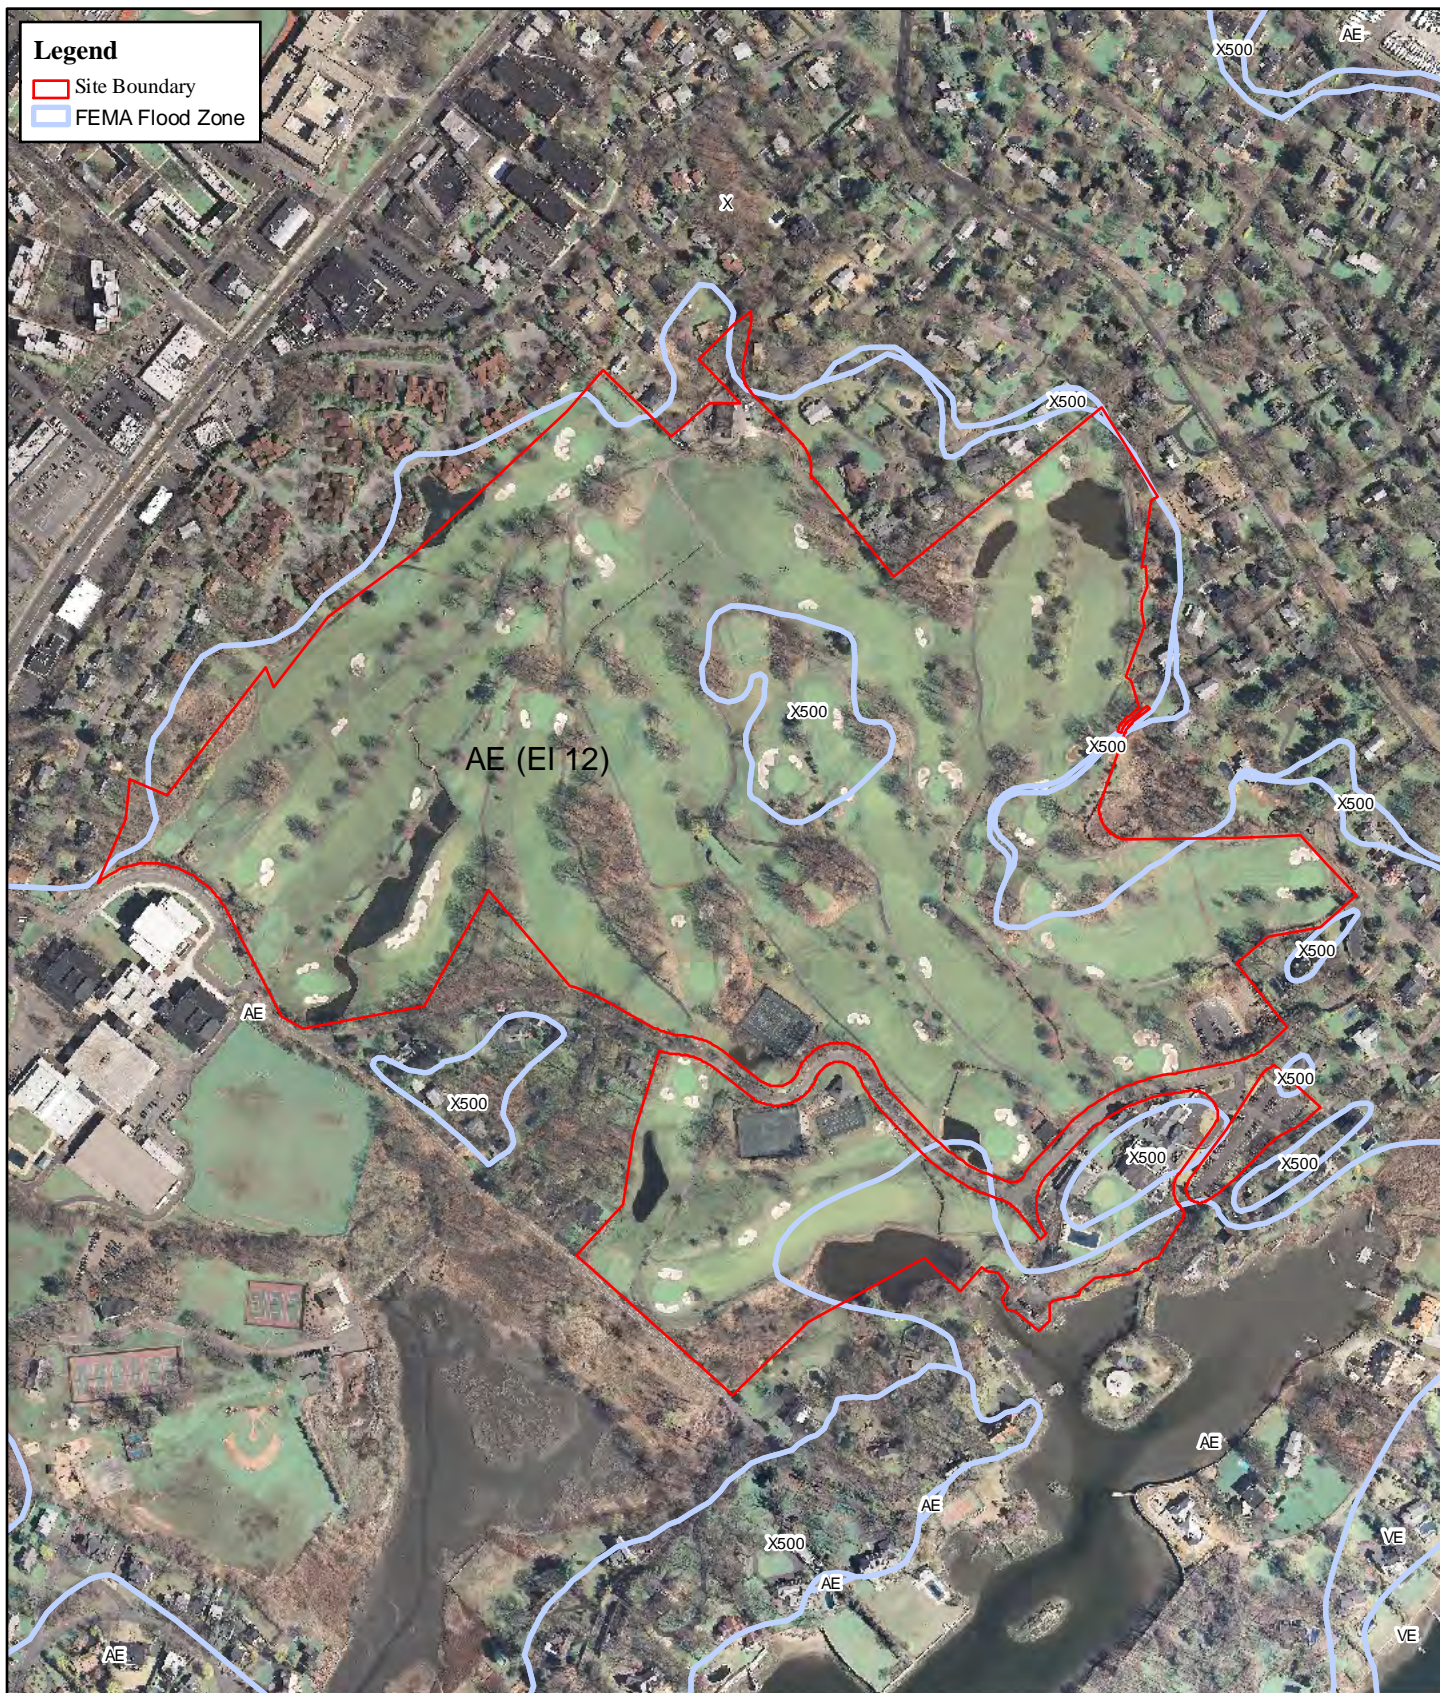
**FIGURE 2
FEMA FLOOD MAP**

Source: NYSGIS Orthophotoimagery Program, 2007
NPV GIS Library;
Scale: 1 inch = 500 feet

As per FEMA, the property is located within a designated flood zone, Flood Zone AE (EL 12) (see **Figure 2**). Pursuant to NYS Building Code, this special flood hazard area requires that the bottom of the horizontal structural members (for multi-family structures) be located a minimum of 12 feet above mean sea level; or, for single family dwellings, a minimum freeboard of two feet be provided above the established base flood elevation (EL. 12 for the subject property). Any new structures situated within the Flood Zone would need to be appropriately designed for such conditions.
