Hampshire Country Club Planned Residential Development
Village of Mamaroneck,
Westchester County, New York
Final Environmental Impact Statement

Q Requests for Jurisdictional Determination, NYSDEC and USACE

Re: Request for Tidal Wetlands Boundary Verification and Jurisdictional Determination
Hampshire Country Club
1025 Cove Road
Republic Airport
Village of Mamaroneck
Westchester County, New York

Wetland Delineation Survey

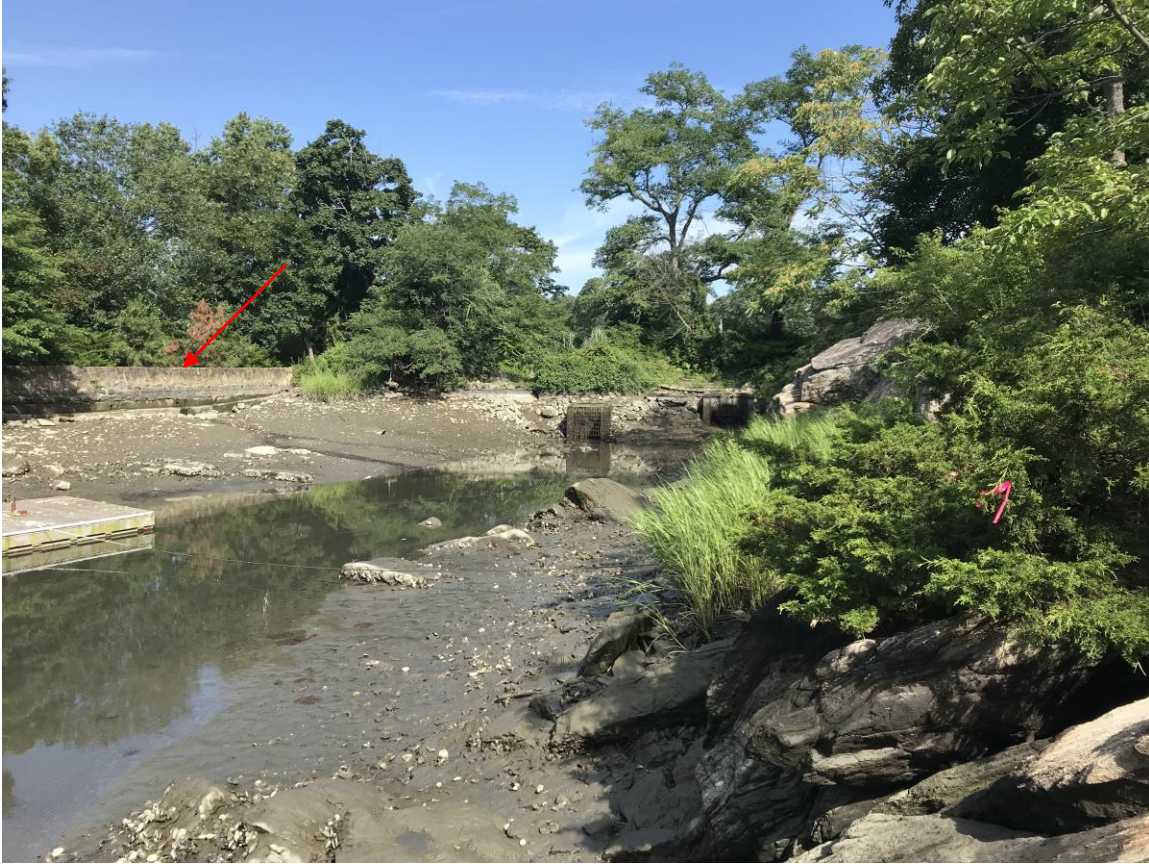
Photograph No. 1: View of stone seawall (as indicated by the arrow) along the Delancey Cove shoreline (July 31, 2018).

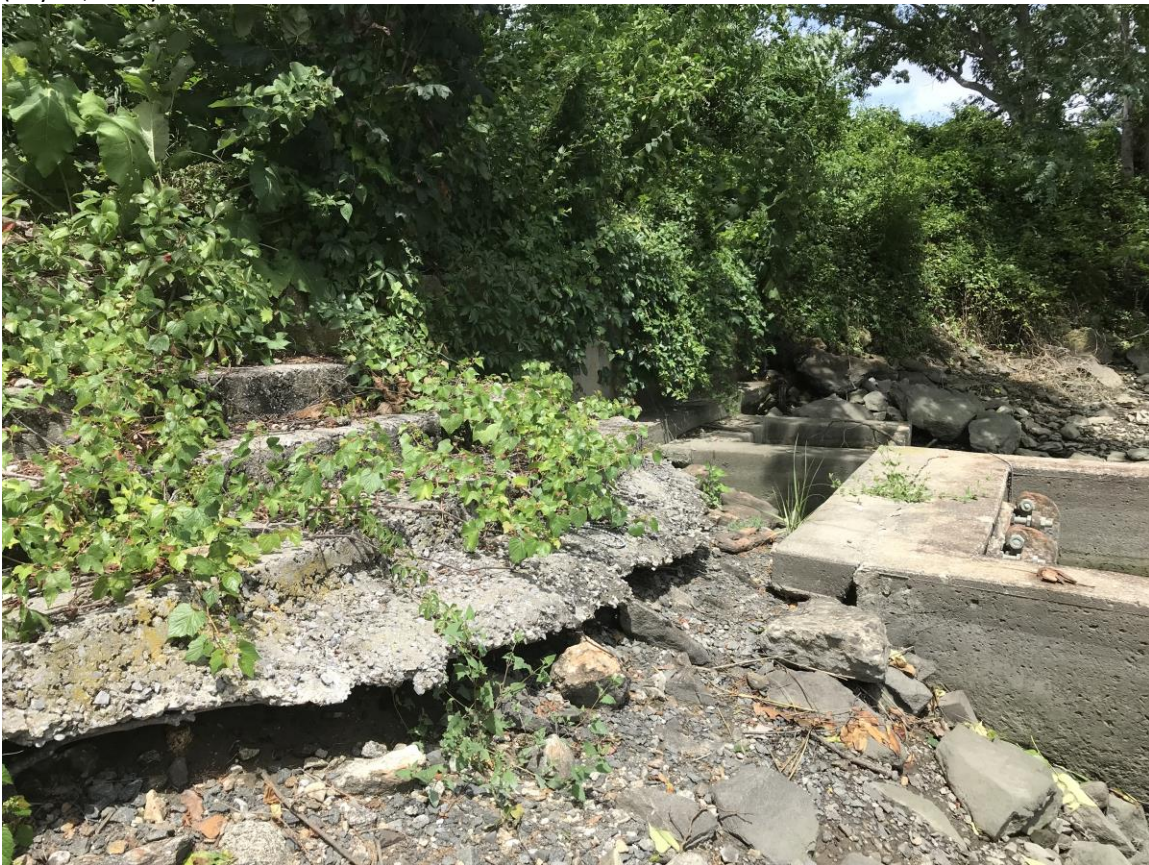
Photograph No. 2: View of concrete retaining wall and tide gate structures along the Delancey Cove shoreline (July 31, 2018).

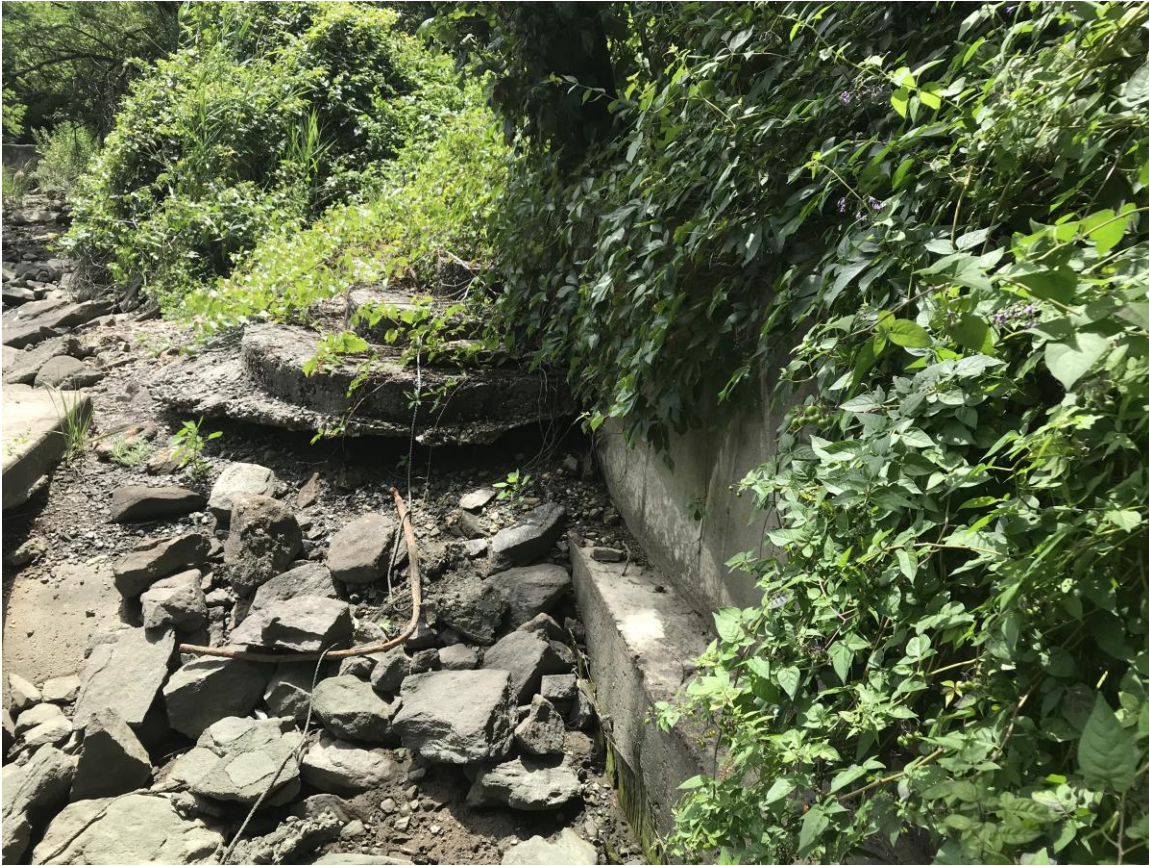
Photograph No. 3: View of concrete retaining wall along the Delancey Cove shoreline (July 31, 2018).

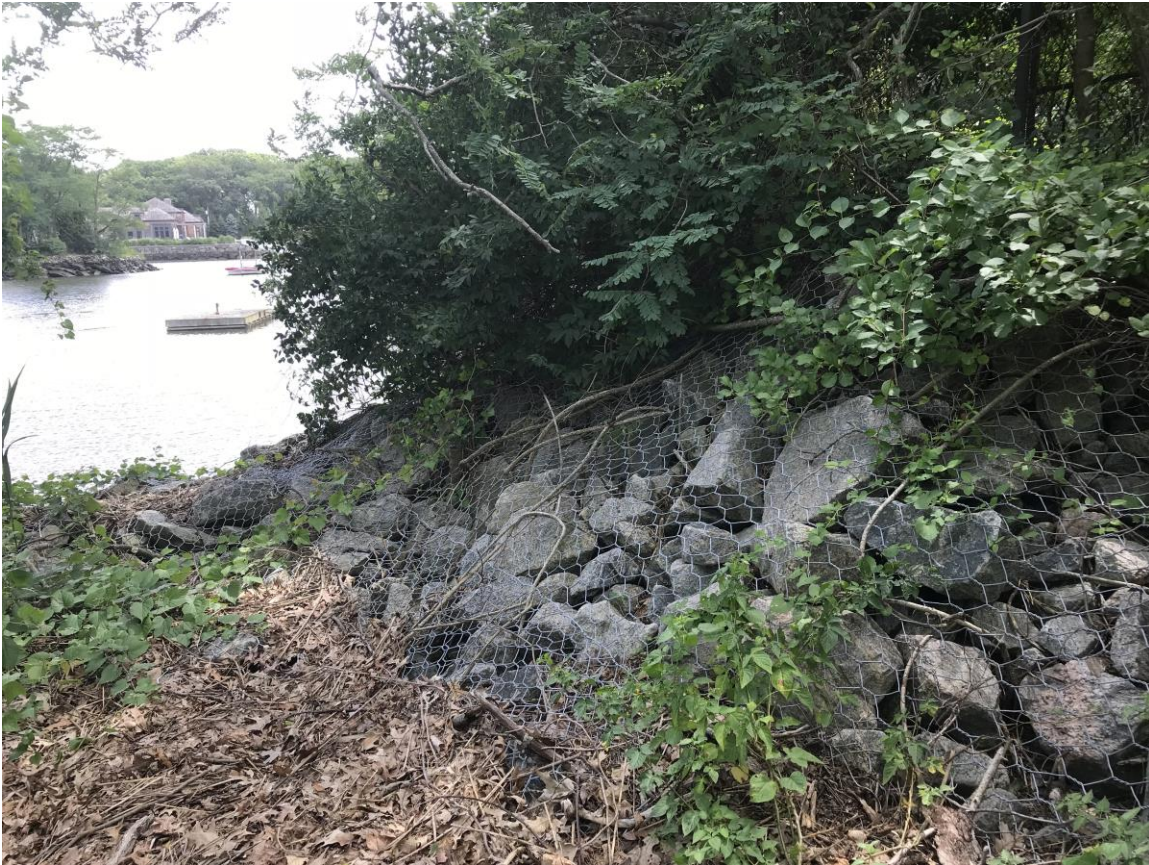
Photograph No. 4: View of rip-rap gabions along the Delancey Cove shoreline (July 31, 2018).

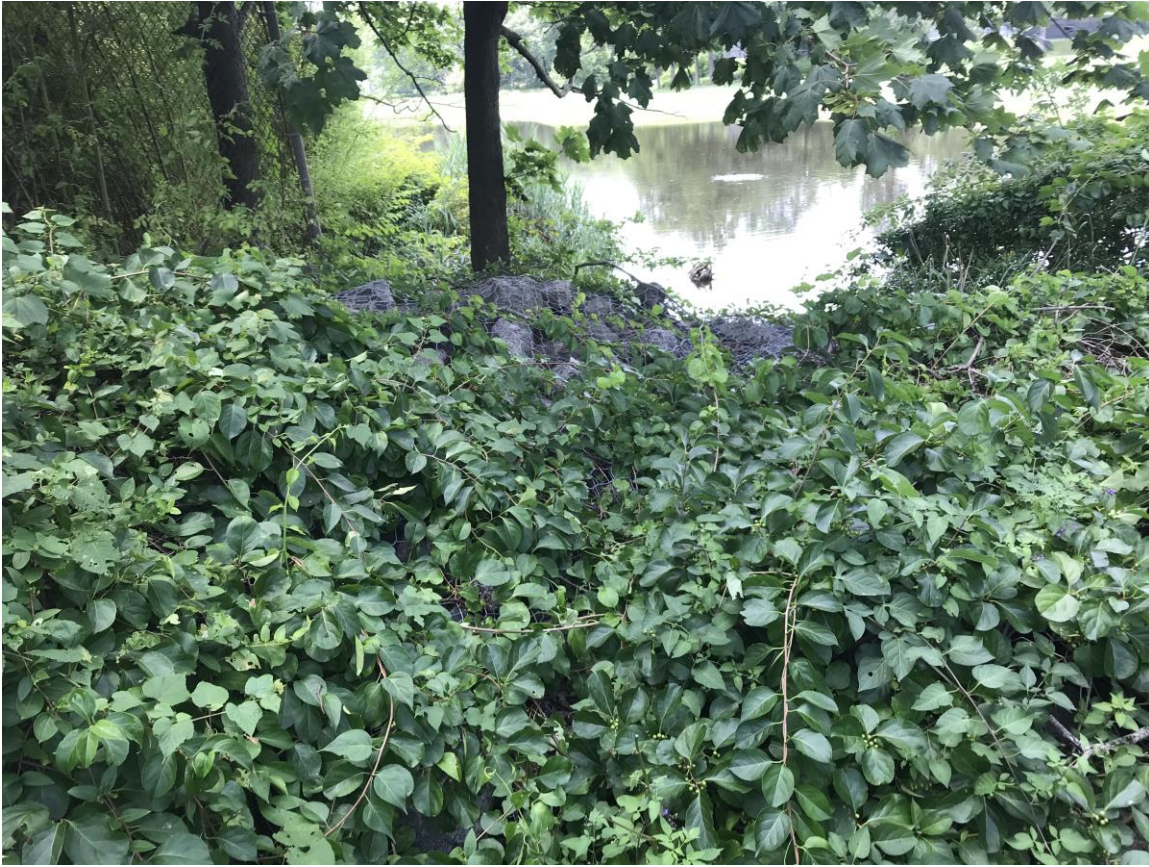
Photograph No. 5: View of rip-rap gabions landward of the shoreline area (July 31, 2018).

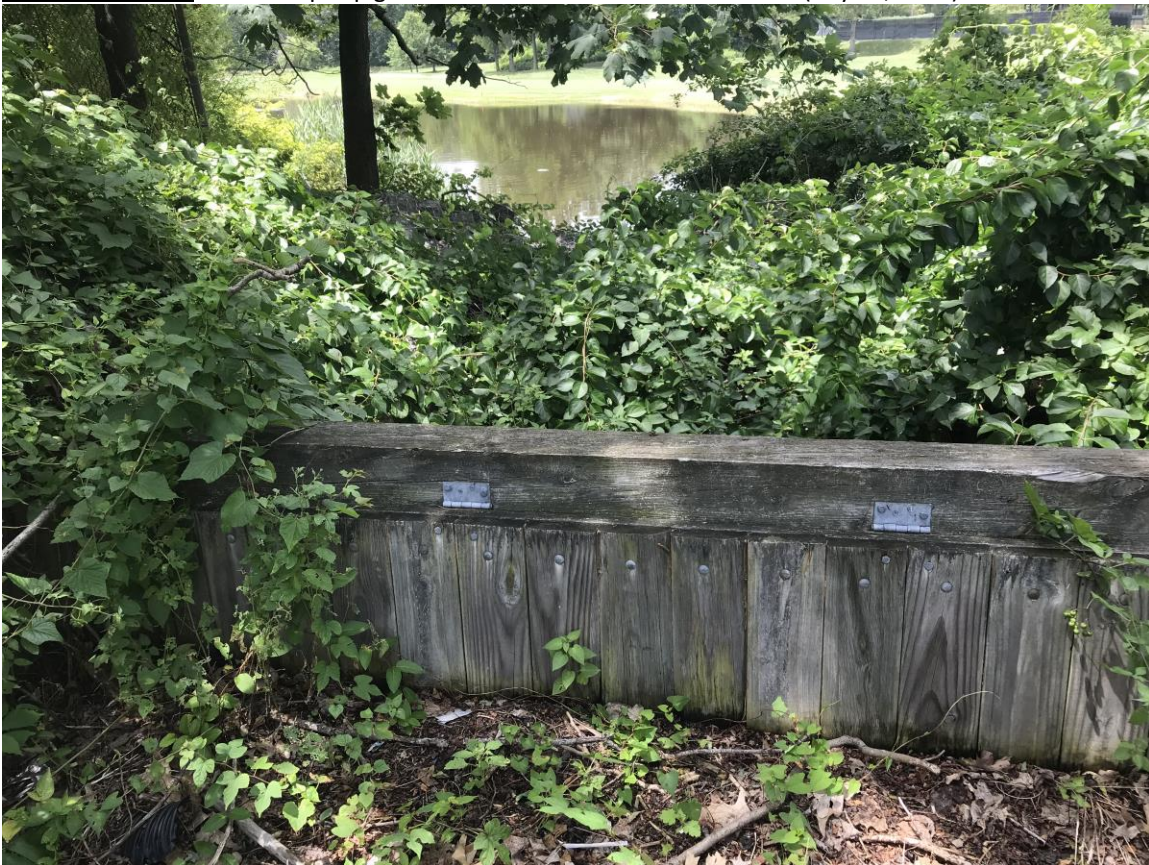
Photograph No. 6: View of timber bulkhead located landward of the shoreline area (July 31, 2018).

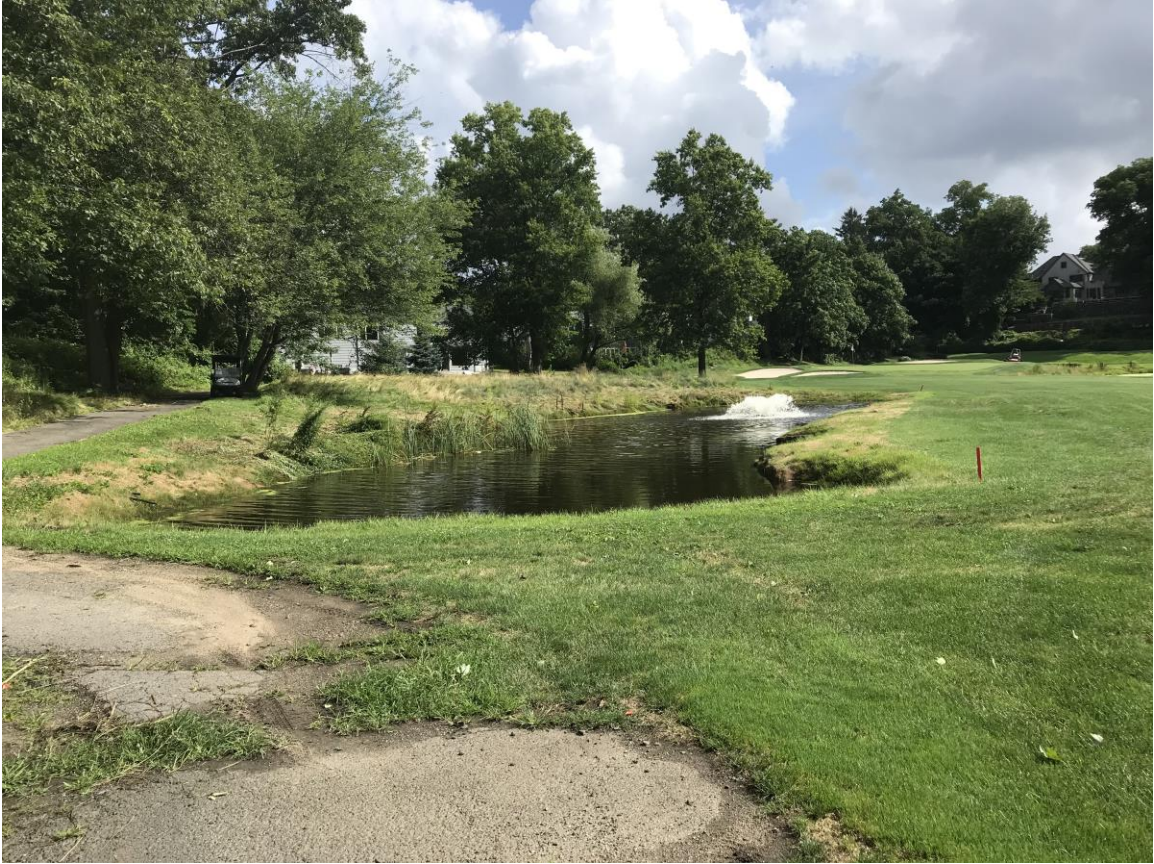
Photograph No. 1: View of Pond 5 (Golf Course Drainage System 2), facing north (July 24, 2018).

The wetland boundaries of the two ponds are well-defined by topographic gradients along the adjacent golf course fairways and greens. Observed wetland vegetation includes duckweed (*Lemna* sp.) on the pond surfaces, as well as narrow-leaved cattail (*Typha angustifolia*), (*Cyperus flavescent*), (*Persicaria amphibia*) and sensitive fern (*Onoclea sensibilis*) along the pond margins. Wetland soils consist of loamy and sandy clays with gravel components that are characterized by hydric soil indicator F3 (Depleted Matrix). Primary and secondary hydrology indicators along the wetland boundary include A2 (High Water Table), A3 (Saturation), B3 (Aquatic Fauna) and D2 (Geomorphic Position).

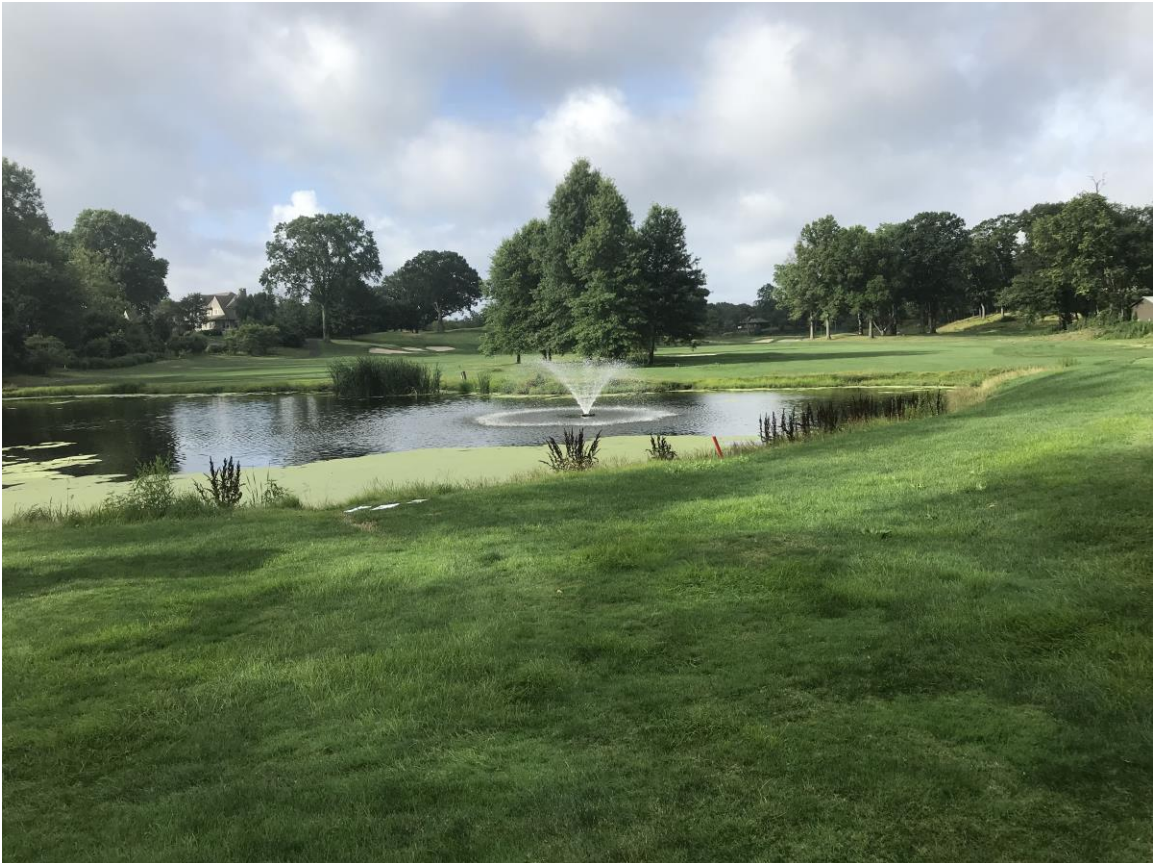
Photograph No. 2: View of Pond 6 (Golf Course Drainage System 2), facing east (July 24, 2018).

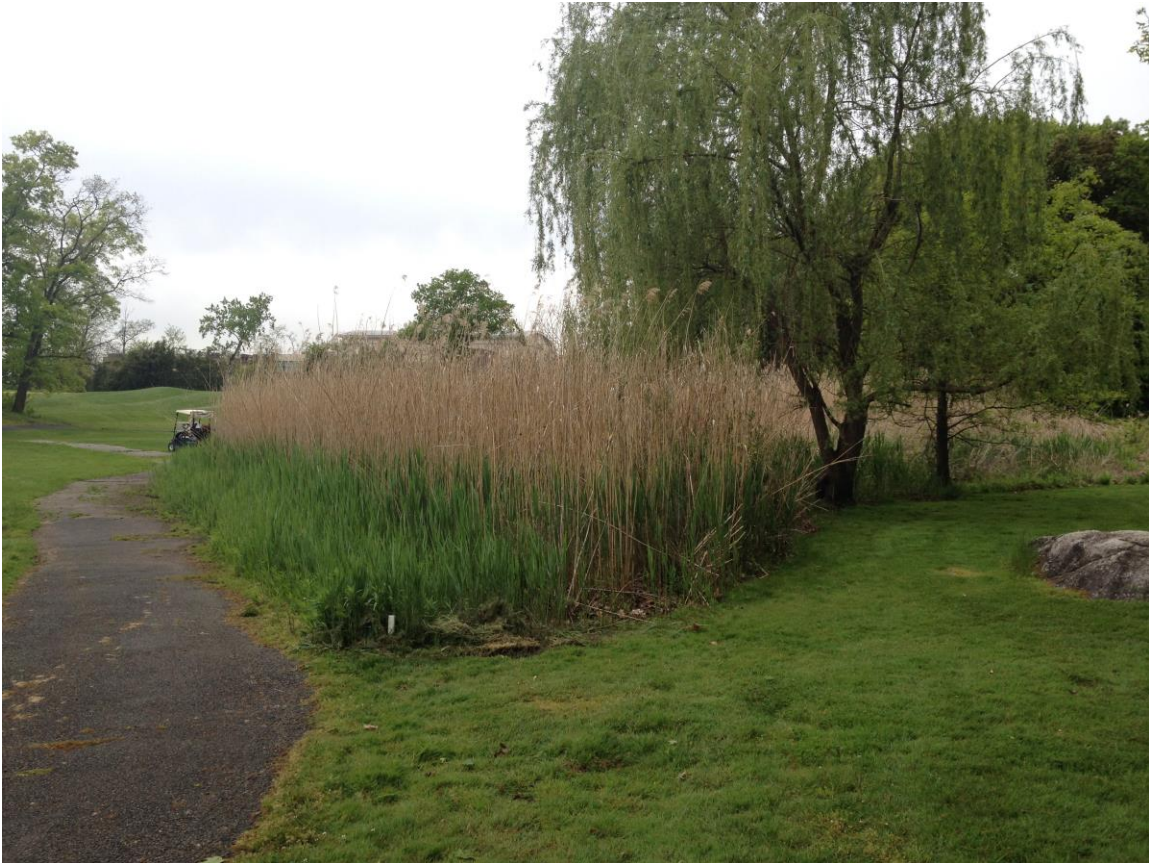
Photograph No. 4: View of Wetland A, facing southwest.

The wetland is dominated by a dense growth of common reed (*Phragmites australis*). Other wetland indicator species include spotted jewelweed (*Impatiens capensis*), false water pepper (*Polygonum hydropiperoides*) and willows (*Salix* spp.) Subsurface conditions are characterized by organic (hemic) soils over a confining clay layer, as characterized by wetland soil indicator A2 (Histic Epipedon). Primary hydrology indicators along the wetland boundary include A2 (High Water Table) and A3 (Saturation).

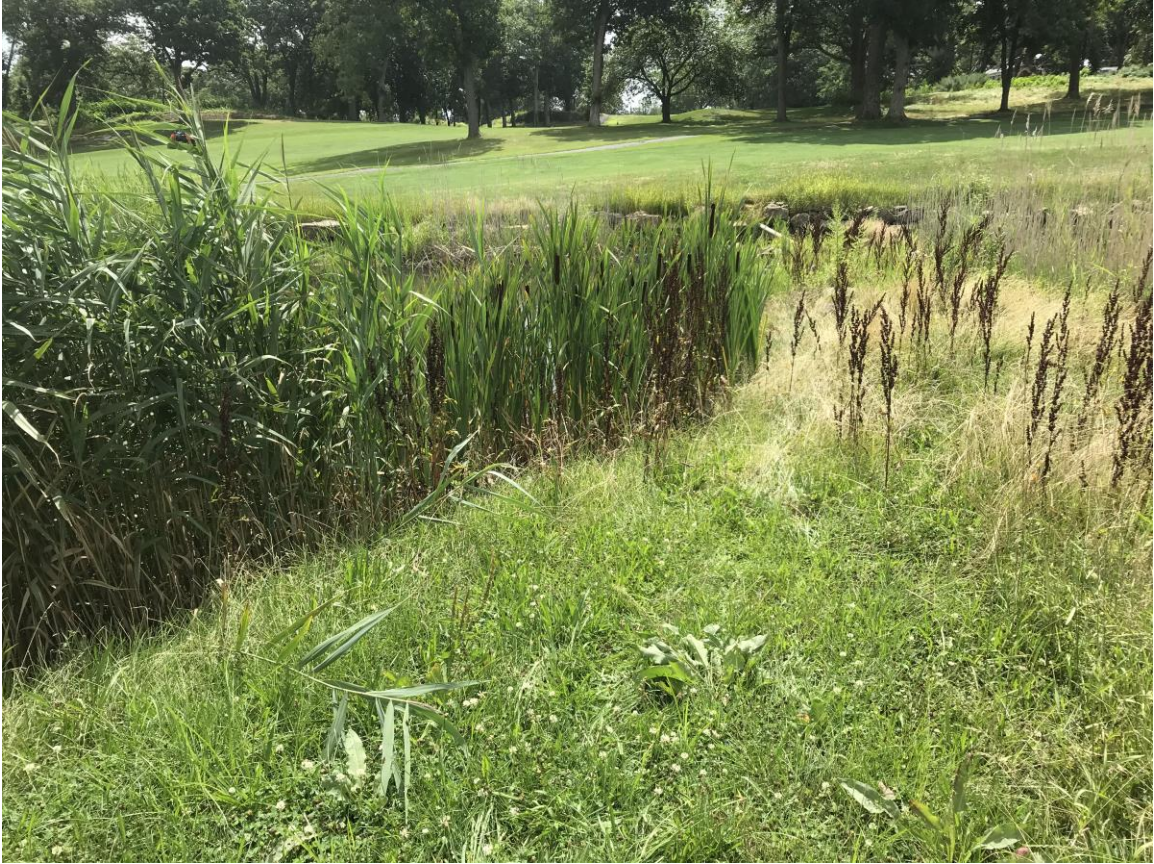
Photograph No. 5: View of wetland and upland data plot locations for Pond 13 (Golf Course Drainage System 1), facing southeast (July 24, 2018).

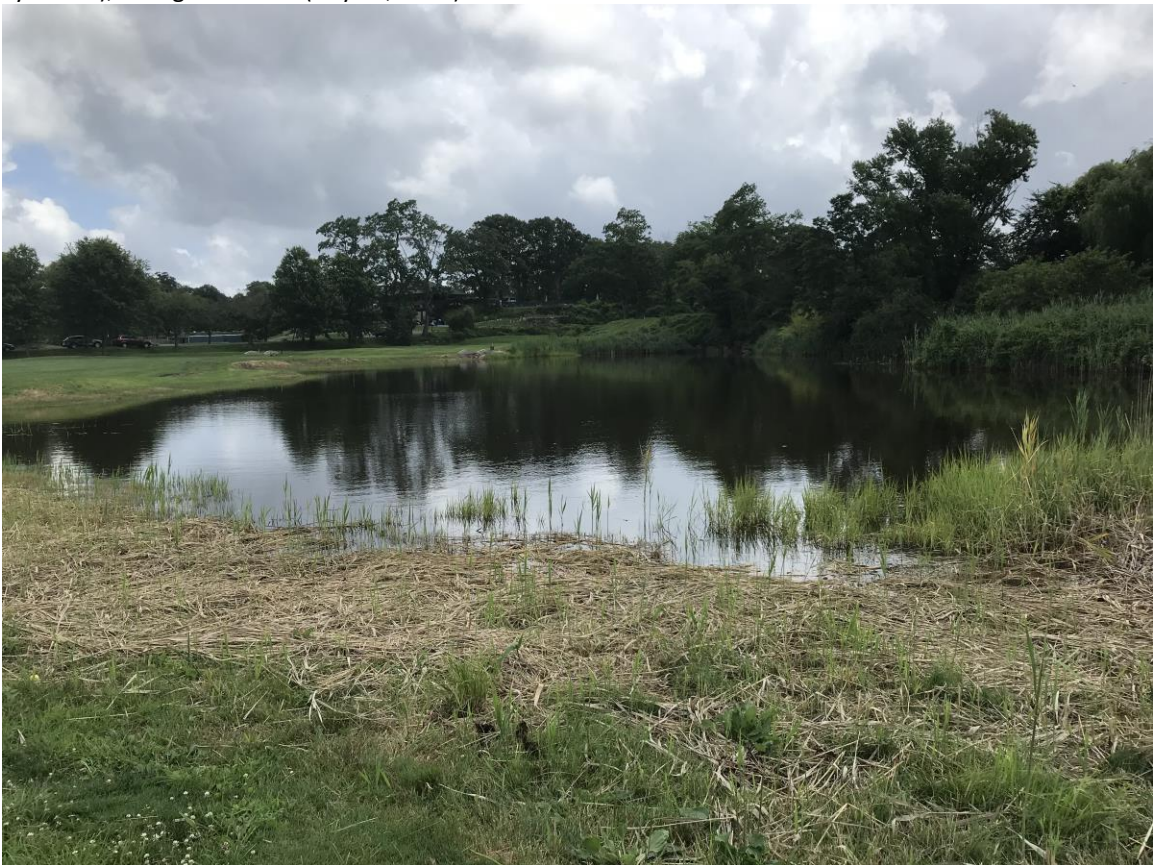
Photograph No. 6: View of wetland data plot location for Pond 10 (Golf Course Drainage System 3), facing east (July 24, 2018).

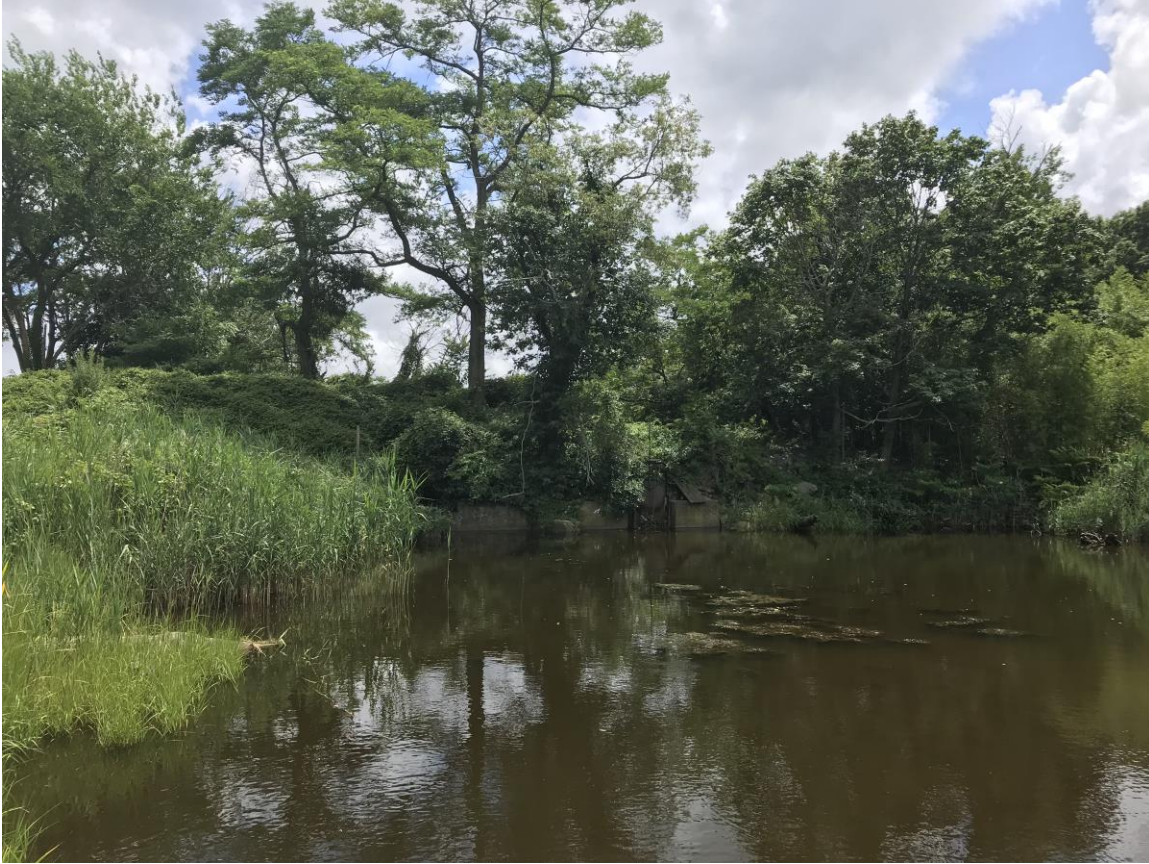
Photograph No. 6: View of tide gate openings at the eastern terminus of Pond 10 (Golf Course Drainage System 3), facing southeast (July 24, 2018).

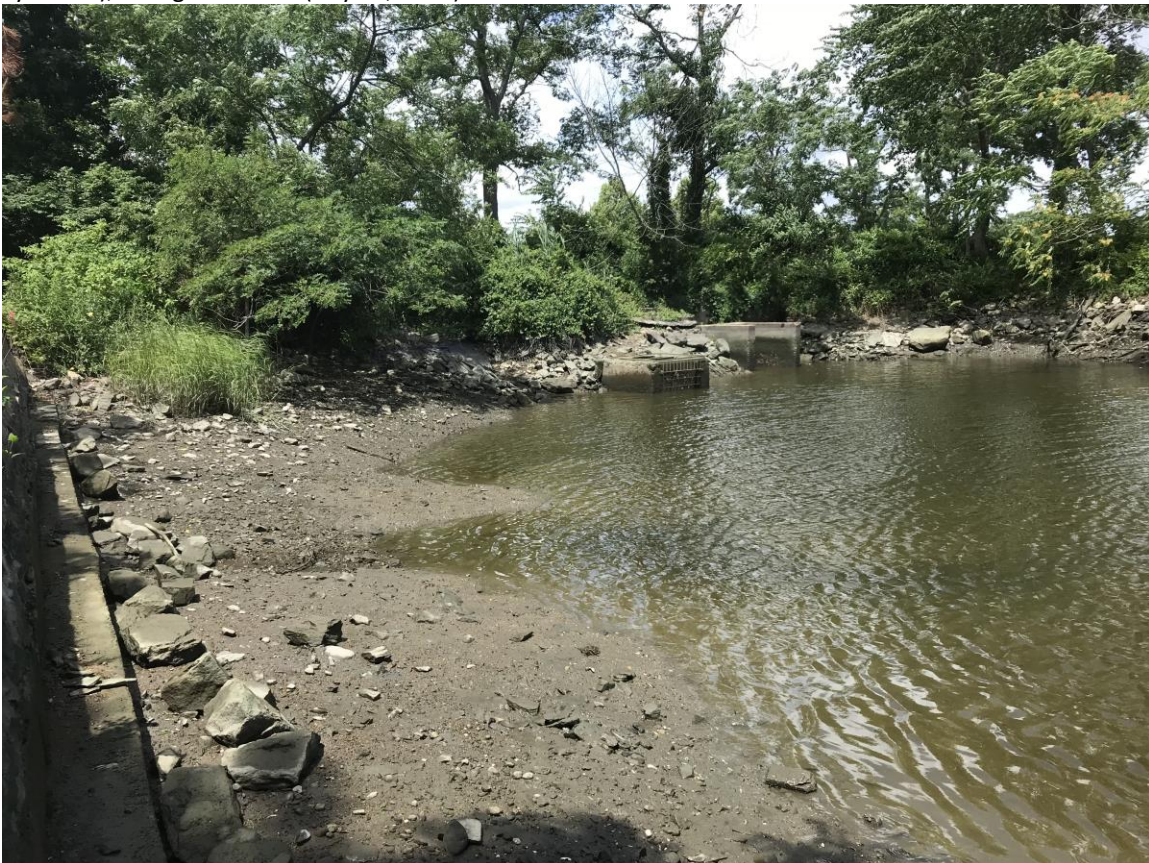
Photograph No. 7: View of tide gate openings along the northern shoreline of Delancey Cove, facing north (July 24, 2018). The tide gates regulate flow through culverts connecting Delancey Cove to Pond 10.
