Hampshire Country Club Planned Residential Development
Village of Mamaroneck,
Westchester County, New York
Final Environmental Impact Statement

Best Management Practices for New York State Golf Courses

February 2014

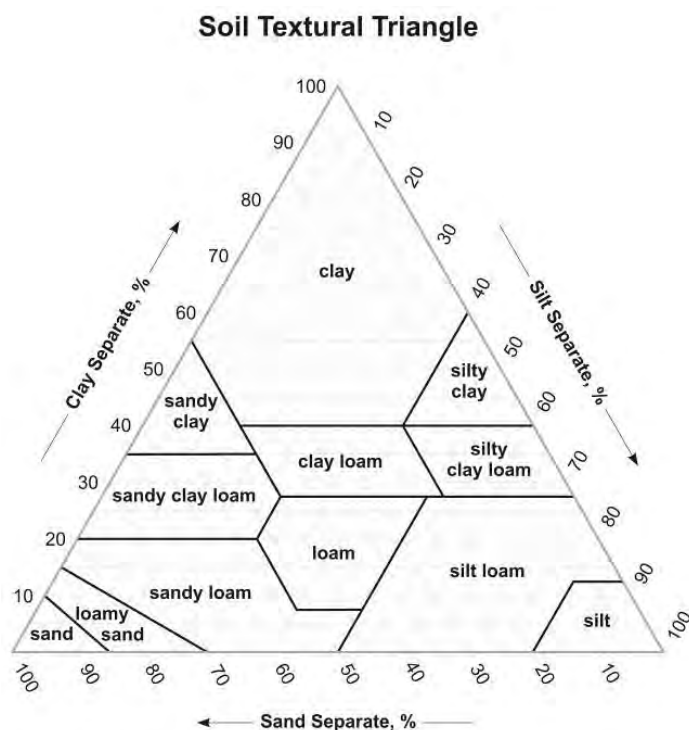
Figure 2-4. Soil textural triangle depicting soil particle distribution for different soils. Soil size definitions are as follows: Clay <0.002mm, Silt = 0.002-0.05 mm, Sand = 0.05 -2.0 mm. Source: USDA.

The amount of plant-available water depends upon the soil structure, texture, and organic matter. The classification of soil structure and textural analysis is shown in the soil texture triangle. (Figure 2-4). Lab analysis can determine the percent distribution of sand, silt, and clay. The amount of plant-available water held by different soils is presented in Figure 2-5. Commercially available moisture meters are able to read soil moisture percentage.

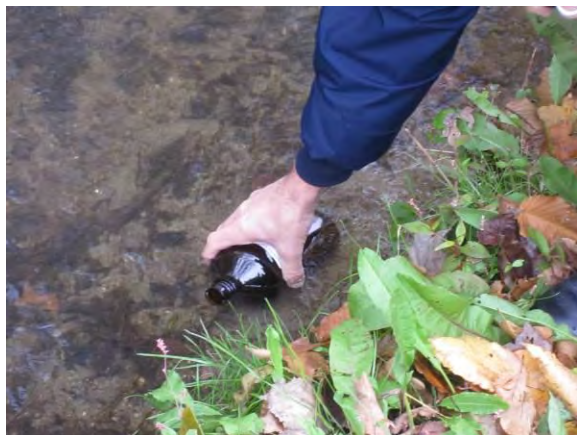
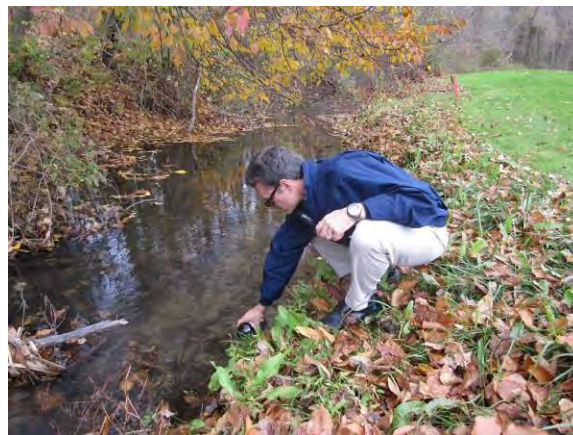
Figure 3-1. Golf course staff can easily sample surface water. Source: Ken Benoit

Surface water monitoring can include the laboratory testing of a number of different physical and chemical parameters to assess water quality. In addition, the sampling of macrobenthic invertebrates can be used as a relative assessment tool for stream health. Sampling of surface waters can be conducted by golf course staff or volunteer monitoring groups (Figure 3-1).

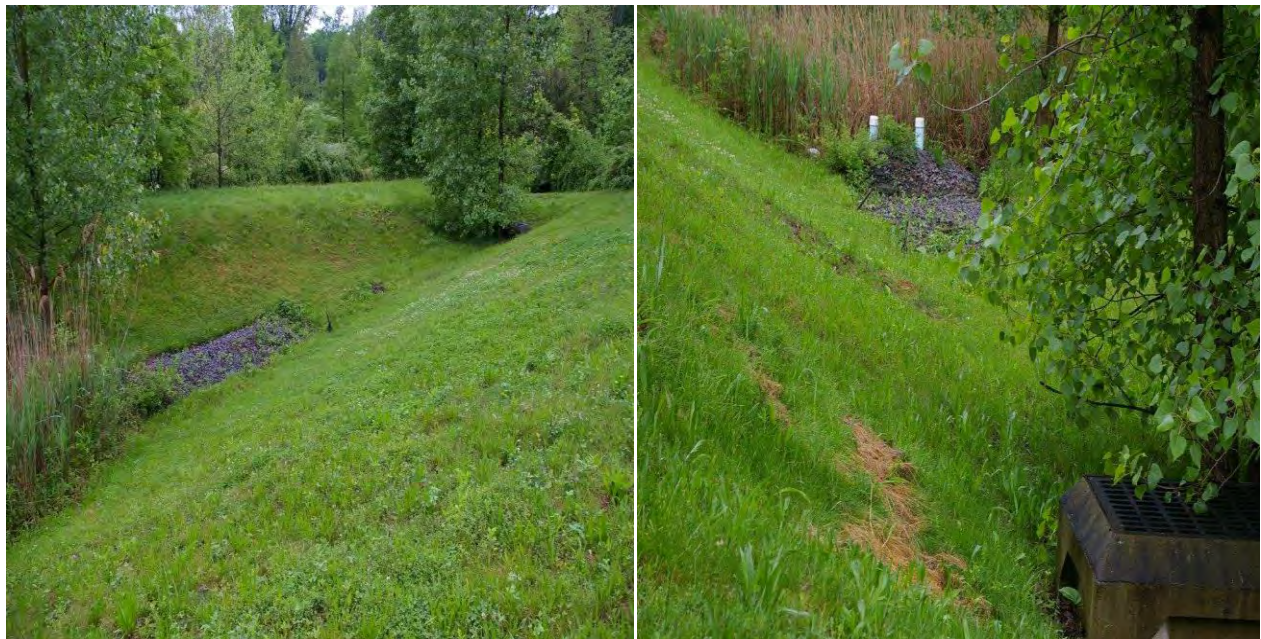
Figure 4-1. Grasses filter strips discharging into water filtration basins. Source: Robert Alonzi.

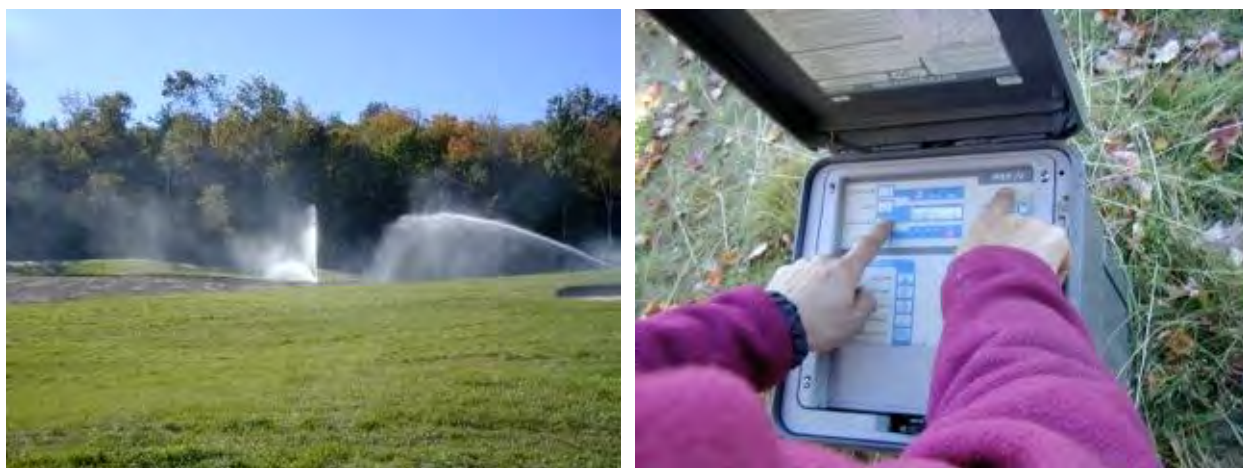
Figure 5-1. Irrigation site-specific designs and technologies help to conserve water. Source: Frank Rossi.

Irrigation systems should be designed to be efficient, distribute water uniformly, conserve and protect water resources, meet state and local code, and meet site requirements. Site specific characteristics and incorporation of water conservation practices and technologies should be evaluated in the design. The Irrigation Association lists 25 design-oriented BMPs. Figure 5-1 includes several examples of irrigation site-specific designs to conserve water.

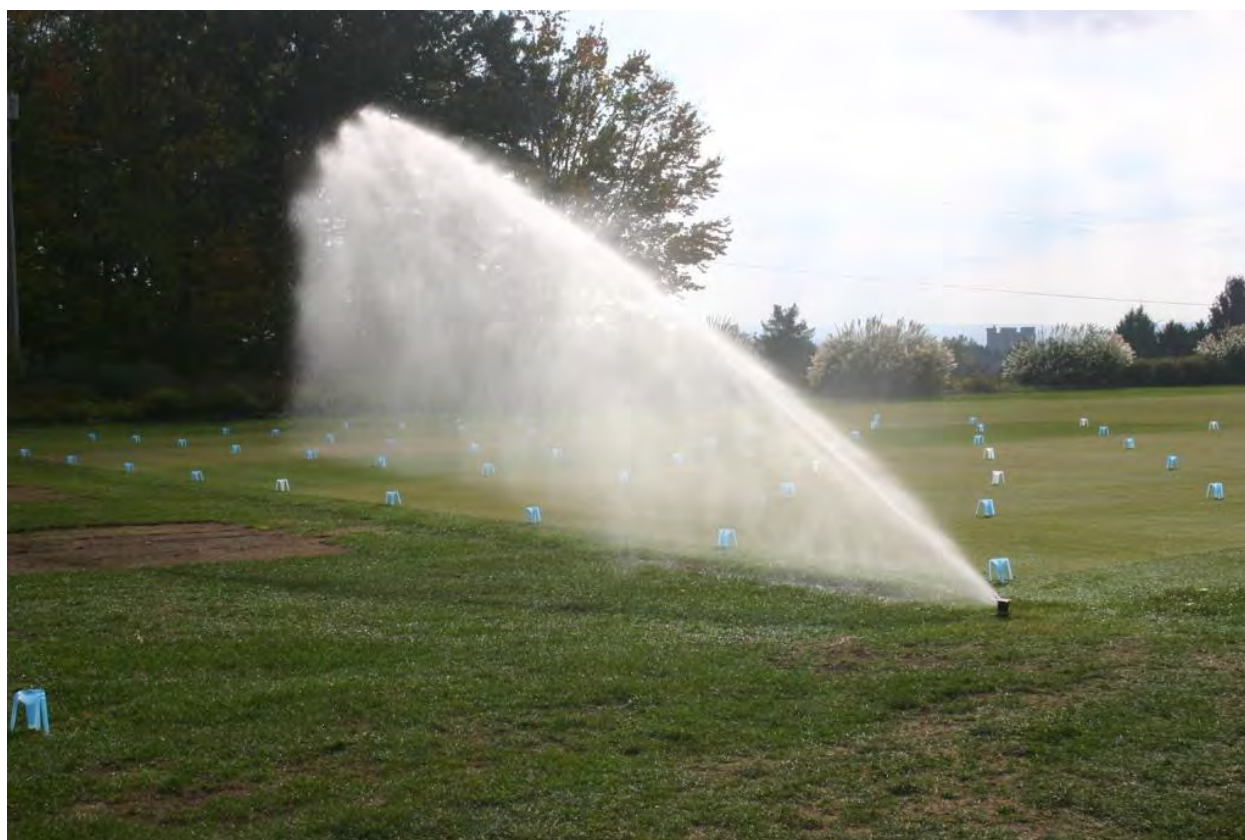
Figure 5-3. Regular irrigation system auditing ensures uniform application. *Source:* Frank Rossi.

Scheduling Coefficient (SC): measures the average water applied to the driest, most critical areas of an area under test and compares to the average. An SC of 100% implies the distribution is uniform. An SC of 120 % indicates that the average was 20% more water applied than the driest area. The SC is often used to adjust run times to ensure that the driest areas receive the required scheduled water replacement. The disadvantage of this method is that all other areas receive 20% too much water, increasing the risk of runoff and leaching.

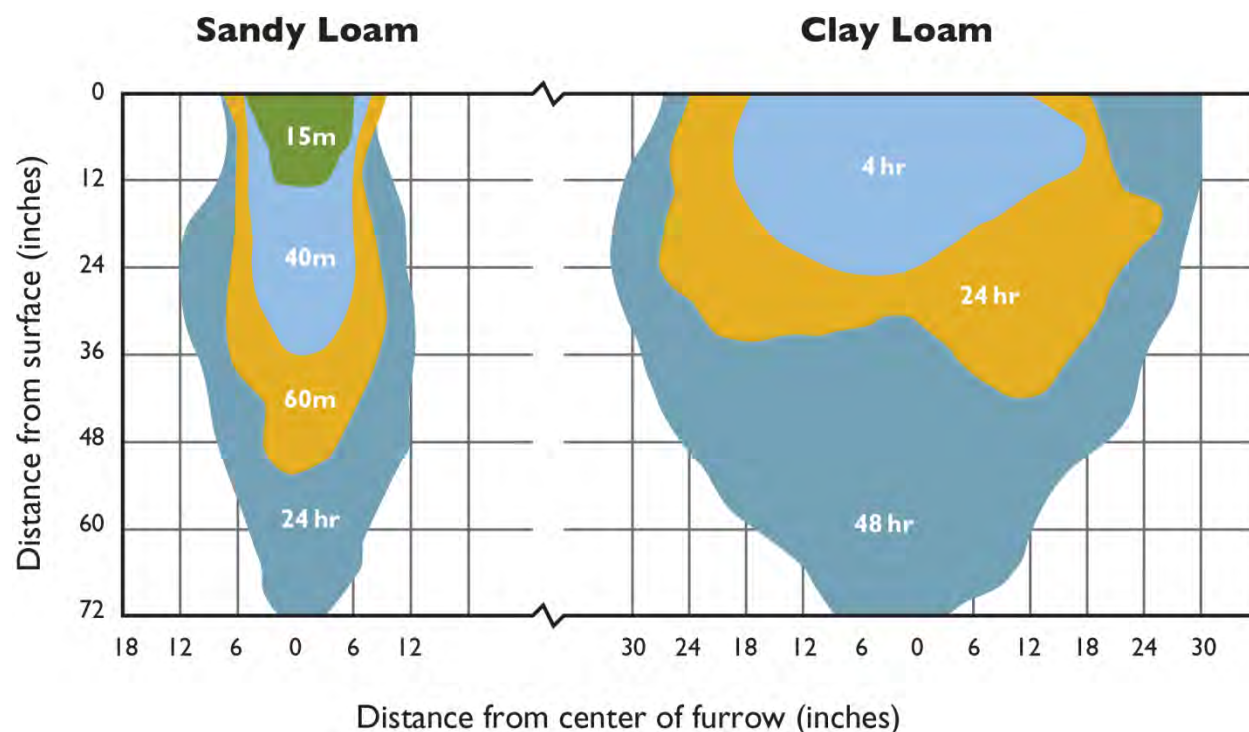
Figure 5-4. Infiltration of two different soil types measured in time and area wetted.

Infiltration rates depend on soil texture. Sandy soils have higher porosity and greater infiltration rates than silty or clayey soils. The matrix potential of the finer particle soils increases the time to wet the soil. Figure 5-2 shows the time and area wetted for two different soils: a 15 minute irrigation cycle on a sandy loam penetrates and wets to a depth of 12 inches and a 40 minute cycle wets nearly 36 inches of sandy loam, while clay loam soil requires hours of irrigation to wet the same profile.

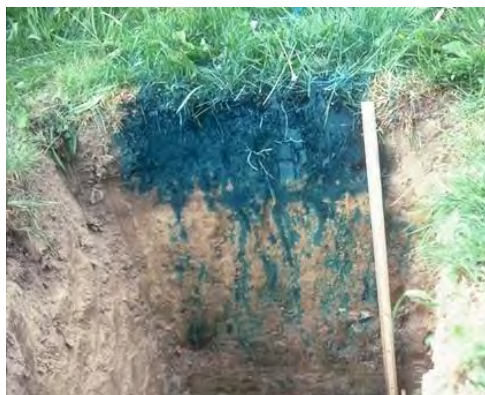
Figure 5-5. Preferential flow in soils. Source: Cornell, Soil & Water Lab.

Preferential flow and restrictions can lead to non-uniform moisture distribution in the root zone. Some areas of turf may be drier and other areas may be wetter, even saturated. Superintendents can develop better and uniform soil conditions by managing the soil compaction and organic matter content or thatch, such as by frequent aerification and top-dressing to provide better root-zone profiles. The use of water dispersants may be required to help water move through hydroscopic soil conditions associated with localized dry spot. Wetting agents, and in some cases organic amendments, may be needed to increase water holding capacity of some soils, particularly sandy soils.

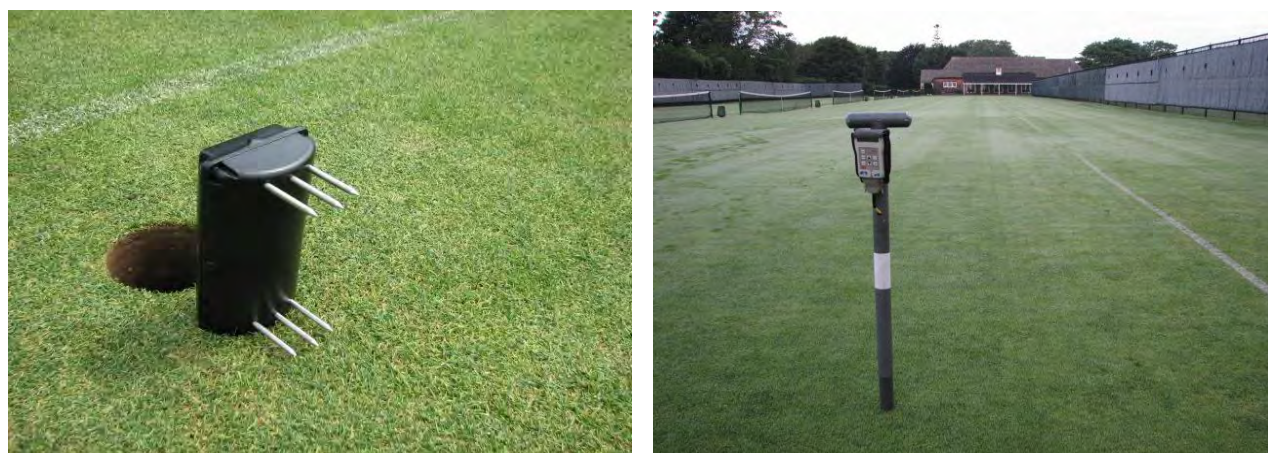
Figure 5-7. Root zone moisture, temperature, and salinity meter (left) and portable moisture meter (right). Source: John J. Genovesi, Maidstone Club

The NRCS provides a guideline for estimating the soil moisture content of soil by touch (<http://nmp.tamu.edu/content/tools/estimatingsoilmoisture.pdf>). The turf industry, however, offers tools to more precisely measure soil moisture content. Several handheld and portable instruments can be used to spot check areas (Figure 5-7).

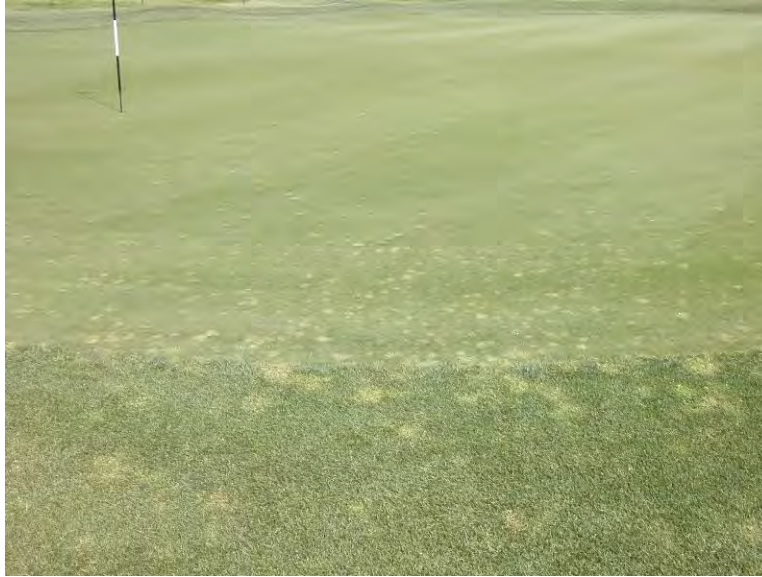
Figure 7-3. Annual bluegrass invasion into existing bentgrass putting green. Over time, the continued surface disruption and shift in maintenance will lead to increasing populations of this invasive species. *Source: Frank Rossi.*

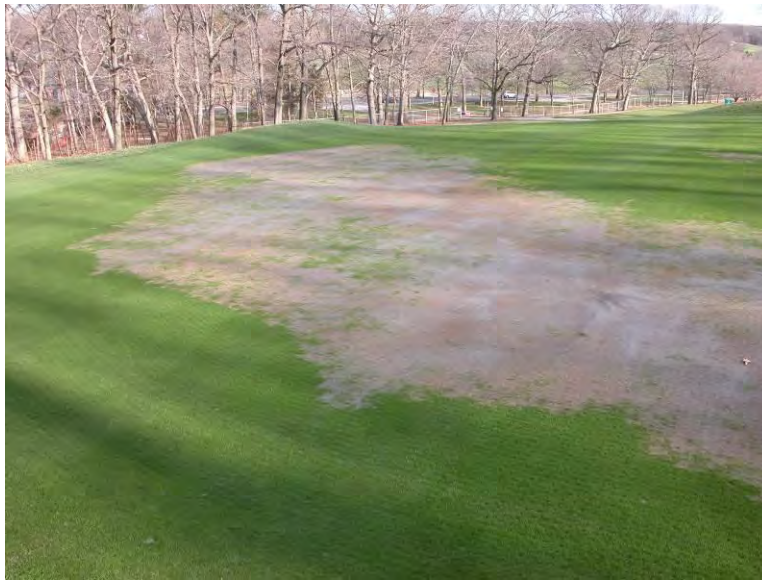
Figure 7-4. Annual bluegrass is very susceptible to winter damage, especially from ice accumulation. Note the live bentgrass amongst the dead annual bluegrass. As the turf thins, the potential for off-site movement of inputs increases. *Source: Frank Rossi.*

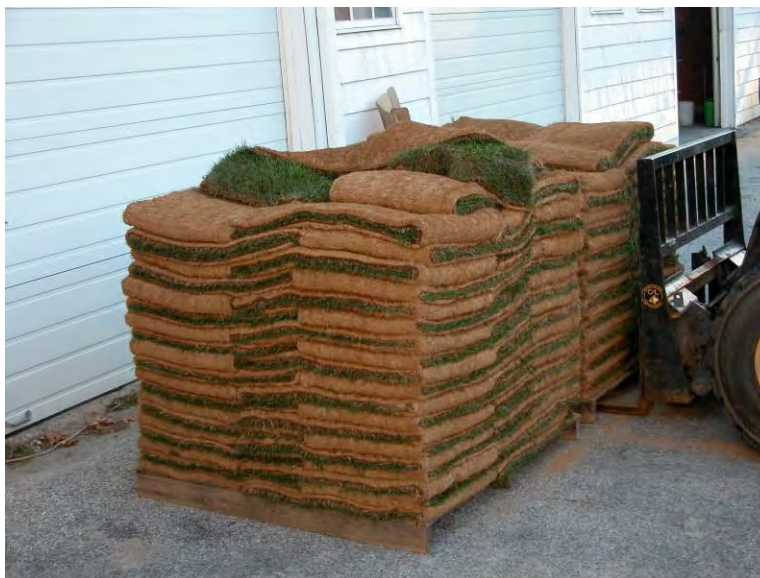
Figure 7-5. The use of sod can limit the species and varieties used, but significantly reduces the risks associated with new establishment. *Source: Frank Rossi.*

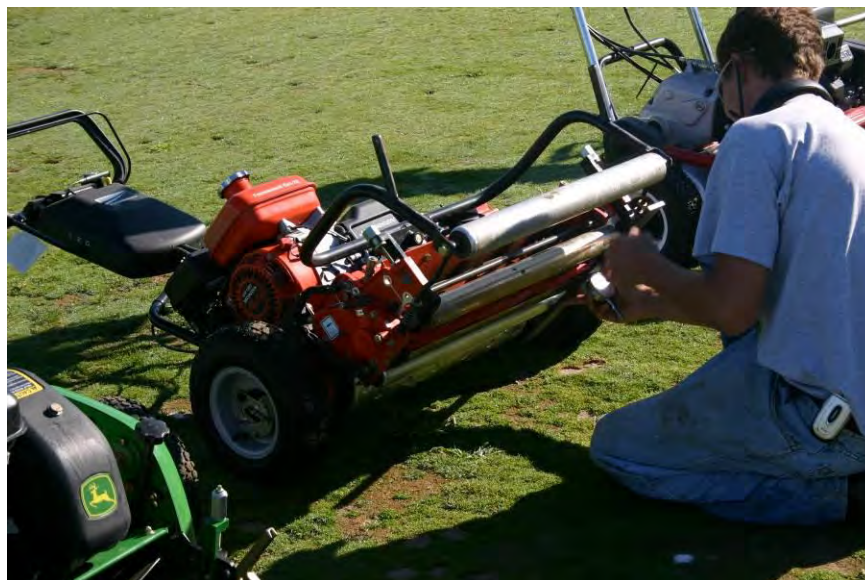
Figure 7-6. Proper mowing adjustment, especially reel mowers, ensures maximum turf performance while minimizing stress that leads to reductions in turf density. Source: Frank Rossi.

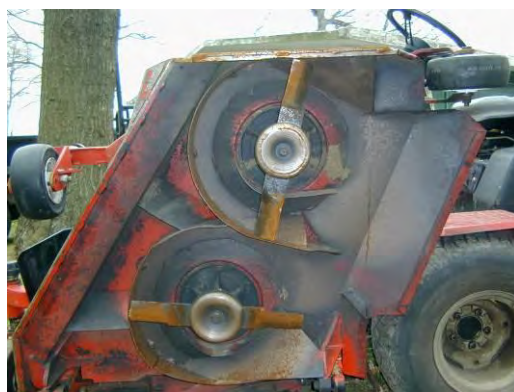
Figure 7-8. Rotary mowers are best used for height of cuts above 1". Blades should be sharpened after every 10 hours of use. Source: Frank Rossi.

Any mistake in mower set up from blade sharpness to bedknife alignment can lead to increased stress from wounding and reduction in turf density. Therefore, the mower must be properly adjusted and set up to minimize leaf shredding and wounding for pathogens. Reel and rotary mower blades are shown in Figures 7-7 and 7-8.

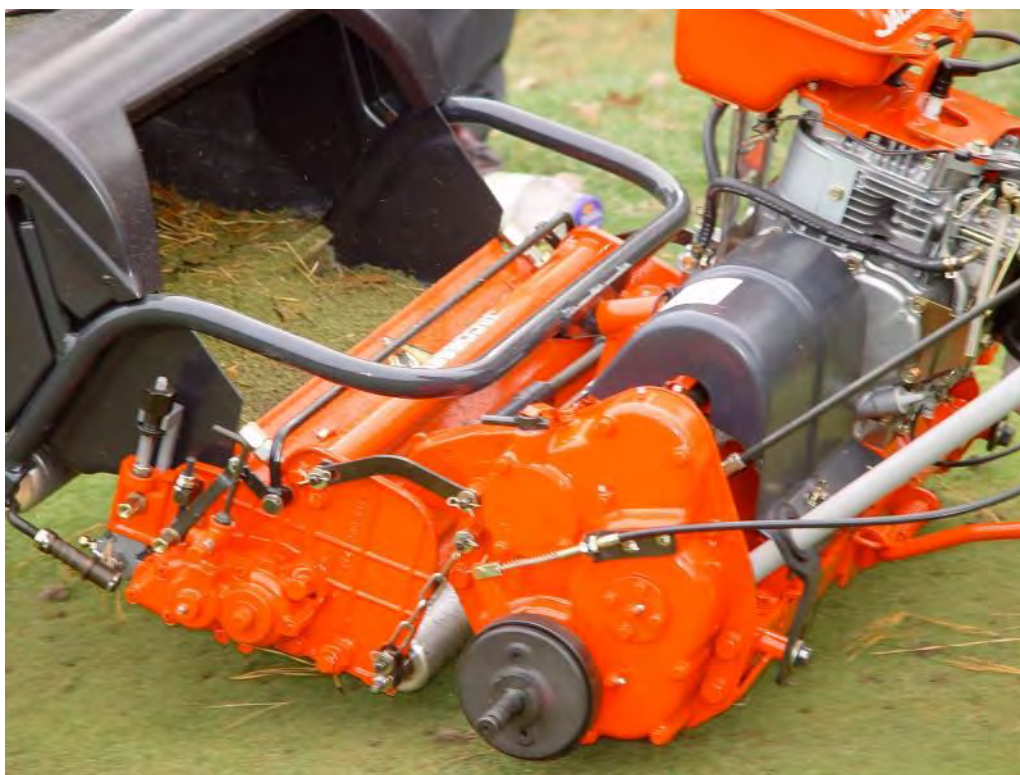
Figure 7-9. Clipping removal is only recommended on surfaces where they disrupt the function of the sites, such as putting surfaces. Source: Frank Rossi.

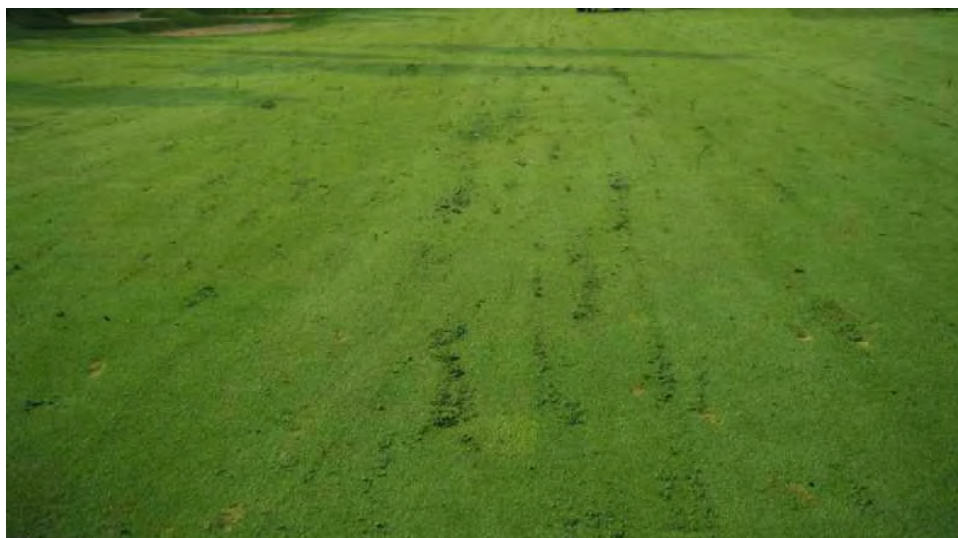
Figure 7-10. Clippings left on turf after mowing can lead to shading of the turf below and heat stress from microbial activity generated in the piles. *Source:* Frank Rossi.

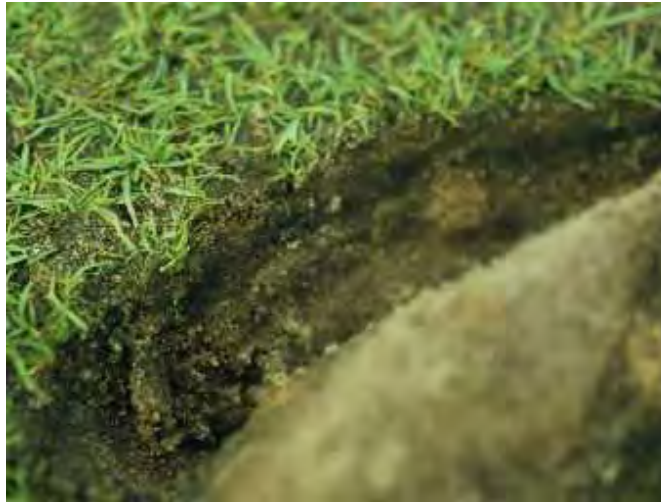
Figure 7-11. Excessive surface organic matter can lead to anaerobic conditions that encourage diseases such as black layer. Source: Frank Rossi.

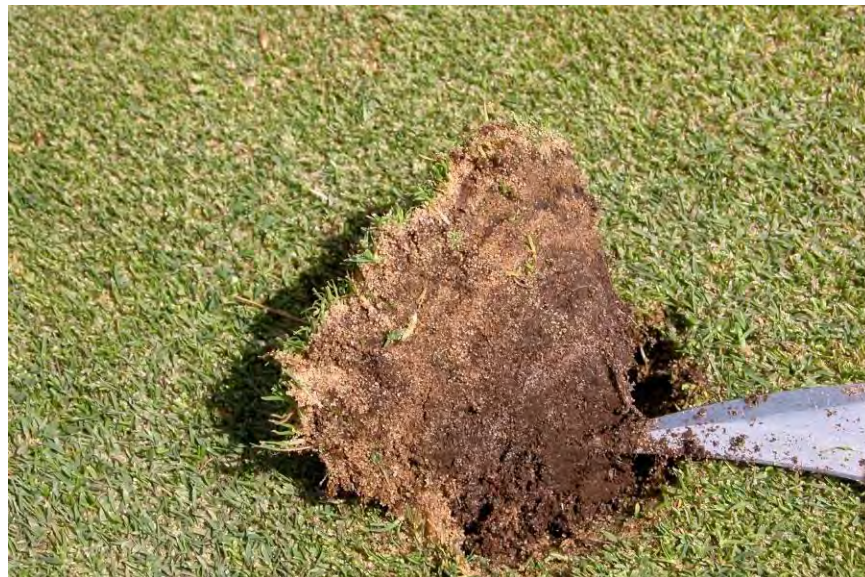
Figure 7-12. Soil layering leads to impeded drainage, increasing surface moisture that can lead to runoff. Source: Frank Rossi.

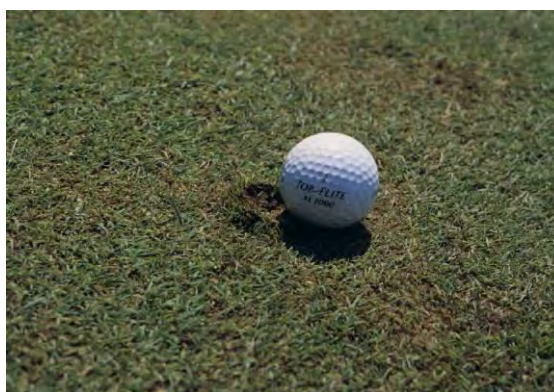
Figure 7-14. Wet surfaces lead to reduction in golf turf performance, such as plugged balls. This also increases the risk of runoff when soil surface is persistently wet. Source: Frank Rossi.

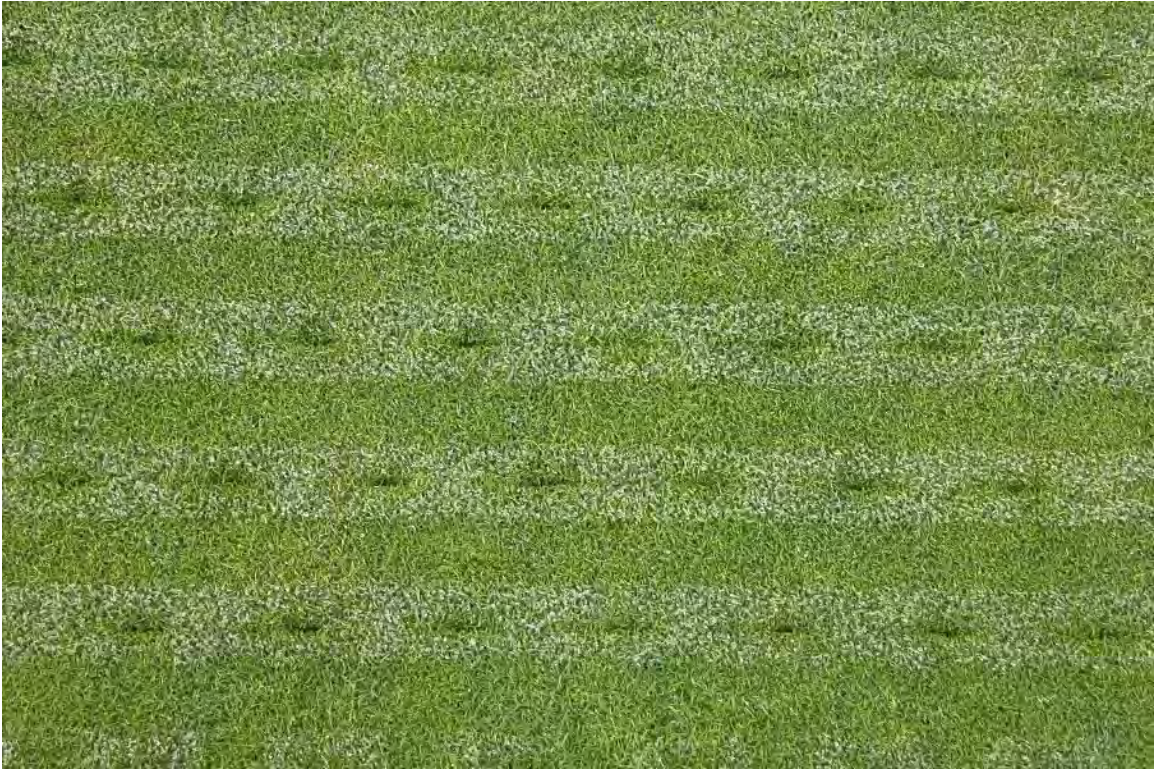
Figure 7-15. Slice holes made from a putting surface spiking operation used to maximize infiltration and gas exchange. *Source:* Frank Rossi.

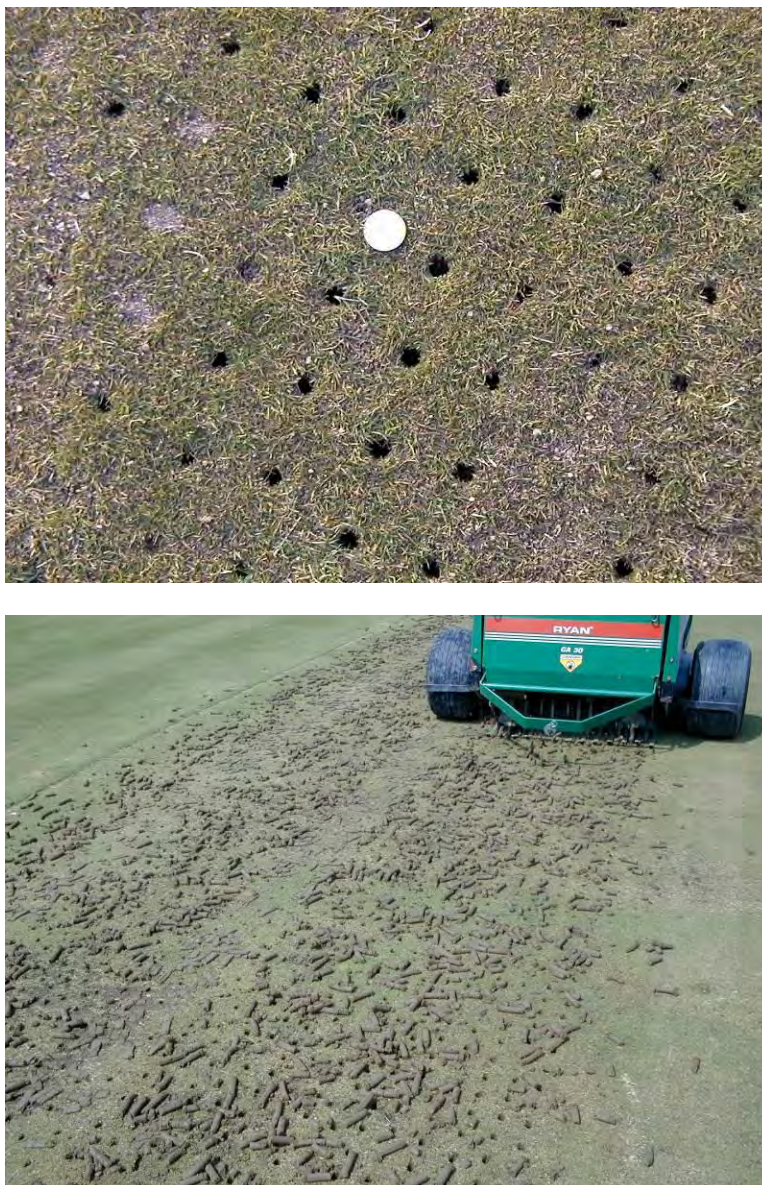
Figure 7-16. Core cultivation shown from a distance (top) and up close (bottom) is an ideal method for alleviating compaction, removing organic matter, and amending problem soils, which should increase infiltration and reduce the risk of runoff. *Source: Frank Rossi.*

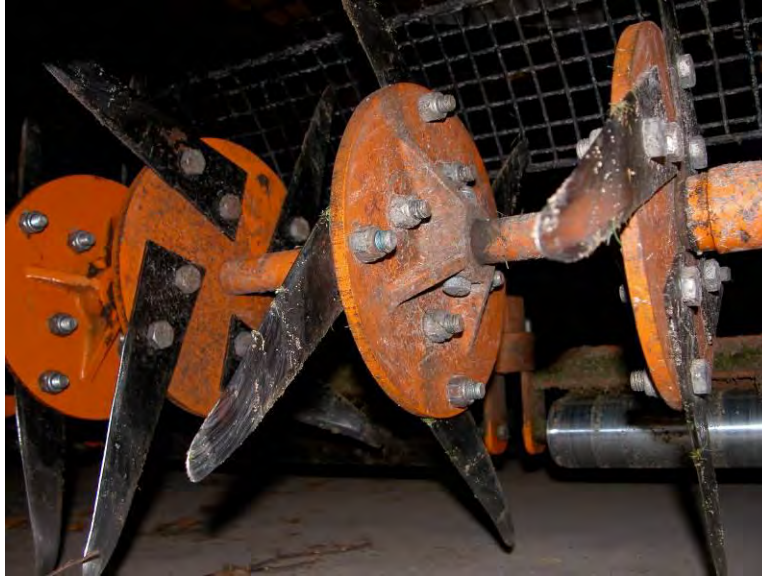
Figure 7-18. Deep slicing can aid with remediating large areas of soil in need of increased infiltration and gas exchange. *Source:* Frank Rossi.

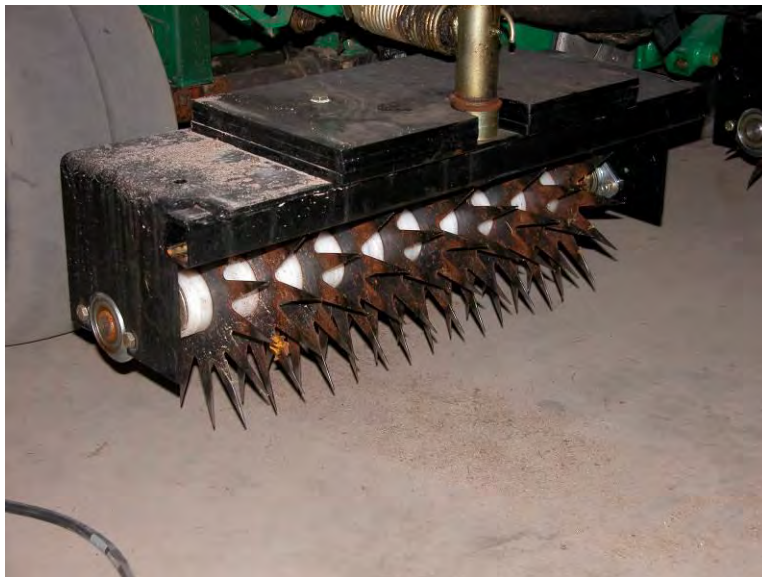
Figure 7-19. Spiking attachments aid with increasing infiltration and can affect significant amounts of surface areas. *Source:* Frank Rossi.

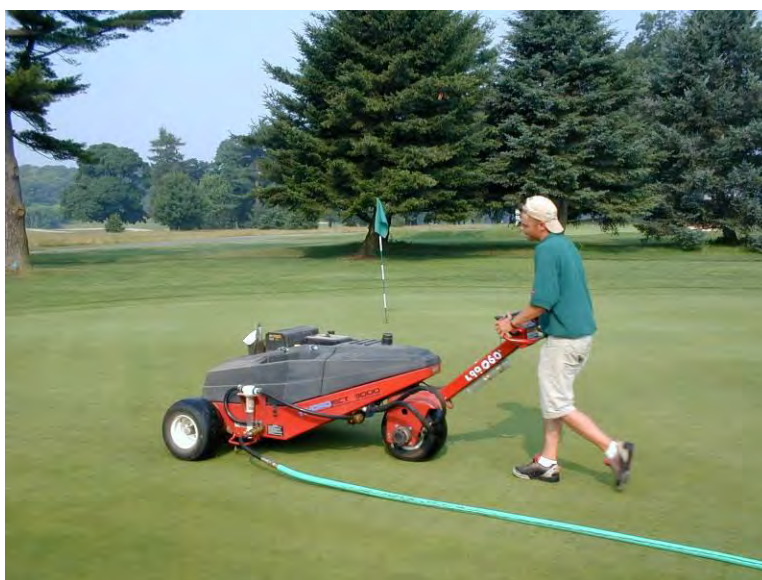
Figure 7-21. Water injection cultivation is the 'gold standard' for increasing infiltration and improved gas exchange with minimal surface disruption. *Source: Frank Rossi.*

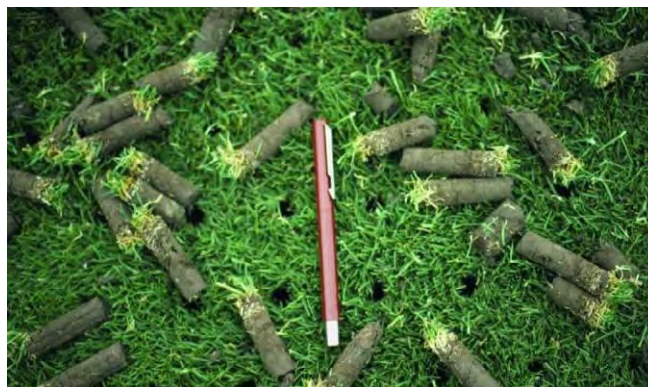
Figure 7-22. Hollow tine cultivation is an ideal method for amending soils. *Source: Frank Rossi.*

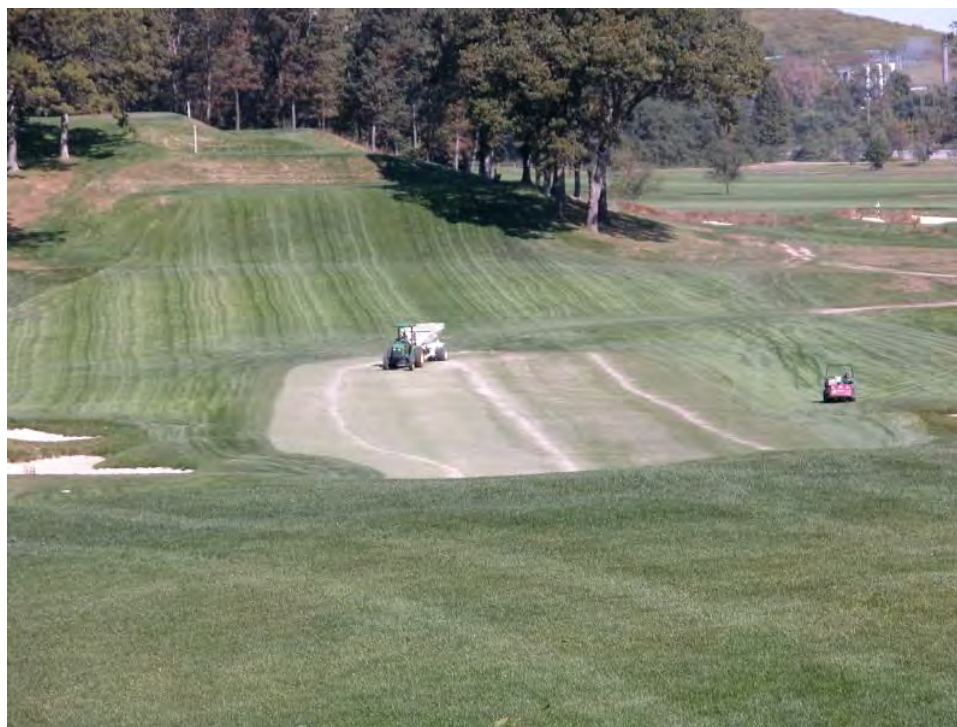
Figure 7-23. Although large scale sand topdressing operations can be costly, they aid in reducing runoff from soils with organic matter accumulation and heavy compaction. Source: Frank Rossi.

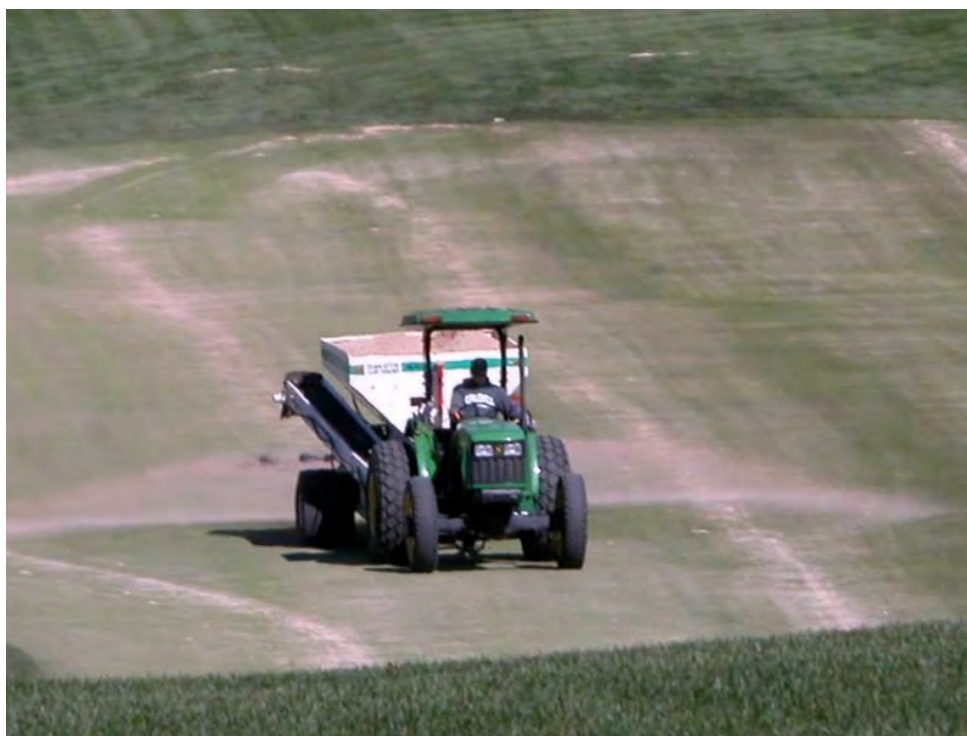
Figure 7-24. Sand topdressing helps provide high performance playing surfaces that also reduce the risk of runoff by increasing infiltration, reducing compaction, and diluting organic matter. *Source:* Frank Rossi.

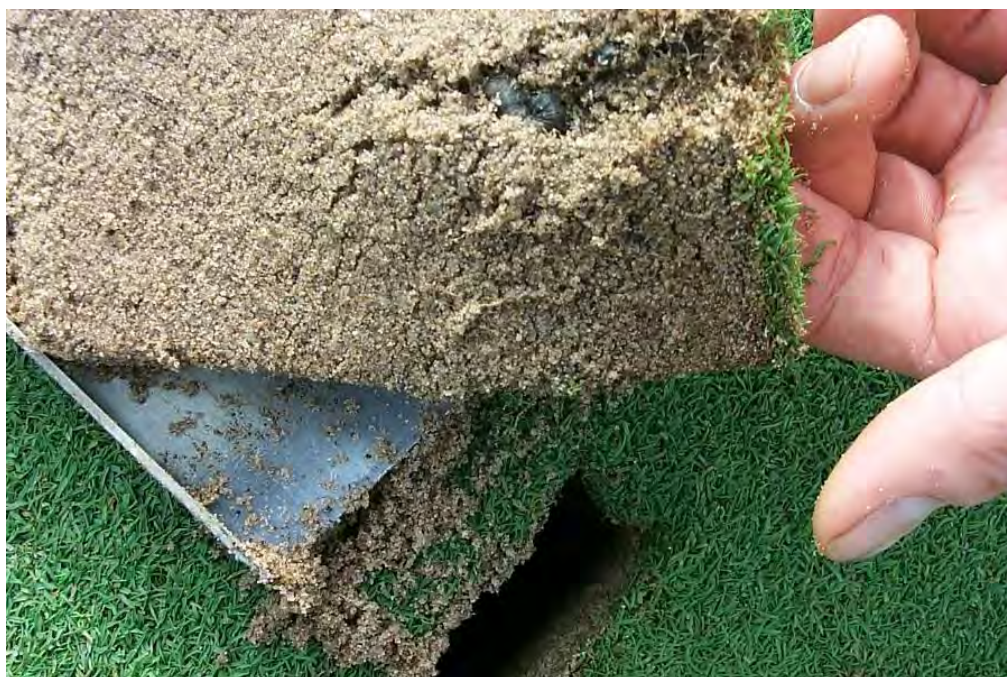
Figure 7-25. Sand-based greens offer the best options for maximizing performance and minimizing water quality issues. *Source:* Frank Rossi.

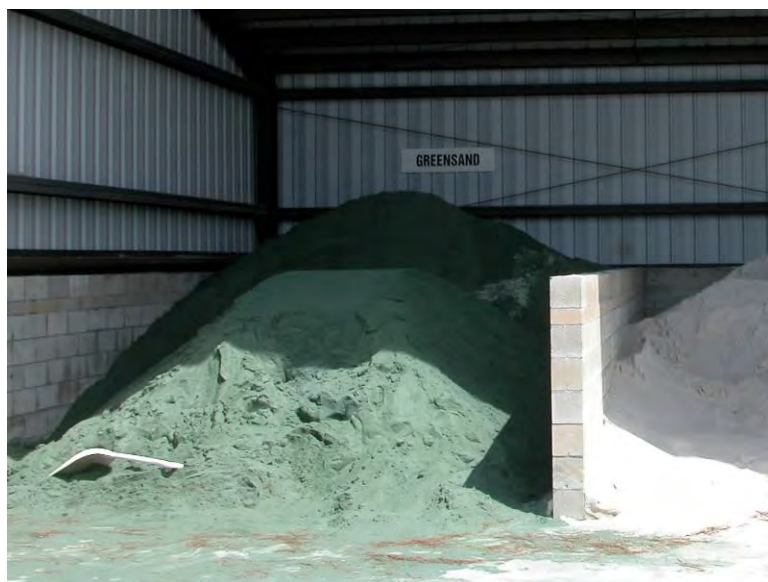
Figure 7-26. Proper topdressing material selection and storage are vital for maintaining a permeable turf surface. *Source: Frank Rossi.*

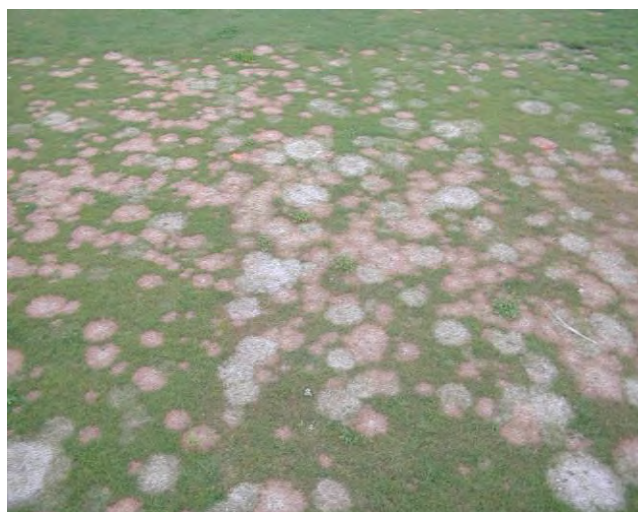
Figure 8-1. Pink and gray snow mold.

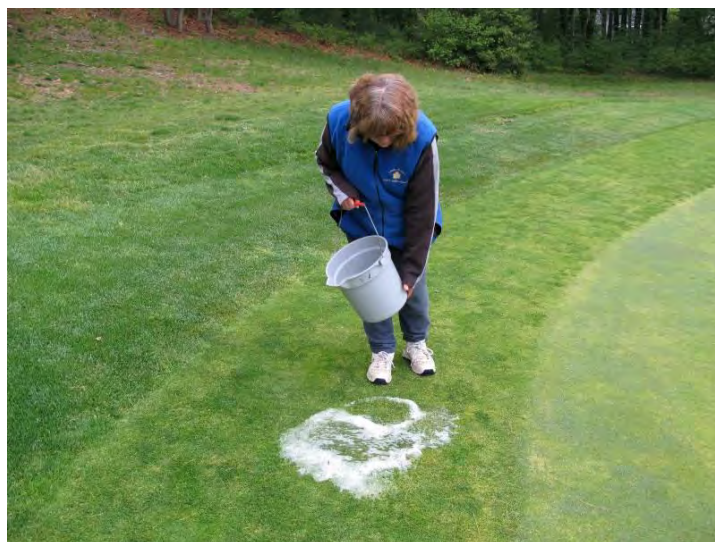
Figure 8-2. Soap flushes are a useful monitoring technique. The soap irritates many insects and causes them move out of the thatch and lower plant parts to the tips of grassblades for easier detection and counting. This technique is especially useful for monitor.

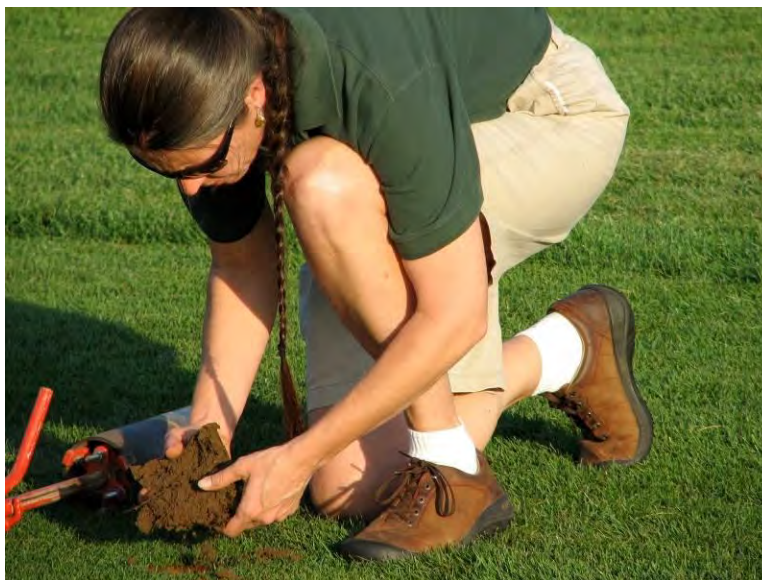
Figure 8-3. Soil cores removed with cup cutters can be searched quickly and easily for the presence of white grubs. The grubs can also be identified for species and life stage. Source: Curt Petzoldt.

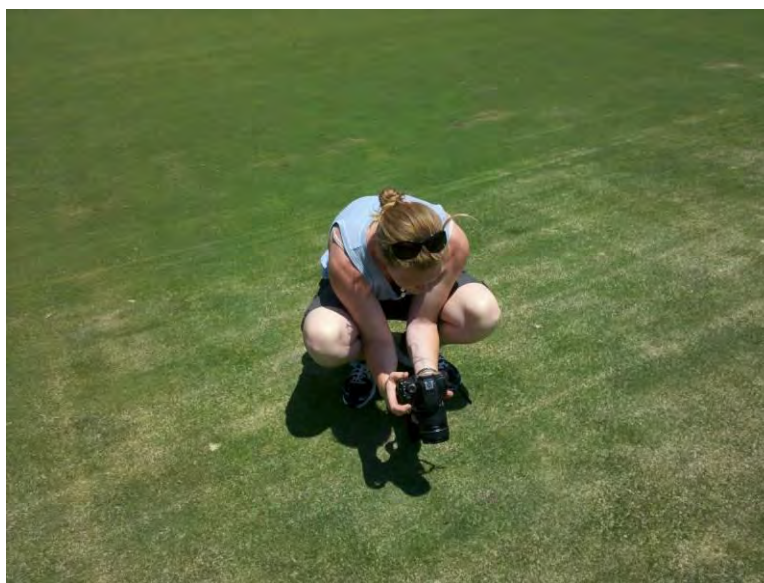
Figure 8-4. Photographs are useful for documenting pest occurrence and damage, and can be compared against past and future photos. *Source:* Jennifer Grant.

Documentation is key to connecting the elements of an IPM program and increasing its value. In order to be effective, IPM record keeping should exceed legal requirements (see Table 8-1, Figure 8-4).

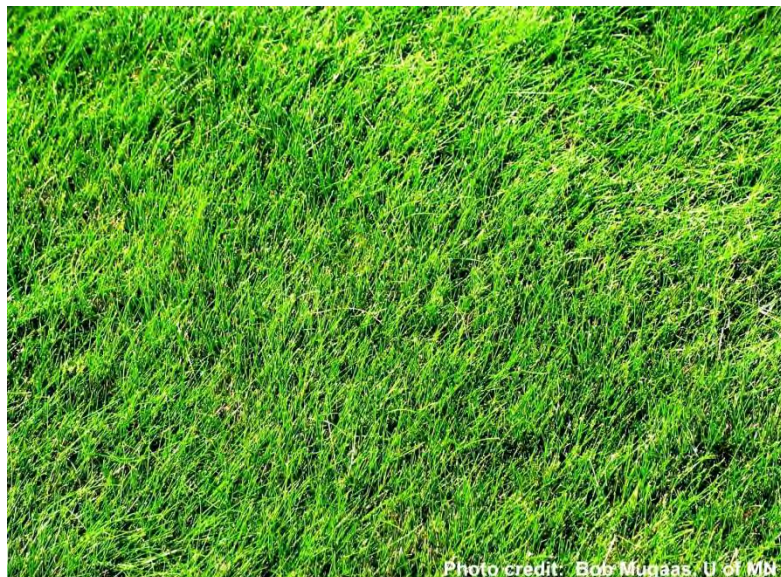
Figure 8-6. Tall fescue/bluegrass blend in a rough. Source: Bob Mugass, University of Minnesota.

One of the most effective prevention strategies in weed management is to use the appropriate turf varieties for the specific site conditions and intended use on the golf course. For example, a recent development in some golf courses is the use of tall fescue/blue blends in the rough because heat and drought in the summers create challenges for turf management (Figure 8-6). Another

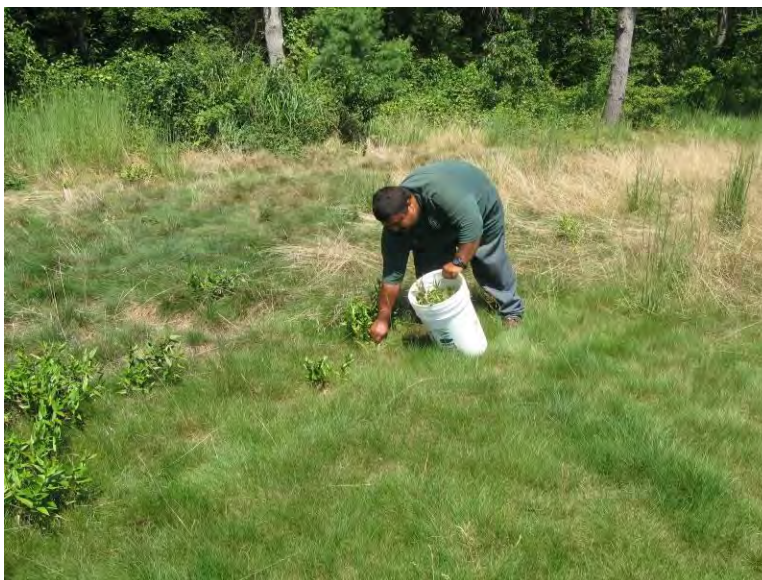
Figure 8-7. Hand weeding is sometimes the most effective and environmentally friendly method of weed management. This photo shows invasive species in the rough. Source: Jennifer Grant.

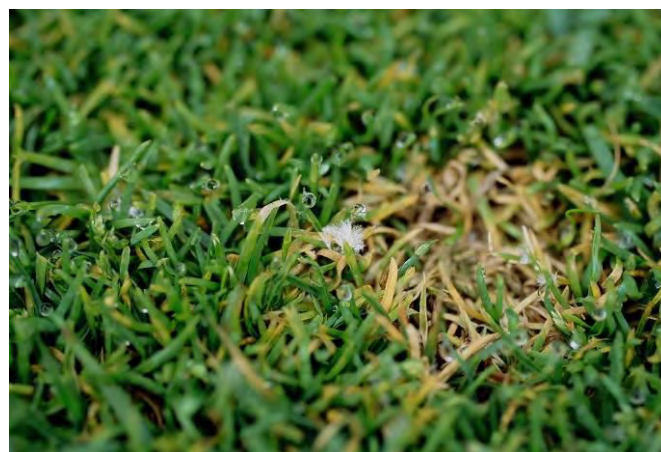
Figure 8-8. Dollar spot. Source: Jennifer Grant.

Dollar spot, caused by the pathogen *Sclerotinia homoeocarpa*, is a common golf course disease in New York State (Figure 8-8). Besides using chemical controls, managers can plan to lessen disease incidence and severity with the following activities:

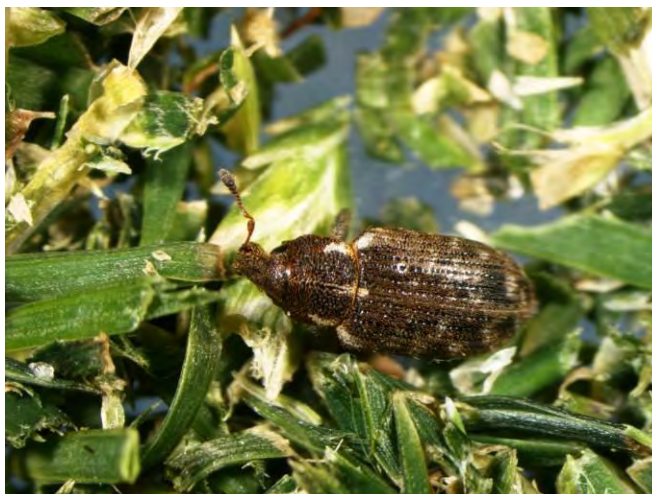
Figure 8-9. Annual bluegrass weevils. *Source: Jennifer Grant.*

Annual bluegrass weevils (ABW) are pests of golf courses in many parts of New York (Figure 8-9). The only cultural practice known to successfully minimize their damage is to reduce the amount of annual bluegrass in infested areas. In mixed stands of annual bluegrass and creeping bentgrass, as is commonly found on putting greens, practices that favor bentgrass can be

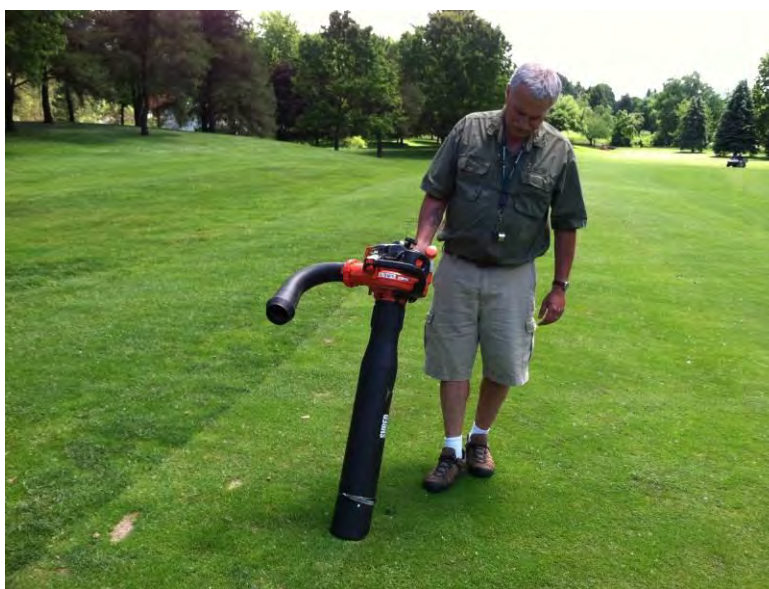
Figure 8-10. Vacuuming to determine annual bluegrass weevil adult presence, location, and movement. *Source: Jennifer Grant.*

Vacuuming has been used to monitor ABW adults in turf, but may also work as a physical and mechanical control practice if done frequently, especially during the spring migration (Figure 8-

Beyond the techniques listed, IPM for ABW has relied mainly on careful monitoring of the insect as well as phenological indicators and degree days to target insecticide applications. Pitfall traps, soap flushes, and vacuum sampling detect when and where the adults are moving from their overwintering spots. An insecticide targeting adults is typically timed for the peak migration time. Subsequently, these sampling techniques, along with saline floats that monitor larval development, are used to time the application of an insecticide targeted at 3rd to 5th instar larvae.
