Hampshire Country Club Planned Residential Development
Village of Mamaroneck,
Westchester County, New York
Final Environmental Impact Statement

Best Management Practices for New York State Golf Courses

February 2014

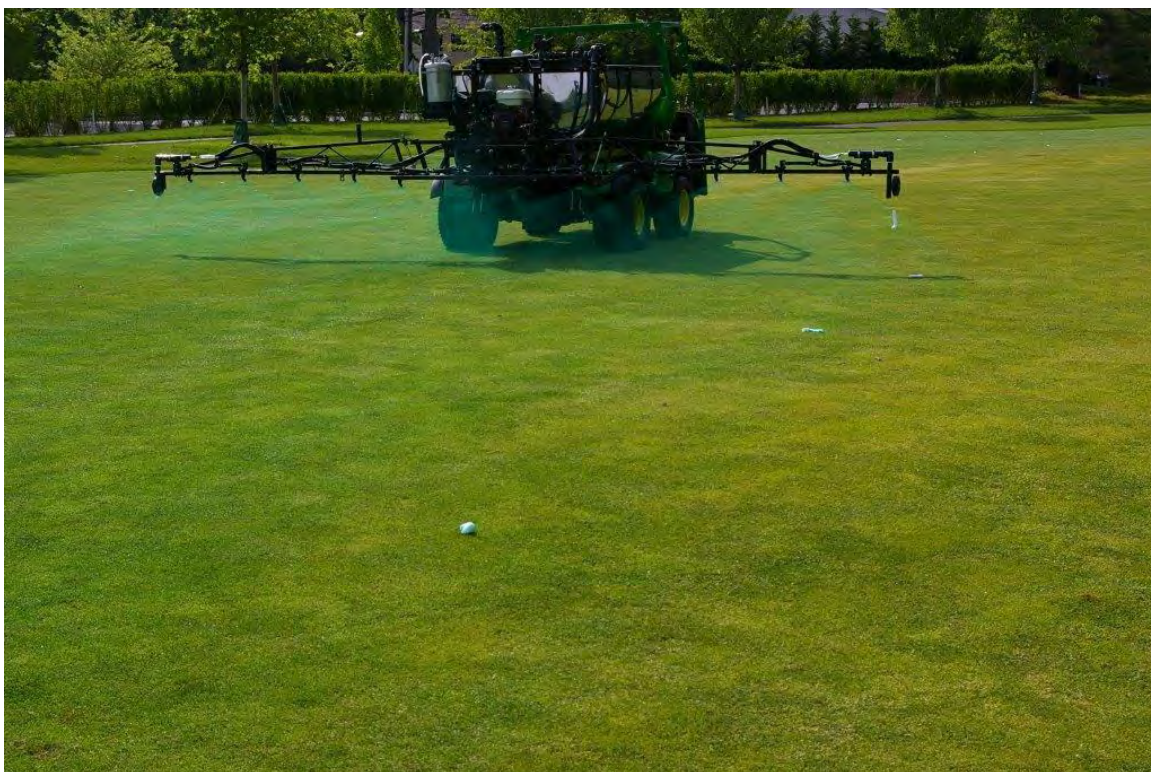
Figure 9-1. Typical fairway pesticide application using foam and dye for accuracy.
Source: Robert Alonzi.

In addition to selecting an appropriate pesticide based on the strategies discussed in Chapter 8, a number of factors should be considered when applying pesticides to avoid water quality impacts (Table 9-1). For example, a number of site-specific considerations for the use of pesticides should be evaluated using the results from the site analysis to identify areas where the risks of pesticides reaching surface or groundwater are greater (such as steep slopes, shallow water tables, and areas with frequently wet soils). In addition, pesticides should be applied accurately and with care to avoid conditions that can increase the chances of runoff, leaching, or drift (Figure 9-1).

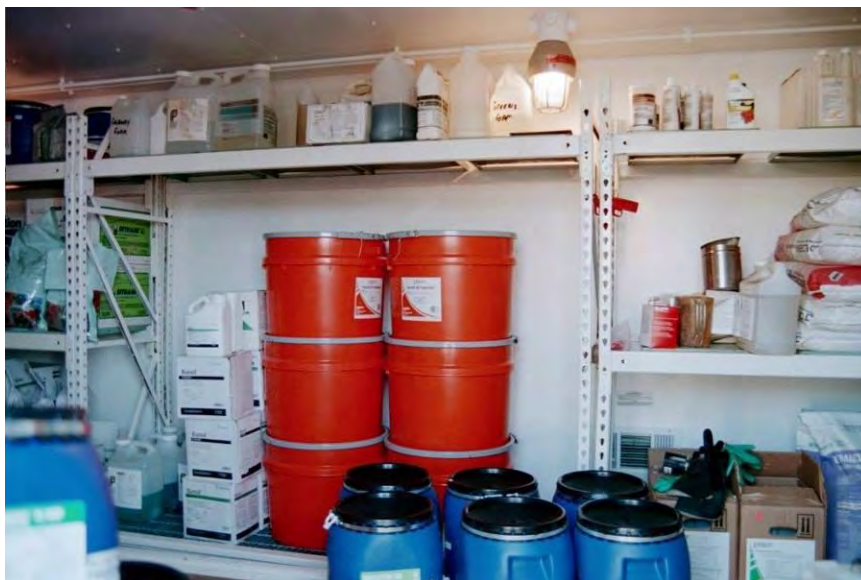
Figure 10-1. Chemical storage building organization. Source: Robert Alonzi.

The goal of an ideal storage facility is the safe siting and storage of potential contaminants that ensures a high level of water quality protection (Figure 10-1). NYSDOH does not allow chemical storage or mixing and loading facilities within 100 feet of a potable well. Other requirements include local zoning for the siting of maintenance facility and operations, which vary by town and county. Requirements often include a minimum distance (set-back) from wetlands, surface wells and property lines. The Freshwater Wetlands Act (<http://www.dec.ny.gov/lands/4937.html>) requires a 100 ft buffer around wetlands. Some townships have even broader requirements.

Floor drains should include a sump and a chemical pump to move the chemicals discharged to a waste tank as in Figure 10-1. The material can be reclaimed, diluted to label concentrations, and applied to turf areas or collected for disposal using certified hazmat haulers.

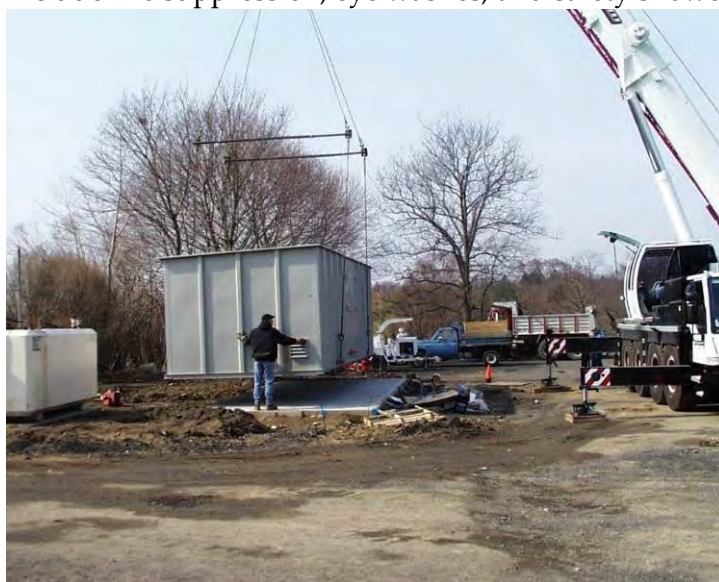
Modular or independent containment units can be installed in many sizes. The units are typically self-contained, fireproof and secure and can be temperature controlled with ventilation. Options include fire suppression, eye washes, and safety showers.

Figure 10-2. Modular containment units can be installed in many sizes. Source: Robert Alonzi.

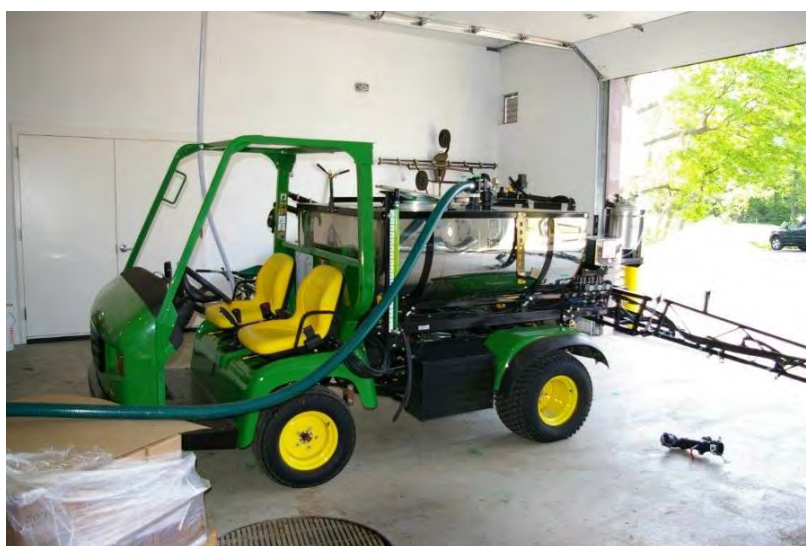
Figure 10-4. Loading fill spray tank from premix. Source: Robert Alonzi.

As with the storage areas, the handling area (mixing and loading) of pesticides and fertilizers should be contained to minimize release of concentrated or diluted pesticides and fertilizers. These compounds should be mixed and loaded on a covered impervious surface properly sized and sloped to capture the maximum potential spill. Backflow preventers should be installed on fresh water supplies used for filling. The station could also be upgraded to pre-mix pesticide/fertilizer loads in a controlled environment then transferred to the sprayer. See Figures 10-4 through 10-6 for proper mixing and loading practices.

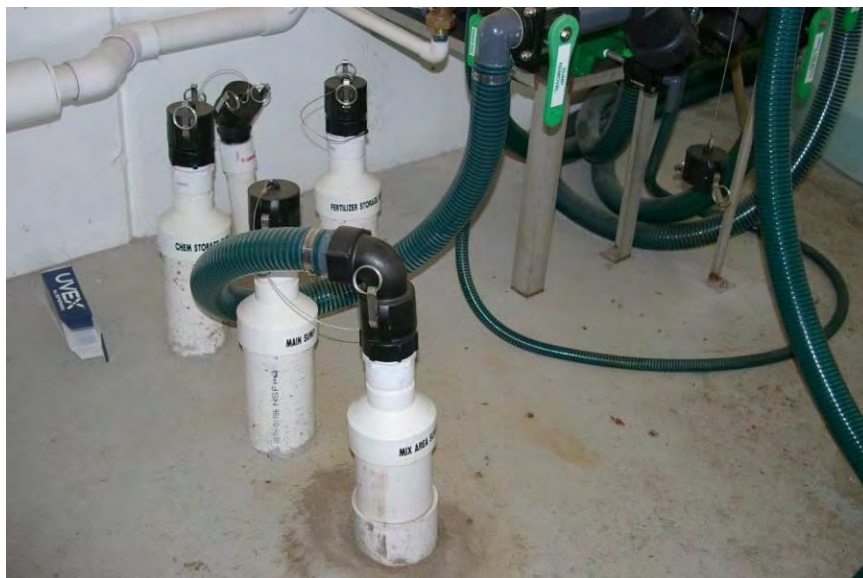
Figure 10-5. Recovery lines and trans pump in the equipment mixing and loading area.
Source: Robert Alonzi.

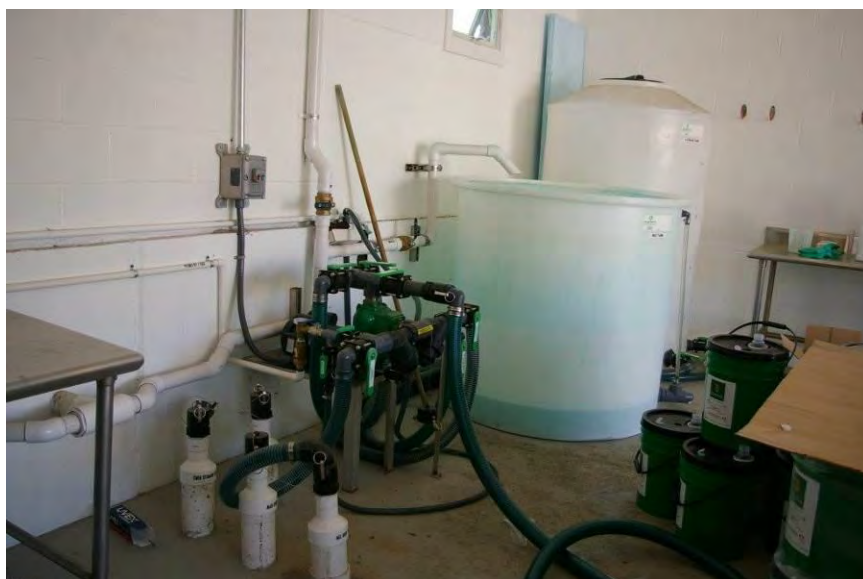
Figure 10-6. Mixing and loading recovery tanks. *Source: Robert Alonzi.*

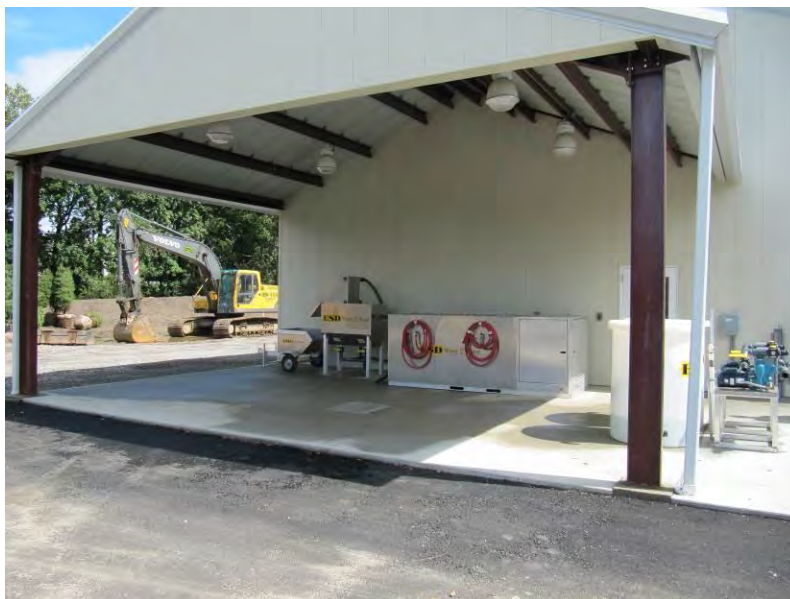
Figure 10-7. Equipment wash area. *Source:* Old Oaks County Club.

The release of organic waste associated with equipment cleaning needs the same level of protection afforded liquid and granular nutrients and pesticides. When debris is removed from equipment, it should not be released into open surface waters or in a location near well heads or shallow groundwater. Figure 10-7 shows a well designed wash area.

Often effective equipment cleaning areas can be maintained as mixing and loading areas with impervious flooring and drains that allow for some separation of organic solids and liquids (Figure 10-7). When using the simple wash-pad and collection area be sure to direct any uncontained liquid to be dispersed along the land, preferably along a designed bio-filtration system. Closed system cleaning stations are available that separate clippings/solids and treat the wash water. The recycled water is reused as wash water. The EPA suggests the stages of treatment, as shown in Figure 10-8. Another approach to wastewater treatment uses microbes to break down chemical compounds (Figure 10-9). Both types of systems may require additional purification steps to remove odors and harmful bacteria. These systems must be carefully sized to process the peak water volume anticipated for contaminant levels expected. The equipment varies in costs but increases with structural requirements and permits.

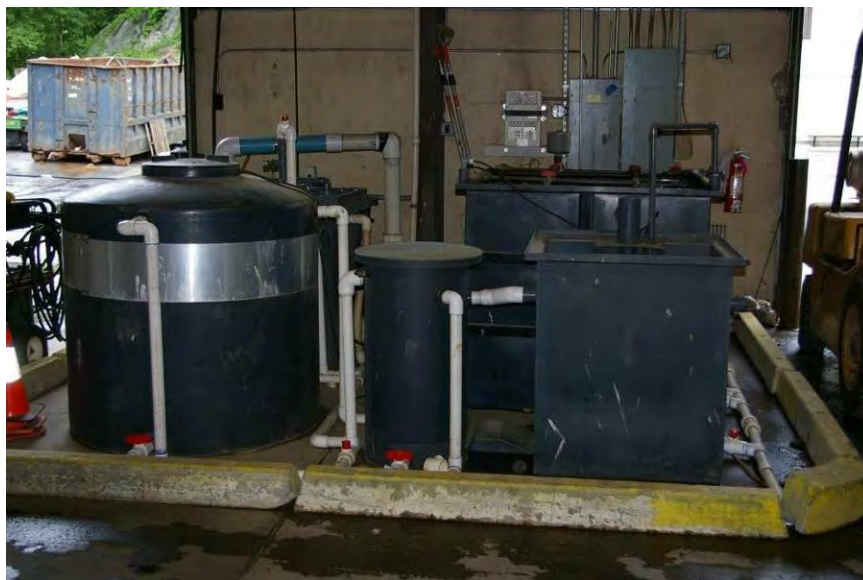
Figure 10-9. Microbial system for treating wastewater. Source: Robert Alonzi.

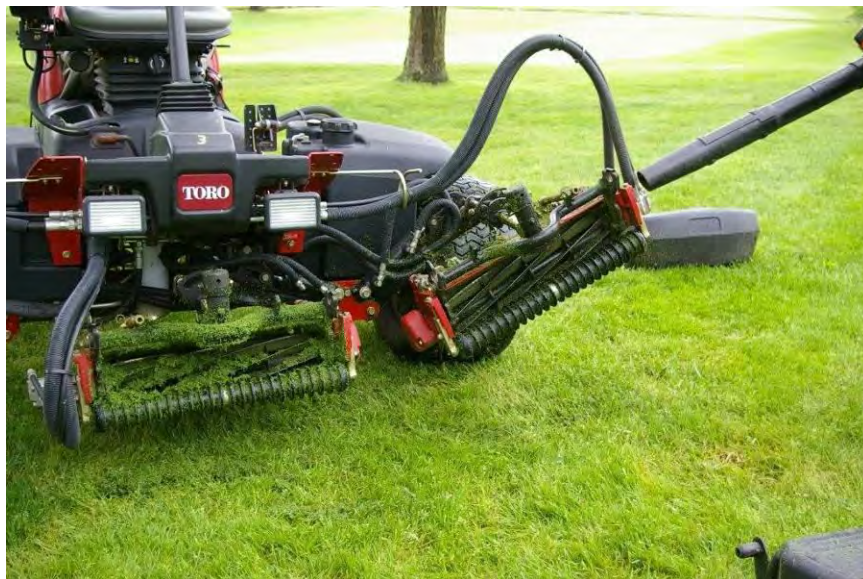
Figure 10-11. Prior to washing equipment, removing clippings while over grass (top) or a pad (bottom) with an air hose or prewash reduces the amount of organic debris in the wash water. Source: Robert Alonzi.

(Figure 10-11). If water is being used, sumps should screen and convey clippings and other solids prior to wastewater disposal or treatment.

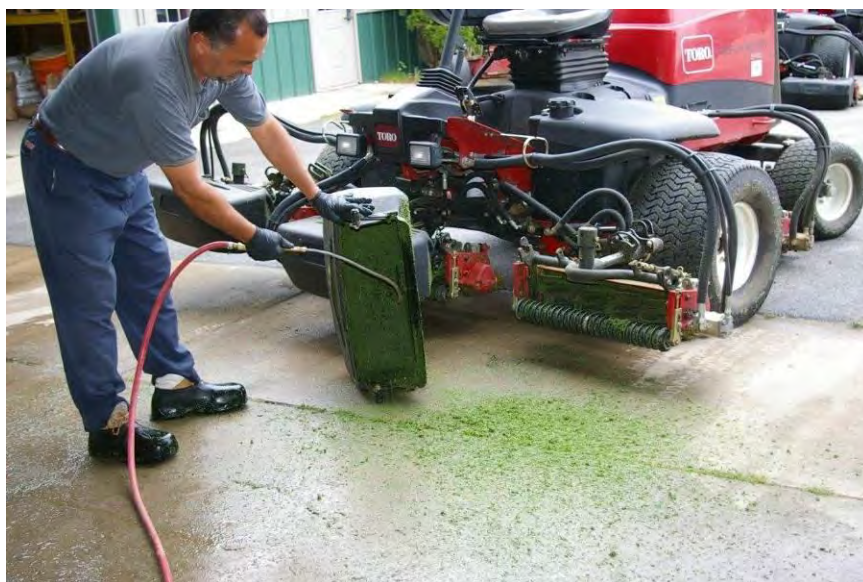
Figure 10-12. Typical equipment wash area with drain. Source: Robert Alonzi.

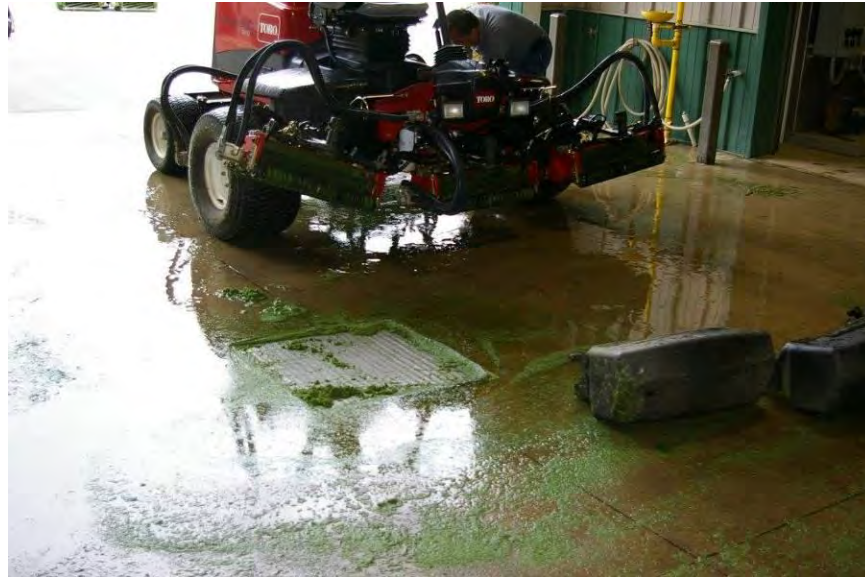
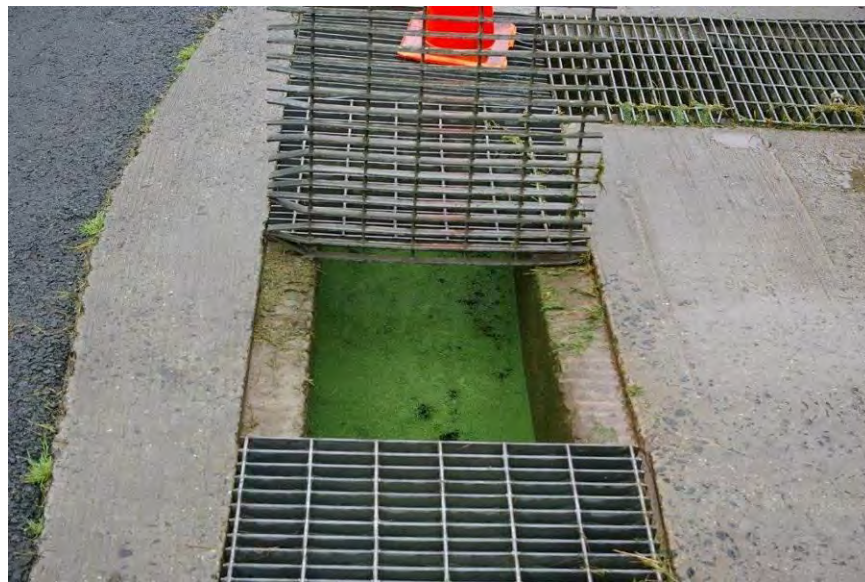
Figure 10-13. A Retrofitted RGF system separates solids in the wash water. *Source:* Robert Alonzi.

Clippings should be screened and collected when cleaning equipment in the maintenance area (Figure 10-13). They should not be allowed into the stream of wastewater. The inherent concentration of organic nitrogen and phosphorus, along with any pesticide residues, can contaminate the wastewater or reduce the effectiveness of wastewater treatment equipment. Ideally, clippings should be blown off using compressed air and then collected

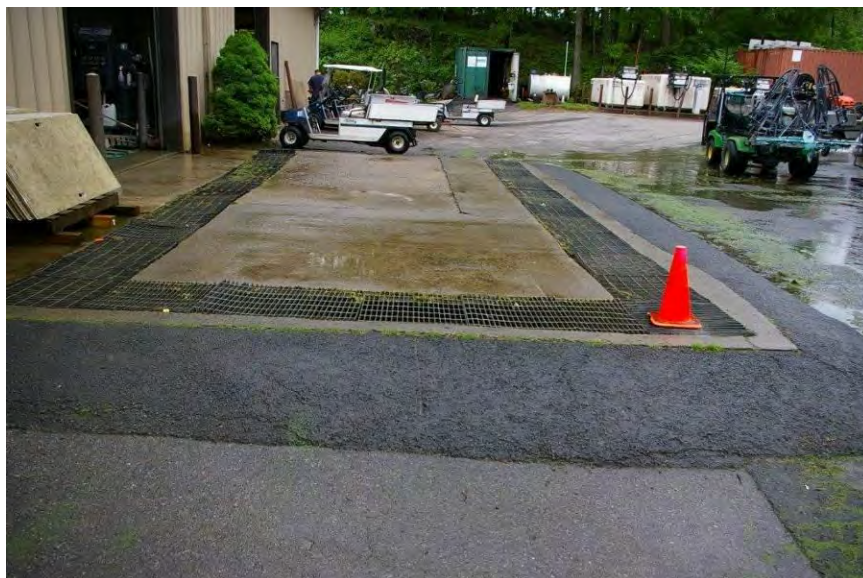
Figure 10-14. A retrofitted RGF system solid separation pad. Source: Robert Alonzi.

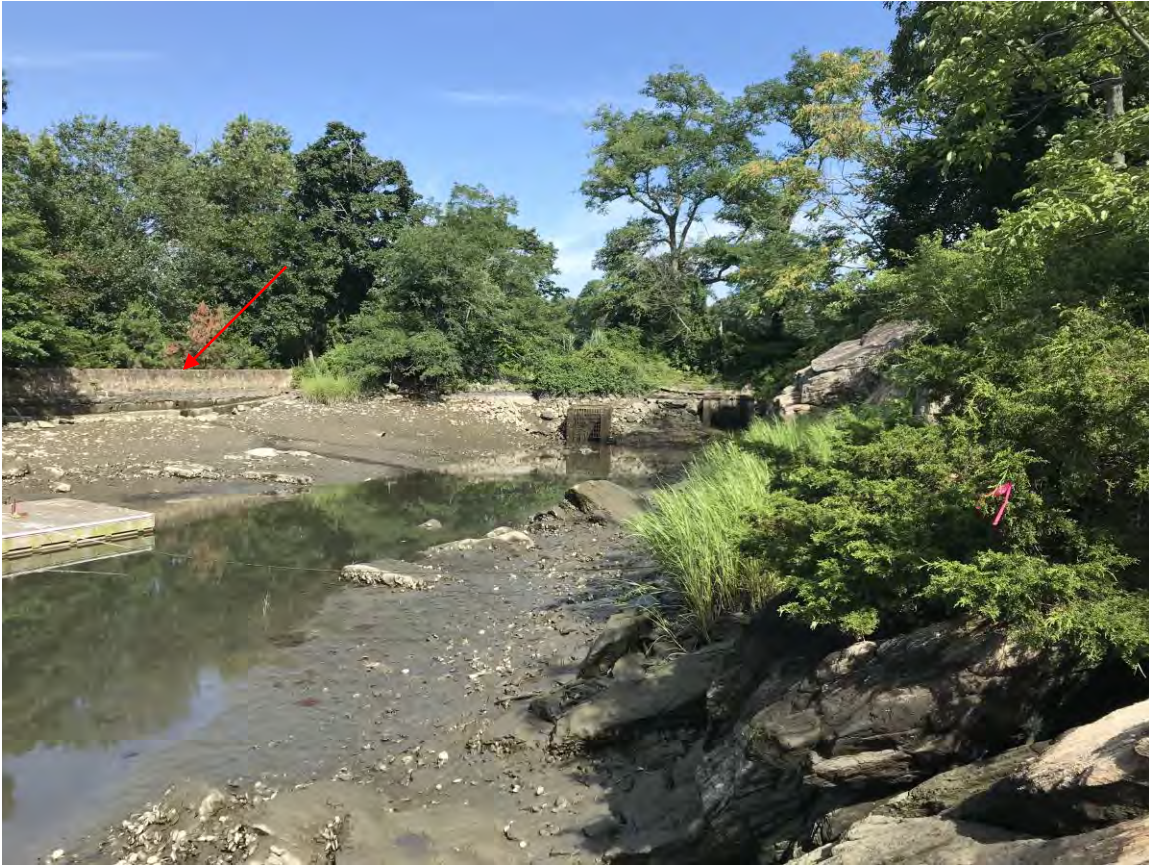
Photograph No. 1: View of stone seawall (as indicated by the arrow) along the Delancey Cove shoreline (July 31, 2018).

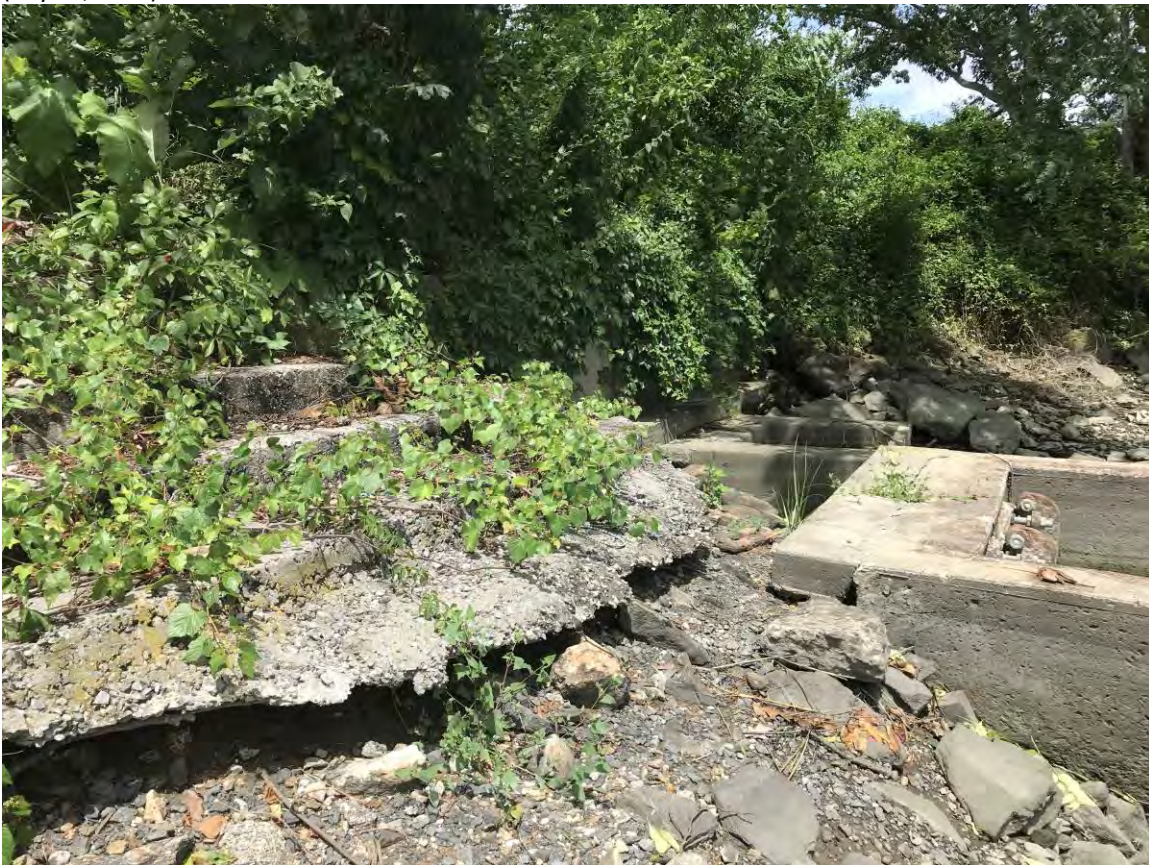
Photograph No. 2: View of concrete retaining wall and tide gate structures along the Delancey Cove shoreline (July 31, 2018).

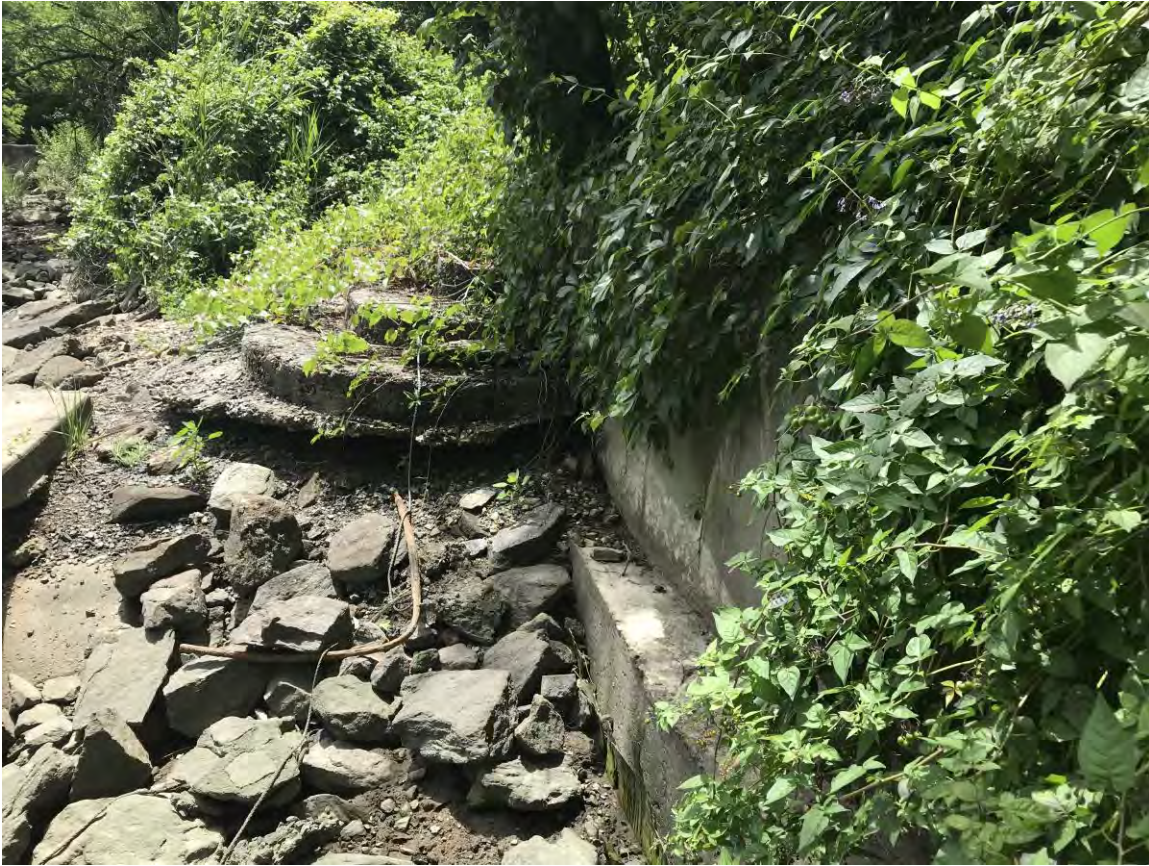
Photograph No. 3: View of concrete retaining wall along the Delancey Cove shoreline (July 31, 2018).

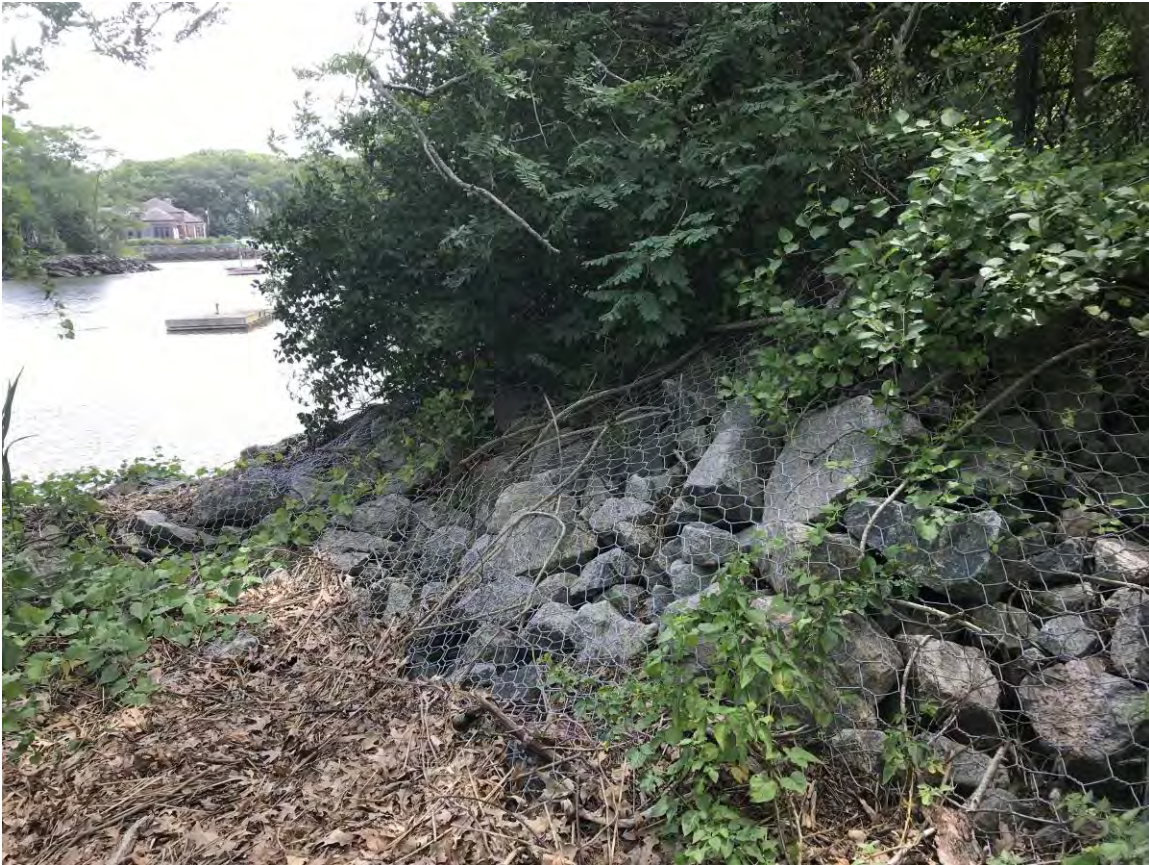
Photograph No. 4: View of rip-rap gabions along the Delancey Cove shoreline (July 31, 2018).

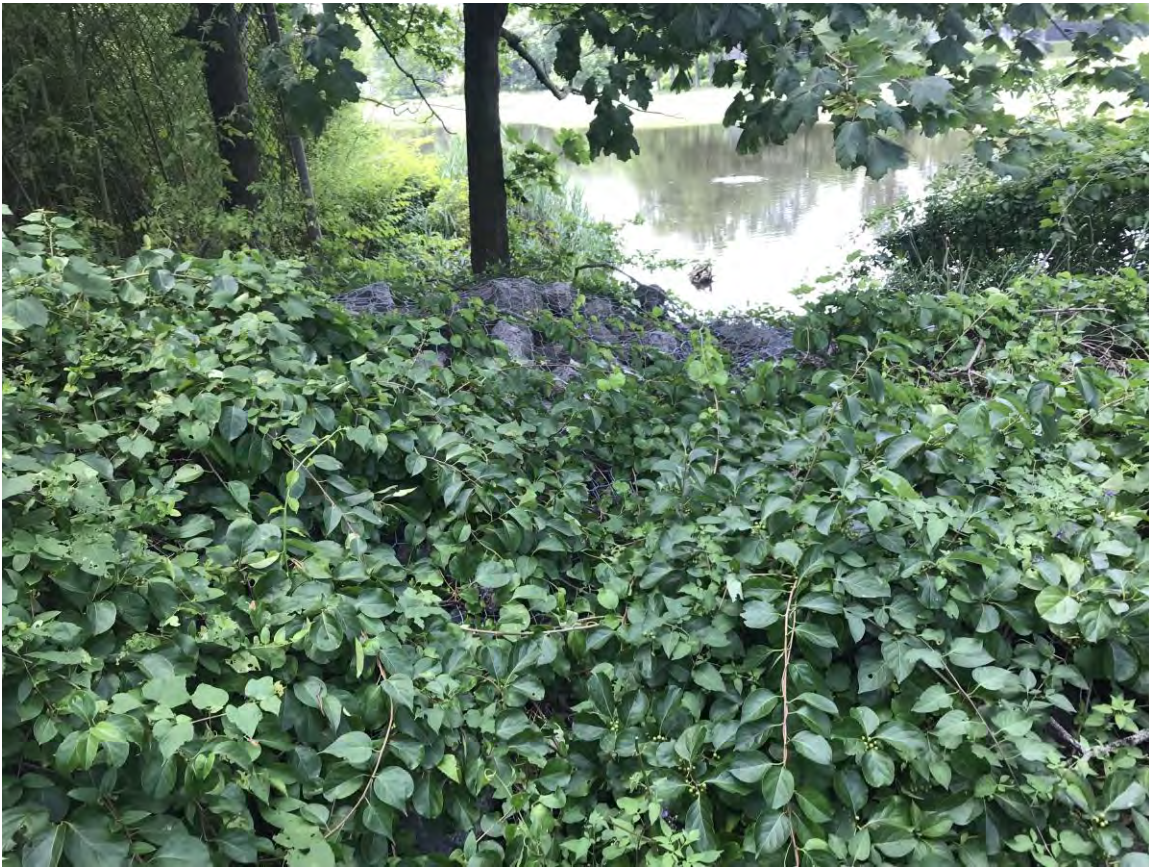
Photograph No. 5: View of rip-rap gabions landward of the shoreline area (July 31, 2018).

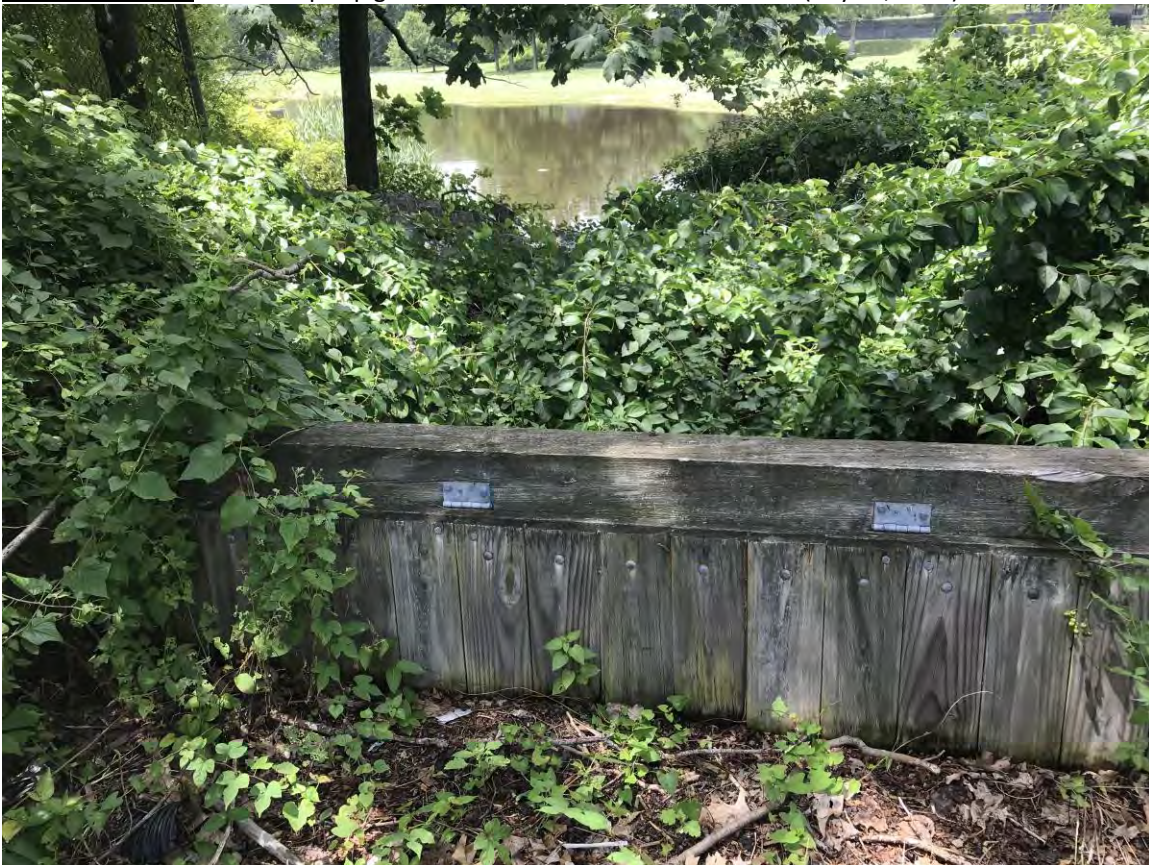
Photograph No. 6: View of timber bulkhead located landward of the shoreline area (July 31, 2018).

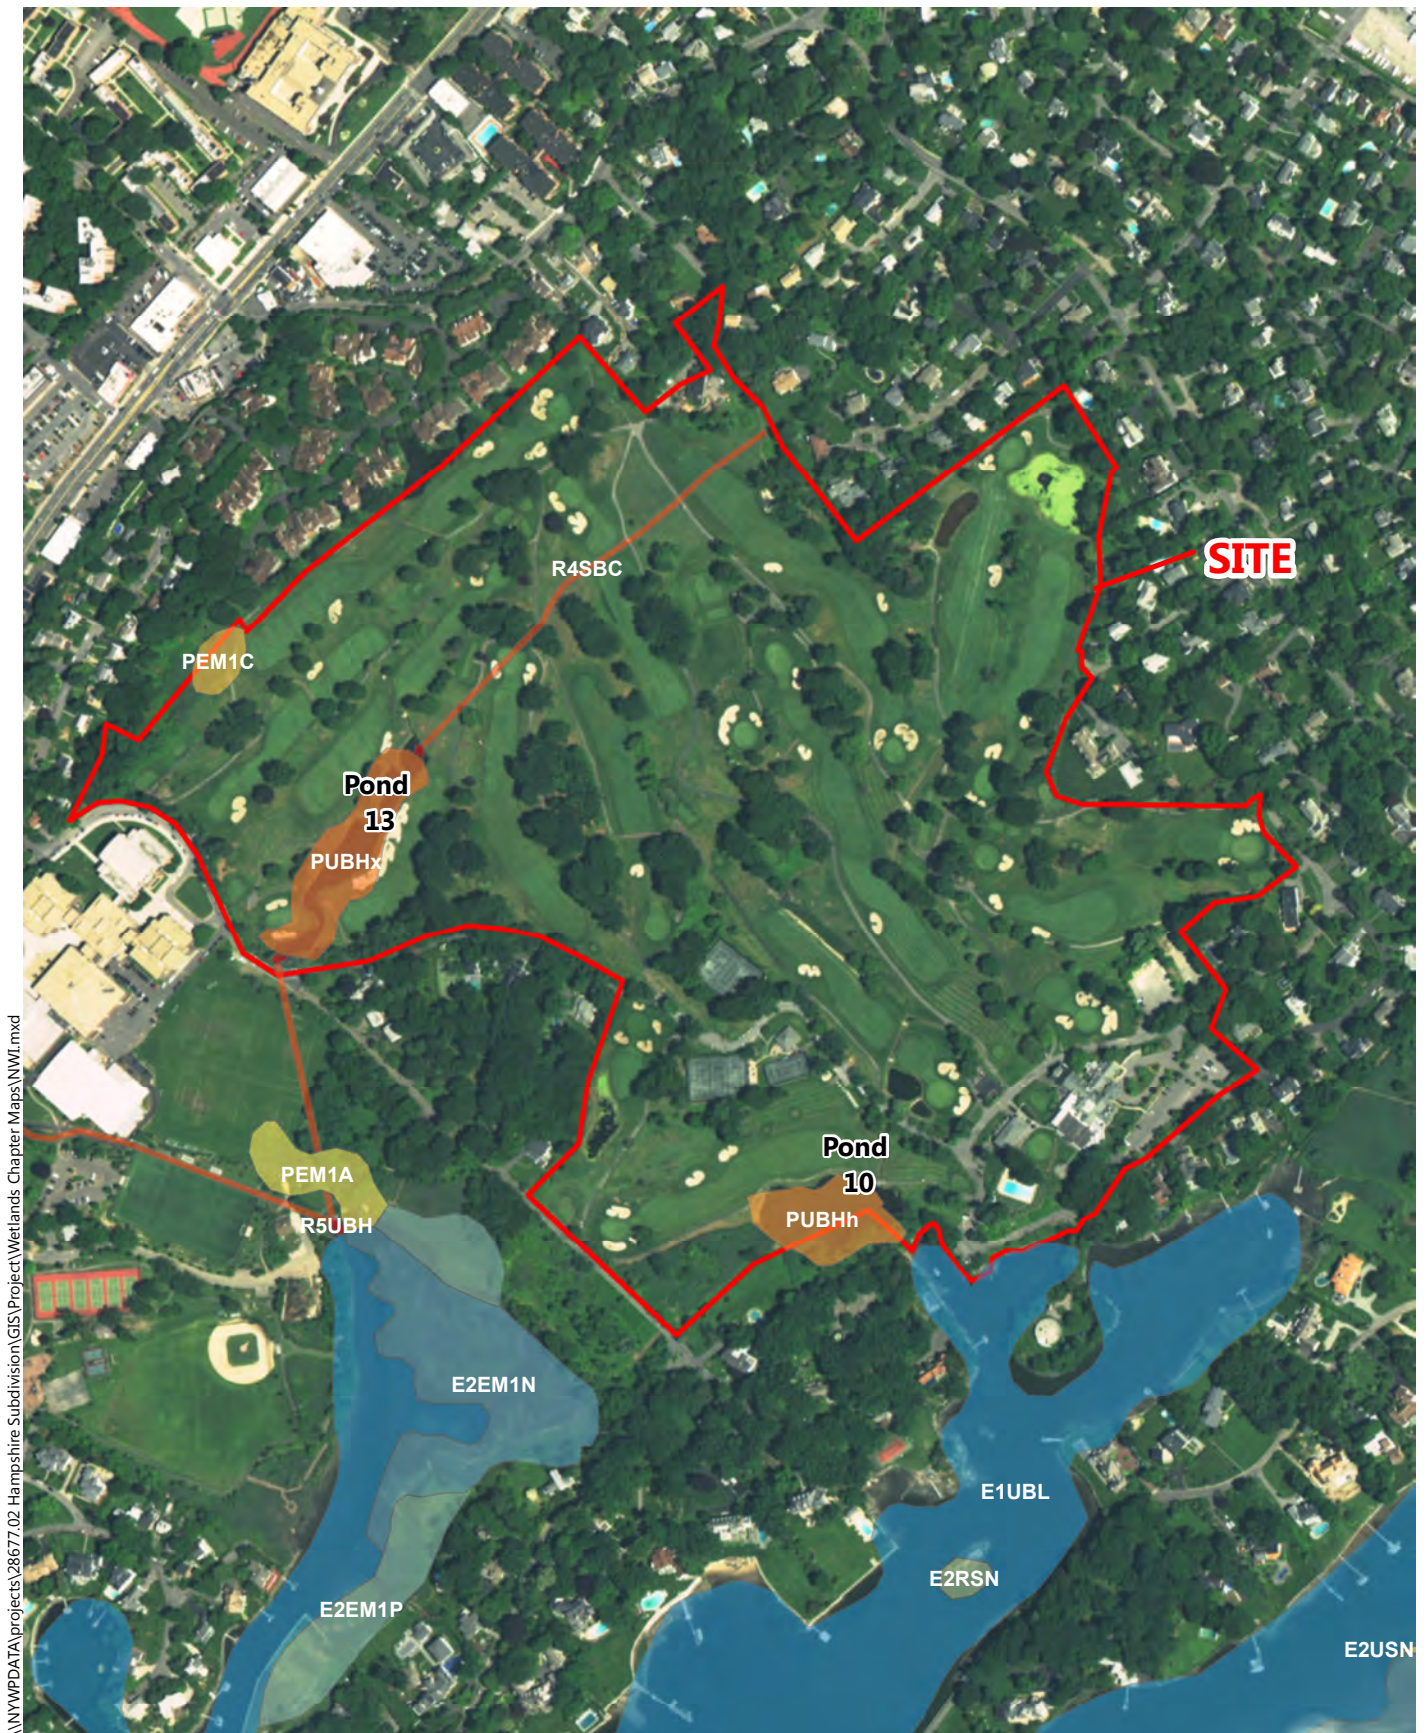
FIGURE 4 – DRAINAGE SYSTEM AND WETLAND MAP*

*Based on wetland delineation conducted by Nelson, Pope and Voorhis, LLC in 2012 and verified by VHB on July 24 and 31, 2018.

The Subject Property, which has a topographic elevation ranging from 0 to 23±-feet above mean sea level (see Appendix A, Figure 3), abuts the tidal waters of Delancey Cove (which is a tributary to Long Island Sound) to the south and contains several ponds, drainage ditches and subgrade drainage pipes associated with three golf course drainage systems (Golf Course Drainage Systems 1, 2 and 3), as well as an emergent marsh (Wetland A) (see Appendix A Figure 4). These features were created or altered historically for drainage and irrigation and to serve as water hazards for the golf course, which has been operational since 1944. Two of the golf course drainage systems (Golf Course Drainage Systems 1 and 3) discharge to Delancey Cove via a series of culverts and tide gates, while the third drainage system (Golf Course Drainage System 2) is self-contained. A summary of the three golf course drainage systems and Wetland A is provided on Table 1.

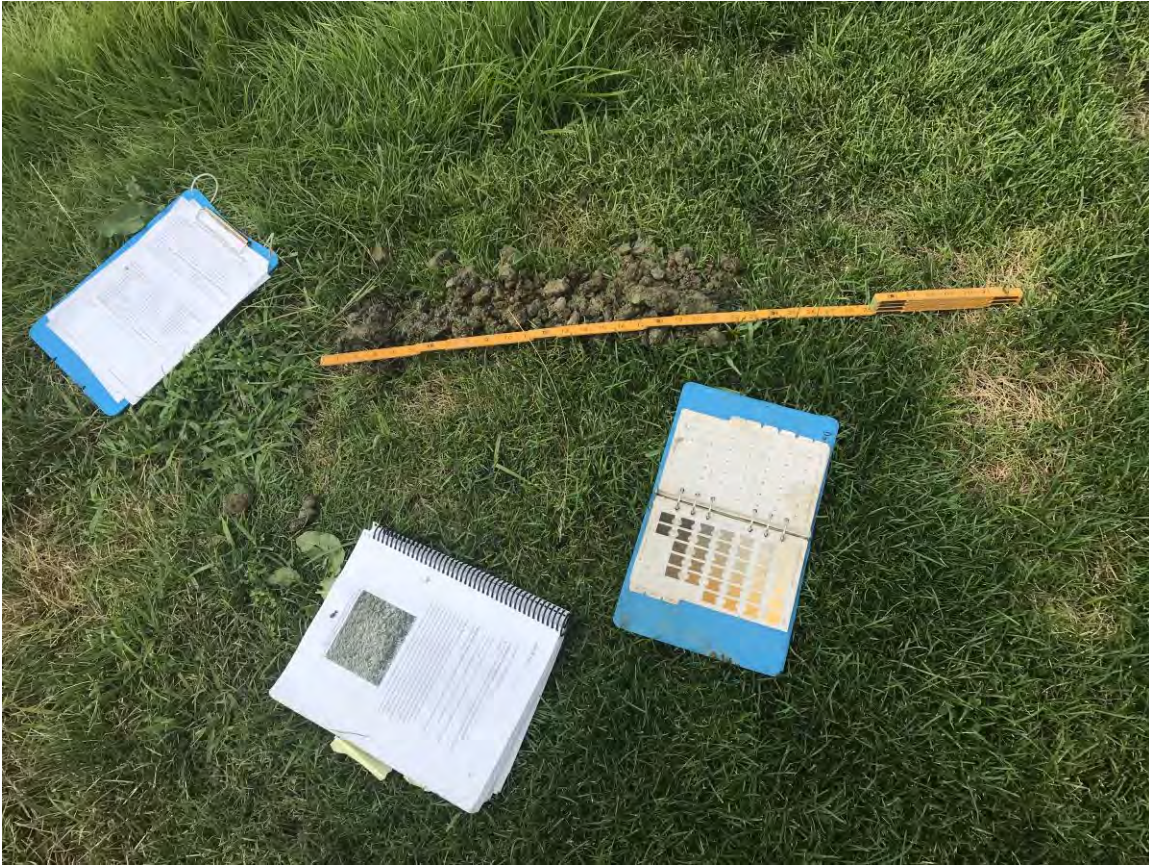
Photograph No. 3: View of wetland soil boring at the Pond 6 data plot (July 24, 2018).

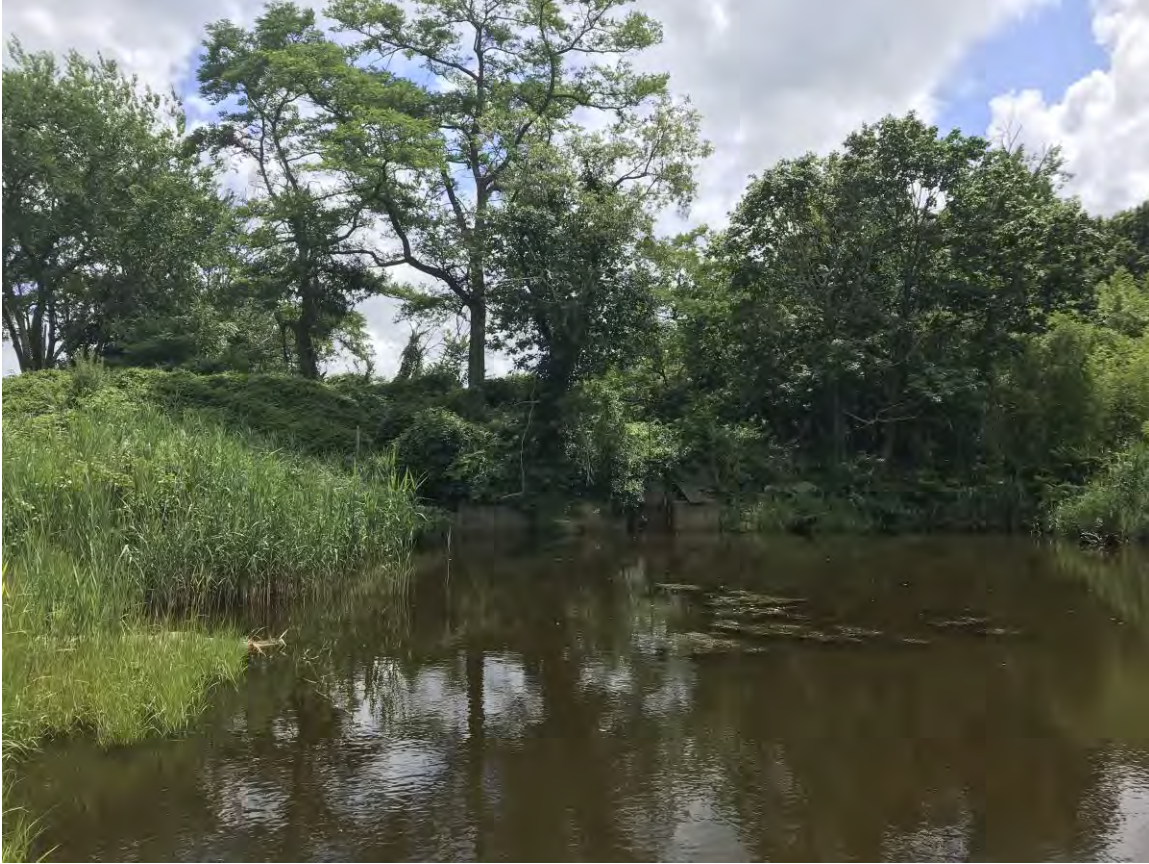
Photograph No. 6: View of tide gate openings at the eastern terminus of Pond 10 (Golf Course Drainage System 3), facing southeast (July 24, 2018).

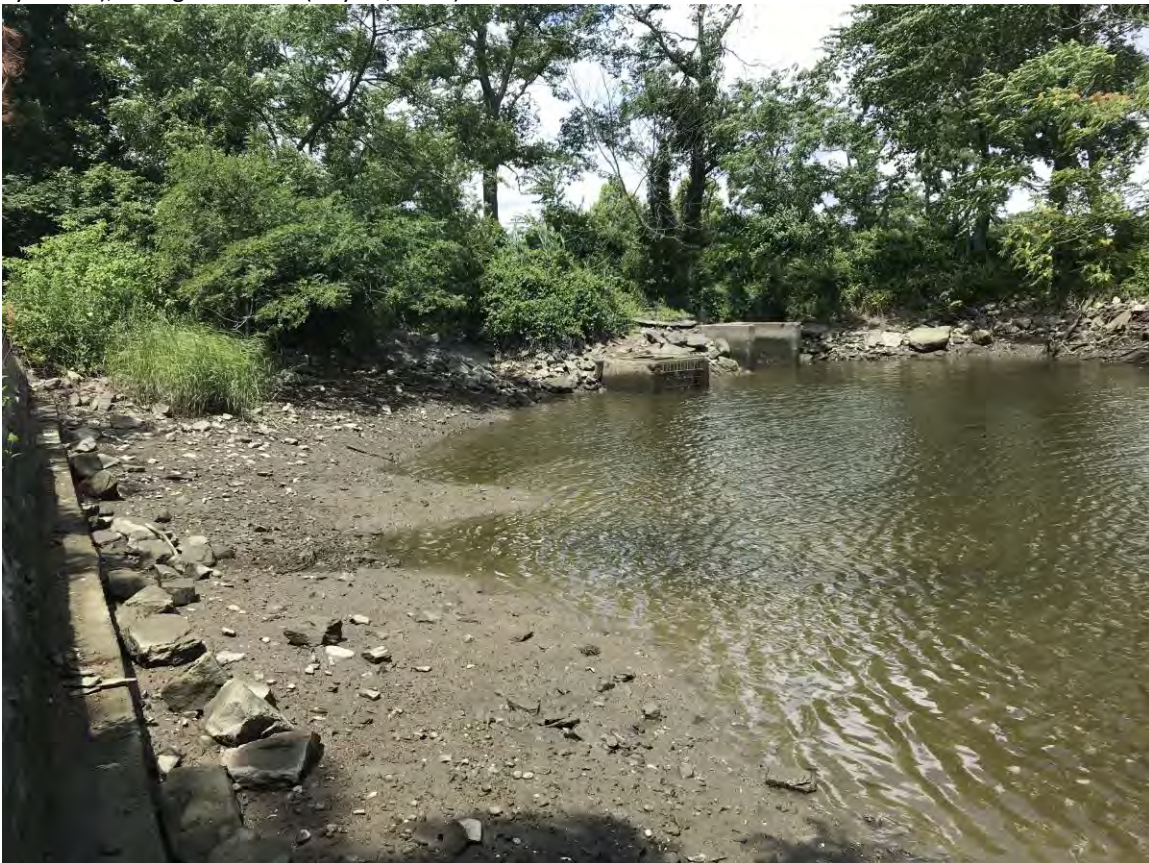
Photograph No. 7: View of tide gate openings along the northern shoreline of Delancey Cove, facing north (July 24, 2018). The tide gates regulate flow through culverts connecting Delancey Cove to Pond 10.

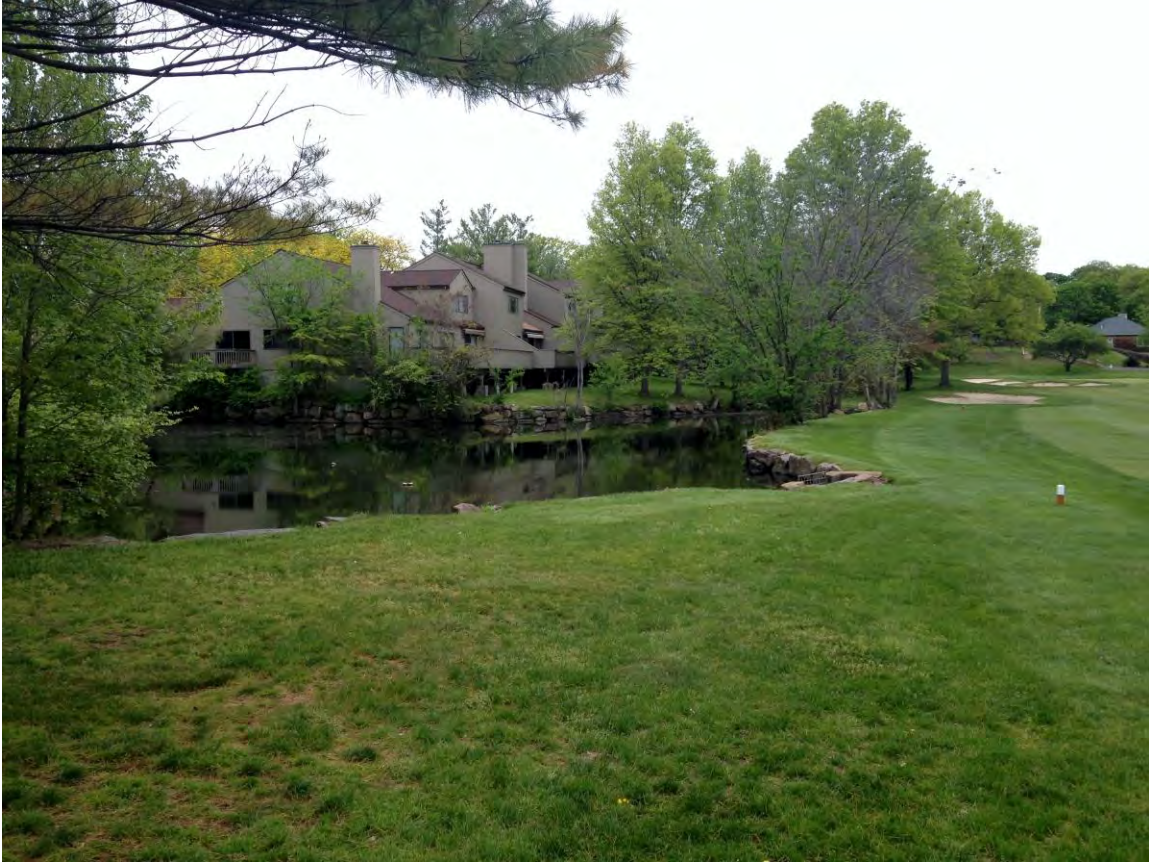
Photograph No. 1: Pond 16 of Golf Course Drainage System 1 (May 17, 2016).

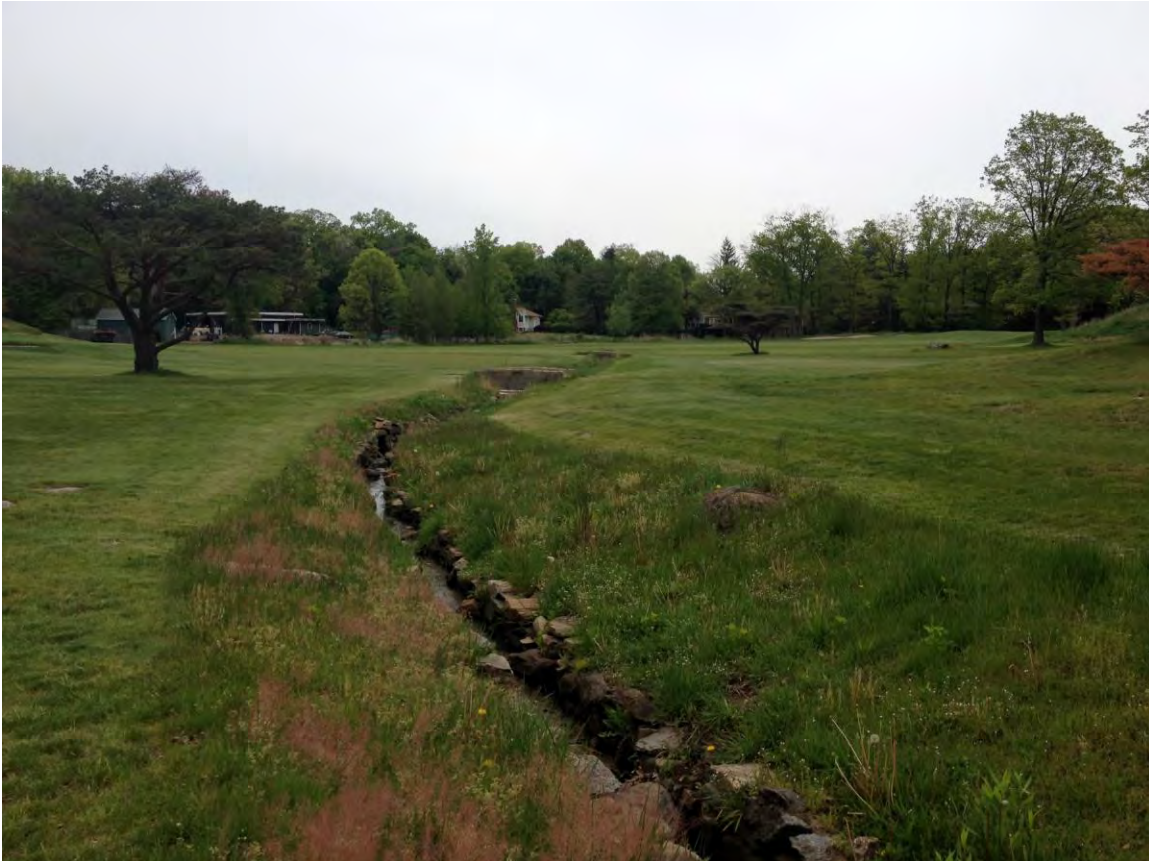
Photograph No. 2: Ditch 1 of Golf Course Drainage System 1 (May 17, 2016).
