Hampshire Country Club Planned Residential Development
Village of Mamaroneck,
Westchester County, New York
Final Environmental Impact Statement

Best Management Practices for New York State Golf Courses

February 2014

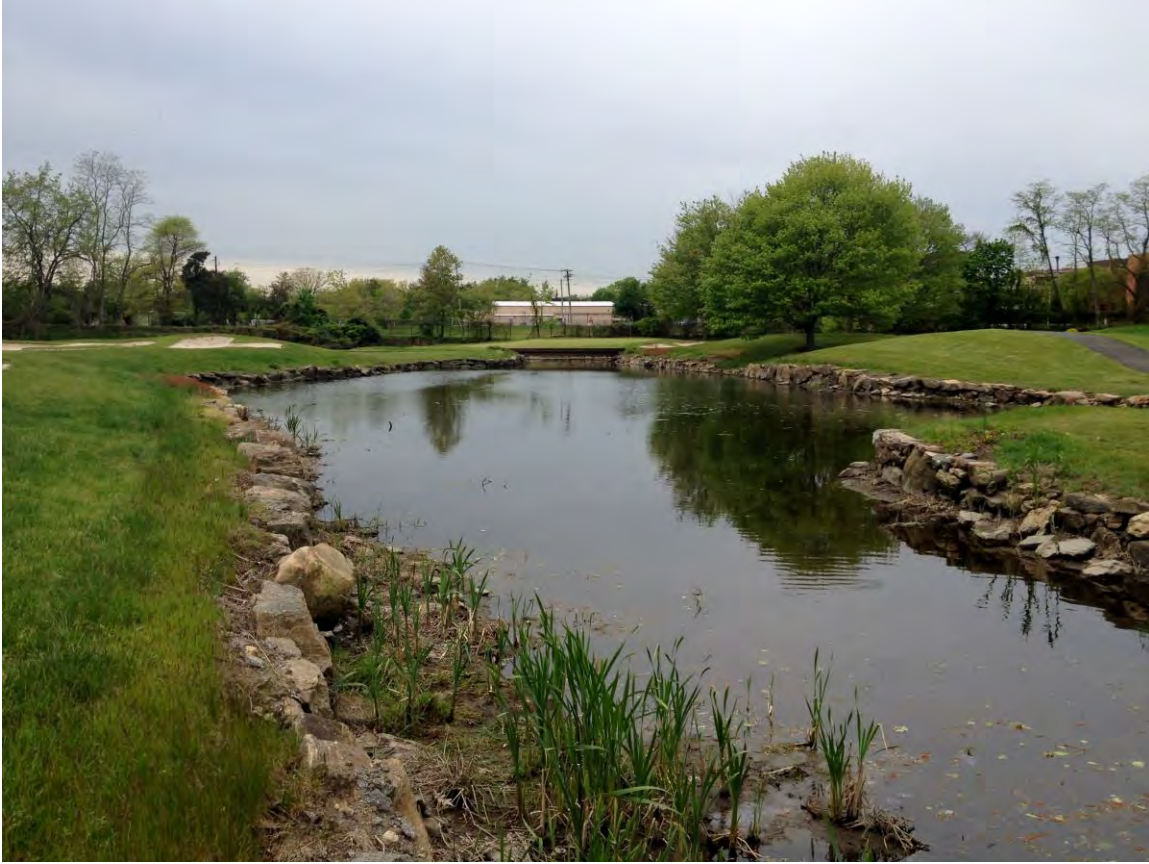
Photograph No. 3: Pond 13 of Golf Course Drainage System 1 (May 17, 2016).

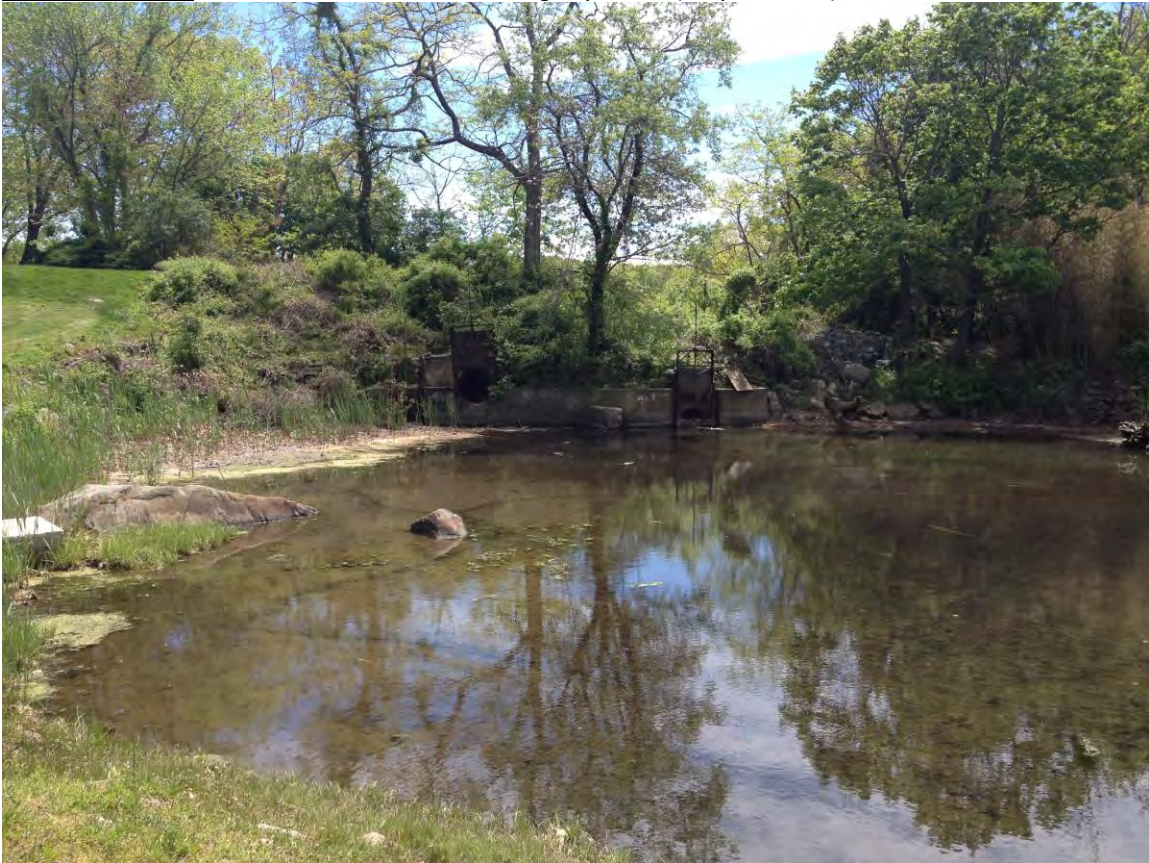
Photograph No. 4: Culverts with gate valves at the western end of Pond13, within Golf Course Drainage System 1 (May 17, 2016).

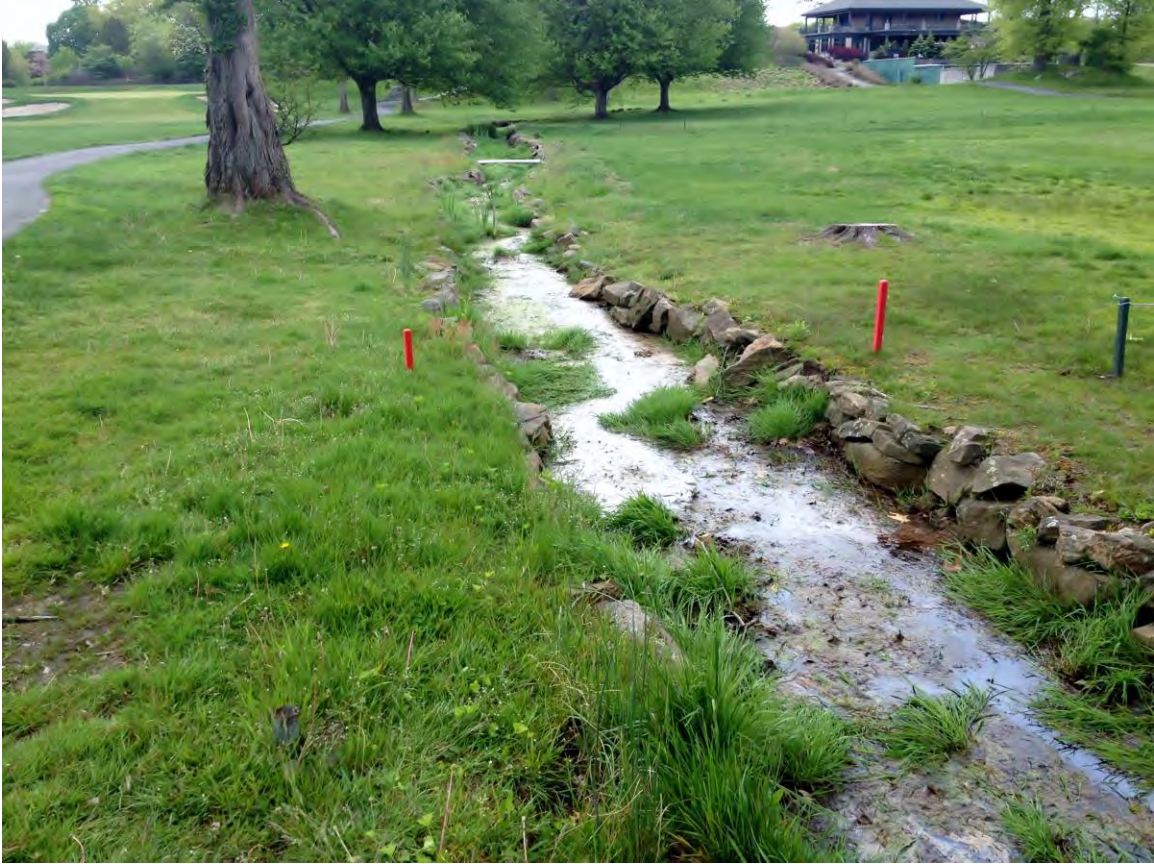
Photograph No. 5: Ditch 2 of Golf Course Drainage System 3 (May 18, 2016).

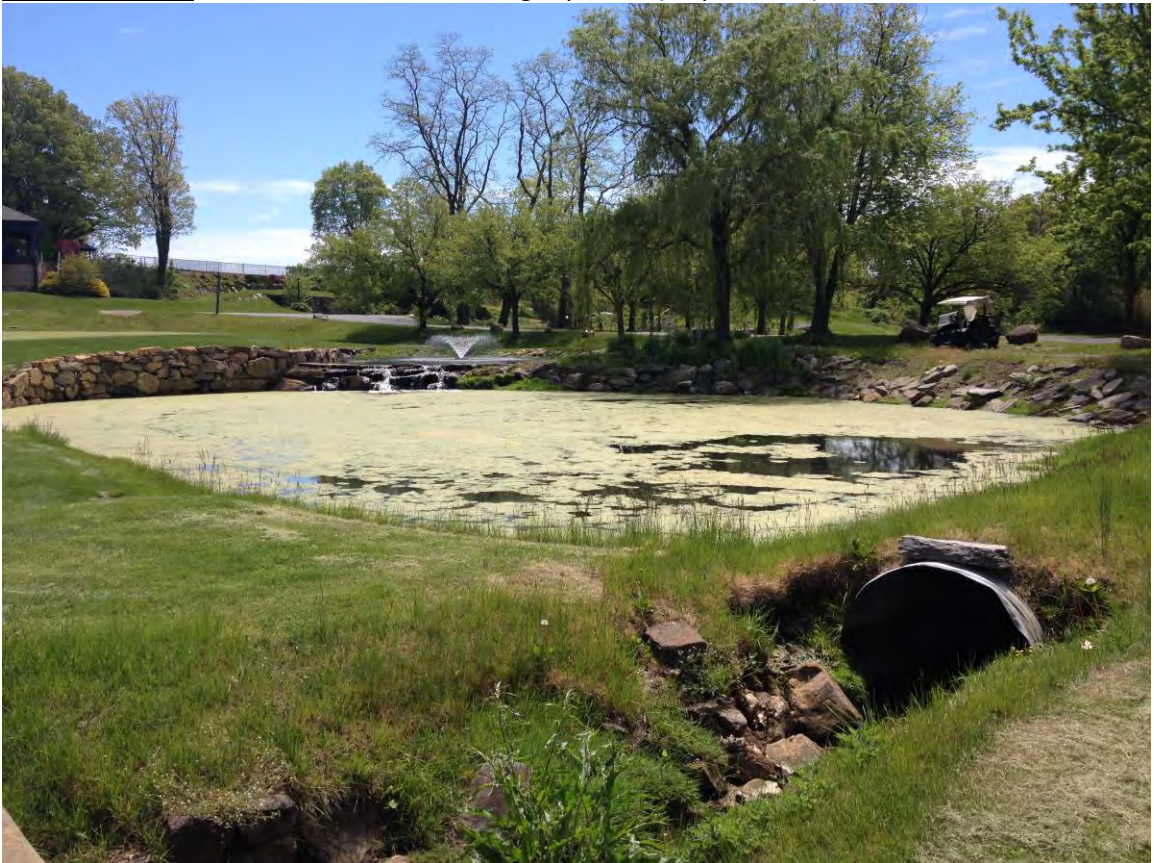
Photograph No. 6: Lower level (foreground) and upper level (background, with fountain) of Pond 18 of Golf Course Drainage System 3 (May 17, 2016).

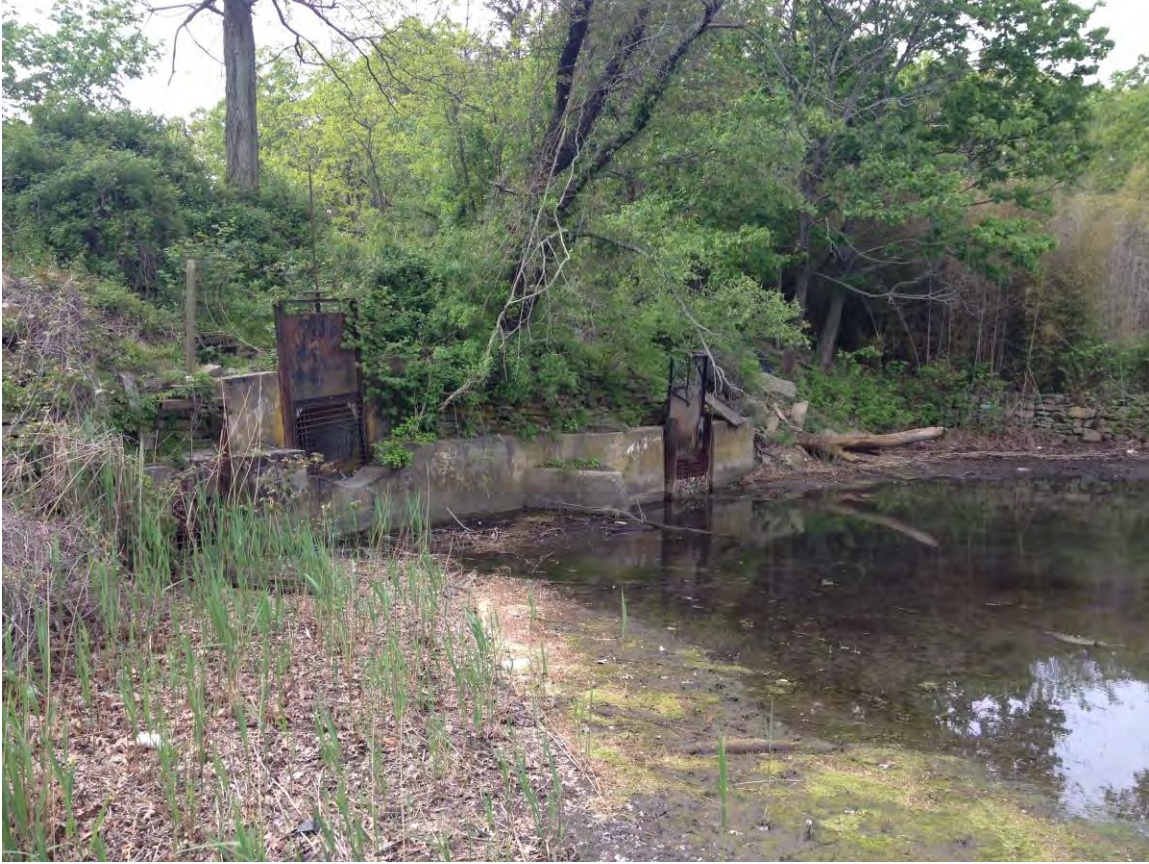
Photograph No. 7: Gate valves at the southeastern end of Pond 10. of Golf Course Drainage System 3 (May 18, 2016).

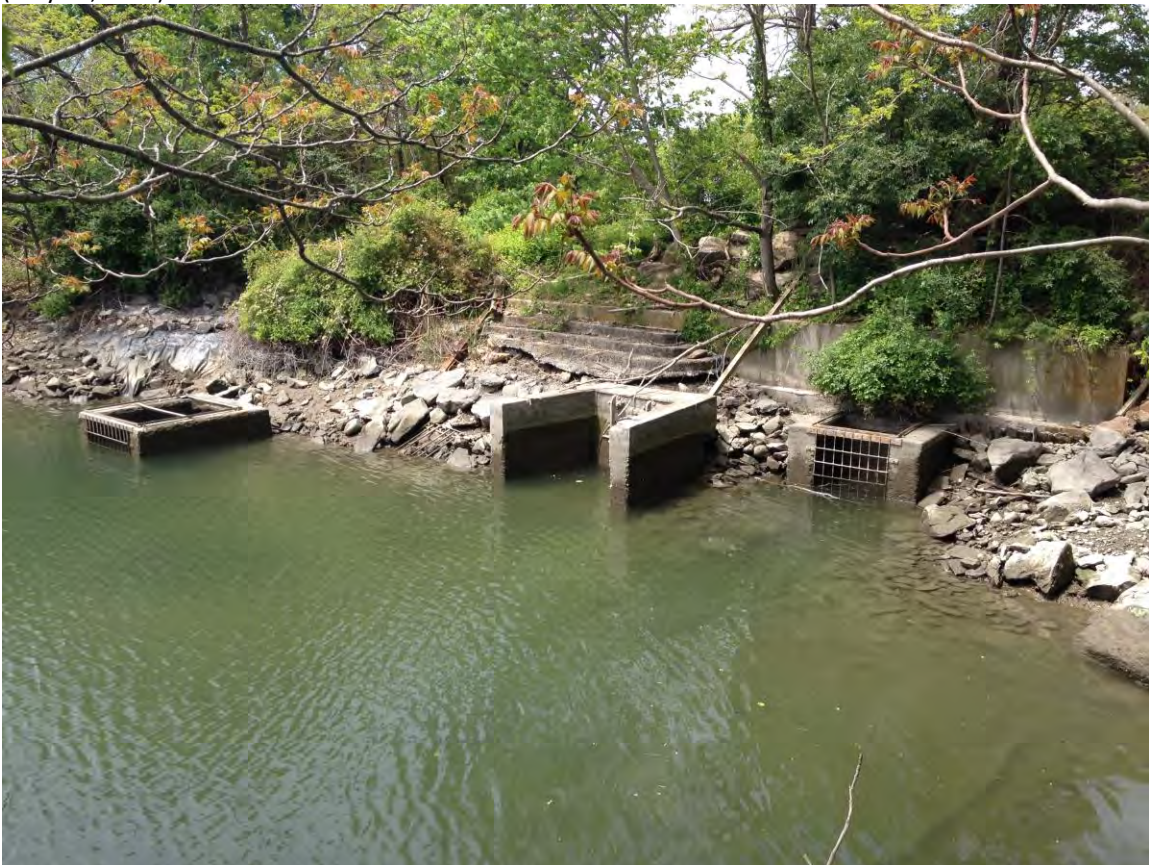
Photograph No. 8: Concrete control structures located along the shoreline of Delancey Cove. The control structures allow intermittent tidal flow to Golf Course Drainage System 3 (May 18, 2016).

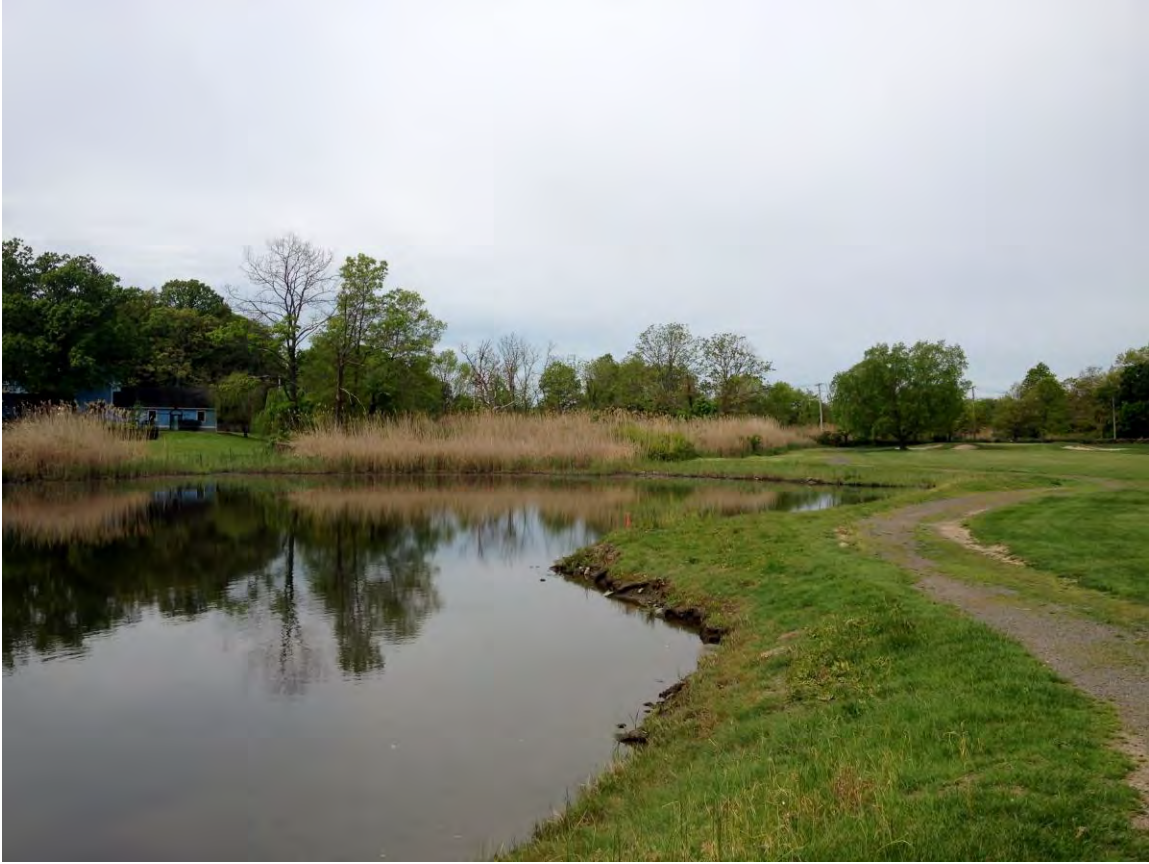
Photograph No. 9: Pond 10 (foreground) and contiguous vegetated wetland (background) of Golf Course Drainage System 3 (May 18, 2016).

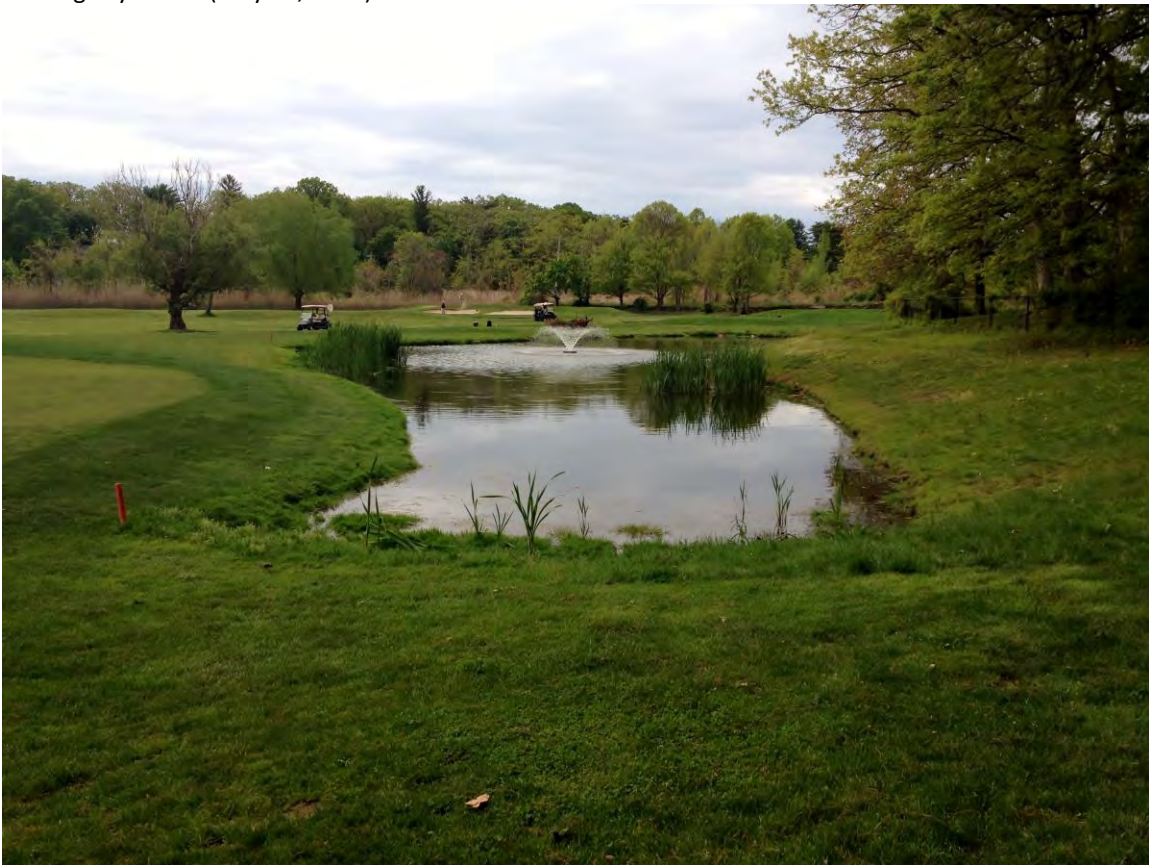
Photograph No. 10: Pond 11 of Golf Course Drainage System 3 (May 18, 2016).

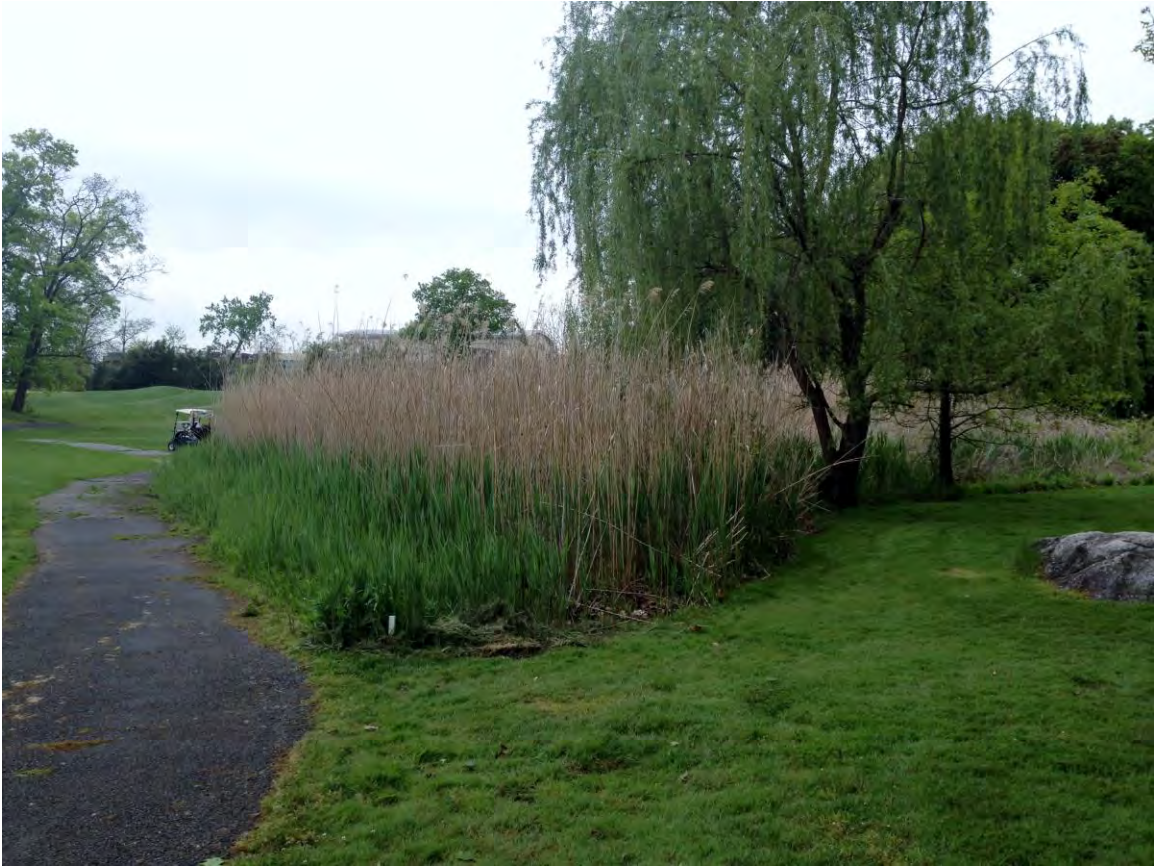
Photograph No. 11: Isolated Wetland A (May 17, 2016).

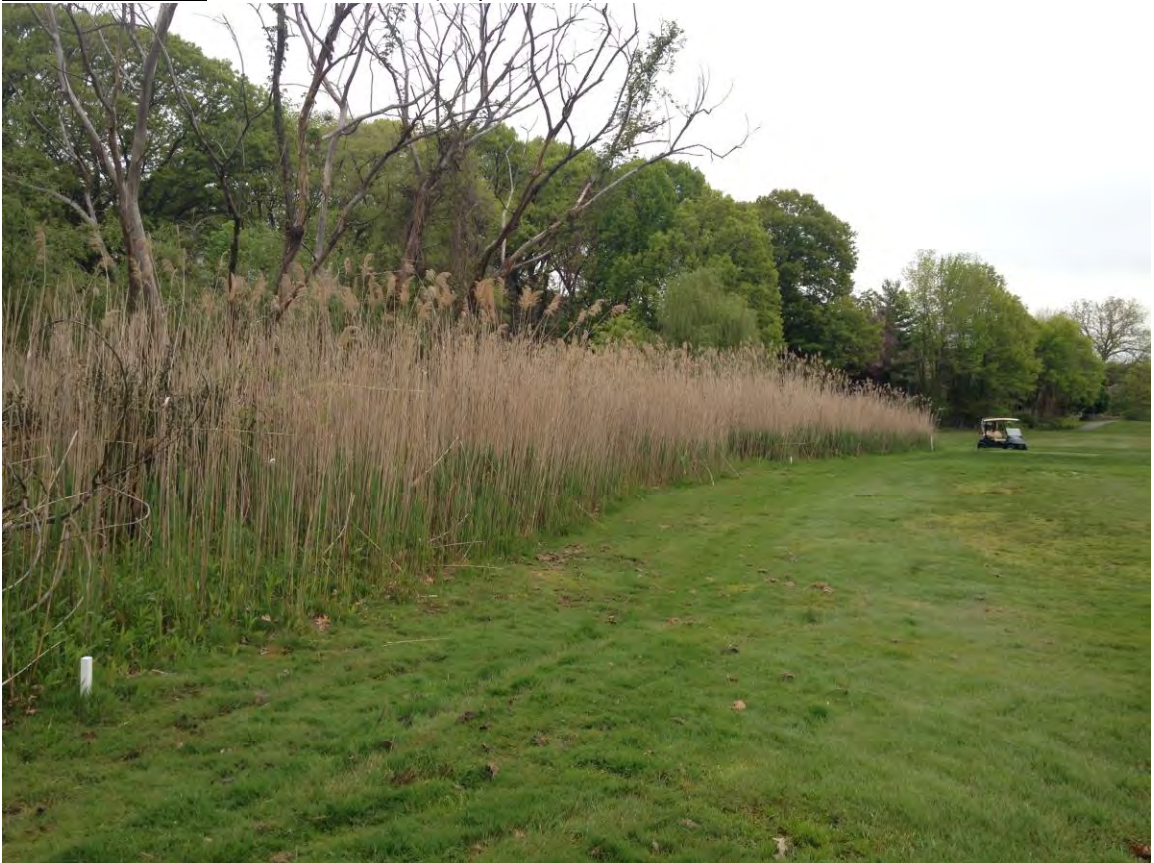
Photograph No. 12: Emergent wetland vegetation along the boundary of Isolated Wetland A (May 17, 2016).

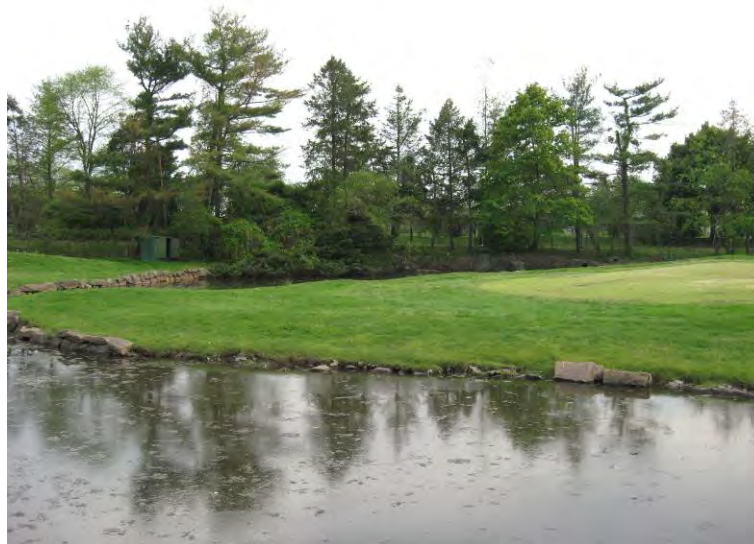
Review of historic aerials suggest that Pond #13 was a naturally occurring system that was modified and expanded between 1960 and 1976. Pond #13's connection to the athletic field on the west side of Hommocks Road is apparent as a pipe beneath Hommocks Road was visible at the western edge of this pond.

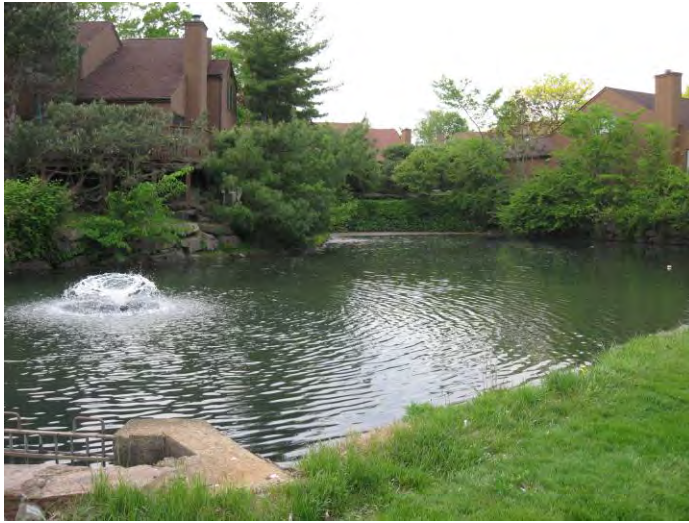
Fairway Green Townhouses pond (Pond #16).

The connection between Pond #13 and Pond #16 was evident also during field inspections. Underground piping and culverts from the Pond #16 were found to be contiguous with the stream which enters Pond #13. Pond #16 was reportedly built in 1982 for use by both the townhomes to the north and the golf course. This pond has notable silt and organic sediment build-up. An illicit discharge from a commercial use located to the north was previously detected and was

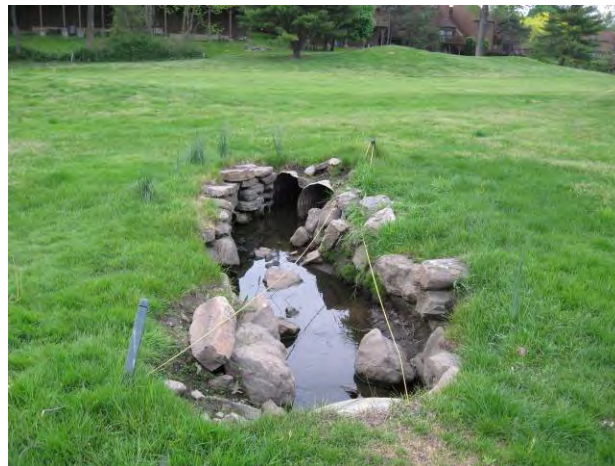
The southern pond, identified on the survey as “Prickly Pear Inlet,” or Pond #10 has a concrete control structure which separates it from the tidal wetlands of Delancey Cove immediately south of the property. The control structure contains two pipes which are set at different elevations so that one is partially submerged during low tides, while the other is raised higher though still within the range of tidal influence. On the landward side of this control structure, the lower pipe appeared to be closed, but the higher elevation pipe is currently in the open position. This pond is also a naturally occurring feature that has been modified over time.

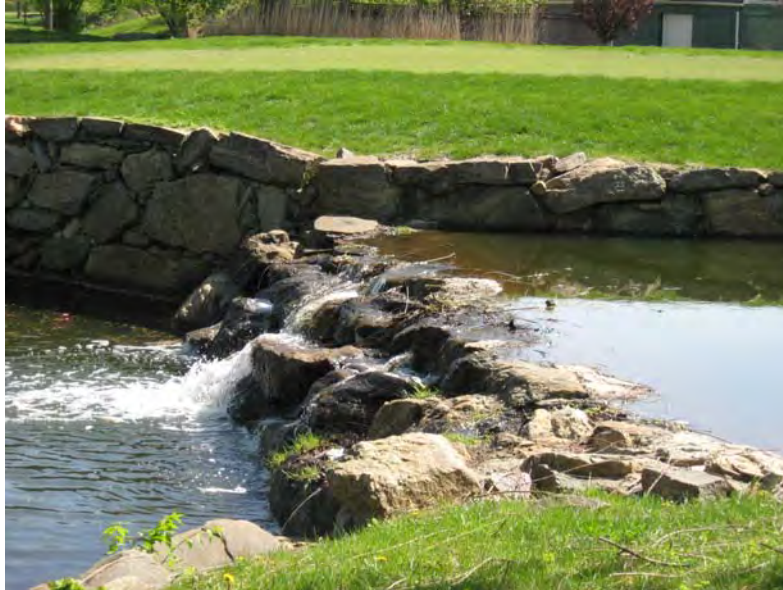
View of the waterfall structure on Pond 18

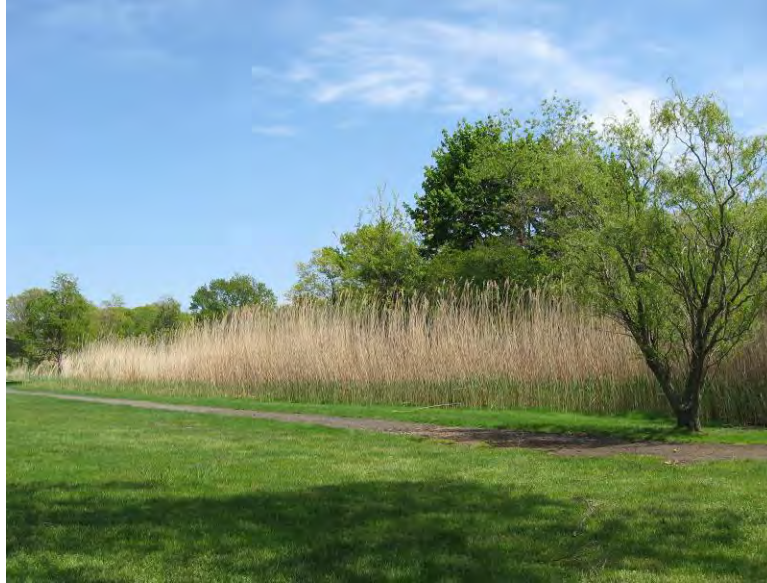
Southern vegetated marsh

Adjacent to the west of Prickly Pear Inlet, an additional wetlands area was identified and field located with a hand-held Geographic Positioning System (GPS). This area is best characterized as an emergent marsh dominated by the invasive strain of common reed (*Phragmites australis*), a common wetland plant. The wetland area exhibited varying degrees of saturated soils and standing water, organic hydric soils and hydrophytic vegetation contiguous with the adjacent pond. Several specimens of bastard oak (*Quercus sinuata*), which is a southern tree characteristic of moist habitats, were also observed growing upon the drier hummocks within this marsh area.

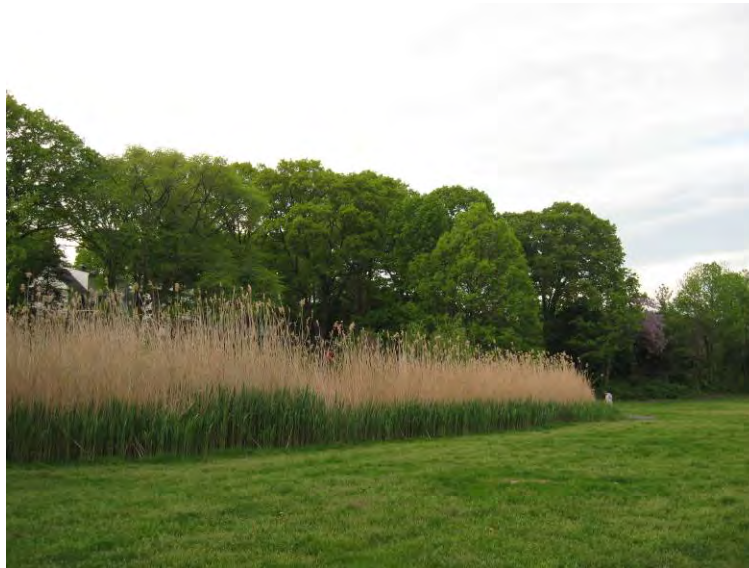
Northern vegetated marsh

The vegetated wetland area in the northwestern corner of the site is also an emergent marsh dominated by *Phragmites australis* as well as jewelweed (*Impatiens capensis*), another hydrophytic species. This marsh also contained black willow (*Salix nigra*) and pussy willow (*Salix discolor*), both of which are characteristic of wetland conditions.

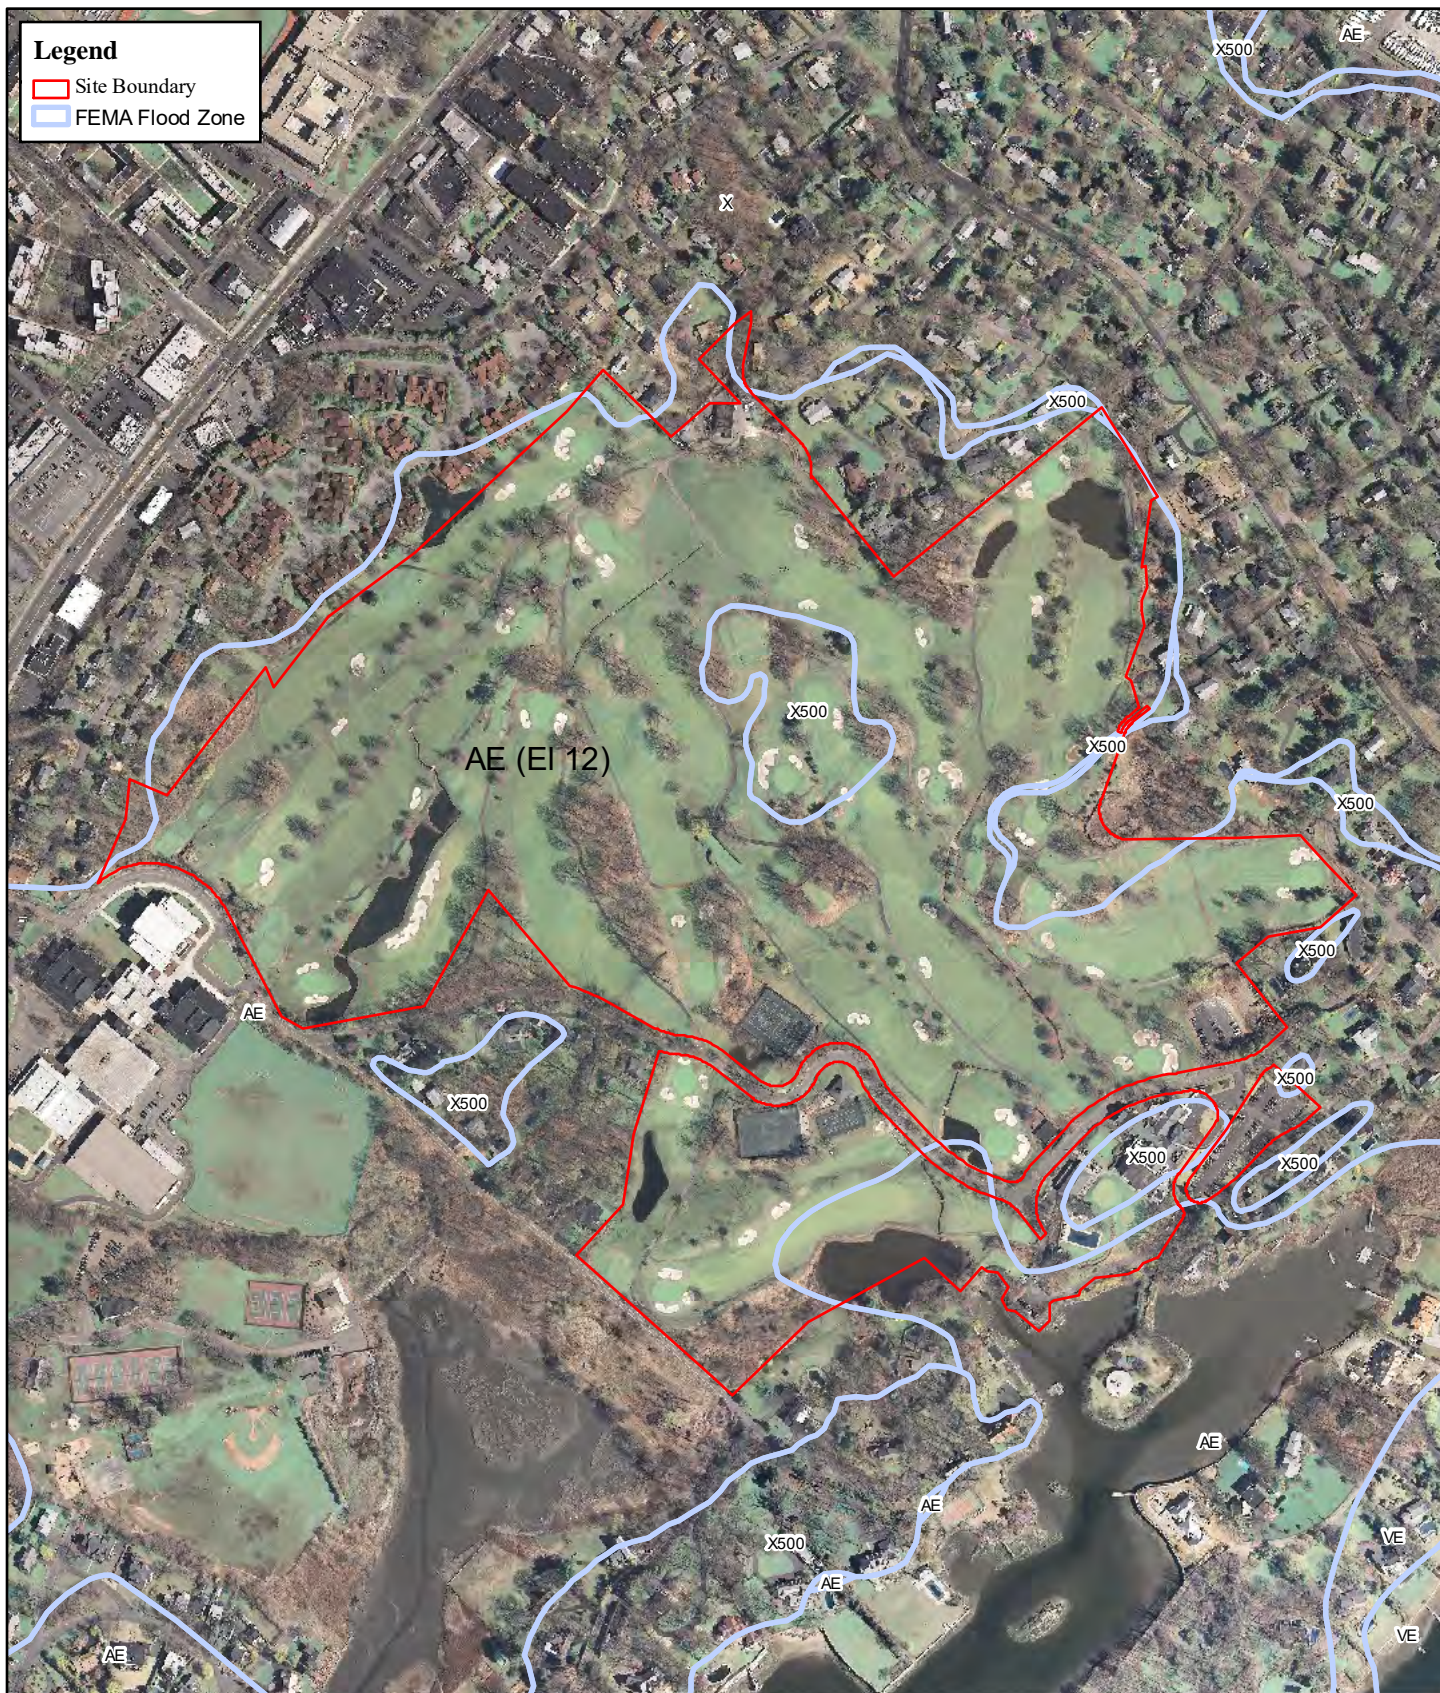
**FIGURE 2
FEMA FLOOD MAP**

As per FEMA, the property is located within a designated flood zone, Flood Zone AE (EL 12) (see **Figure 2**). Pursuant to NYS Building Code, this special flood hazard area requires that the bottom of the horizontal structural members (for multi-family structures) be located a minimum of 12 feet above mean sea level; or, for single family dwellings, a minimum freeboard of two feet be provided above the established base flood elevation (EL. 12 for the subject property). Any new structures situated within the Flood Zone would need to be appropriately designed for such conditions.

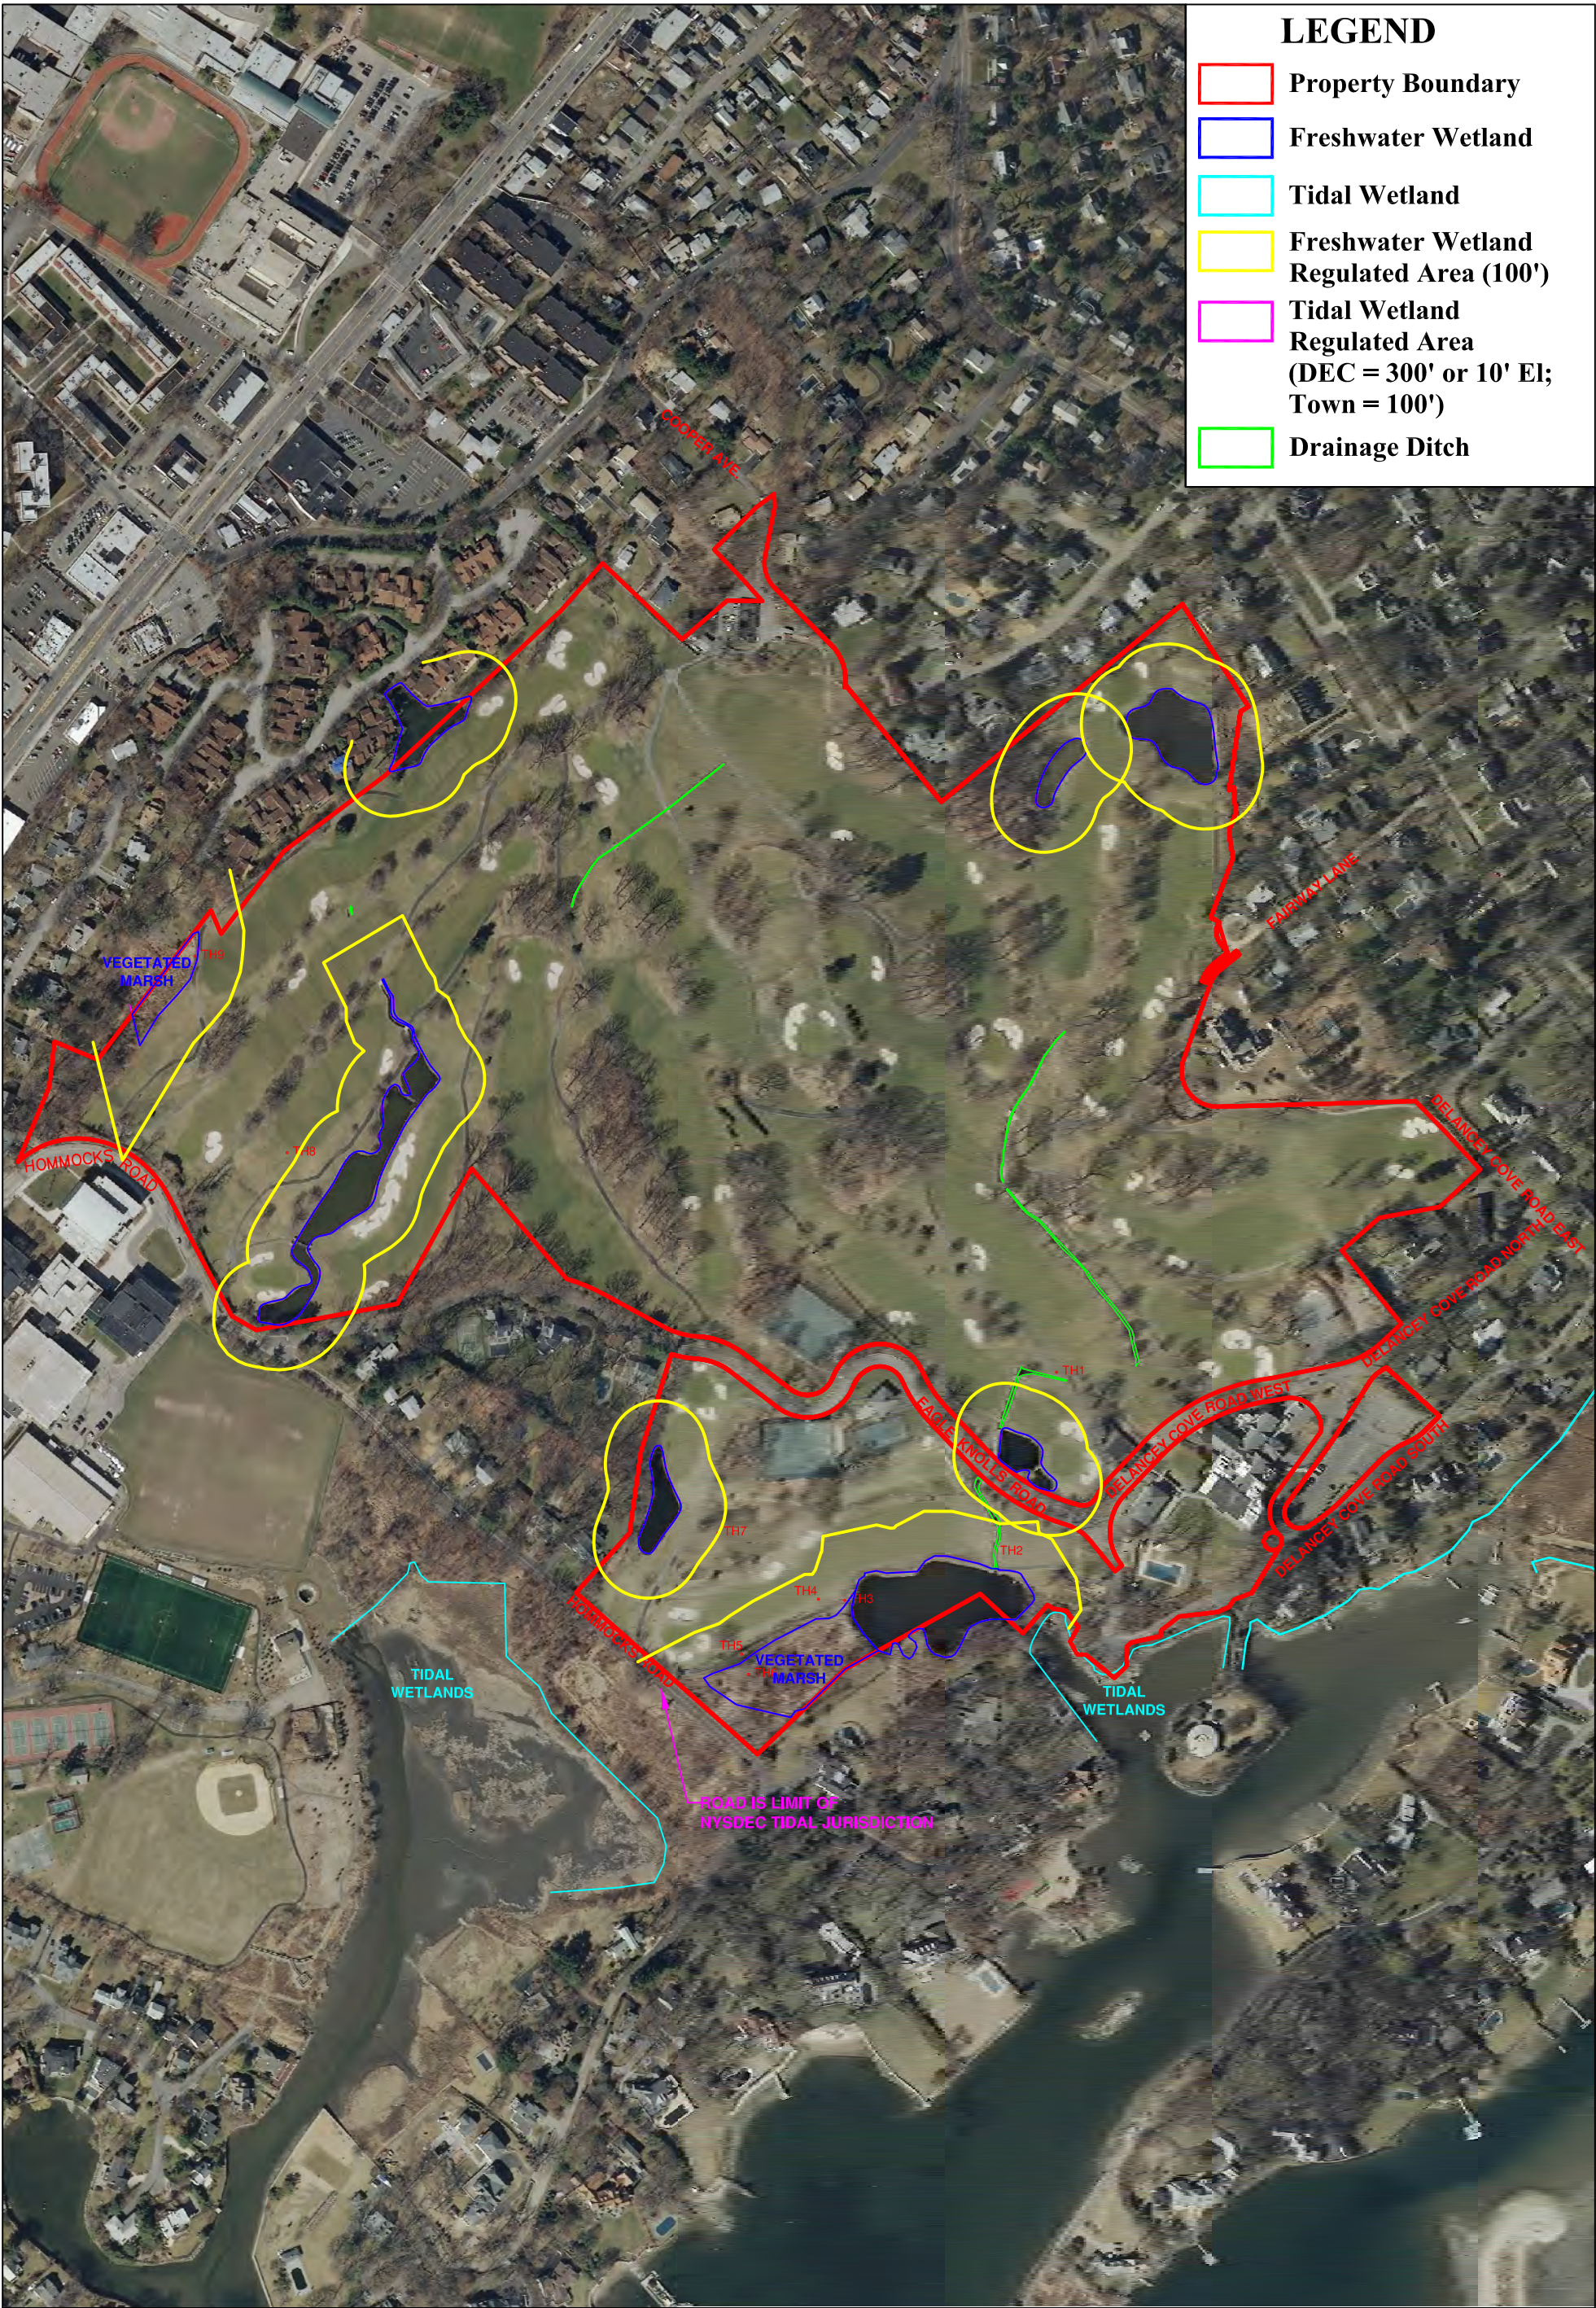
FIGURE 4
REGULATED WETLAND AREAS

The boundaries of the ponds, streams/drainage ditches and two additional vegetated wetland areas on the property are illustrated in by **Figure 4**.

Field observations of the property found that there is an extensive drainage system throughout the property that is comprised of a series of underdrain pipes that feed into the on-site ponds and associated man-made streams within the low-lying areas of the site. The boundaries of the ponds and man made streams on the property were determined to be at the well-defined edge of surface water, where the ponds and streams are either rock-lined or quickly transition from surface water to bank and then to maintained turf vegetation. Two vegetated wetland areas were identified; one in the northwest corner of the property and the second in the southwest corner of the property (see **Figure 4**).
