**Village of Mamaroneck Walking Safety Assessment:
Halstead Avenue and North Barry Avenue
October 5, 2018
SUMMARY REPORT**

The Village of Mamaroneck Traffic Commission was made aware of two such corridors through direct resident complaints AND local crash data: Halstead Avenue, between West Street in Harrison and North Barry Avenue in Mamaroneck; and North Barry Avenue, between Halstead and Boston Post Road (U.S. Route 1) in Mamaroneck¹. In concert with the Mayor’s recently announced “Safe Streets Initiative,” the Traffic Commission held a *Walking Safety Assessment* along Halstead and North Barry Avenues on Friday, October 5, 2018; the resulting report follows.

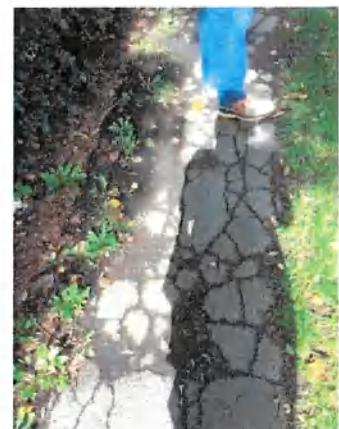
- Sidewalks are present, but some are outdated and inadequate. Often too narrow, damaged, or collapsing, and not ADA-compliant
- Crosswalks were absent at some heavy pedestrian traffic crossings, such as a well-used playground entrance pathway to the school, and street parking sometimes blocks pedestrian pathways.
- No pedestrian crossing signals at North Barry and Halstead Avenue

Sidewalk along North Barry Avenue

- Install complete, continuous ADA-compliant sidewalks at least five feet wide along both sides of North Barry Avenue
- Install well-marked crosswalks with in-street pedestrian crosswalk sign at points of greatest pedestrian traffic, particularly at the well-used playground entrance pathway to the school
