# SECTION V HARBOR ISLAND - COAST GUARD BUILDING

## VILLAGE OF MAMARONECK MUNICIPAL FACILITIES SPACE NEEDS ASSESSMENT

# **COAST GUARD BUILDING PLAN**

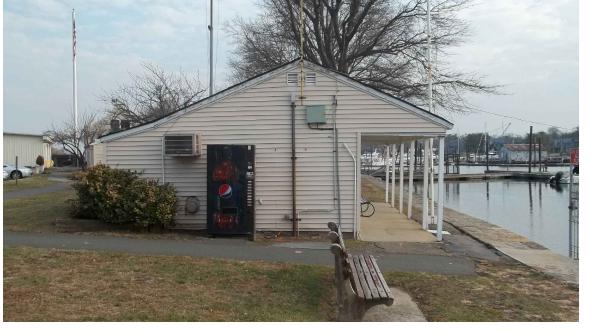
SOUTH ELEVATION NOT TO SCALE

The roof is in poor condition there is evidence of leaks and sections of the rake trim are damaged or missing. There is a noticeable sag in the ridge indicating that there may also be concealed structural problems.

- At minimum replace roof and provide accessible entrances to the building and storage area.
- Lack of toilet facilities also needs to be addressed. This can be handled by constructing a toilet building with men's and women's ADA compliant toilet rooms sized to serve the load of this building, the police building and the senior building. This could be a free standing structure or could be added to the senior building.
- A third option would be to completely remove all 3 buildings and provide a single structure that could provide for the functions of all three existing buildings and toilet facilities as well as be more appropriate to the park setting.
