Village of Mamaroneck

# ILLICIT DISCHARGE DETECTION AND ELIMINATION – PHASE 5 REPORT

Mamaroneck, NY

February 4, 2016

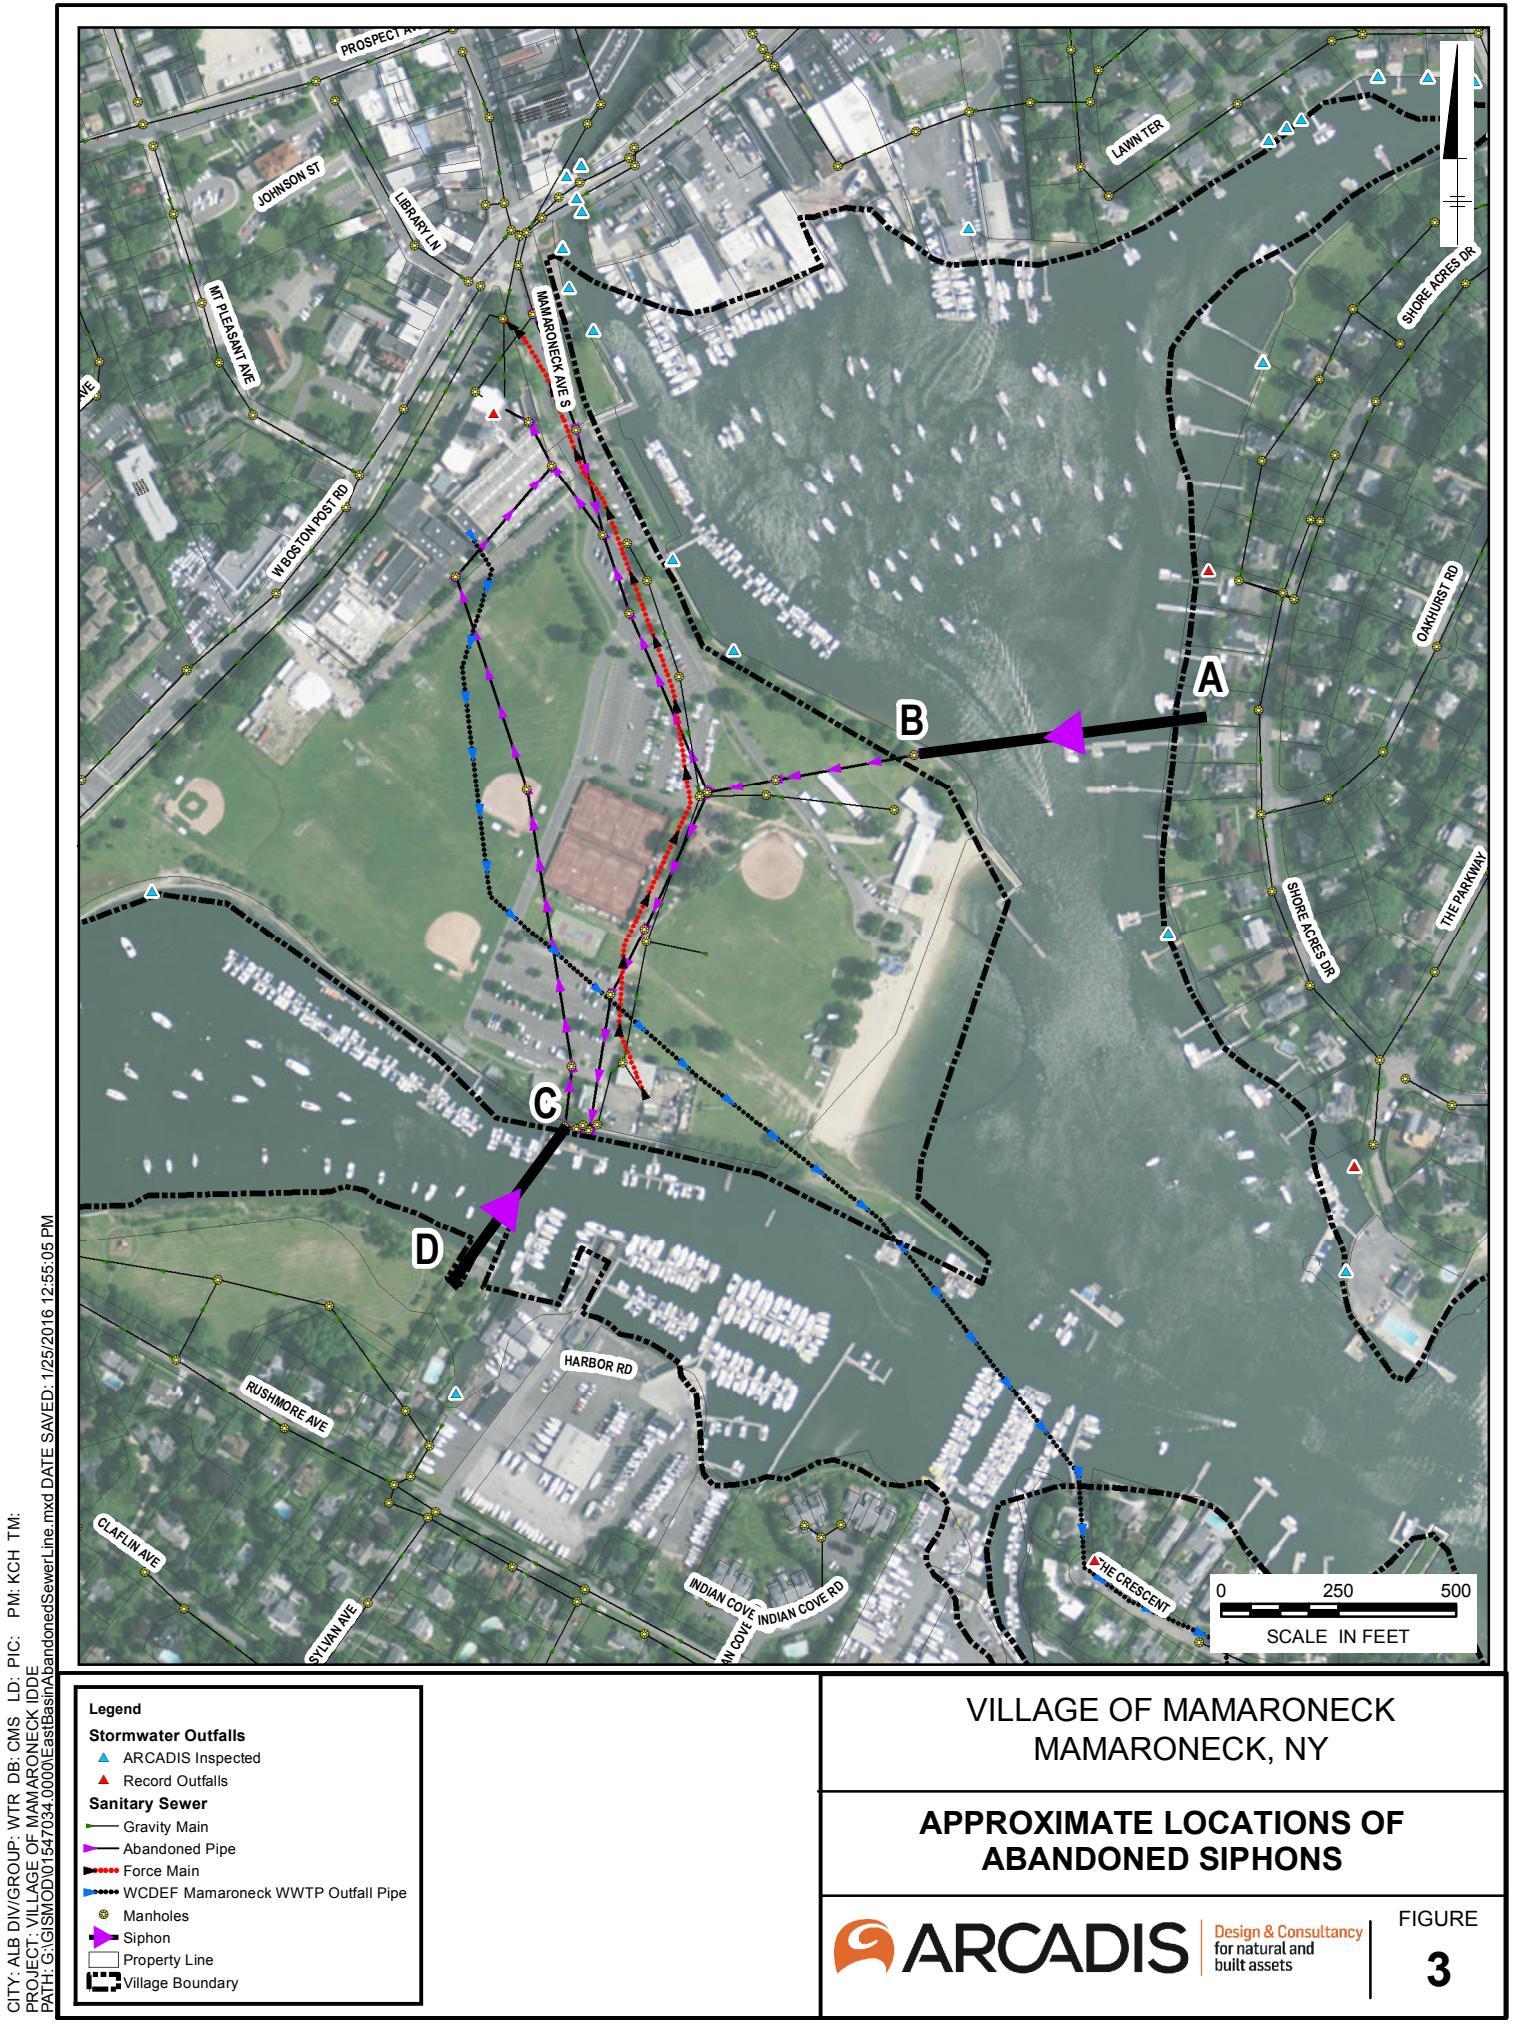
The downgradient end of the historic East Basin Siphon was located at Harbor Island Park, next to what is currently the Parks and Recreation building. This is shown as location "B" on Figure 3. The abandoned sewer line runs parallel to the active Parks and Recreation building sewage line, which flows toward the parking lot adjacent to the tennis courts.

A diagram of the manholes in the Harbor Island Park is included as Figure 4. The abandoned manholes, labelled MH 1 and MH 2, were partially submerged with stagnant water. MH 1 is 7.3 feet deep and, and the water depth was 6.5 feet at the time of the inspection. The stagnant water in the manhole was murky, but a survey rod was used to probe the manhole walls and a pipe opening was discovered. This opening is oriented toward the Parks and Recreation building and agrees with historic maps. MH 2 was also partially submerged. This manhole is 14.5 feet deep and the water depth was 7.5 feet at the time of the inspection. A survey rod was again used to probe the bottom of the manhole, and another opening was discovered. MH 3, which would have been the closest manhole to the Harbor could not be located. MH 4 and MH 5, which are downgradient and closer to the wastewater treatment plant, appear to have been paved over.

Based on observations of the manholes on this abandoned sewer line, it is not likely that sewage could enter the Harbor at this location. The water in these manholes is stagnant which means the pipe is blocked at both ends. In addition, the sewer was designed to flow from the Harbor to the plant, so there would have to be significant flow or head for a discharge to travel upgradient and reach the Harbor.

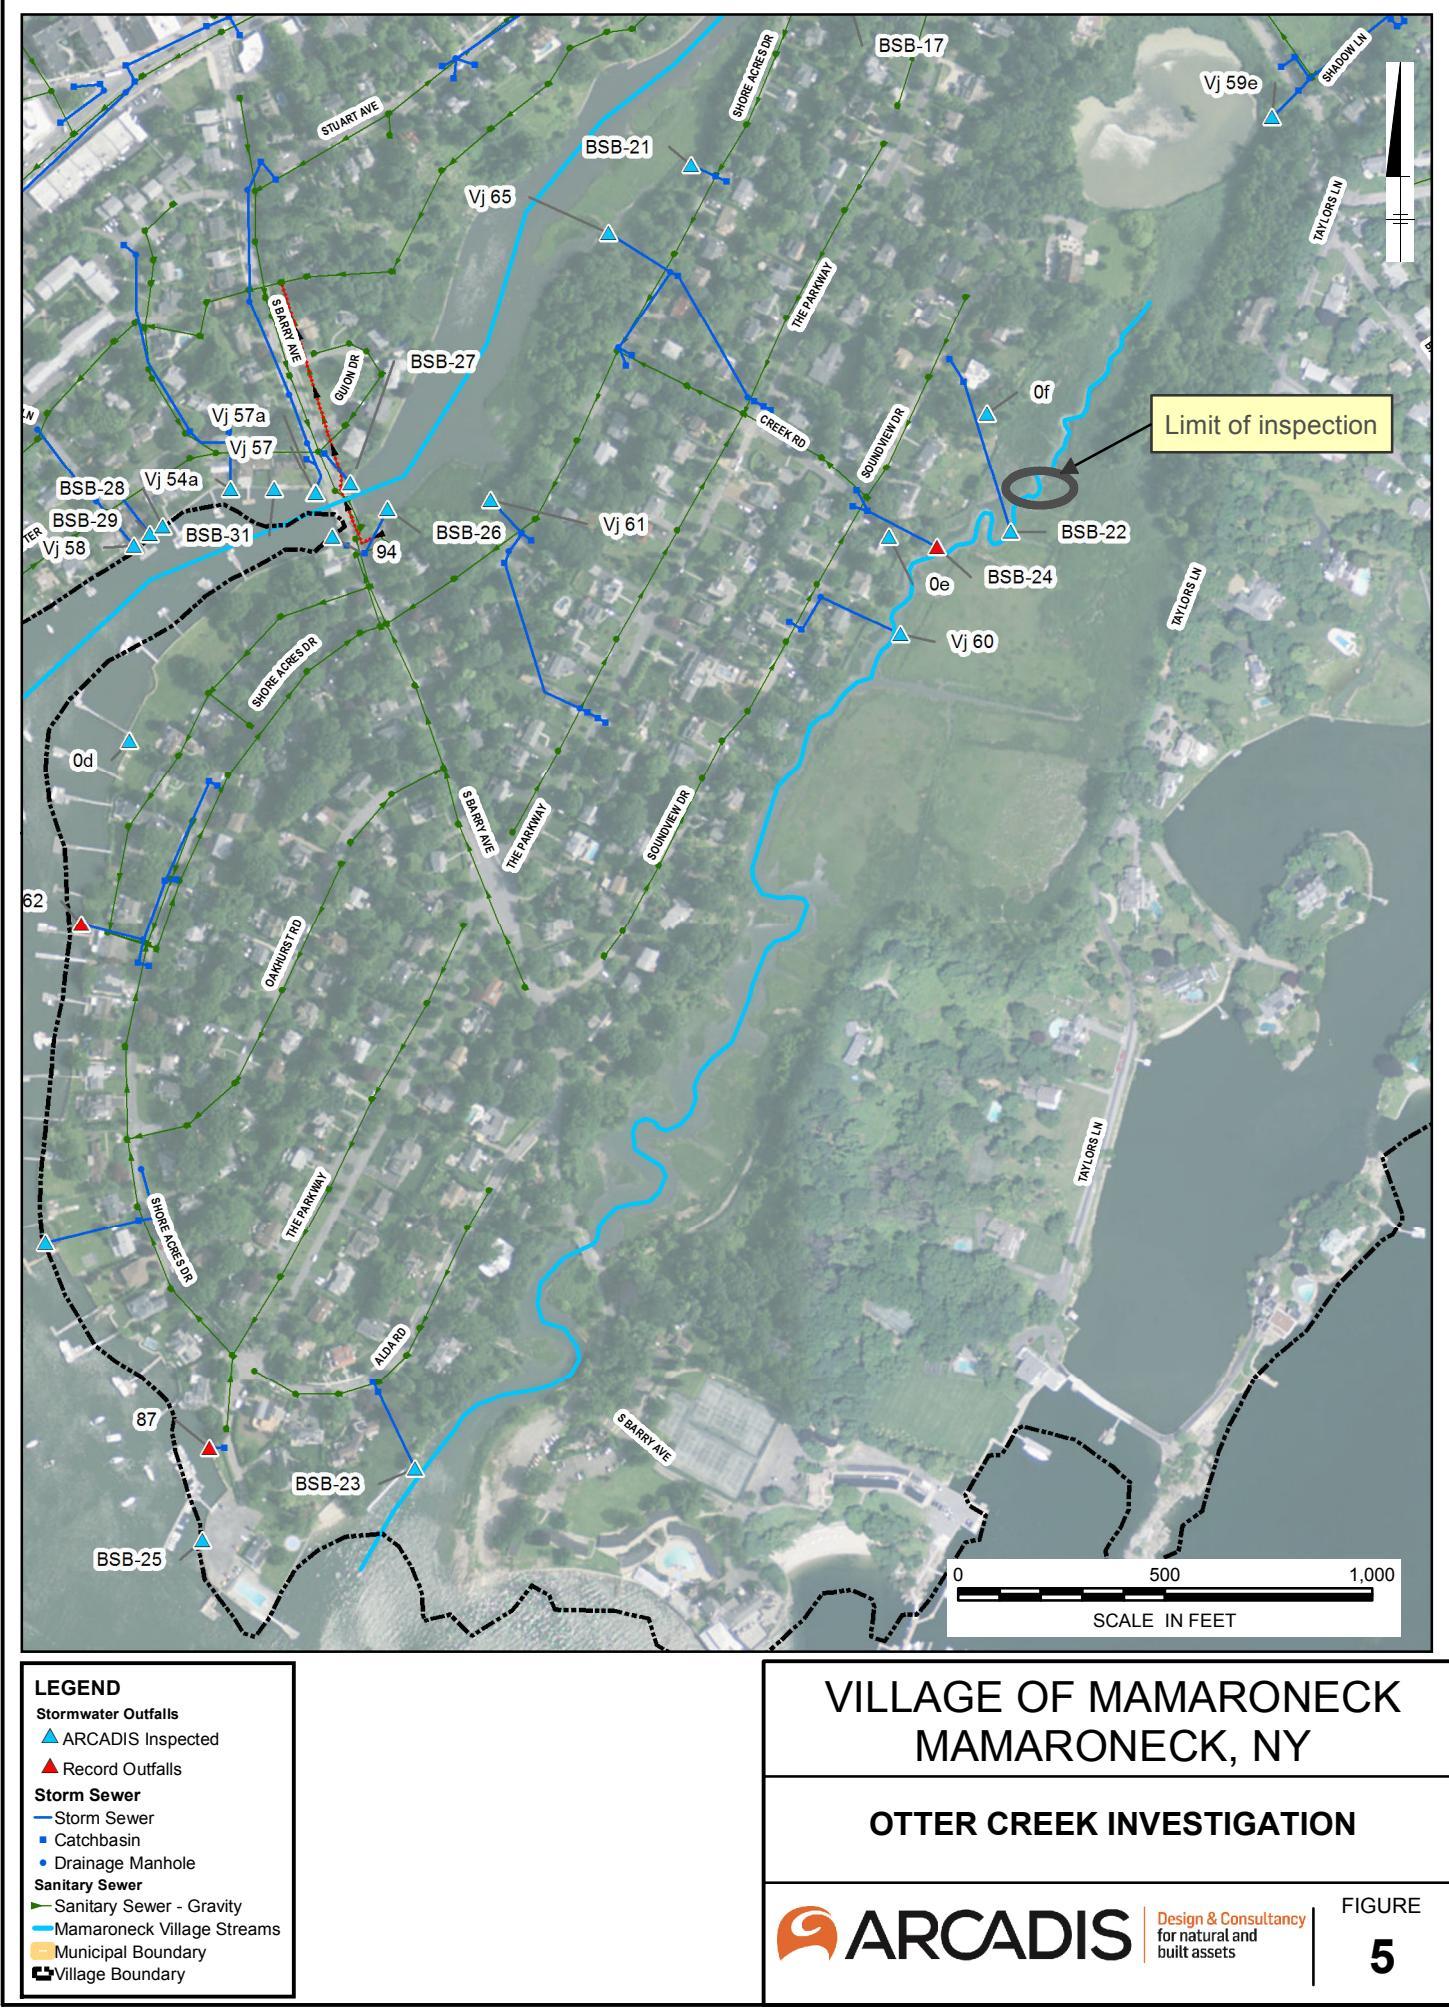
Though sampling at the bridge on South Barry Lane suggests there may be an illicit discharge in Otter Creek, no distinguishable sources of fecal coliform have been identified. If Otter Creek were to be revisited in the winter, there would be less vegetation, making outfalls more visible and the ground easier to traverse during low tide. There are several homes with septic systems adjacent to Otter Creek. These septic systems should be inspected to confirm the leach fields are functioning properly.

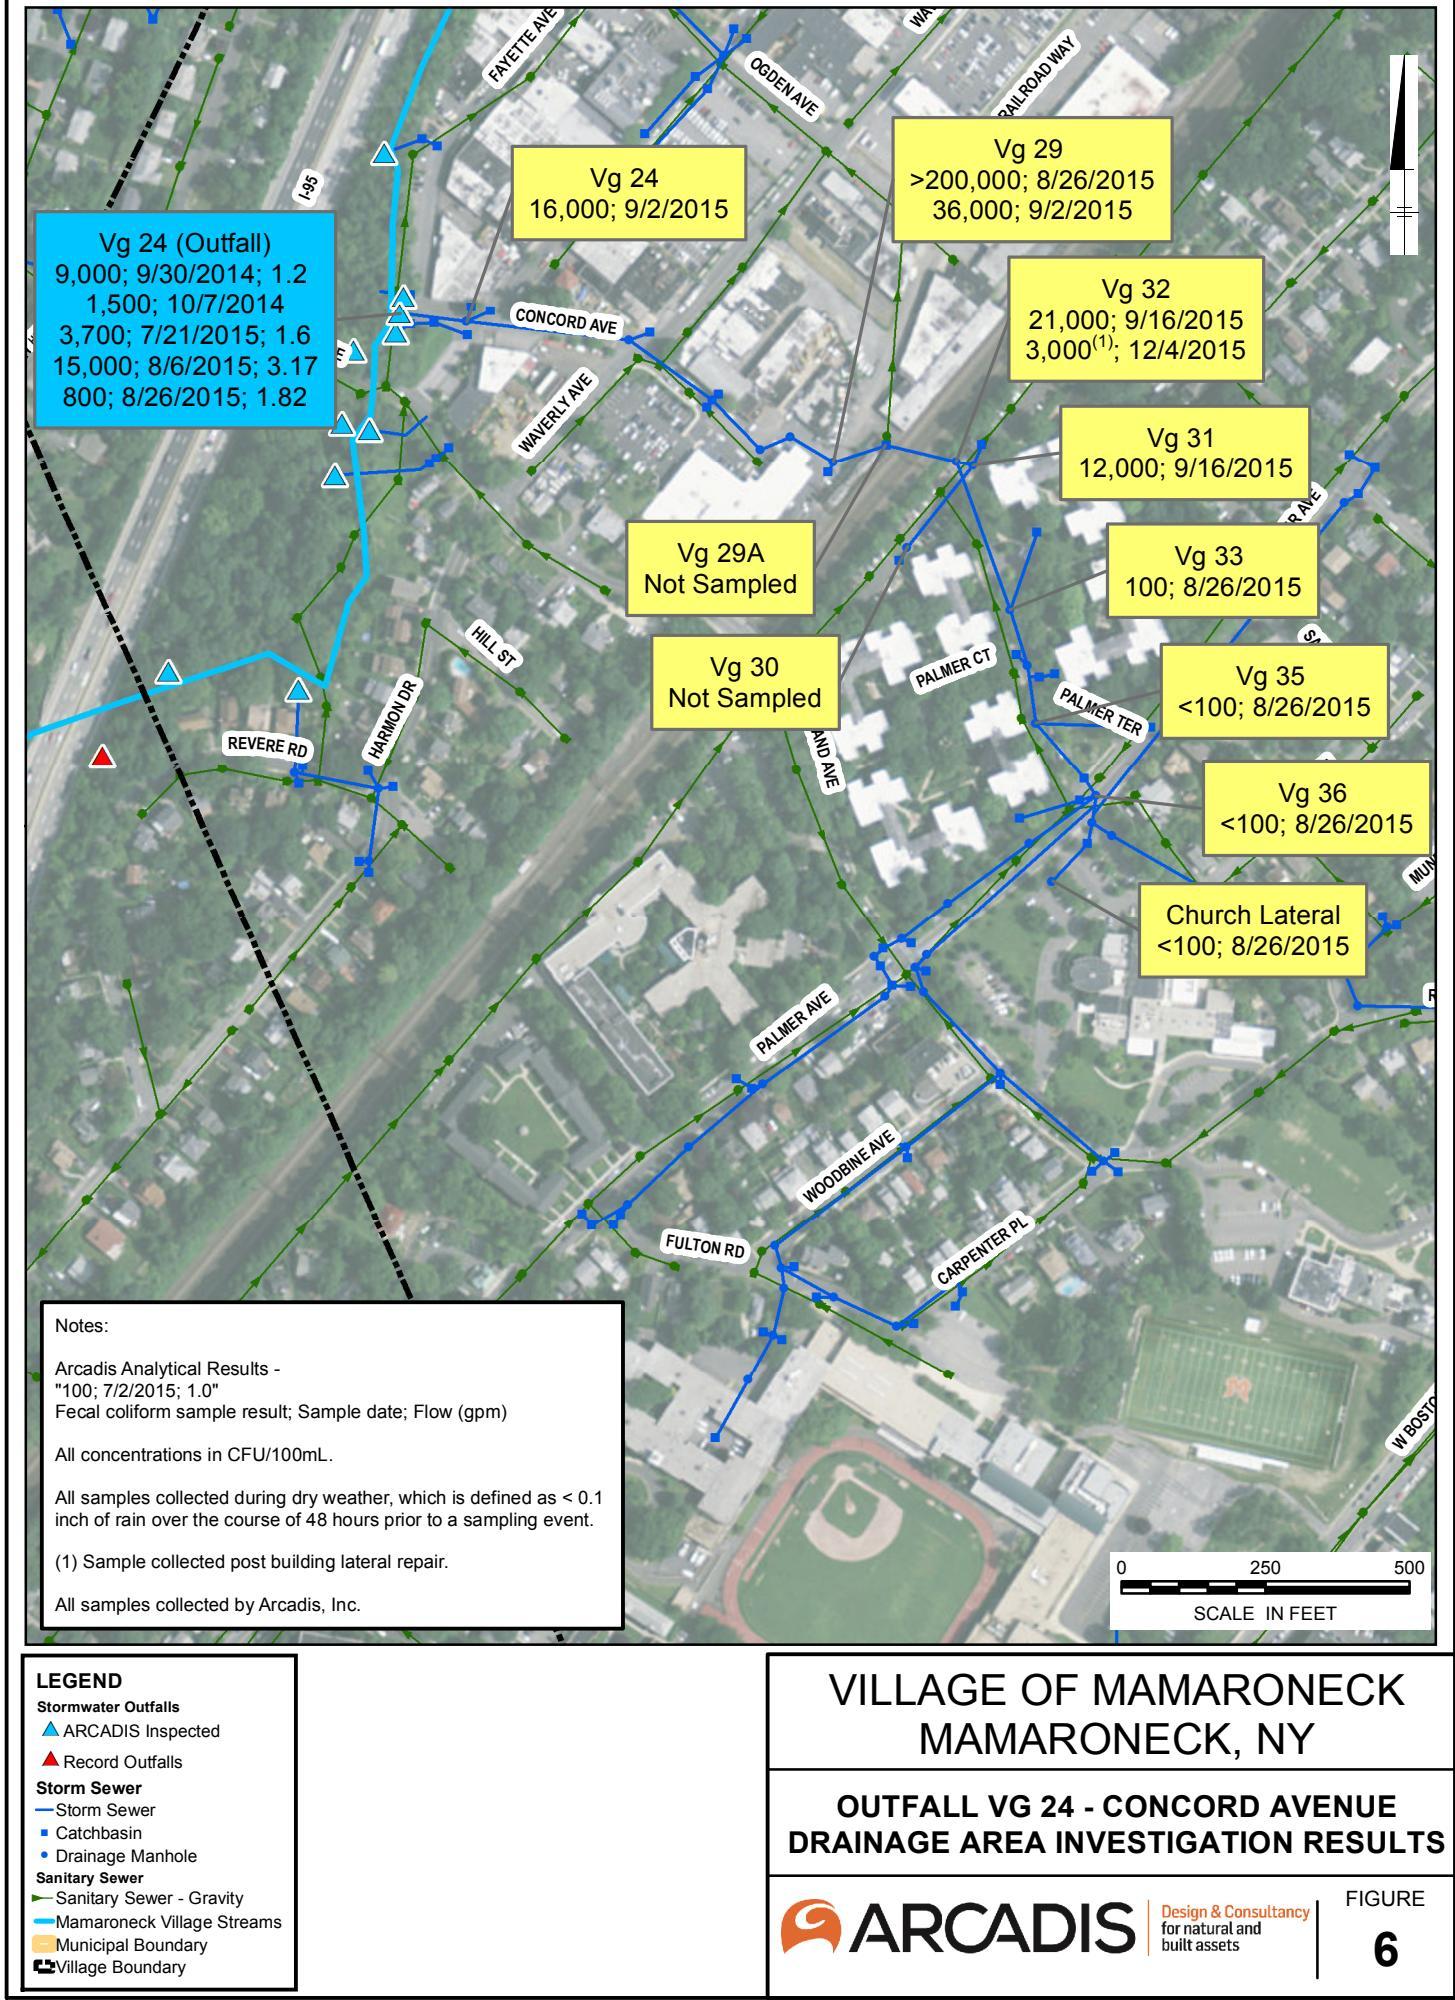
This outfall was sampled on July 21, 2015. The fecal coliform concentration was 3,700 cfu/100 ml, with a flow of 1.6 gpm. Arcadis field staff began a drainage area investigation by opening manholes and catchbasins upgradient of the outfall, looking for dry weather flow, and sampling flow for fecal coliform concentration. The field team isolated the problem(s) to the sewer downgradient of manhole Vg 33. Manhole Vg 33 had a fecal coliform concentration of 100 cfu/100 ml and sample results from upgradient manholes did not show any concentration of fecal coliform. Sampling concentrations varied downgradient of the isolated area, but the highest sample was >200,000 cfu/100ml at manhole Vg 29. Sample results are shown on Figure 6.

Arcadis coordinated CCTV inspection of the storm sewer with subcontractor Fred Cook Inc. to look for illegal connections, cracks or breaks in the pipe, or signs of bacteria indicative of sewage flow. Arcadis staff added dye to sanitary manholes that either crossed or were in close vicinity of the storm sewers, to determine if sewage was entering the storm sewer from any direct or indirect connections. Televising began at Concord Avenue from manhole Vg 29. Fred Cook Inc. televised from Vg 29 to Vg 29A. The next section was televised was Vg 32 to Vg 33. Between Vg 32 and Vg 33, there were two laterals that enter the east side of the sewer and were both flowing at the time of the inspection. Upstream of these two laterals, the evidence of bacteria along the bottom of the pipe decreased dramatically. CCTV was also completed between Vg 31 and Vg 32, but there were no signs of illicit discharge in this section. Between Vg 31 and Vg 30, there was raccoon scat observed in the sewer.

Based on the sampling results and the CCTV investigation, it was reasonable to ascertain there was an illicit discharge coming from the stormwater building laterals identified between manholes Vg 32 and Vg 33. The Village notified the building owner at that location that additional investigations would need to be conducted at the building.

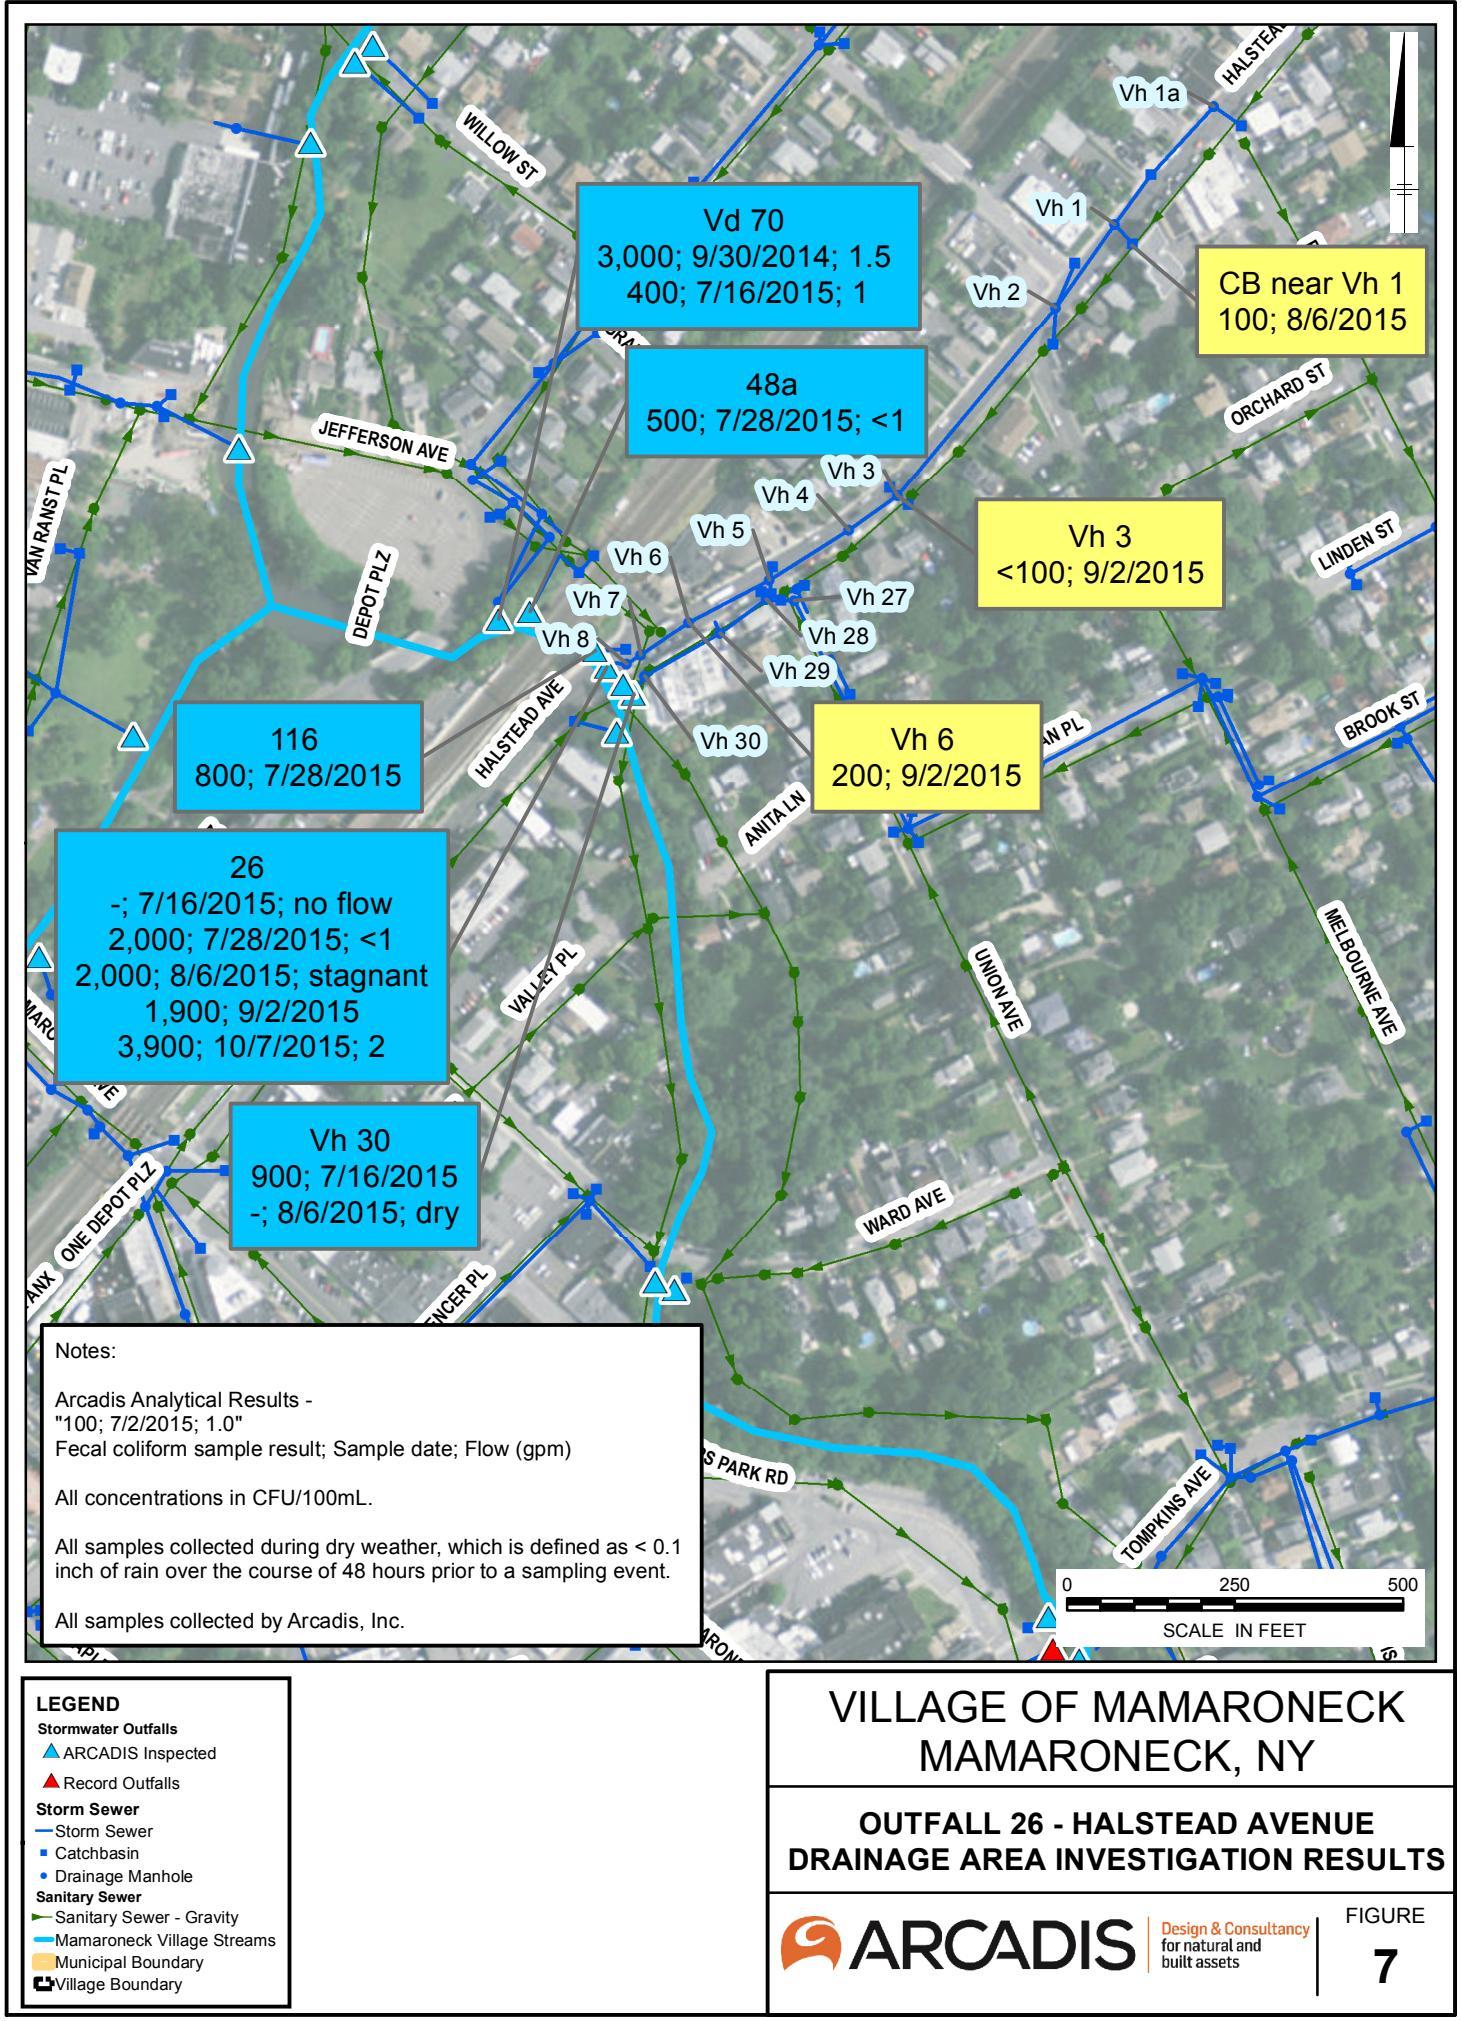
CCTV inspection was completed between manholes Vh 1a and Vh 1, continuing to Vh 2. At manhole Vh 2, the inspection had to be discontinued because a lateral in the storm sewer line protruded too far into the sewer to allow the camera to pass. A water main enters the storm sewer 40 feet upgradient of manhole Vh 1. None of the sections of storm sewer included in this inspection had evidence of bacteria.

The investigation did not uncover a direct illicit discharge that could be corrected. During the CCTV inspections, it was observed that ground water was infiltrating into the storm sewer at the pipe joints, as the flow in the pipe decreased slowly as the pipe moved from the downgradient sections to the upgradient sections of sewer. There was not noticeable infiltration but a slow increase in the amount of flow. The bacteria may be slowly migrating from a small leak in an adjacent sanitary sewer or lateral, or from animal scat in the storm sewer. The pollutant load from this

outfall is not concerning at this time. Arcadis recommends sampling this outfall annually to monitor the fecal coliform concentrations.

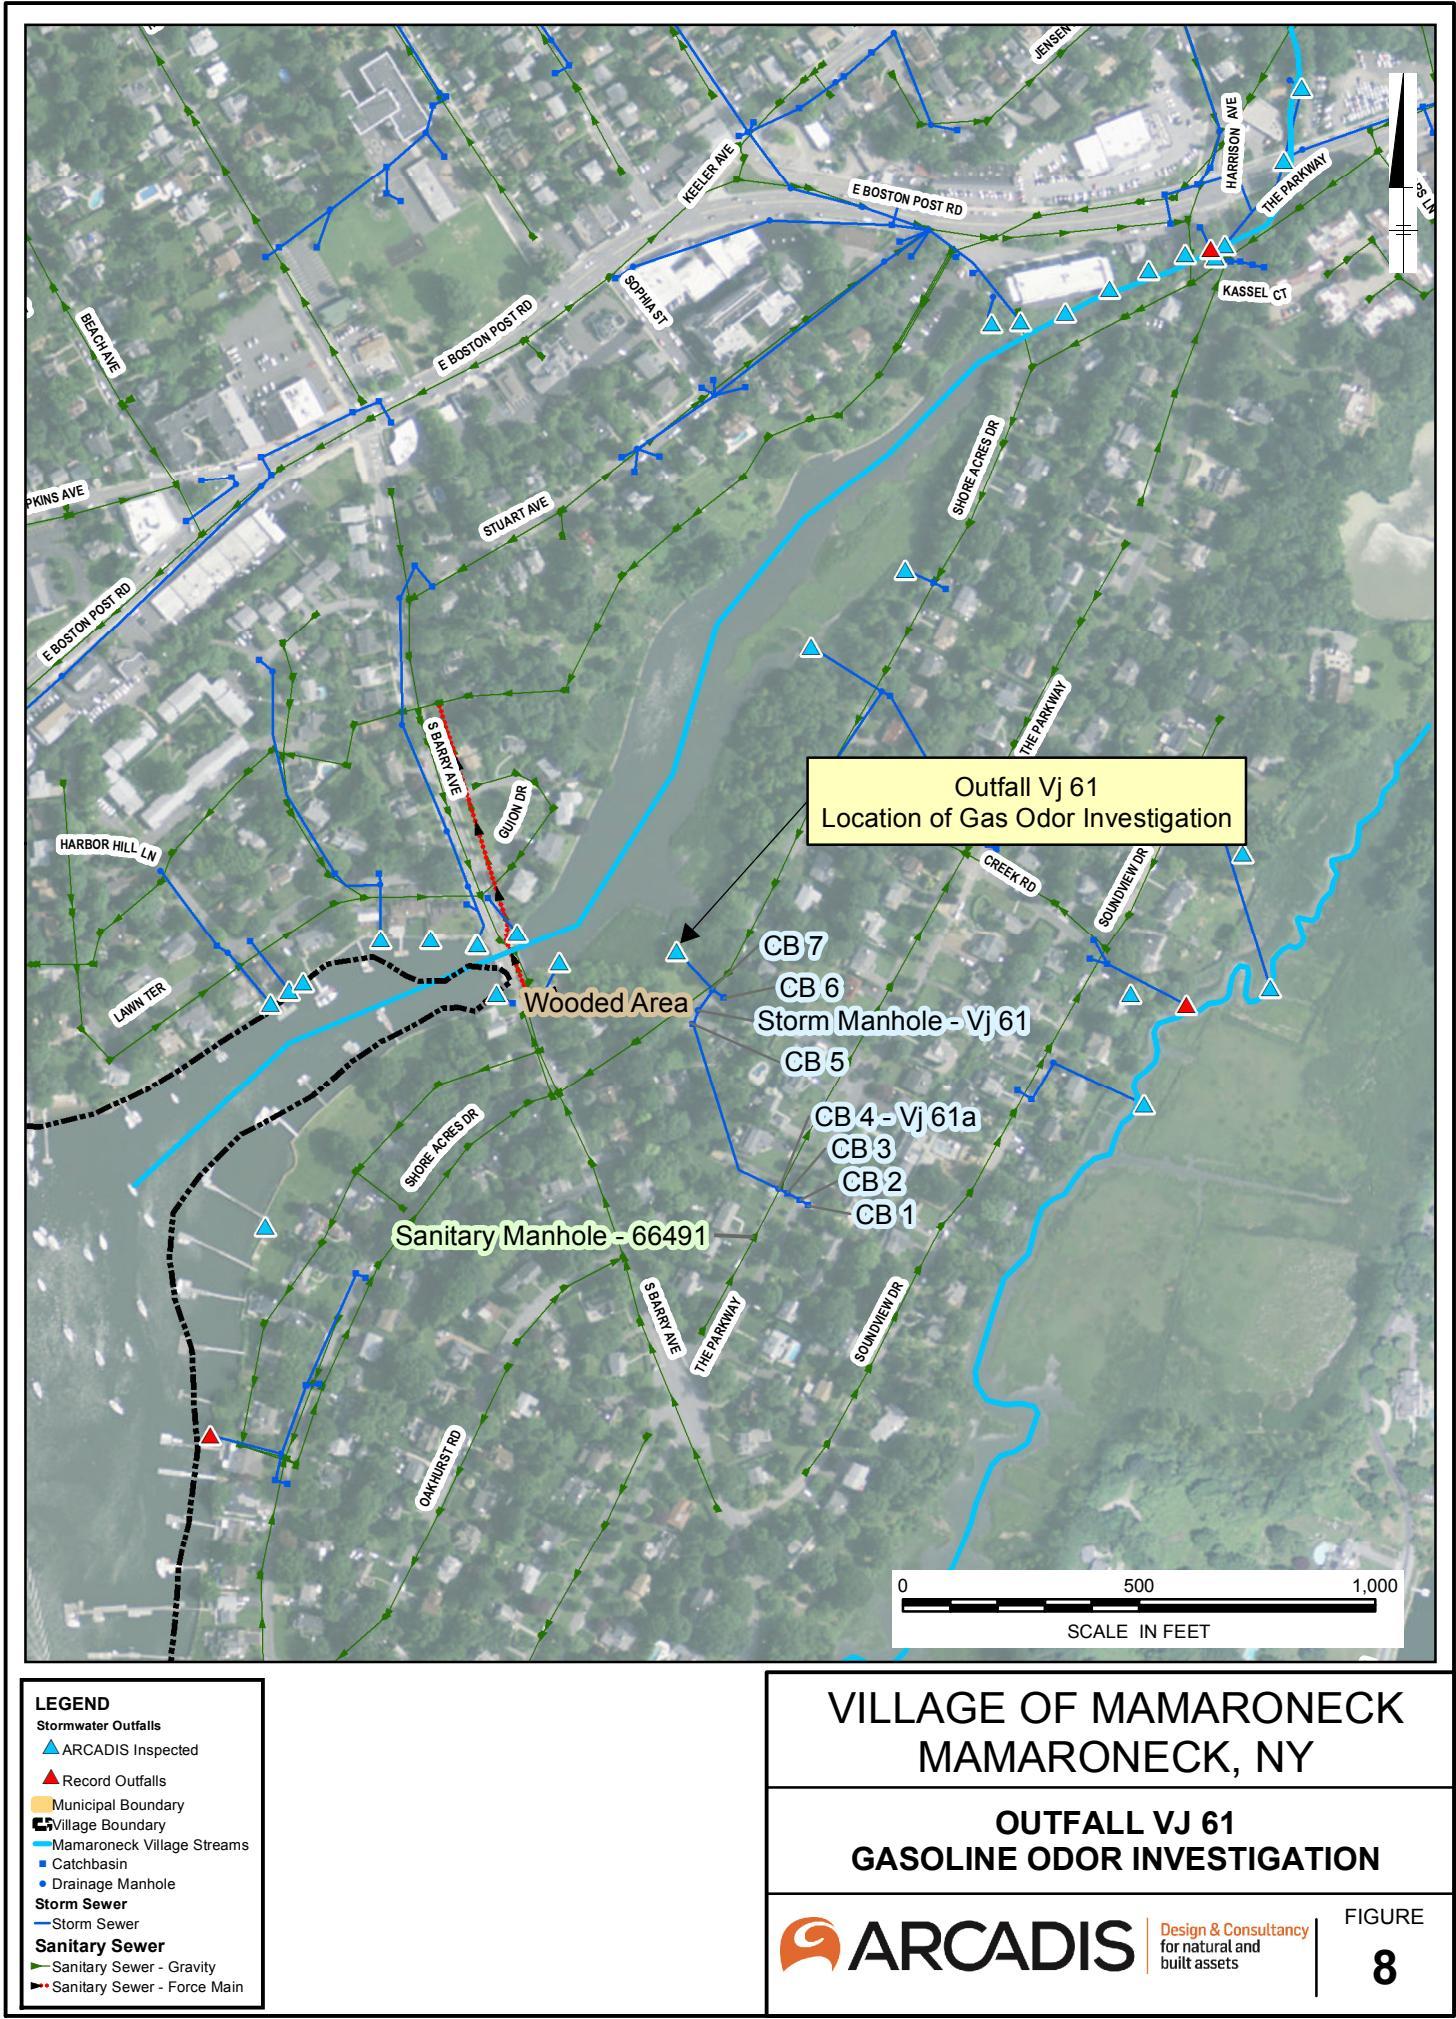
Vj 61 is a 12-inch diameter reinforced concrete pipe. During the first site visit, Outfall Vj 61 was wet, but no dry weather flow. There were no odors; no evidence of oil, grease, or petroleum; and no dead vegetation. All of the storm sewer structures within the Vj 61 sewershed were also inspected. This includes a total of seven catch basins and one storm manhole. Again, no evidence of oil or grease was found and no unusual smells were detected. A nearby sanitary sewer manhole was also inspected to determine if the odor could be coming from the adjacent sanitary sewer.

The field team returned on July 21<sup>st</sup> prepared for sample collection. When the samples were collected, no unusual scent or signs of oil or grease were observed by Arcadis staff. Arcadis staff also investigated a wooded area adjacent to the outfall and found no evidence of oil dumping. At the time the sample was collected it was flowing less than one gpm. There was a stagnant puddle less than one inch deep immediately outside of the outfall. It should also be noted that there was construction work being completed on Creek Road near the intersection of the Parkway and Creek Road at the time of the investigation. This is being included in this summary as a potential source for the odors originally detected.

Samples were analysed for volatile organic compounds (VOCs) (EPA method 624) and Oil/Grease (EPA Method 1664A) analysis by Envirotest Laboratory. The results did not show any evidence of gasoline, oil or grease; all parameters tested were non-detect. Based on our investigation we did not find evidence of a spill or dumping at this outfall. Photos of the investigation are included as Appendix E. Laboratory results are provided in Appendix B.

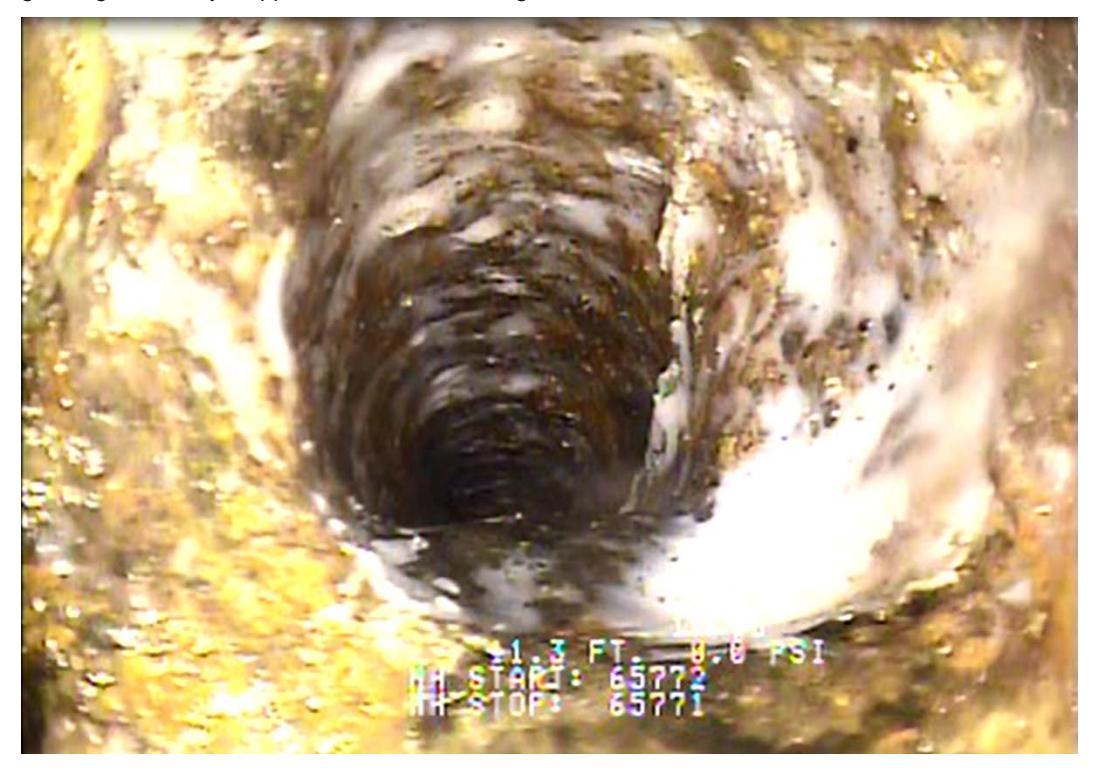
Unfortunately since these problems prohibited the contractor from completing the work, the pilot was cut short after grouting only three laterals. An example of a lateral connection after grouting is shown in Photo 3. The pressure grouting effectively stopped the water infiltrating at the connection.

The pilot provided valuable information for the Village for the full scale program. Attempting to grout sewer lateral pipe connections in a cast iron pipe for the full scale program is not recommended. Cast iron pipe is typically not as common a construction material in older sewer systems as vitrified clay pipes. Based on a review of the historic Village drawings, most of the pipes in the area planned to be grouted are vitrified clay pipe. Pressure testing and grouting vitrified clay pipe should not present a problem unless the pipe has structural defects or offset joints. One alternative to quickly confirm pipe material and condition would be to use a sewer zoom camera to inspect the pipe segments from the manhole surface prior to developing the final plan for pipe segments to will be grouted. One other potential problem is with pipes that have been previously lined with cured-in place liner. If the holes for the laterals were not trimmed back properly the grouting contractor may need to spend some time making the pipe condition right for air testing and grout sealing.

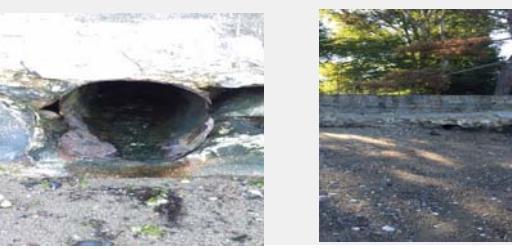
STRUCTURE						
Structure ID	71	Diameter (in)		12		Outfall Type
Material	Corrugated Metal	Waterbody		Mamaroneck S	ound	System Outfall
Shape	Circular	Submerged in Wa	Submerged in Water			
Quantity	Single	Submerged in Se	diment	Partially		
INSPECTION EVENT						
Inspector	JL, MS	Air Temperature (F)		75	Photo Numbers.	71, 71 (1)
Date	8/13/2015	Rainfall, Past 24 hrs (in)		0		
Time	8:00 am	Rainfall, Past 48 hrs (in)		1		
INSPECTION EVENTCO	MMENTS					
ASSESSMENT		FLOW			FIELD PARAM	METERS
Structural Condition	Poor	Flow Description	No flow	,	Sample Temper	ature (F)
Operational Condition	Poor	Flow (gpm)	í —		Sample pH	
Illicit Discharge Potential	Potential	Determination:	eye		Sample Ammon	ia (mg/mL)
DISCHARGE CHARACT	ERISTICS					
Color		Turbidity			Flow Line	
Color Strength		Floatables (Suds)			Abnormal Vega	atation
Odor Type		Floatables (Sewage)			Bacteria Growt	h
Odor Severity		Floatables (Oil)			ĺ	
POOL QUALITY					POOL QUAL	ITY COMMENTS

Color		Suds			Algae growth	on flowline
Color Strength		Oil Sheen				
Odor		Algae			1	
Odor Severity					ļ

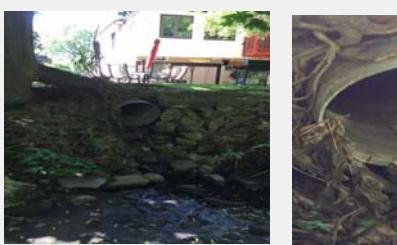
STRUCTURE							
Structure ID	VI 1	Diameter (in)	]	36		Outfall Typ	De
Material	RCP	Waterbody	]	Sheldrake Rive	r	System (	Dutfall
Shape	Circular	Submerged in Wa	Submerged in Water No				
Quantity	Single	Submerged in Se	Submerged in Sediment No				
INSPECTION EVENT							
Inspector	JL	Air Temperature (F)		85	Photo Numbers.		VI 1, VI 1 (1), VI 1 (2)
Date	8/13/2015	Rainfall, Past 24 hrs (in)		0			
Time	11:30 am	Rainfall, Past 48 hrs (in)		1			
INSPECTION EVENTCO	MMENTS		L				
		FLOW					
Structural Condition	Good	Flow Description	No flow		Sample Temper	ature (F)	
Operational Condition	Good	Flow (apm)			Sample nH		
Illicit Discharge Potential	Unlikely	Determination:	eye		Sample Ammoni	ia (mg/mL)	
DISCHARGE CHARACT	ERISTICS		,				,
Color		Turbidity			Flow Line		Yes
Color Strength		Floatables (Suds)	í —		Abnormal Vega	atation	No
Odor Type		Floatables (Sewage)	í —		Bacteria Growt	h	No
Odor Severity		Floatables (Oil)	<u> </u>				,

POOL QUALITY					POOL QUAL	ІТҮ СОММІ	ENTS
Color	Clear	Suds	None				
Color Strength	NA	Oil Sheen	Yes, ve	ery little	1		
Odor	none	Algae	None				
Odor Severity	NA				1

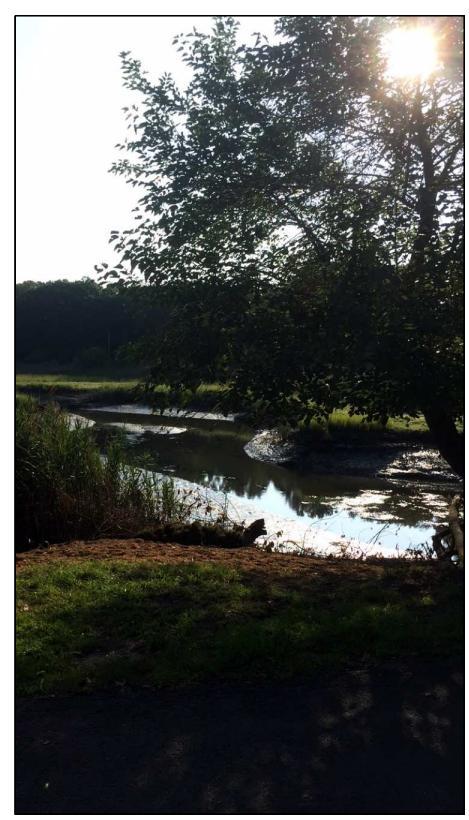
Photo filename (.jpg): Otter Creek (1) Arcadis visited Otter Creek at low tide to locate outfalls to investigate potential for illicit discharges. Otter Creek is very shallow at low tide.

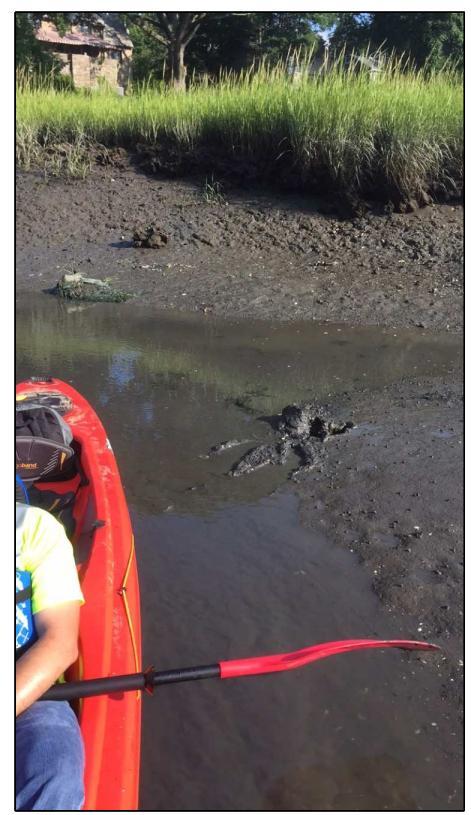
Photo filename (.jpg): Otter Creek (2) Bank Arcadis paddled upstream until the creek became too shallow to continue. 2

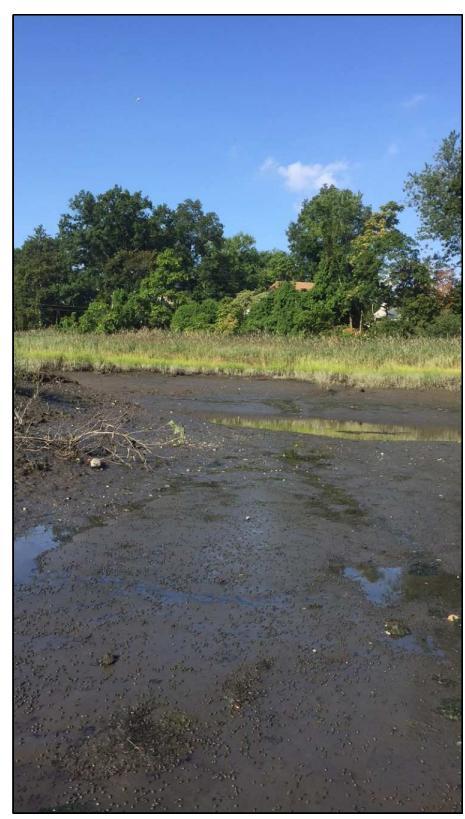
Photo filename (.jpg): Otter Creek (3) Mud Arcadis staff were unable to walk through mud because it was soft and unstable.

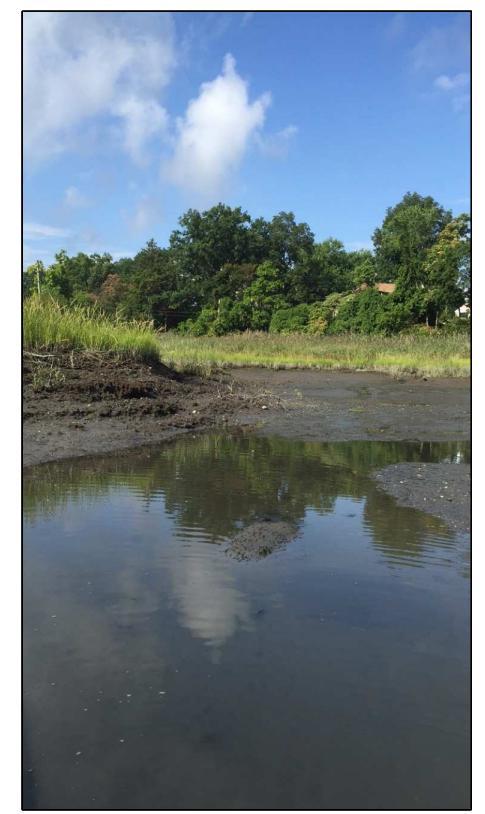
Photo filename (.jpg): Otter Creek (4) The width of the creek and dense vegetation along the shoreline prevented Arcadis staff from seeing outfalls from the kayak. 3

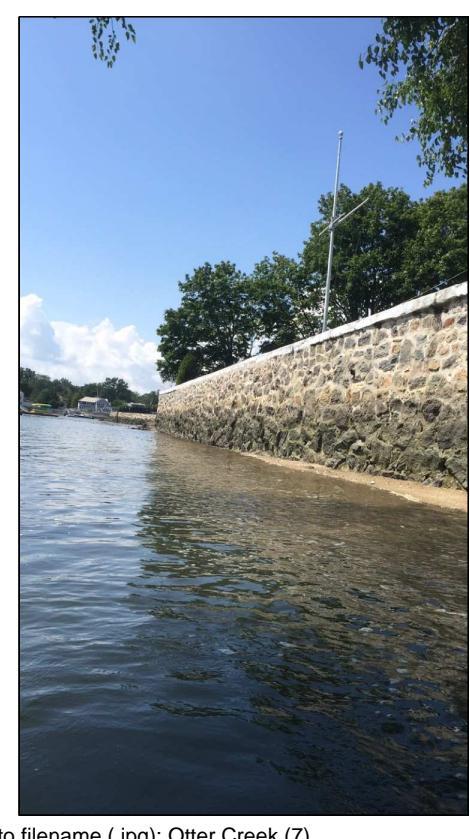
Photo filename (.jpg): Otter Creek (7) At mid-tide, the water depth in the Creek is greater, such that Arcadis staff could travel further than at low tide.

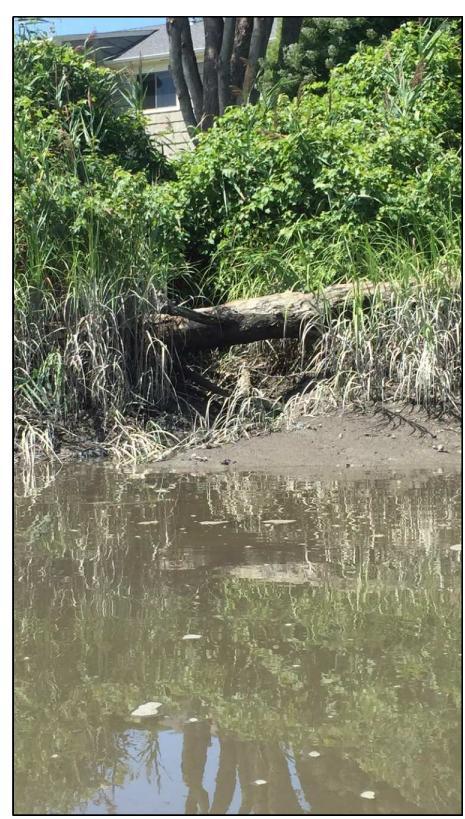
13

Photo filename (.jpg): Vj 60 (not verified) The approximate location of outfall Vj 60 was located, but the outfall could not be seen.

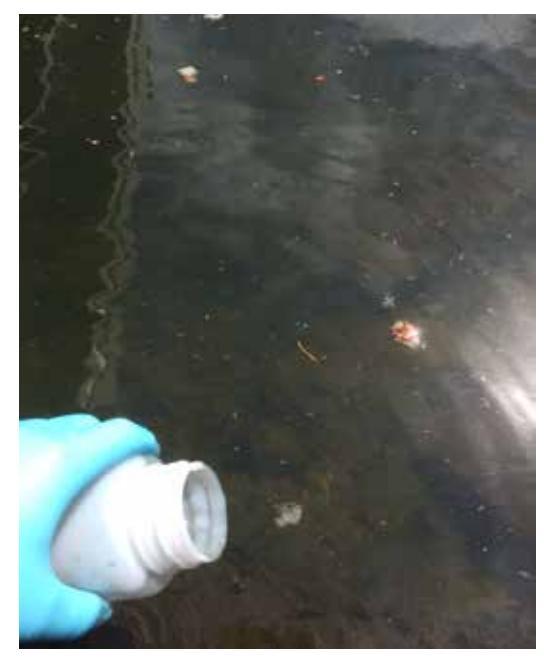
Photo #2: Sampling of the river - Clumps of foam can be seen in the background of the photo. Foam was collected in each sample bottle.

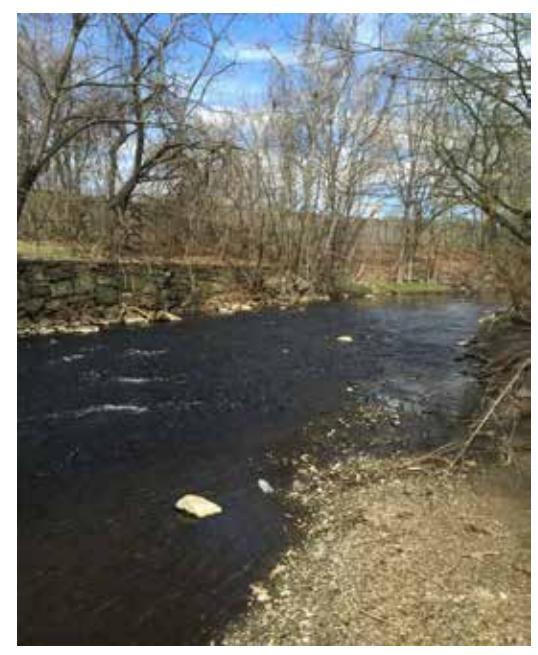
Photo #4: Sampling location on the river - Clumps of foam can be seen on the left hand side of the photo

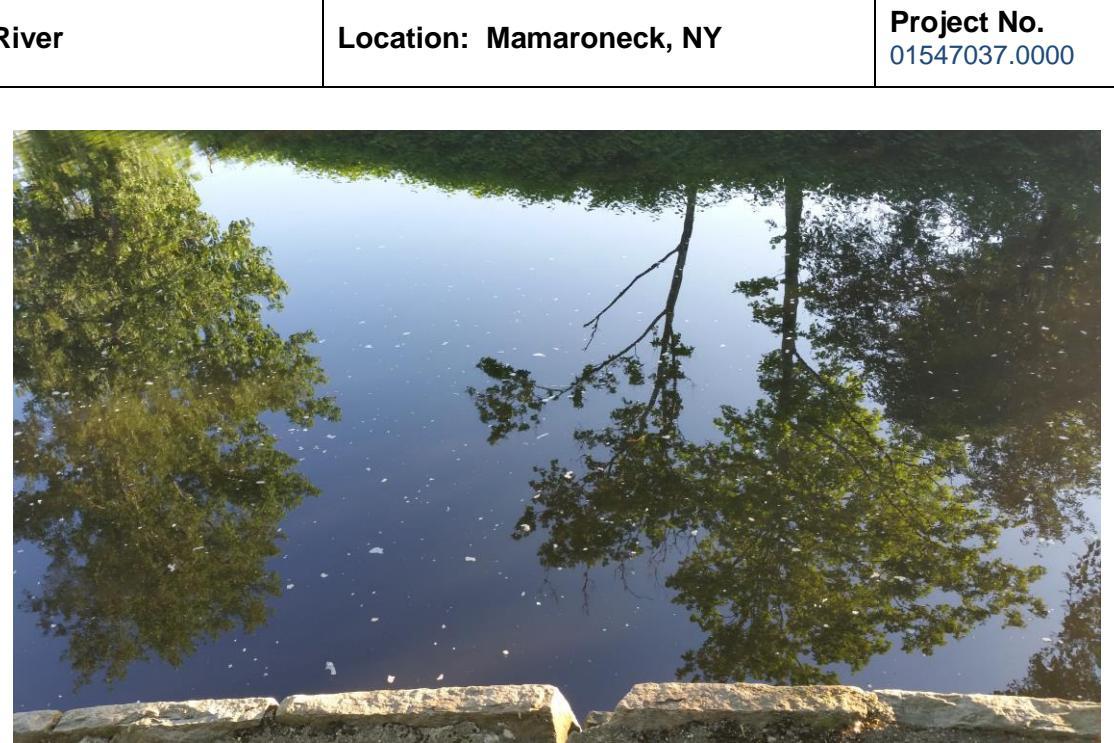
Mamaroneck River just north of Station Plaza (looking east). Some foam visible.
