Village of Mamaroneck

# ILLICIT DISCHARGE DETECTION AND ELIMINATION – PHASE 5 REPORT

Mamaroneck, NY

February 4, 2016

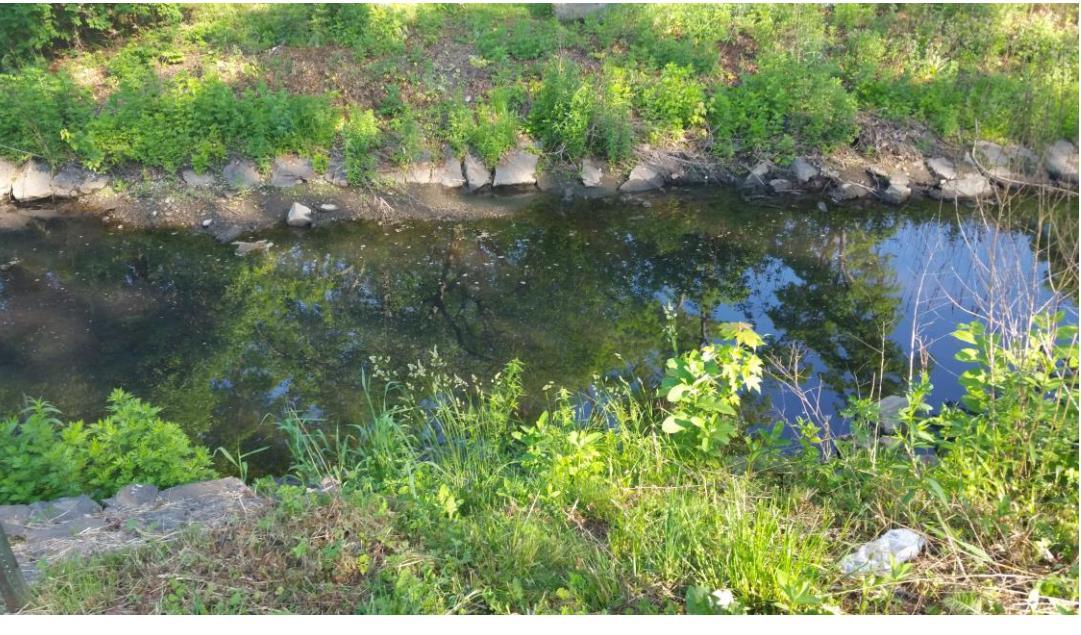
Project: M	amaroneck	River	Location: Mamaroneck,	NY	Project No. 01547037.0000
Photo No.	Date:				
18	05/29/15				
Descriptior	ו:				
Sheldrake F Mamaronec	River near k Ave

Mamaroneck Ave. (looking north). Foam visible.

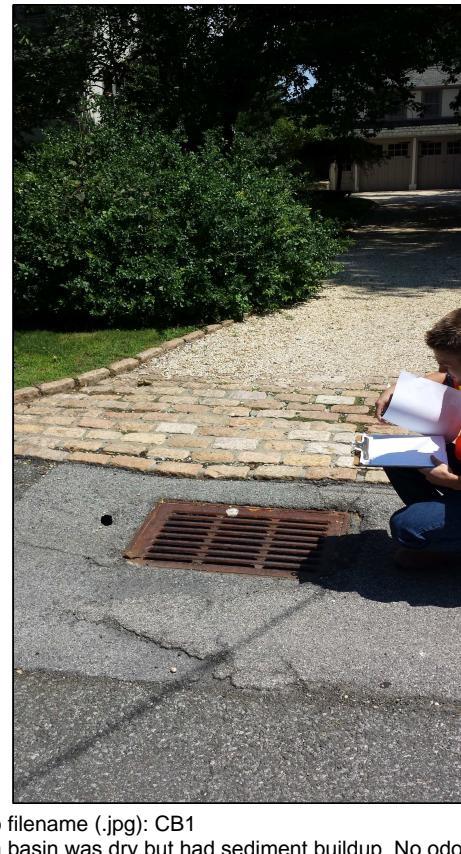
Photo filename (.jpg): CB1 Catch basin was dry but had sediment buildup. No odors, flow, or evidence of oil or gasoline present.

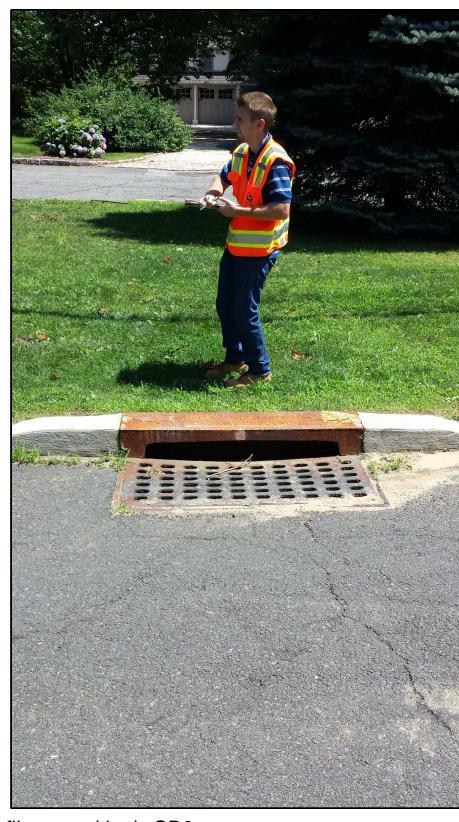
Photo filename (.jpg): CB3 Catch basin was dry. No odors or evidence of oil or gasoilne.

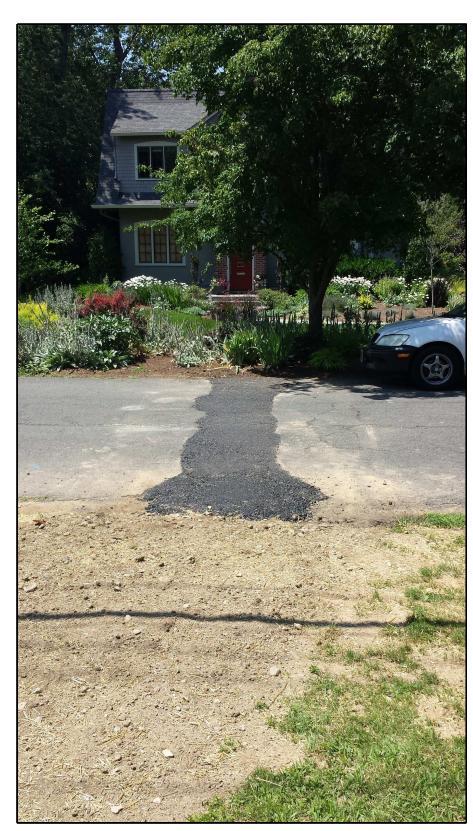
Photo filename (.jpg): Recent Water Main lateral work near CB3 Recent water main lateral work near CB3.

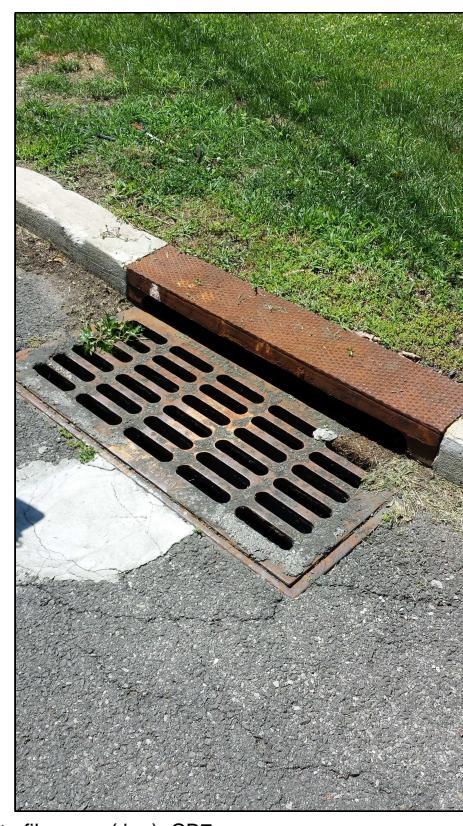
13

Photo filename (.jpg): CB7 Catch basin had flow, but no odors. No evidence or oil or gasoline.

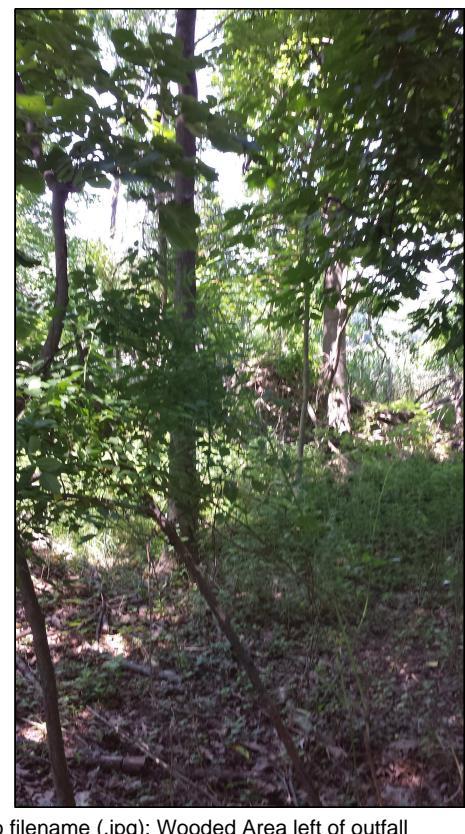
Photo filename (.jpg): Wooded Area left of outfall Vegetated area was investigated for evidence of oil dumping. Nothing was found.

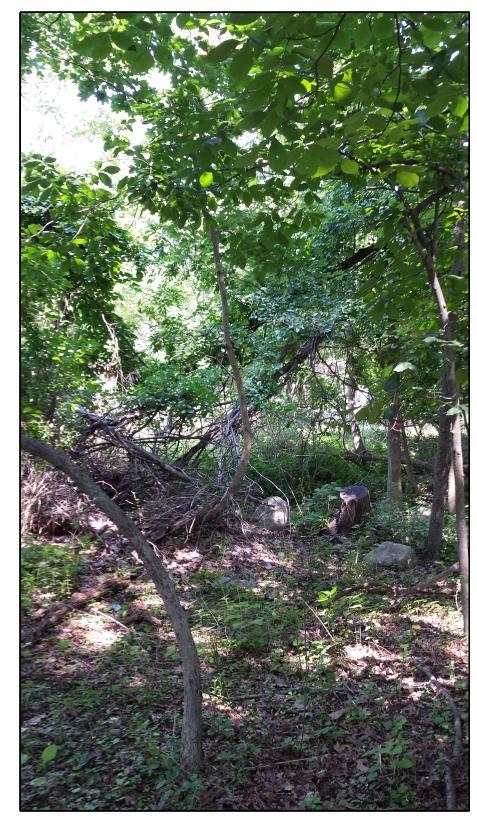
Photo filename (.jpg): Wooded Area left of outfall 1 Vegetated area was investigated for evidence of oil dumping. Nothing was found.

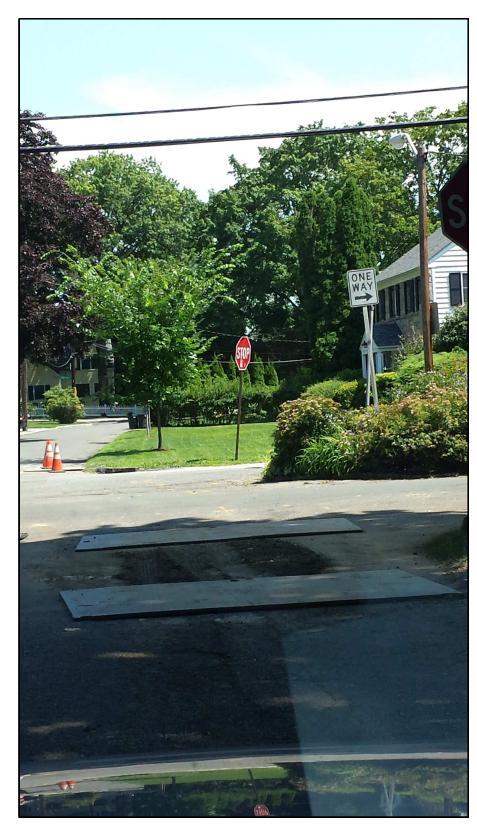
Photo filename (.jpg): More recent Work (far) Recent roadwork covered by metal plates.
