**Village of Mamaroneck**

**Illicit Discharge Detection and  
Elimination Study**

**Sewer System Investigation -  
Phase 3 Report**

Drainage Areas 3, 10, 17, 25, and 26

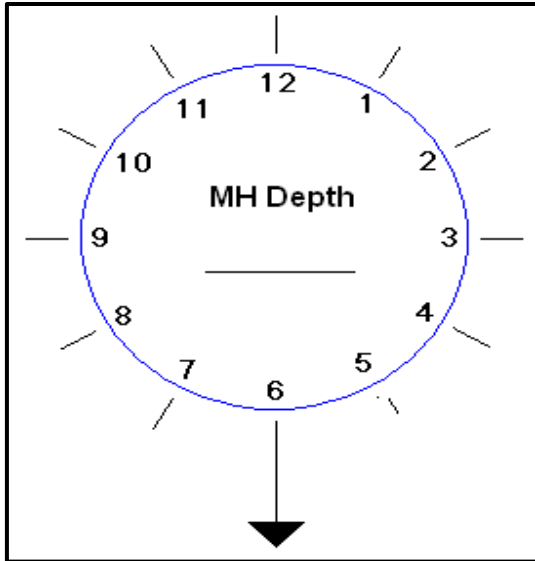
Clock Position (1-12)	Pipe Diameter (in)	Upgradient Structure/Source (MH ID, CB, Priv, Unk)	Flow (gpm or ft/s)

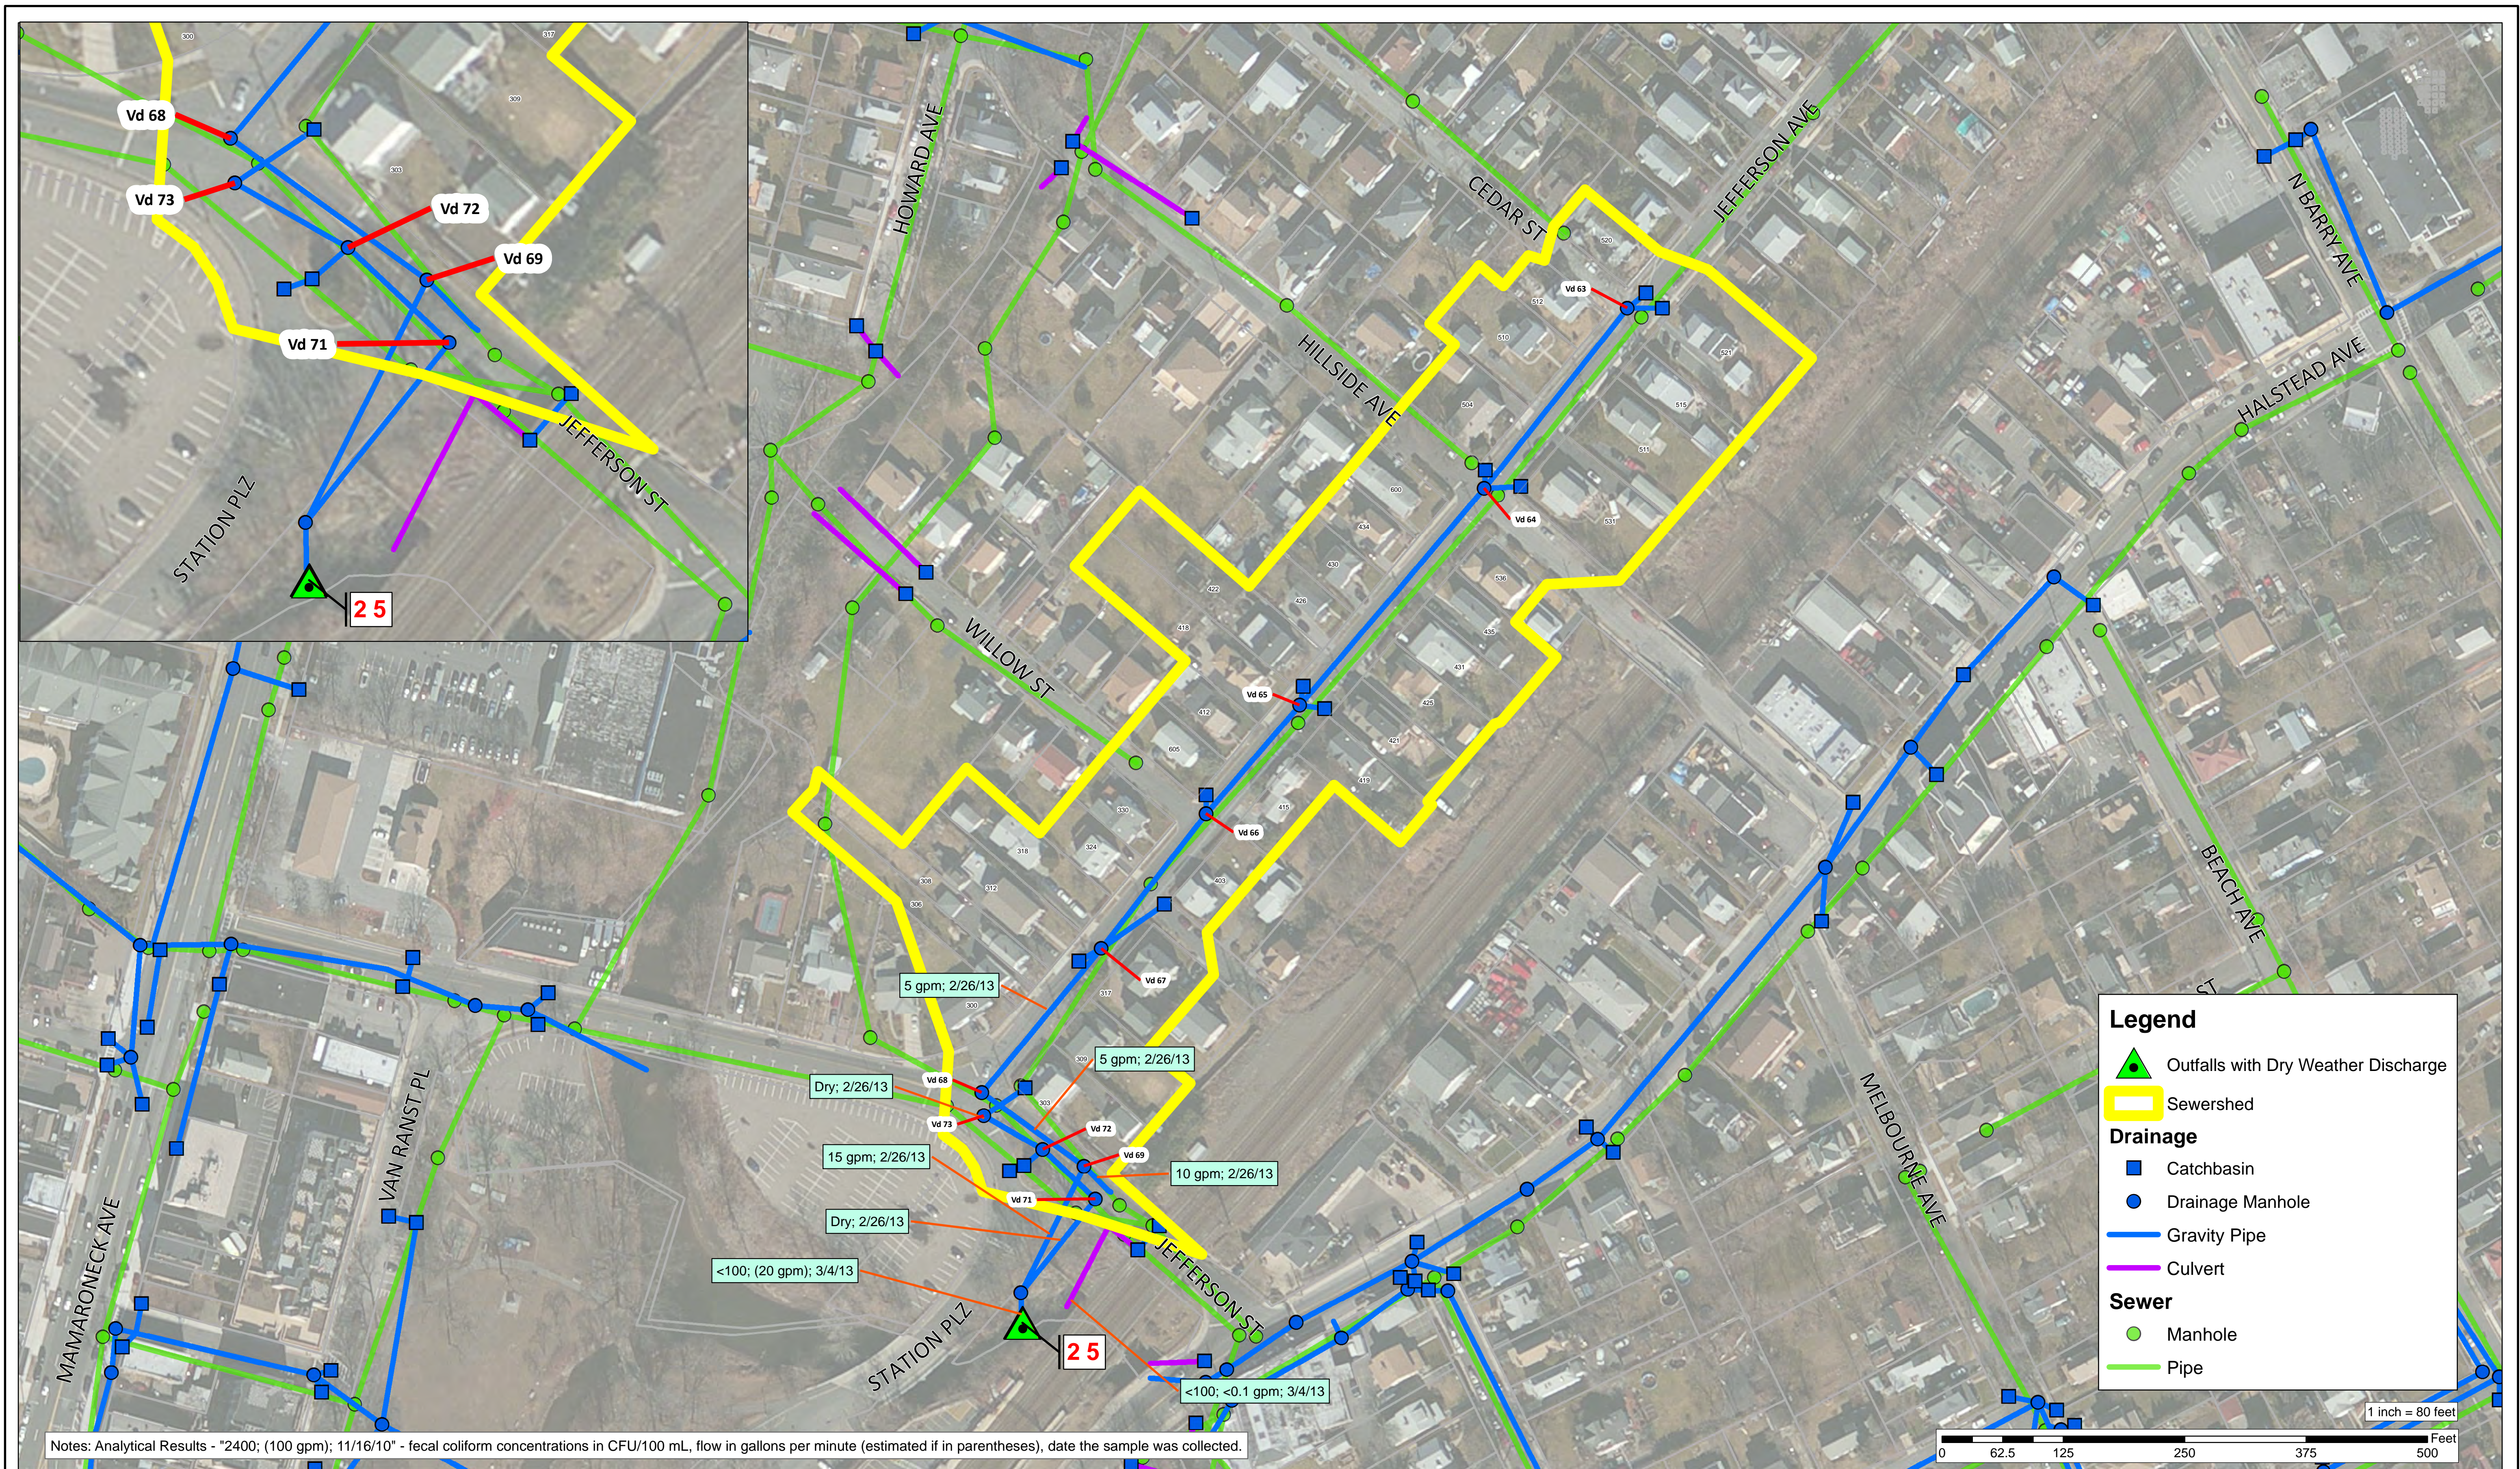
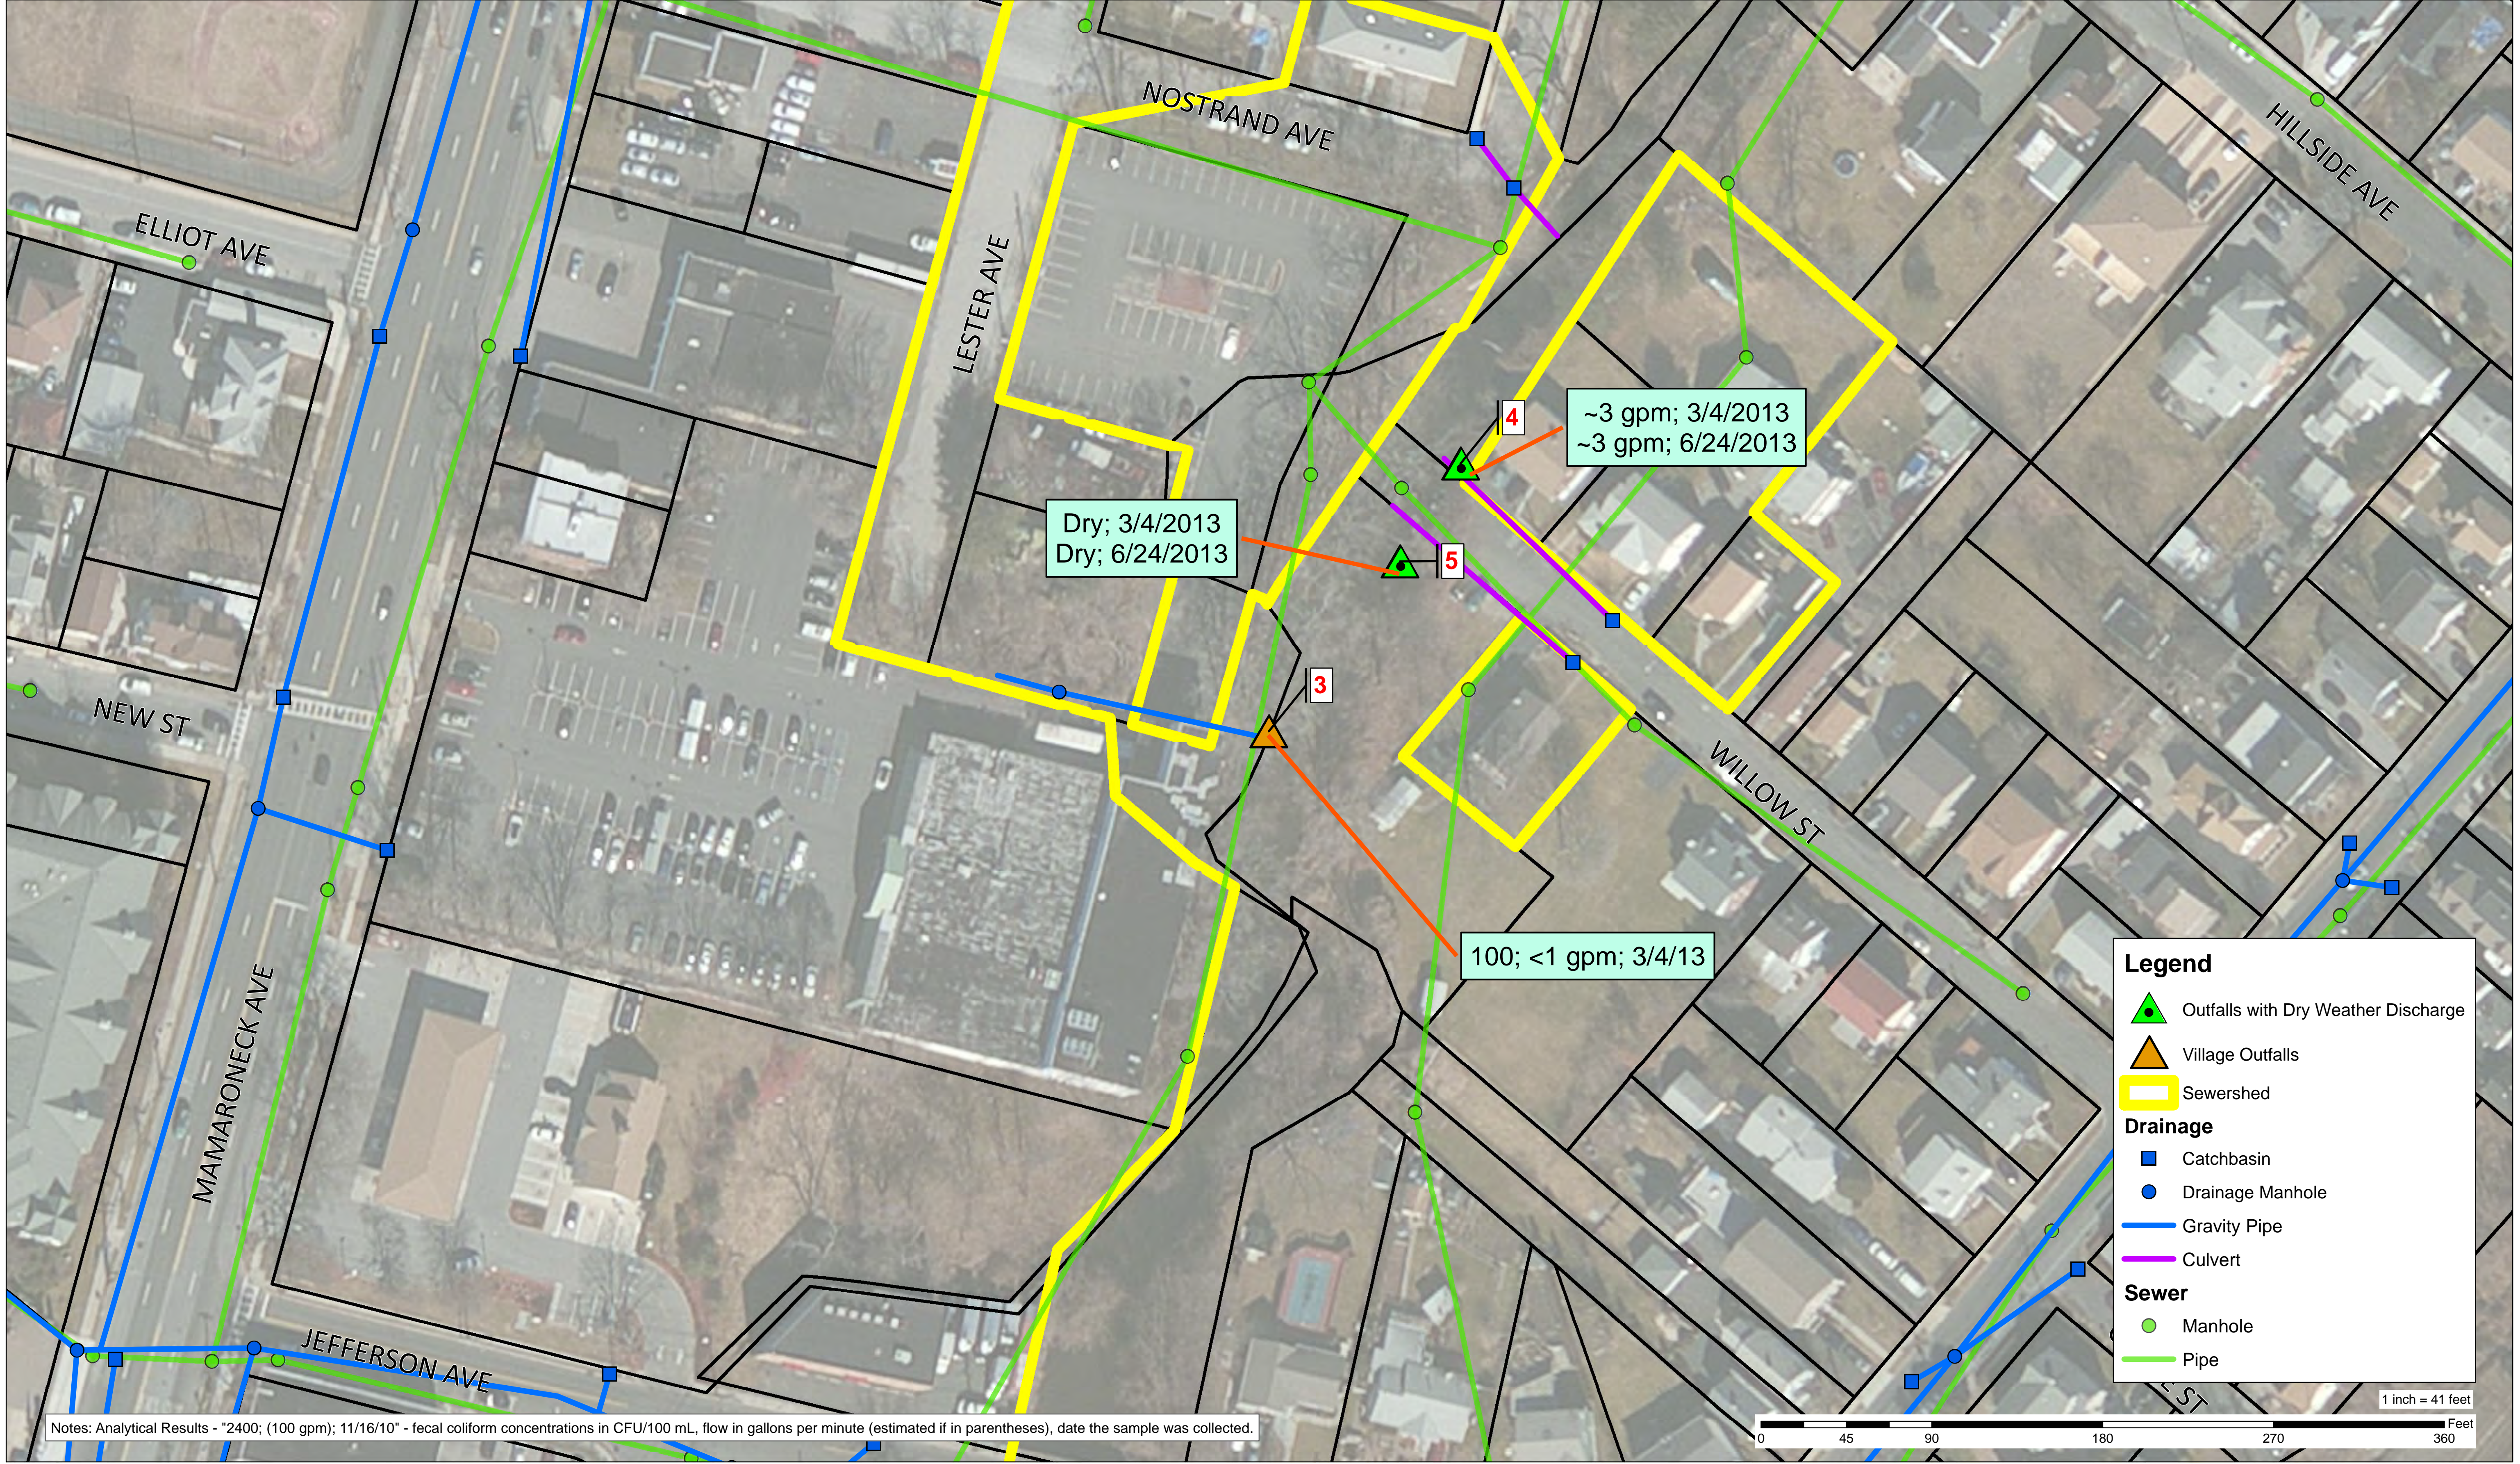
Drainage Area Investigation Maps

Notes: Analytical Results - "2400; (100 gpm); 11/16/10" - fecal coliform concentrations in CFU/100 mL, flow in gallons per minute (estimated if in parentheses), date the sample was collected.

The fluorescence readings on Hinman Place, Melbourne Avenue, and Brook Street, were relatively low, but indicated there is an additional source of fecal coliform on these streets. The drainage area investigation maps in Appendix E show the locations the samples were collected. Dye testing the buildings did not reveal any illicit discharges and, since the sanitary sewer is much lower than the storm sewer on these streets, a leaking sanitary sewer is not likely the cause for increased fecal coliform concentrations. The raccoon feces observed in the storm sewer is certainly a contributing factor. There is also a dead opossum in vh20 that could be contributing to the elevated concentrations. It is recommended that additional sampling be completed at Outfall 26 once the opossum is removed and the illicit discharge has been corrected. If the bacteria concentrations at that time warrant further investigations, DNA testing could be performed to determine if human fecal sources are more significant than animal sources. This could
