Subject:  
Illicit Discharge Detection and Elimination Study  
Outfall and River Sampling Results

Date:  
November 13, 2012

Technical Memo  
Mamaroneck Outfall and River Sampling

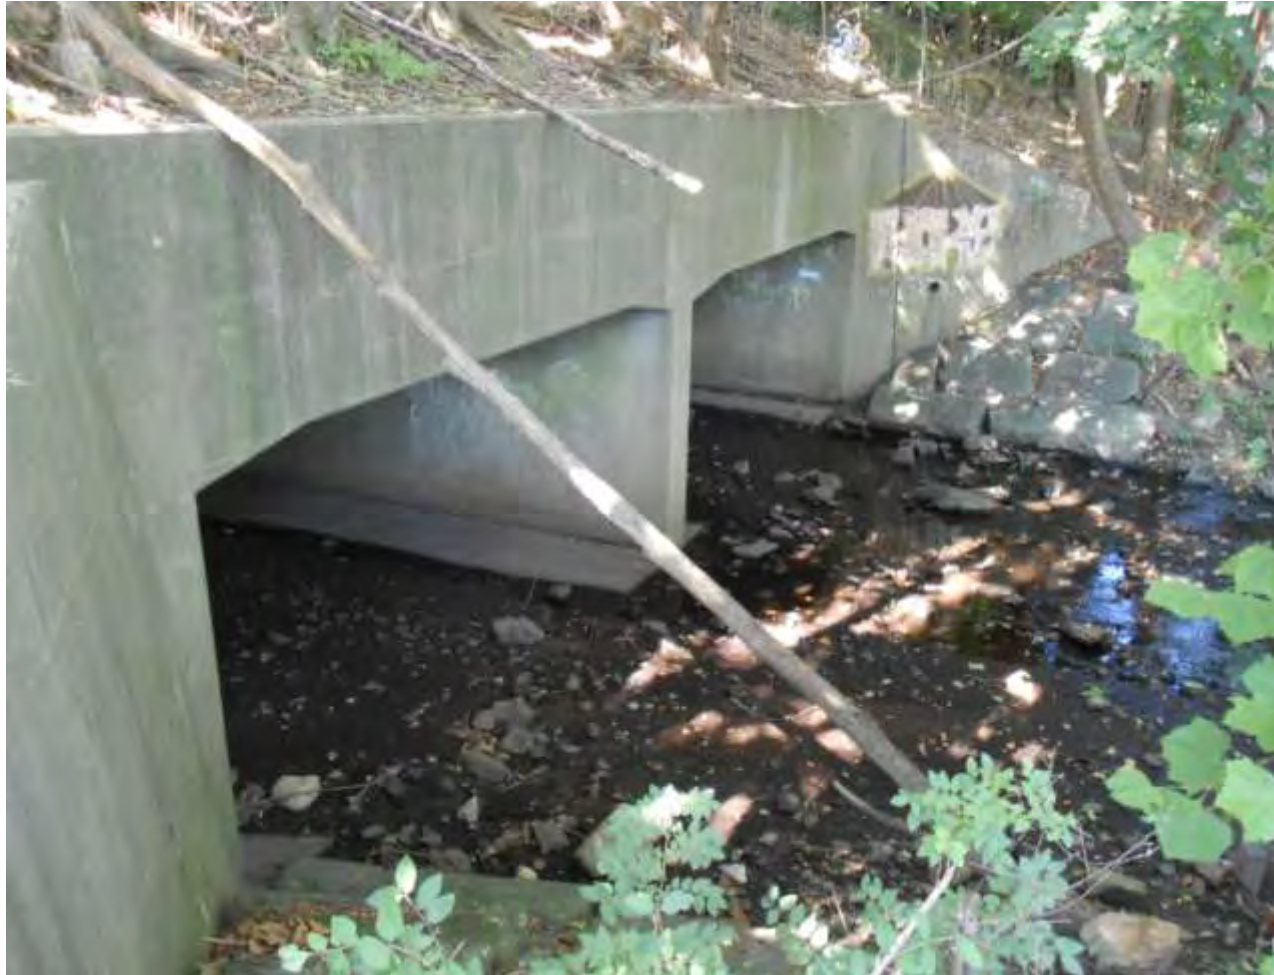
Location 1- 2 culverts, Left dry, Right with minimal flow.

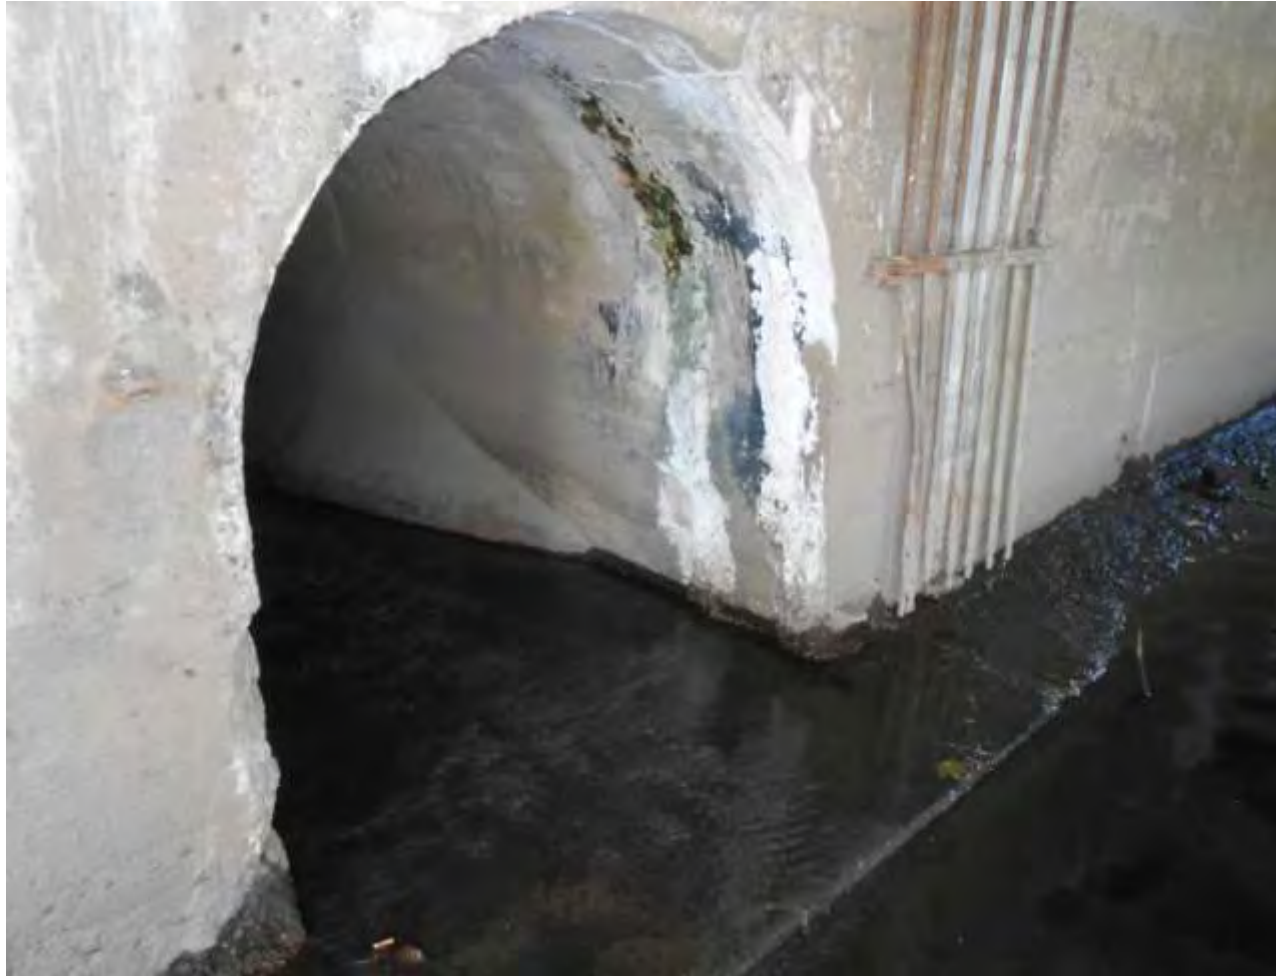
Location 2- Flow too shallow for flow measurements. Estimated discharge ~5 gpm.

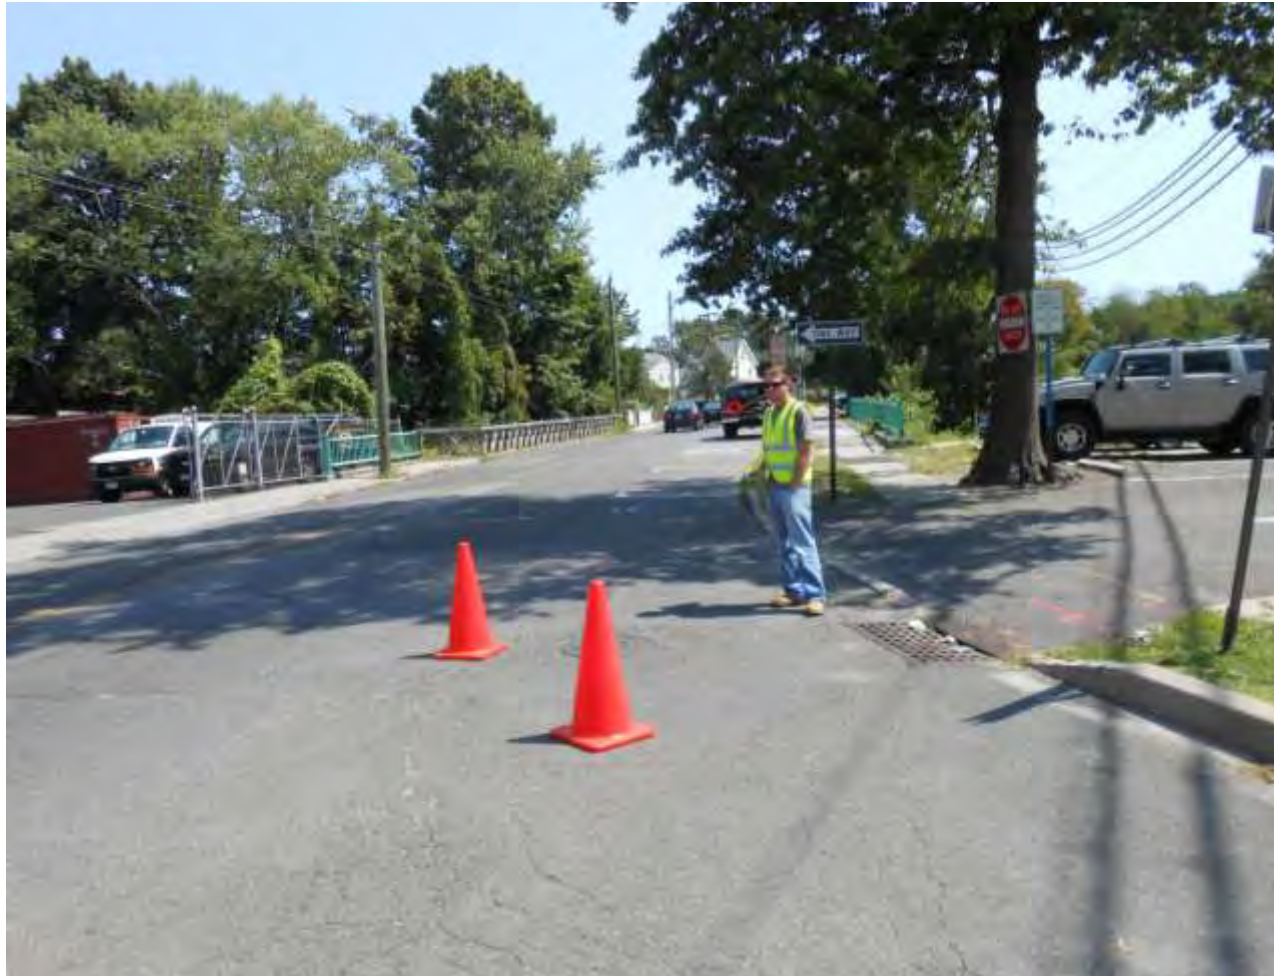
Location 2- Jefferson Ave, culvert over Mamaroneck river. Storm sewer located just before outfall, could be used as “judgment outfall location” for future sampling.

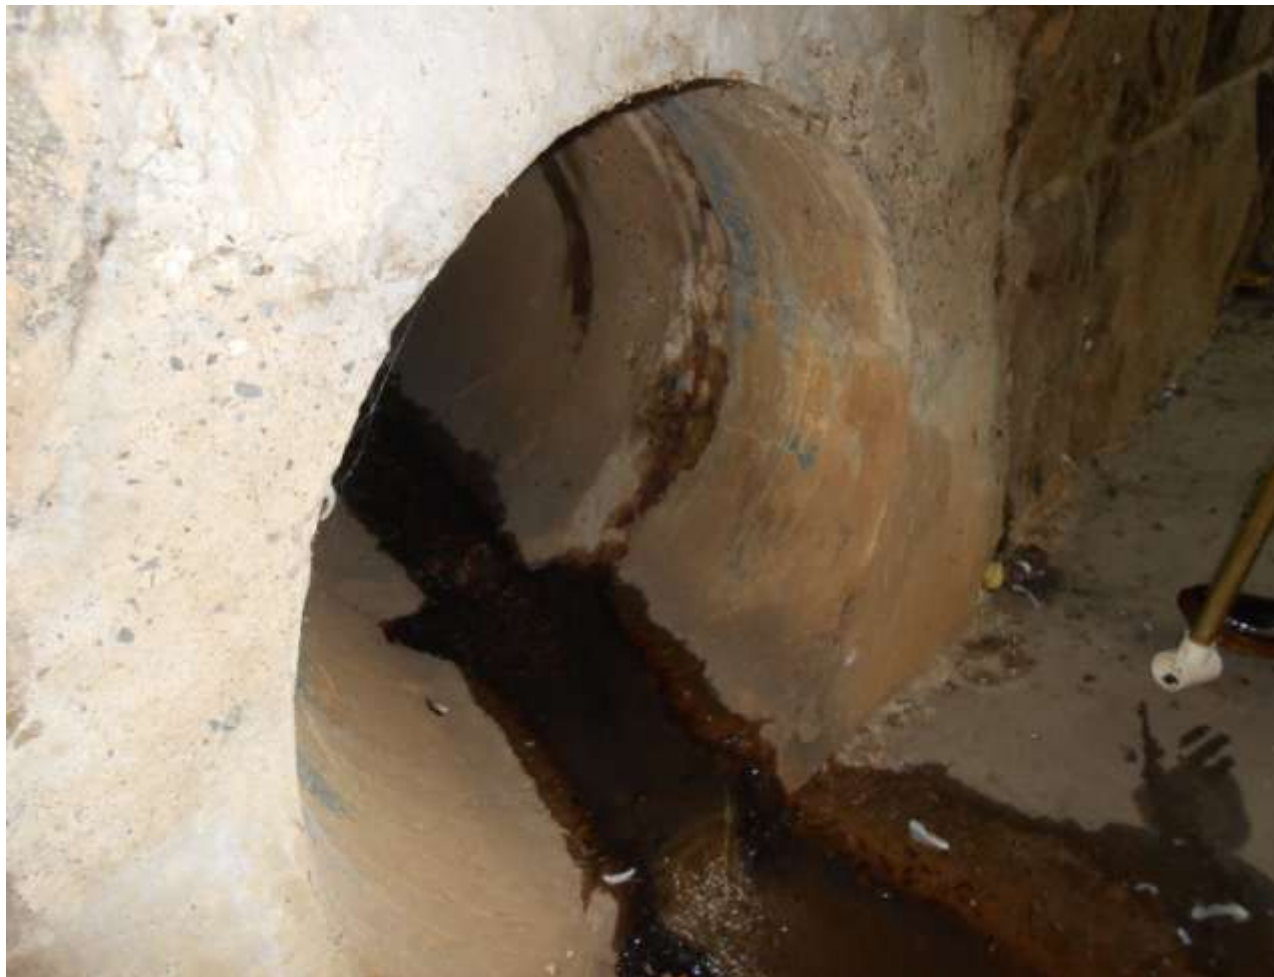
Location 3- Outfall 52 located in wall of Halstead Ave culvert. Sample collected.
